A.U.W.E. Tech Note 192/65

A CORROSION STUDY ON MATERIALS  
FOR USE WITH PHOSPHORUS & SULPHUR  
BEARING FUELS

ADMIRALTY UNDERWATER WEAPONS ESTABLISHMENT  
PORTLAND

EXAMINATION OF COMBUSTION CHAMBER COMPONENTS ETC.

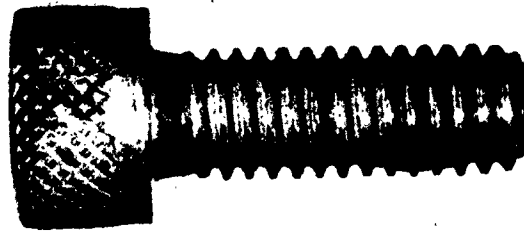
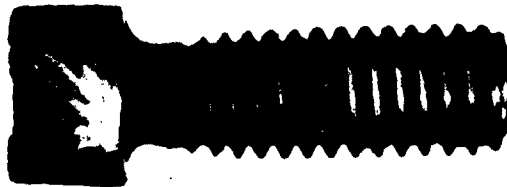
FIG 1

1. The head and last seven threads had been affected, the appearance being that of an eroded surface (Figure 1). The circumference of the head had been reduced and the socket enlarged to such an extent that the wall corresponding to one side of the hexagon had been removed almost completely (Figure 2).

14. It is considered that the set screw had suffered damage by corrosion/erosion. Erosion by flowing acid probably contributed the major part of the damage.

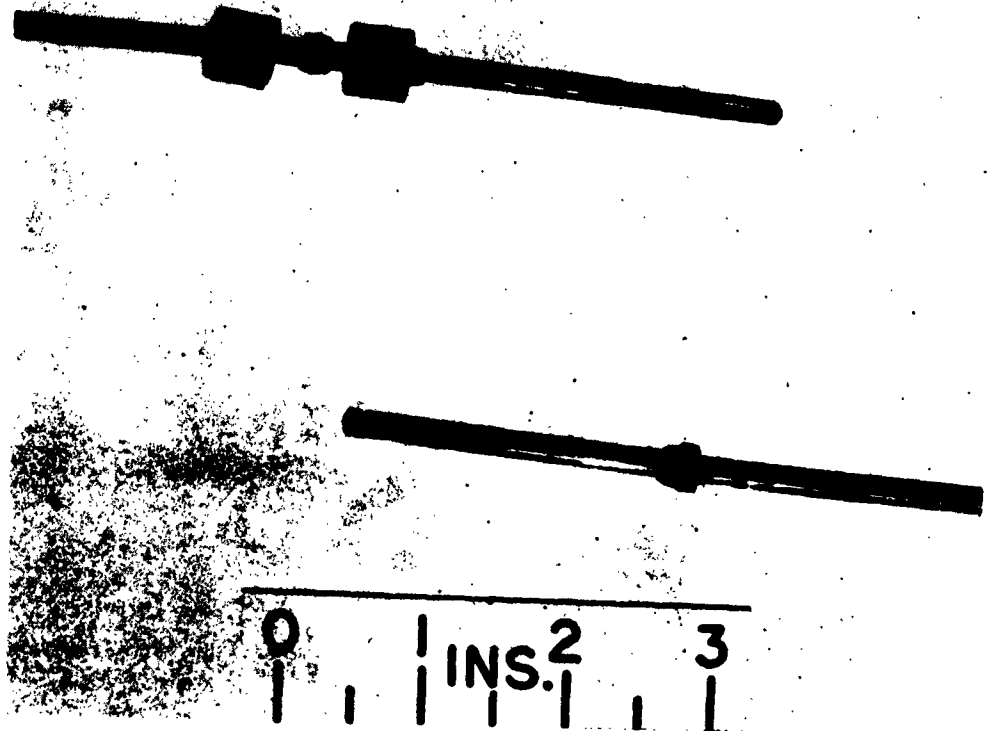
FIG 3

15. Figure 3 shows that an area of the probe approximately 0.7 inch long and half the circumference wide had a highly-polished appearance. Approximately at the centre line of this area and adjacent to the tip of the probe a longitudinal hole had been formed.

16. Further examination revealed that the wall thickness had been considerably reduced at the polished area, the area of maximum reduction resulting in a hole. The down stream side of the probe appeared heavily pitted, probably due to a form of abrasive blasting by extremely fine combustion product particles.

18. It is considered that failure of the thermocouple probe was principally due to erosion caused by fine combustion product in the gas stream. The flow of liquid droplets of phosphoric acid would also produce a polished and rounded surface.

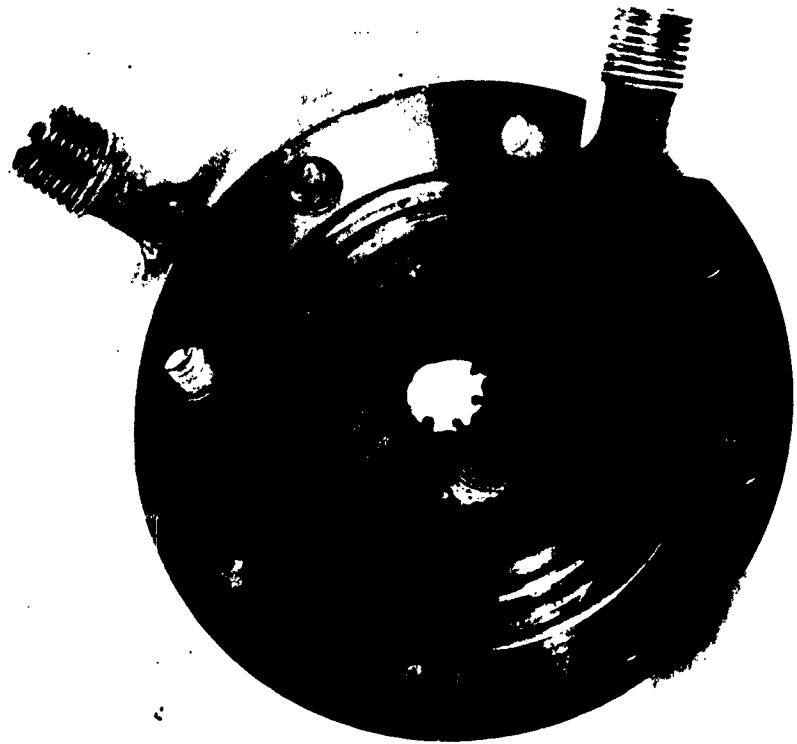
FIG 4  
UPSTREAM FACE

19. The mouth and bore of the diluent ring were covered with a green deposit of inorganic phosphate. The rear face was partially covered with a dark adherent metallic scale. The scale was subsequently found to be magnetic. The conical approach wall and areas adjacent to the water injection holes had been badly damaged (Figure 4). The rear face also suffered damage (Figure 5), the corrosion/erosion pattern being dependent on the location of the water injection holes.

25. It is considered that the damage to this component was caused principally by high-temperature corrosion from phosphorus compounds.

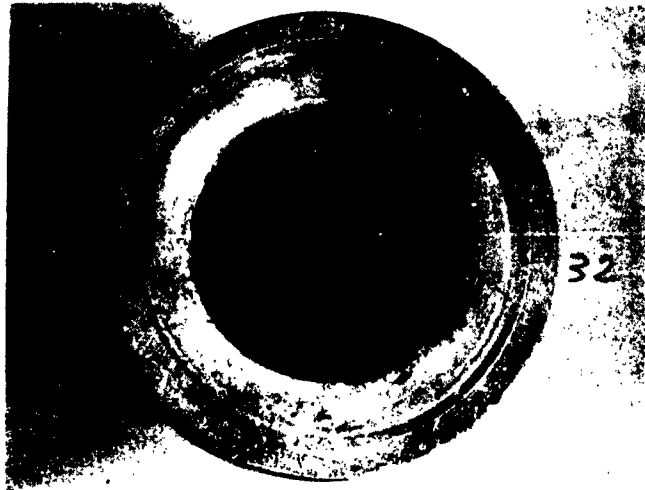
FIG 14

28. The upstream surface of the nozzle was covered with a green deposit of metaphosphate (Figure 14). The throat area showed evidence of coating failure due to blistering. The exhaust area was badly blistered and showed deposits of solid corrosion product. The rear face of the nozzle was also damaged (Figure 15).

30. The examination failed to show positive evidence of direct chemical reaction between combustion phases and the protective gold. It is considered that the damage to this component was caused by

- (a) chemical attack of the base metal through cracks and pores in the protective coating,
- (b) the action of the fast moving gas/liquid acid stream over the soft gold layer.

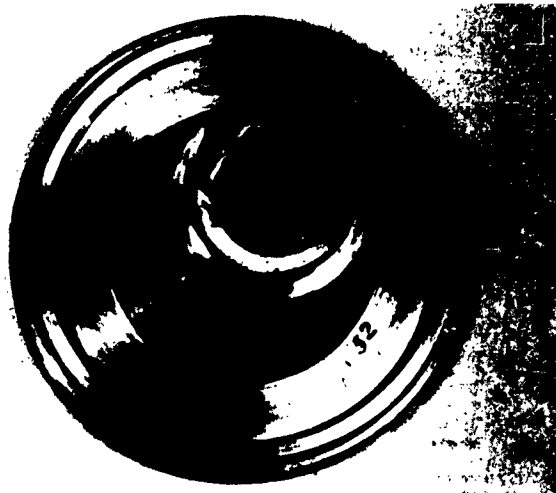
FIG 15

29. Metallurgical examination revealed that the blistering may have resulted from the effect of heat on poor quality plating. Irregular pile up of gold 0.030 inch thick appeared on the downstream surfaces. Areas were visible where the gold had been completely removed leaving the base metal exposed to the combustion gases.

31. However it is difficult to account for the large pile up of gold on the downstream surfaces unless the temperature within the chamber was higher than 400°C.

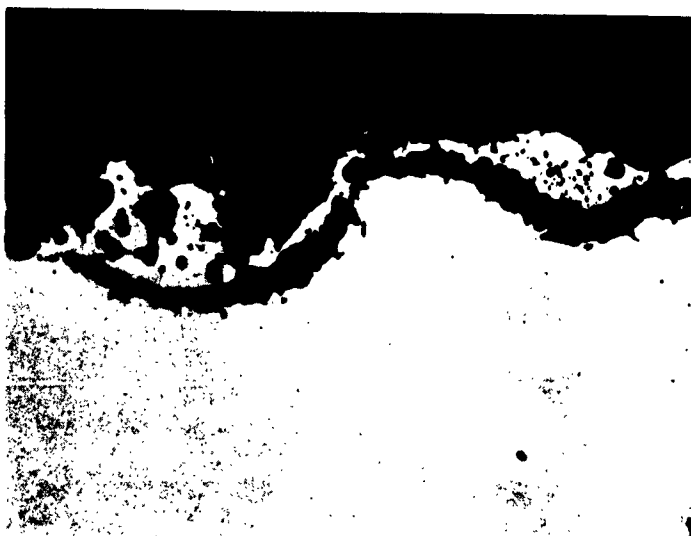
FIG 17

33. Microscopical examination showed an almost continuous non-adhering metallic scale at the damaged surfaces (Figure 17). Certain areas showed evidence of intercrystalline attack and deposits of metaphosphate associated with the metallic scale, (Figure 18). Subsequent etching revealed that the scale contained eutectic phosphides (Figure 19).

34. It is considered that the damage to this component was caused by reaction between base metal and phosphoric acid (probably metaphosphoric vapour) ultimately resulting in the formation of low melting point phosphides. These compounds once formed would be rapidly removed by the action of the gas stream.

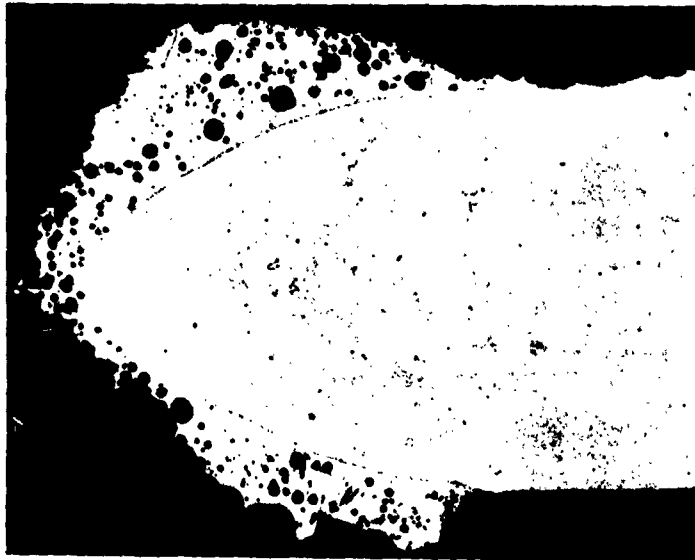
FIG 20

35. The tip of the exposed end had been completely removed while the remainder appeared to be covered with a dark metallic deposit. This deposit was subsequently found to be extremely hard and porous (Figure 20).

39. The porous nature of the deposit may have resulted from a gas-forming reaction similar to that of "carbon boil" in steel making. This would require removal and oxidation of carbon from the silver steel/deposit to form carbon monoxide by the reaction

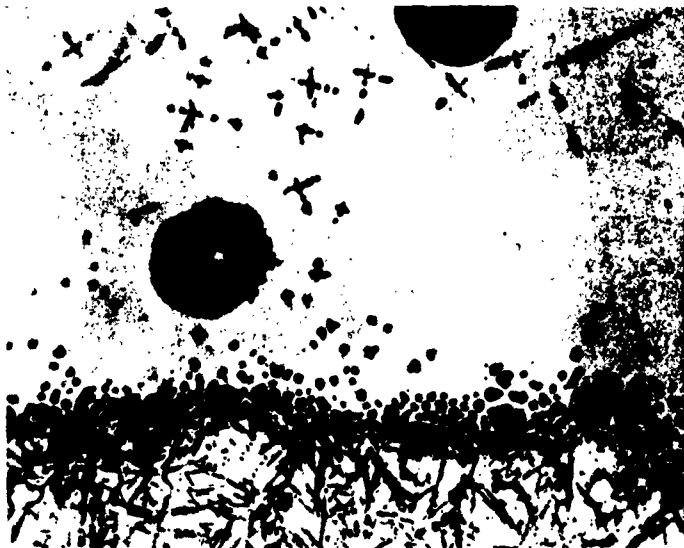
FIG 21

36. Microscopical examination of a longitudinal section cut from the rod revealed a rapid change in microstructure between unexposed and exposed areas. The former showed a spheroidised structure related to that of the original condition of the material. The latter was found to consist of coarse martensite, a structure normally associated with heating to temperatures above the upper critical followed by rapid cooling. The deposit was found to contain primary dendrites of martensite in a fine eutectic matrix. Figure 21 shows the structure after etching at the steel/deposit interface.

38. Although phosphorus was found in the deposit, the eutectic matrix was considered to be essentially transformed Ledeburite. This structure probably resulted from a temperature exceeding the equilibrium liquidus i.e. for silver steel approximately 1350°C.
