**Automatic Light Aircraft Readiness Monitor
Project ALARM**

VOLUME III

Project ALARM
AUTOMATIC LIGHT AIRCRAFT READINESS MONITOR
Phase II Test Program

VOLUME III
ADDENDUM - REINSTALLATION

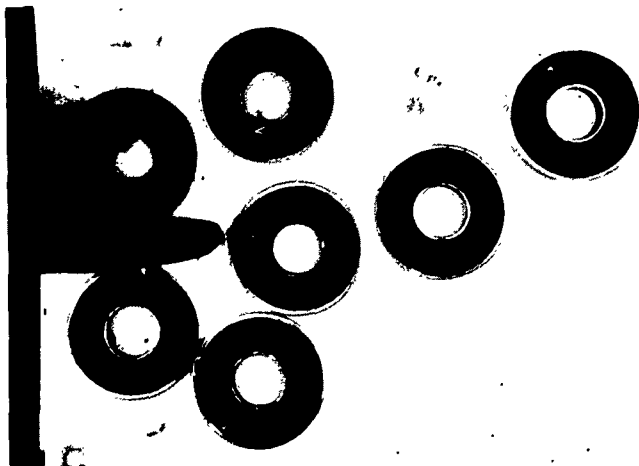
This section contains basic photographic documentation of certain specific component reInstallations. Figure 7 and Figure 8 are photographs showing evidence of accumulation of metal particles in the Engine Oil Filter. This condition was discovered during the process of reInstalling the new-type filter which contained the ALARM sensors.

The engine had been overhauled prior to installation on this particular aircraft and this prompted an investigation by the Lycoming Engine representative to determine the cause(s) of the accumulations. As a result of the investigation, it was determined that the particular engine oil filter (old-type) had not been properly maintained prior to installation in the engine.

Figure 8. Engine Oil Filter Screens (Shows evidence Of Metallic Particles After Engine Overhaul).
