**INTERIM RESEARCH REPORT NO. 16A**  
for  
**HIGH-SPEED DATA PROCESSOR  
SYSTEM RESEARCH**

**Project LIGHTNING**

This report covers the period of  
August 31, 1962 to November 30, 1962

**RADIO CORPORATION OF AMERICA**

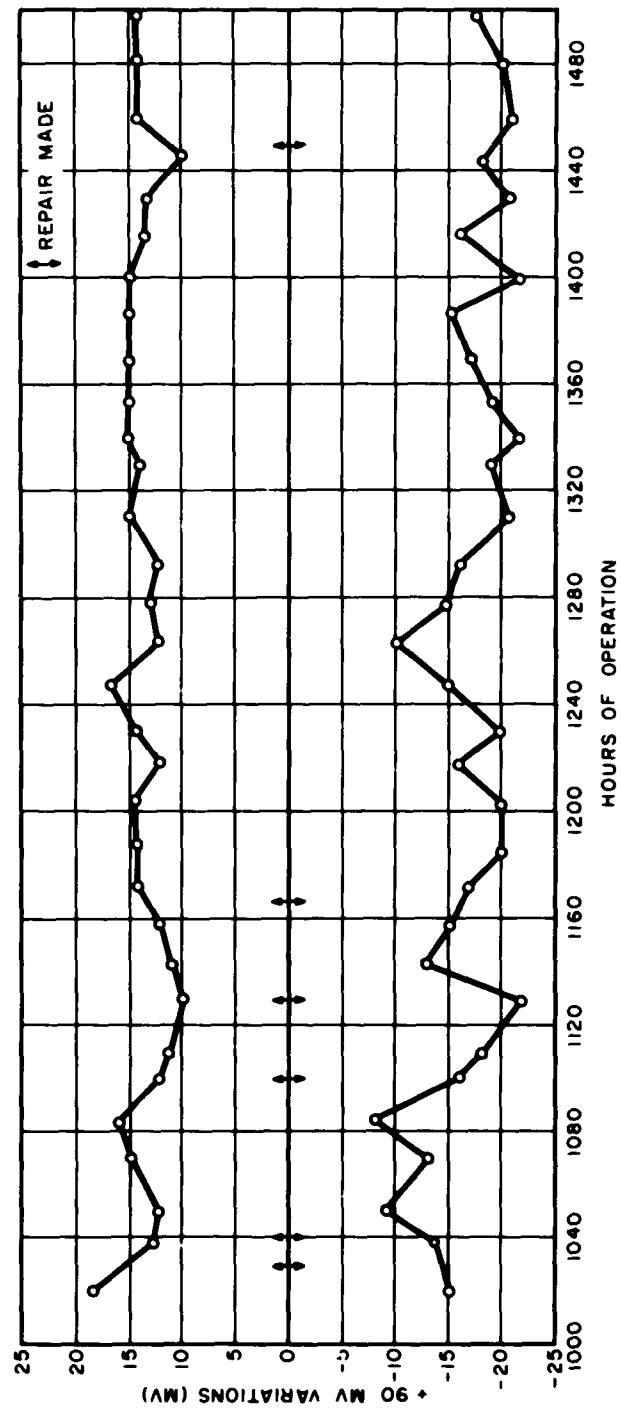
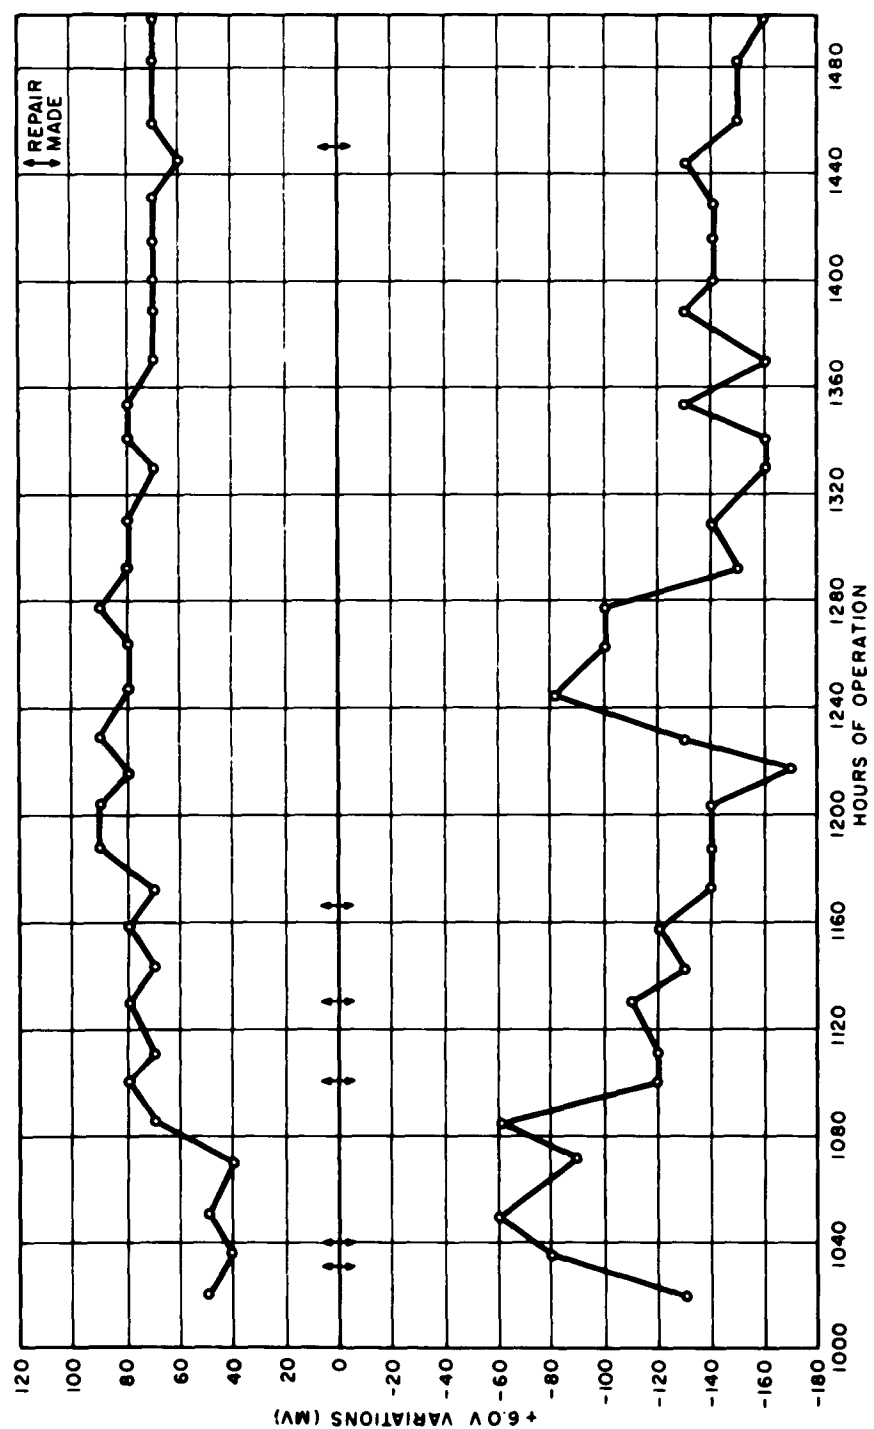
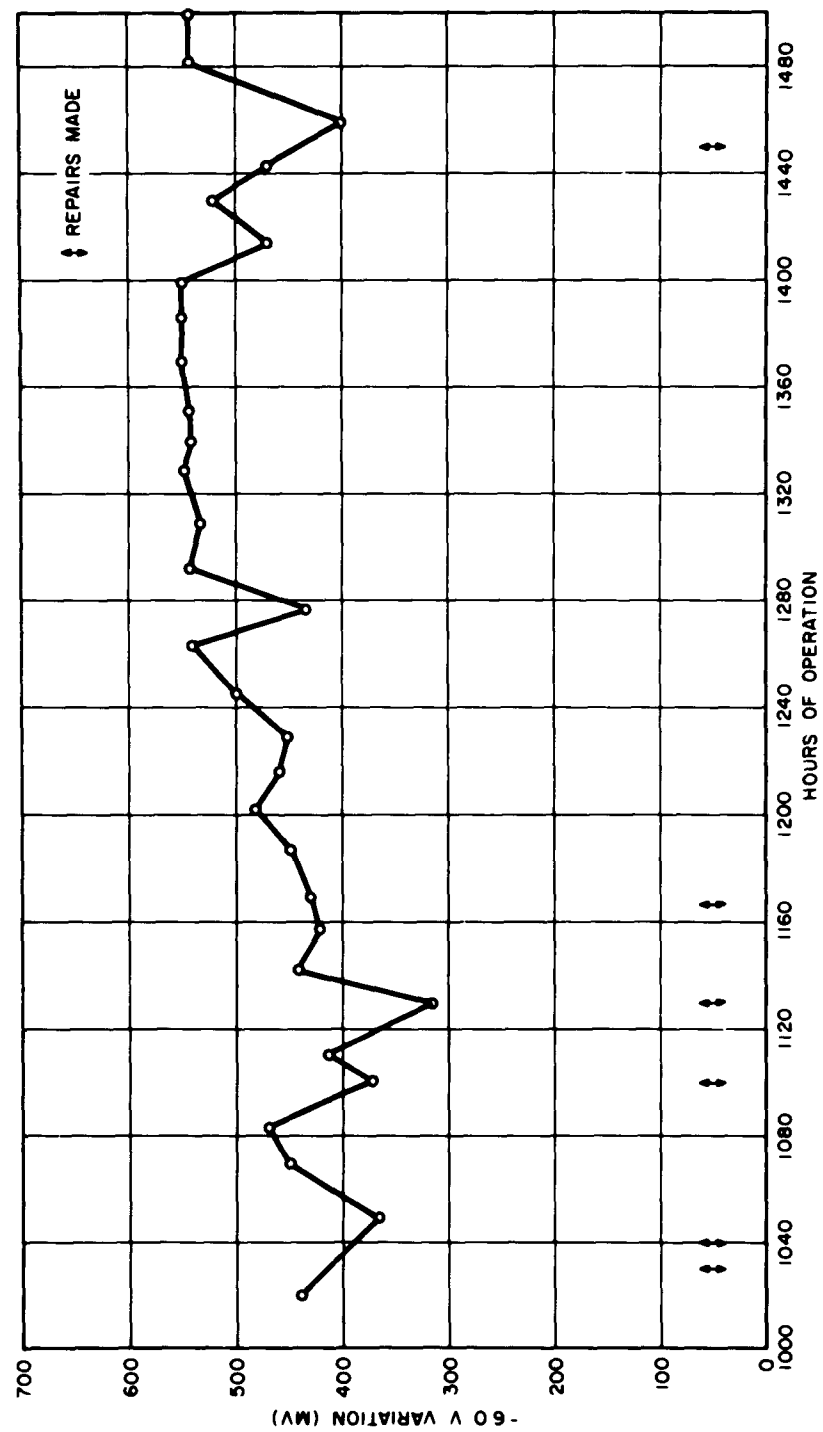
The graphs of Figures 2-1, 2-2 and 2-3 indicate the variation in the +90 mv, +6.0 v, and -6.0 v power supplies of the Logic Subsystem, up to the point where the system produces a malfunction. These variations were taken while the subsystem was running in its normal mode of operation. (INT, STEP, REP.)

Figure 2-1. +90MV Variation of Logic Subsystem vs. Hours of Operation in its Normal Operating Mode

Figure 2-2. +6.0V Variation of Logic Subsystem vs. Hours of Operation in its Normal Operating Mode

Figure 2-3. —6.0V Variation of Logic Subsystem vs. Hours of Operation in its Normal Operating Mode

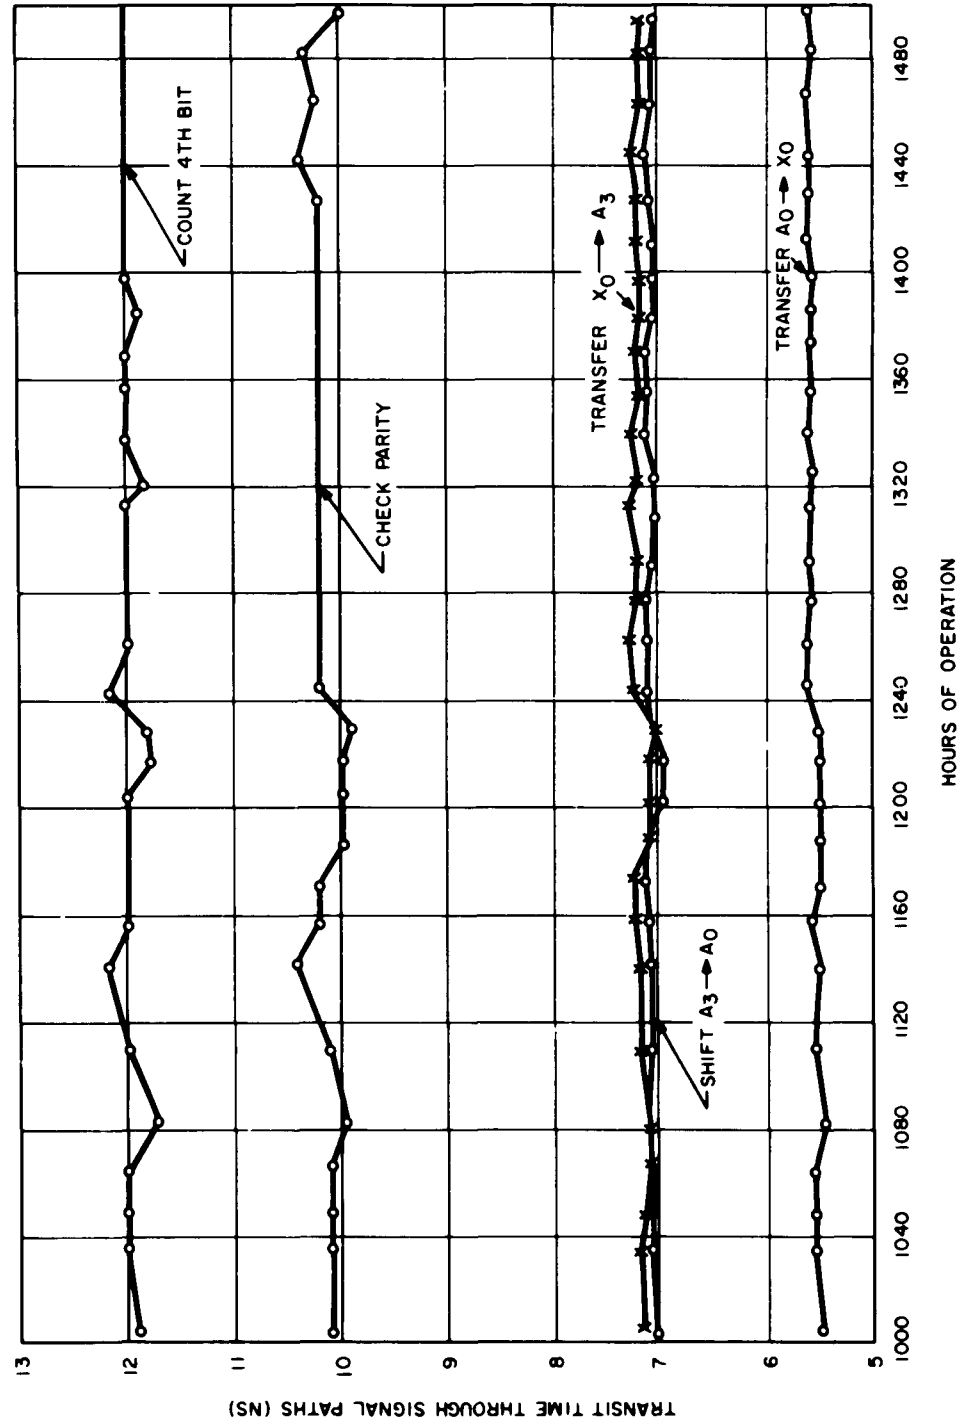
Figure 2-4 shows the time it takes to complete commands from the control logic vs. hours of operation. There is no indication of any change in these times. The variations are due to measurement discrepancies. These curves are typical of other measurements made; for instance, the period of the control program vs. hours of operation; and the transit time through a typical signal path vs. hours of operation, which also show no distinct changes.

Figure 2-4. Plot of Time to Complete Control Commands vs. Hours of Operation in the Logic Subsystem at Nominal Voltages

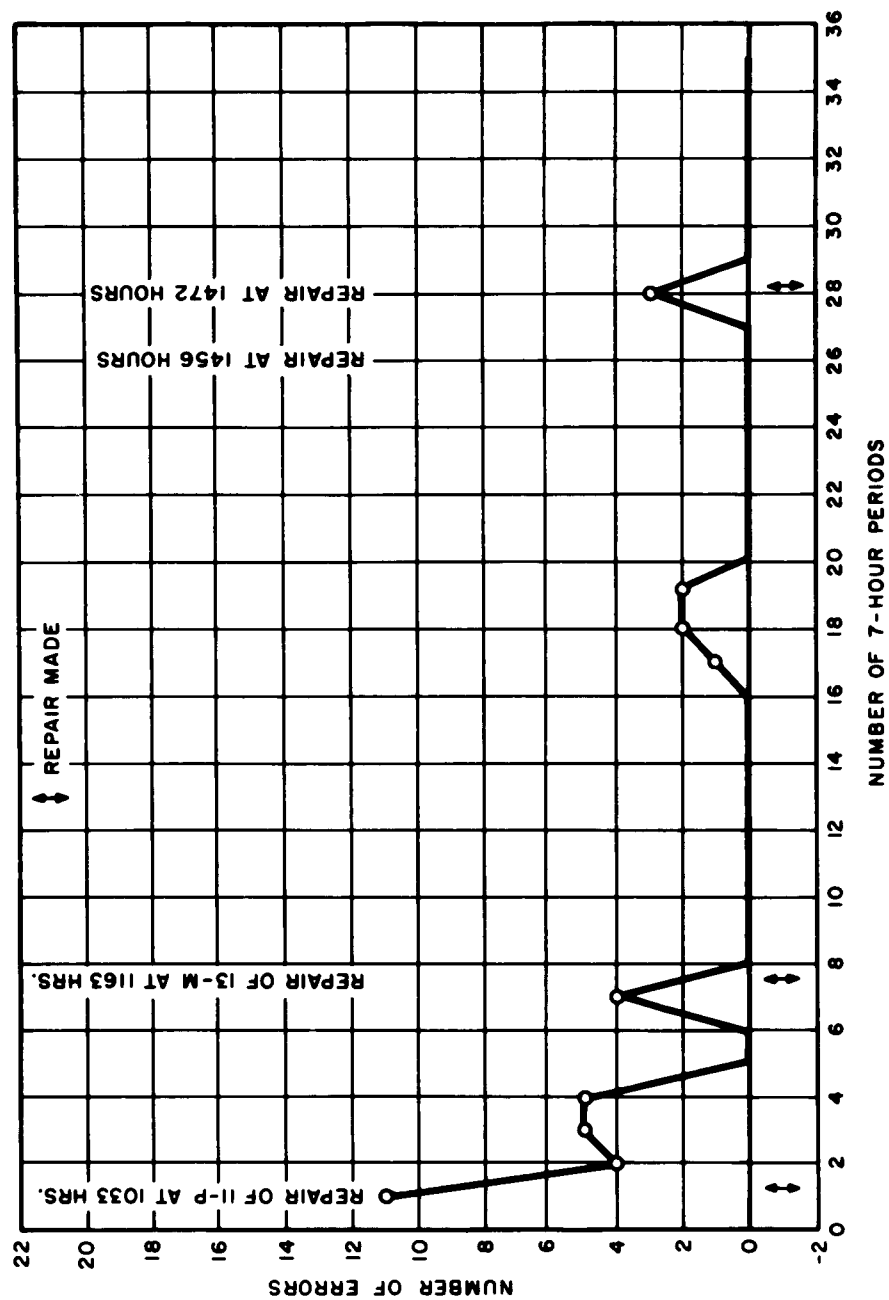
All errors made by the subsystem were recorded during the second half of the 16-hour daily periods. There is no indication of malfunctions due to noise sensitivity. All malfunctions were due to intermittent conditions which eventually resulted in a major repair. Figure 2-5 shows a curve of the number of errors made versus a 7-hour period of observation. The errors were detected individually by removing the PEO in the Logic Subsystem, thereby stopping the system for each malfunction.

Figure 2-5. Number of Errors vs. Number of 7-Hour Periods of Logic Subsystem Operation
