AIR FORCE REPORT NO.  
SAMSO-TR-69-37

## Flaw Growth in Ti-6Al-4V in Freon Environments

Prepared by L. RAYMOND and R. J. USELL  
Materials Sciences Laboratory

November 1968

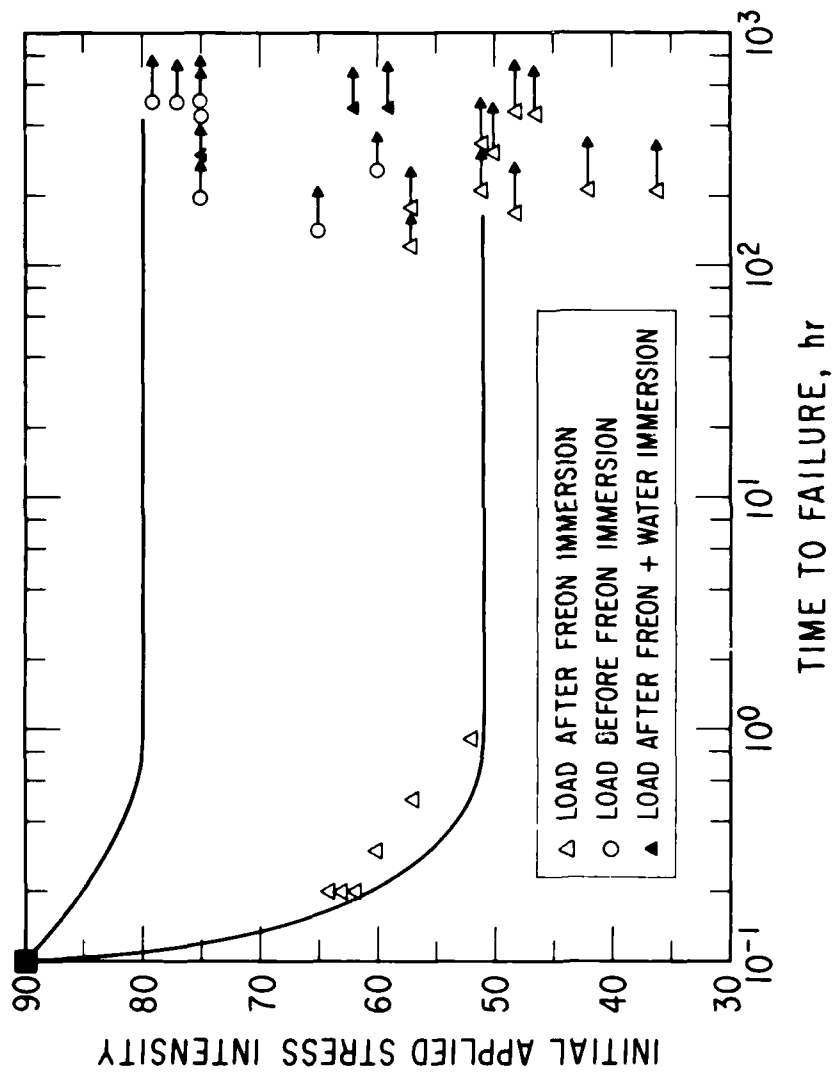
For specimens exposed to Freon MF, time-to-failure versus initial applied  $K_c$  is plotted in Fig. 2. The data are listed in Tables 2 and 3. The data points with arrows (Fig. 2) indicate that the test was terminated and no crack growth was observed; those without arrows indicate that the specimens failed. The shaded triangles represent the water-saturated Freon MF environment; the circles represent the load before Freon MF immersion.

Figure 2 shows that  $K_{th}/K_c$  was 0.57 when specimens were loaded after immersion, increasing to more than 0.85 when specimens were loaded in air for several hours prior to immersion in Freon MF. Figure 2 also shows that loading in the presence of water-saturated Freon MF results in  $K_{th}/K_c$  of more than 0.83.

Figure 2. Ti-6Al-4V Exposed to Freon MF

The data shown in Fig. 2 indicate that the primary function of the stress intensity at the crack tip is to expose fresh titanium metal to the Freon MF environment and to keep the crack moving sufficiently fast that repassivation does not occur. The specimens loaded in air for several hours prior to exposure to Freon MF were unaffected for applied stress intensity values approaching  $K_{IC}$ . Presumably, an oxide coating protected the crack tip. For specimens loaded in the Freon MF environment, applied stress intensity values greater than  $0.57 K_{IC}$  were sufficiently high to initiate and sustain the Freon MF attack. The higher oxidation power of the water-saturated Freon MF environment protected the crack tip from attack.

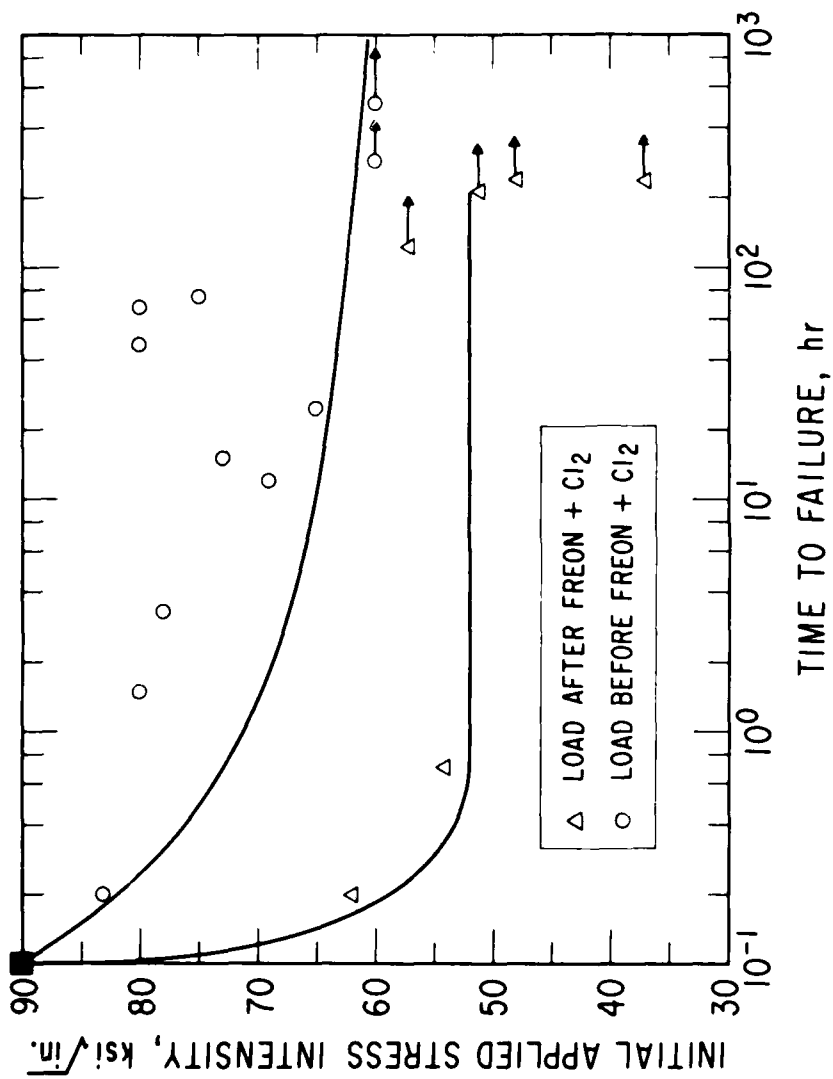
For specimens exposed to Freon MF with from 20 to 100 ppm of Cl<sub>2</sub> added, time-to-failure versus initially applied  $K_c$  is plotted in Fig. 3. The data are listed in Tables 2 and 3. Again, the data points with arrows indicate that the test was terminated and no crack growth was observed, while those points without arrows indicate that the specimen failed.

Figure 3 shows that  $K_{th}/K_c$  is 0.57 when specimens were loaded after immersion in chlorinated Freon MF. Also, note that the time-to-failure curve is similar to that obtained in the uncontaminated Freon MF environment; i. e., all failures occurred in less than 1 hr.

Figure 3. Ti-6Al-4V Exposed to Freon MF + Cl<sub>2</sub>

The effect of chlorine additions on the titanium-Freon MF interaction may be seen by comparing Figs. 2 and 3. The oxide film that formed during preload in air and protected the crack tip from Freon MF did not protect the crack tip from chlorinated Freon MF. The applied stress intensity versus time-to-failure behavior for the specimen preloaded in air and exposed to chlorinated Freon MF is distinctly different from the other data. The remaining three curves of Figs. 2 and 3 contain no failure times in excess of 1 hr; however, failure times approaching 100 hr were recorded for the specimens preloaded in air and exposed to chlorinated Freon MF. Very little of this long failure time could be attributed to crack propagation; most of the time was consumed in attack of the oxide coating. Presumably, the principal damaging function of the chlorine is to aid the degradation of the oxide coating since the threshold stress intensity value is essentially the same for both Freon MF environments.

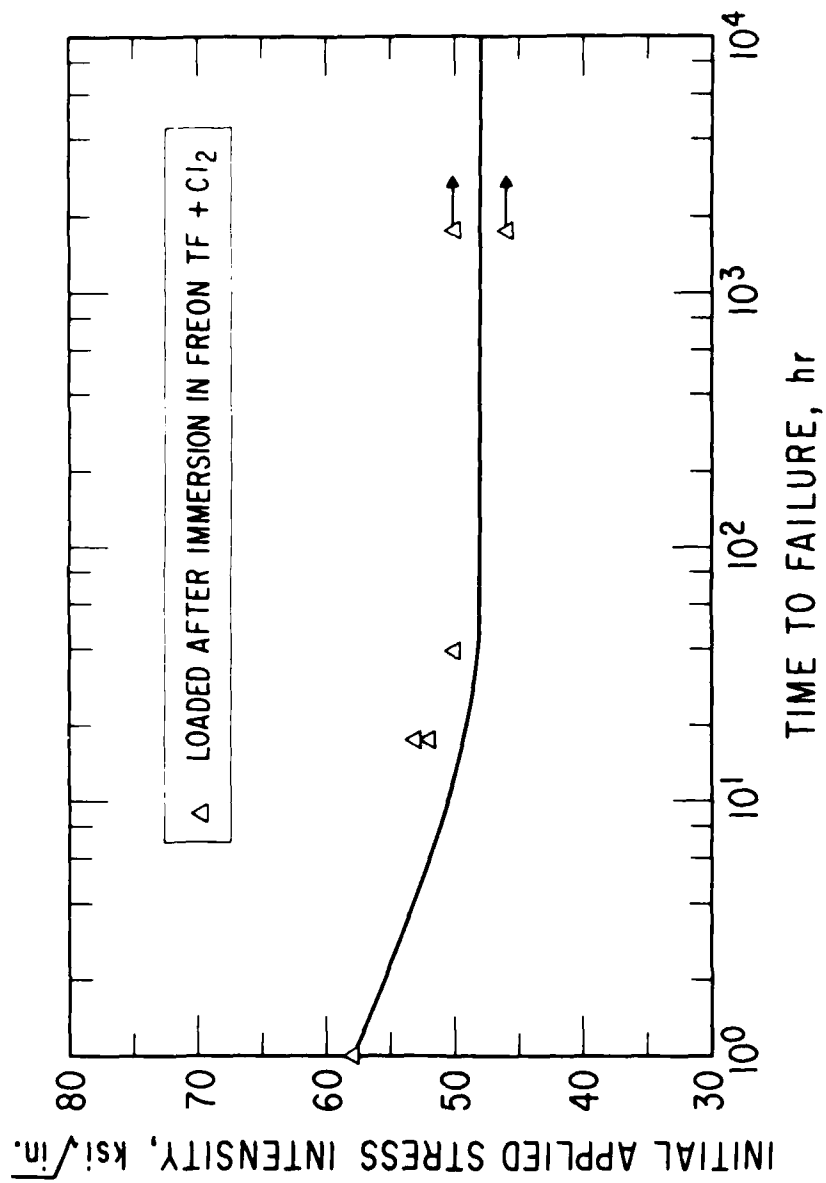
For specimens exposed to chlorinated Freon TF, time-to-failure versus initial applied  $K_c$  is plotted in Fig. 6; the data are listed in Table 3. Figure 6 shows that  $K_{th}/K_c$  is 0.85. Direct evidence of the attack is provided by Fig. 7. The environmentally induced crack growth region (B) is plainly visible ahead of the fatigue region (A). Region C fractured rapidly.

Figure 6. Ti-6Al-4V Exposed to Freon TF + Cl<sub>2</sub>
