**USAAVLABS TECHNICAL REPORT 68-82**

**DEVELOPMENT OF A  
CRASH-RESISTANT FLAMMABLE FLUIDS  
SYSTEM FOR THE UH-1A HELICOPTER**

**S. Harry Robertson**

January 1969

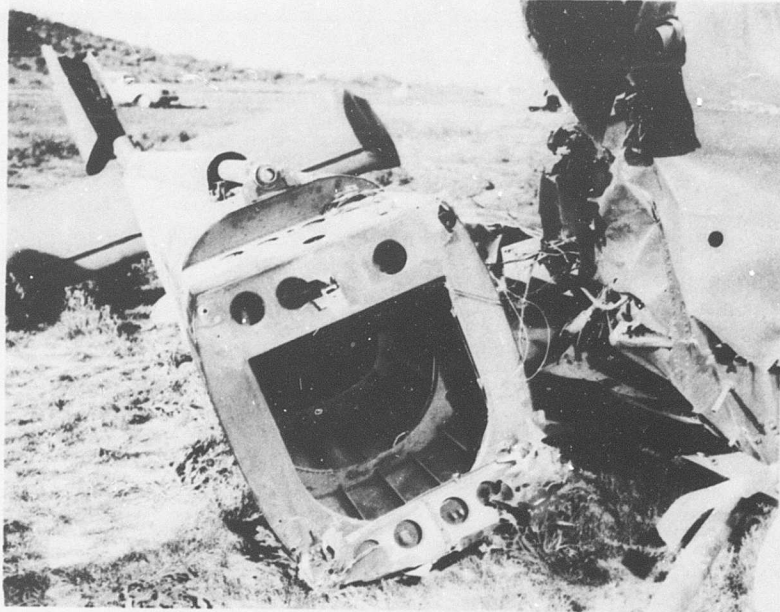
Figure 37. Tail Boom Broken From Fuselage.

The main rotor blades remained attached to the rotor head. The main transmission, as well as the engine, broke free of all mountings and displaced leftward, as shown in Figures 39, 40, and 41. Most of the cabin roof was torn free, and the fuselage broke, nearly separating, where the aft passenger compartment vertical bulkhead joins the floor; see Figure 42.

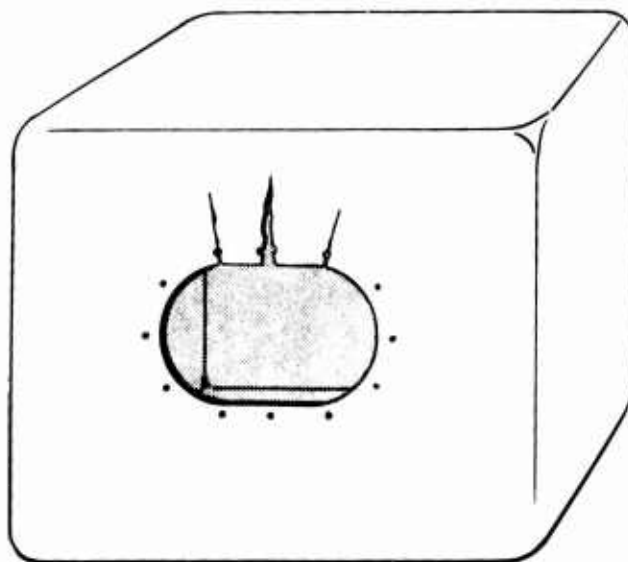
Figure 61. Tank Wall Failure as a Result of Overstressed Bearing Holes.

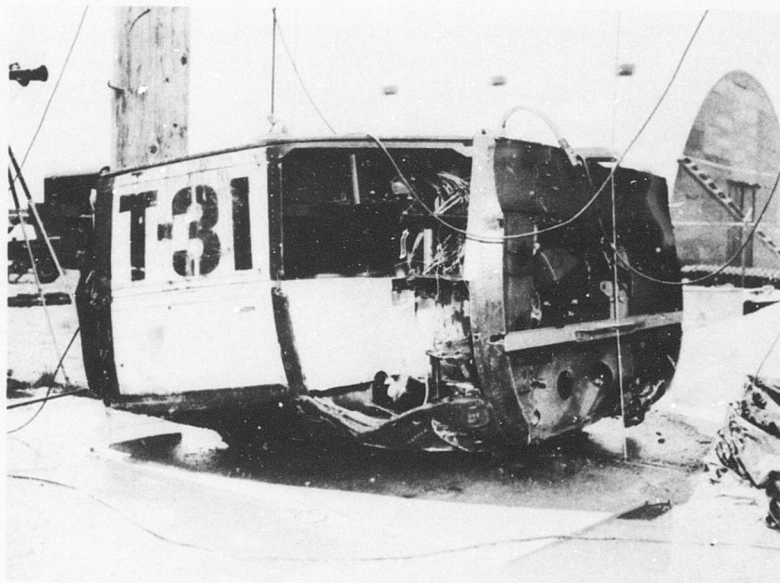
Figure 96. Posttest View of Section - Left and Rear Sides.

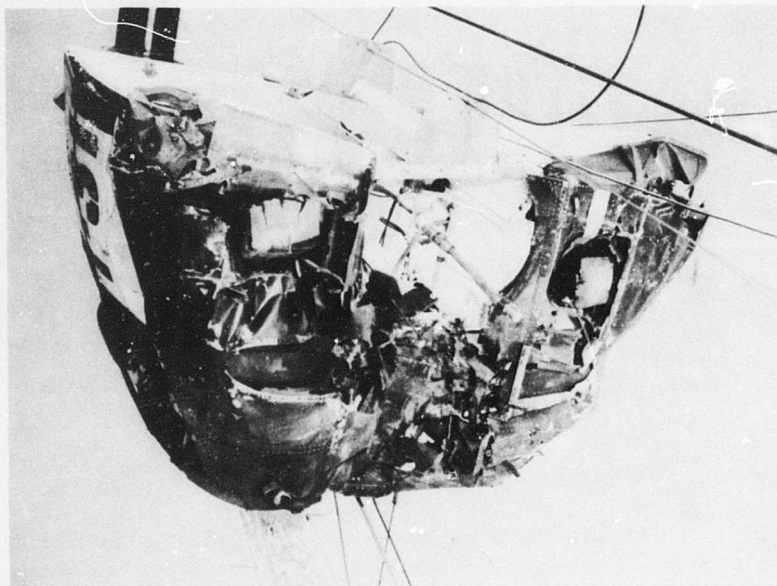
Figure 98. Posttest Condition of Bottom of Fuselage Section.

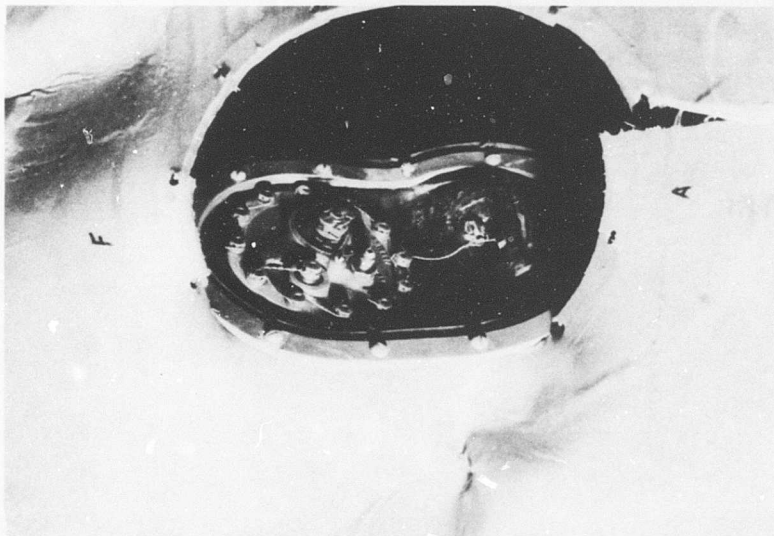
Figure 102. Damage to Boost Pump and Fuel Cell.

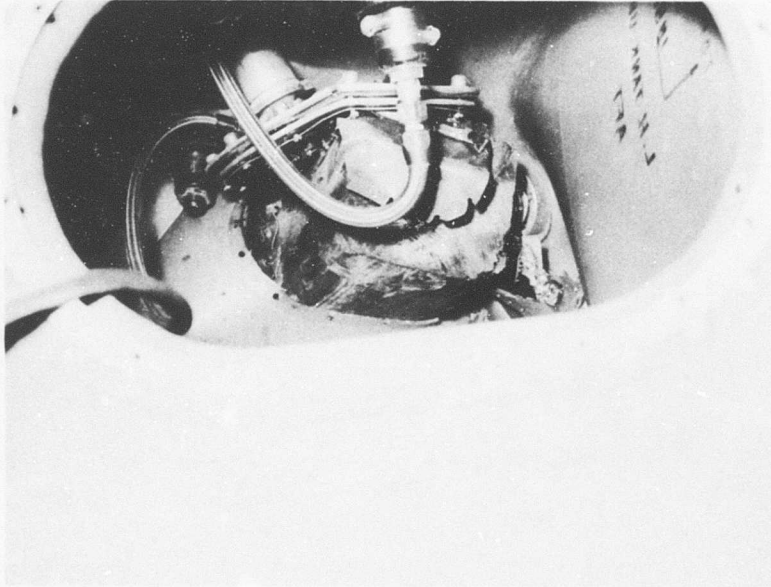
Figure 103. Railroad Tie Penetration Into Left Cell.
