Report No. FAA-RD-71-3

# TITANIUM FUSELAGE ENVIRONMENTAL CONDITIONS IN POST-CRASH FIRES

Constantine P. Sarkos  
National Aviation Facilities Experimental Center  
Atlantic City, New Jersey 08405

MARCH 1971

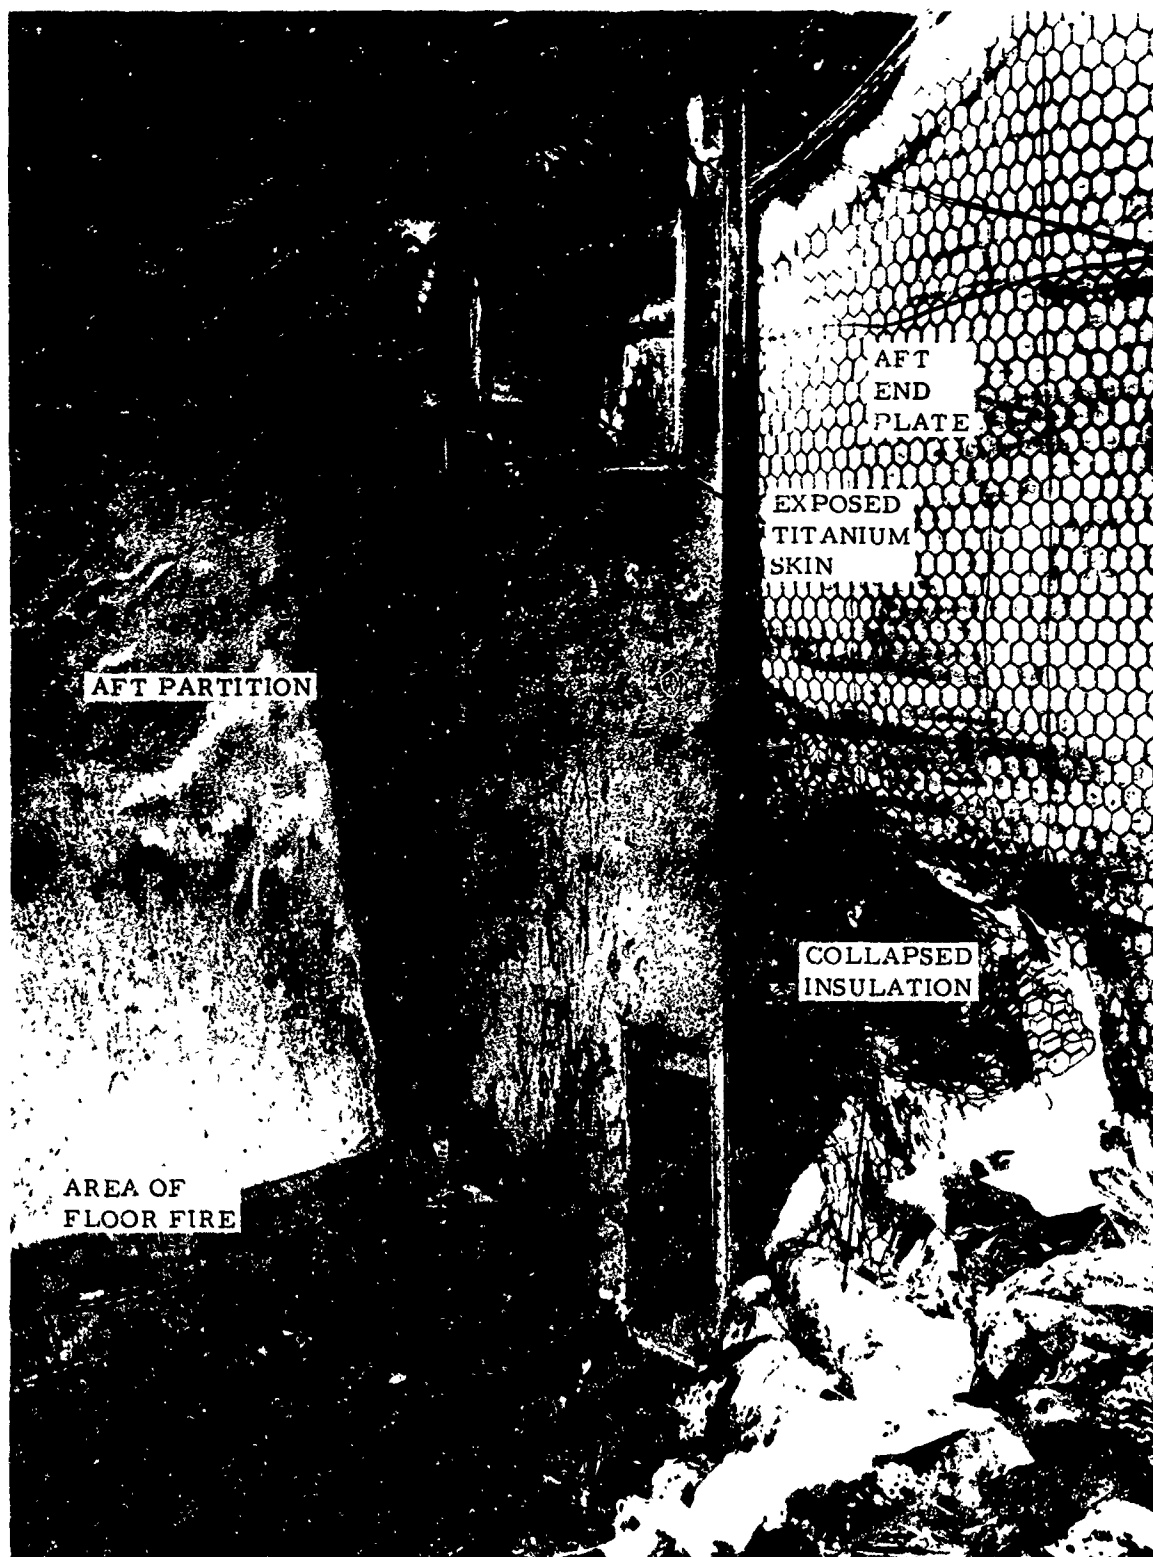
The short length of fuselage sidewall extending from the end plate to each partition was not insulated in the original titanium test article. It was necessary to insulate this area with fiberglass supported by chicken wire. As is noticeably evident in Figure 16, the insulation mounted at the aft end of the fuselage collapsed at some time during the test. This then allowed for a significant increase in heat transfer from the adjacent firewhirl which may have contributed (in addition to the panel interface and vent flaming) to the early heating of the cabin environment. The partition experienced fire damage alongside the interior panel from flames which, as will be subsequently demonstrated, originated from burning RTV sealant and fiberglass insulation.

FIGURE 16 - DAMAGED CABIN NEAR AFT END

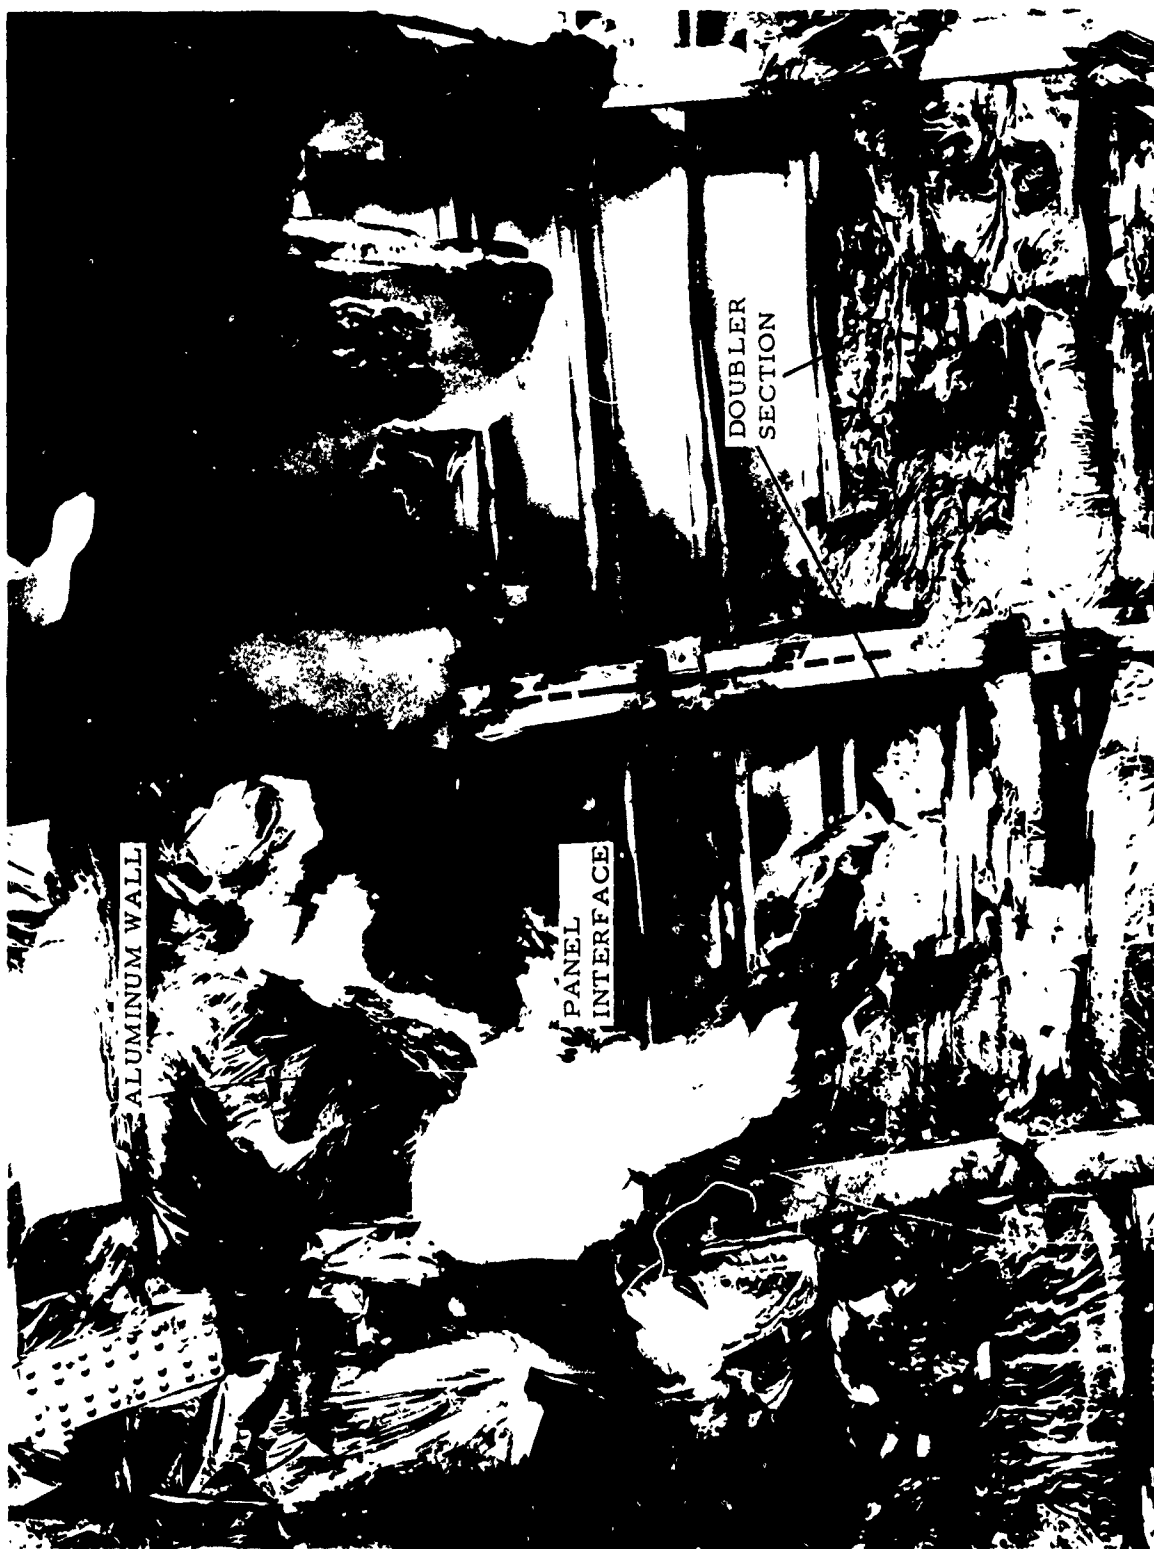
FIGURE 18 - BURNED INSULATION ABOVE DOUBLER SECTION

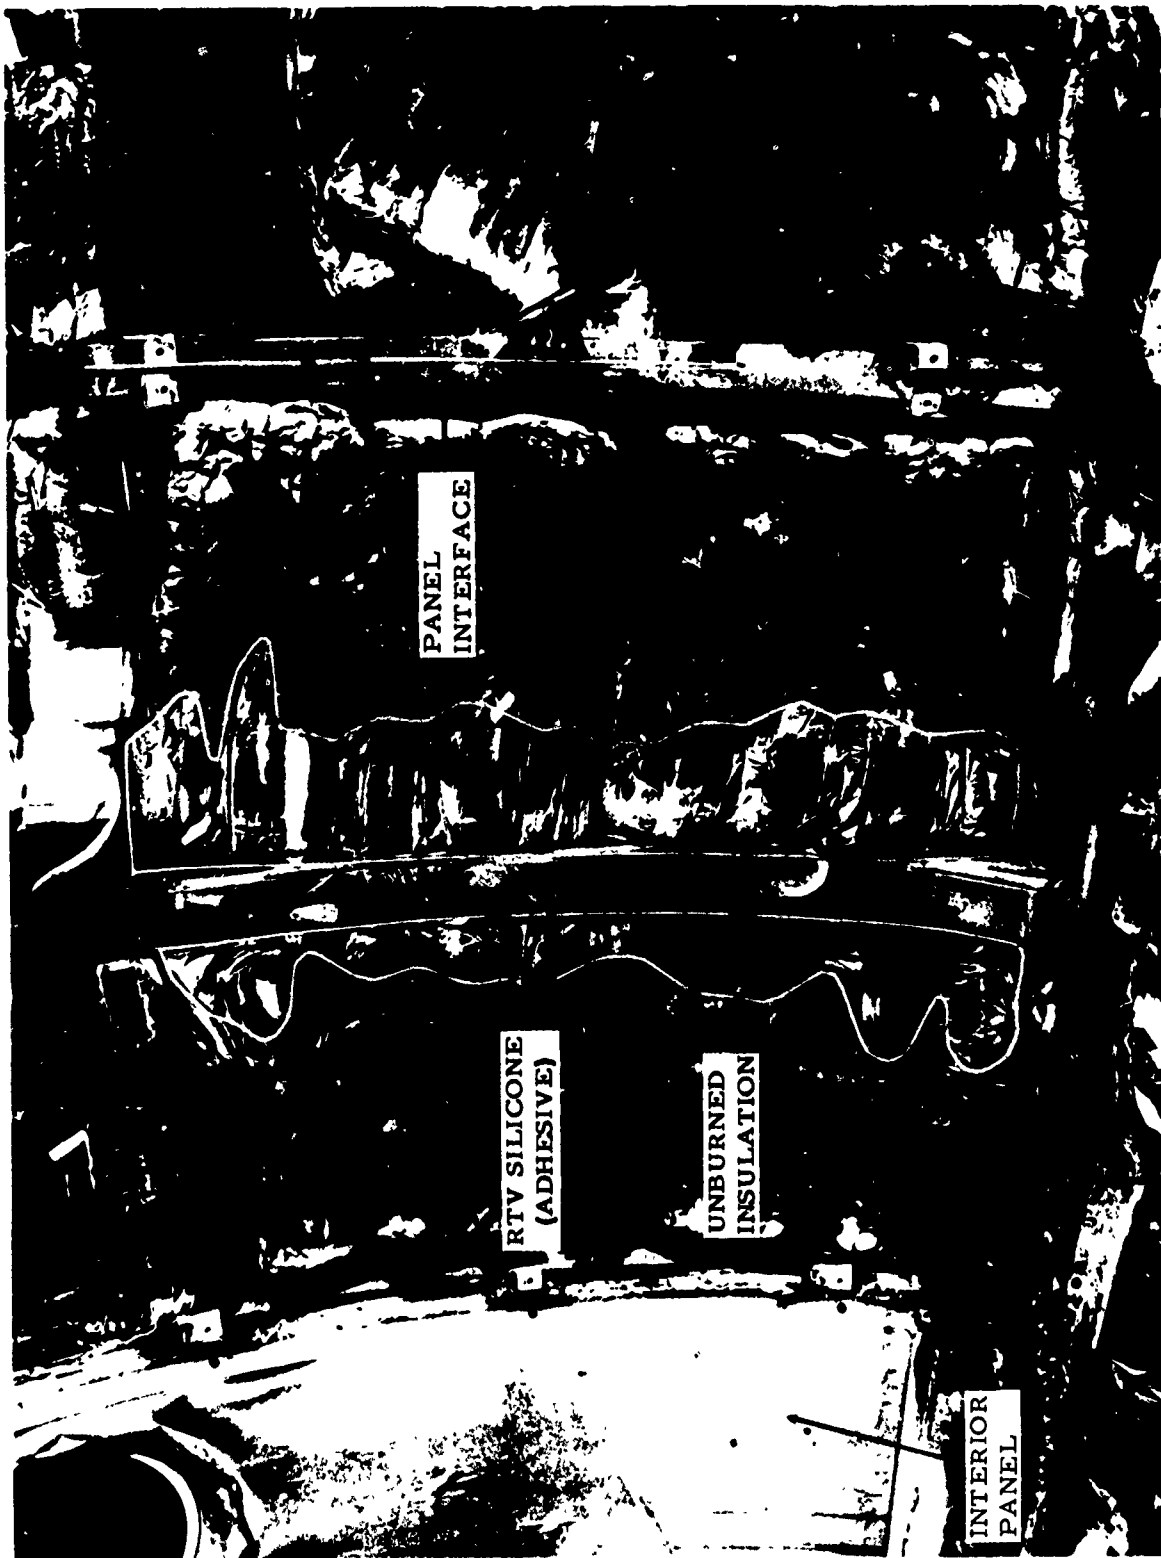
FIGURE 19 - BURNED INSULATION NEAR INTERIOR PANEL INTERFACES
