THERMAL AGING OF SILVER-PLATED COPPER AIRCRAFT  
ELECTRICAL WIRE

AIR FORCE MATERIALS LABORATORY

MAY 1973

AFML-TR-73-113

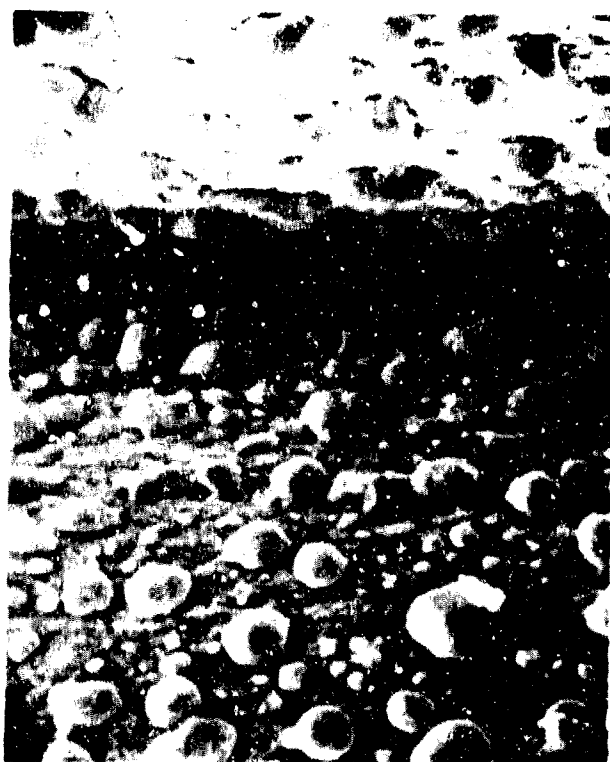
Figure 6. Surface of No. 20 (19/32) Kapton insulated unilay wire, unaged and aged at 200°C, X1600. (a) Unaged. (b) 500 hrs. (c) 1000 hrs.

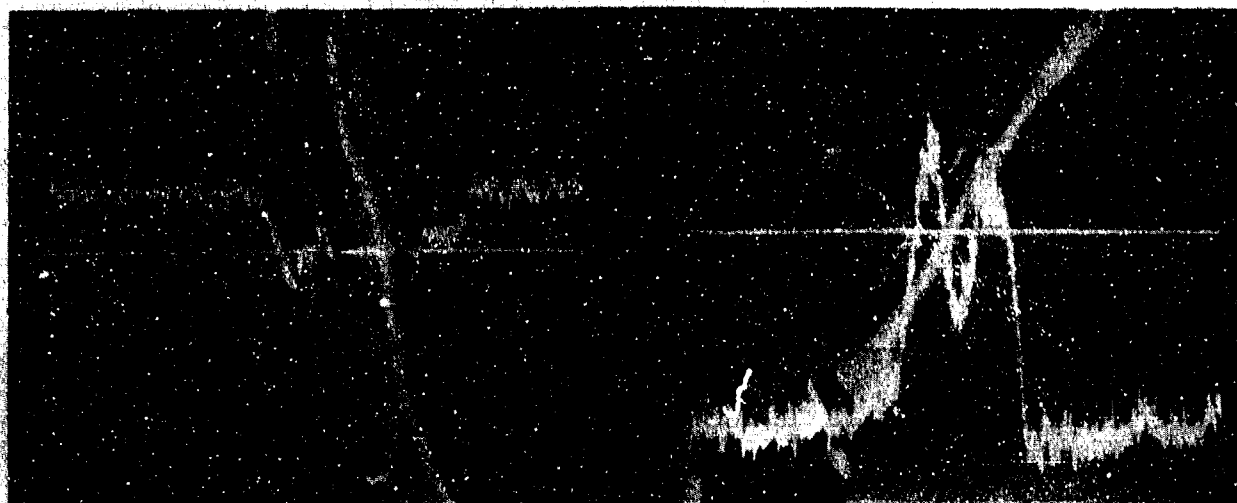
the copper/silver interface is a simple compound of copper and oxygen. Figures 9a and b show the changes in the intensity of the characteristic copper and oxygen X-rays emitted from various points along a scan through an interstrand boundary. The location of the scan trace is nominally represented by the heavy white line superimposed on the reversed-polarity back-scattered electron image of the sample. Numerous cursory scans failed to reveal the presence of any additional elements of significance other than the silver plate between the copper oxide layers and a number of iron-base impurities that occurred well within the copper strands. The oxygen X-ray intensity originating from the silver layer is quite low, indicating that this material is primarily silver metal and not silver oxide ( $\text{Ag}_2\text{O}$ ).

Figure 9. Electron microprobe scans of No. 20 (10/32) Kapton insulated unilay wire aged 500 hrs at 230°C. (a) Reverse electron image with Cu K<sub>α</sub> X-ray emission scan, X2880. (b) RE image with O<sub>2</sub> K<sub>α</sub> X-ray emission scan, X1440. (c) Cu L<sub>α</sub> X-ray emission band profile for Cu, Cu<sub>2</sub>O, CuO.

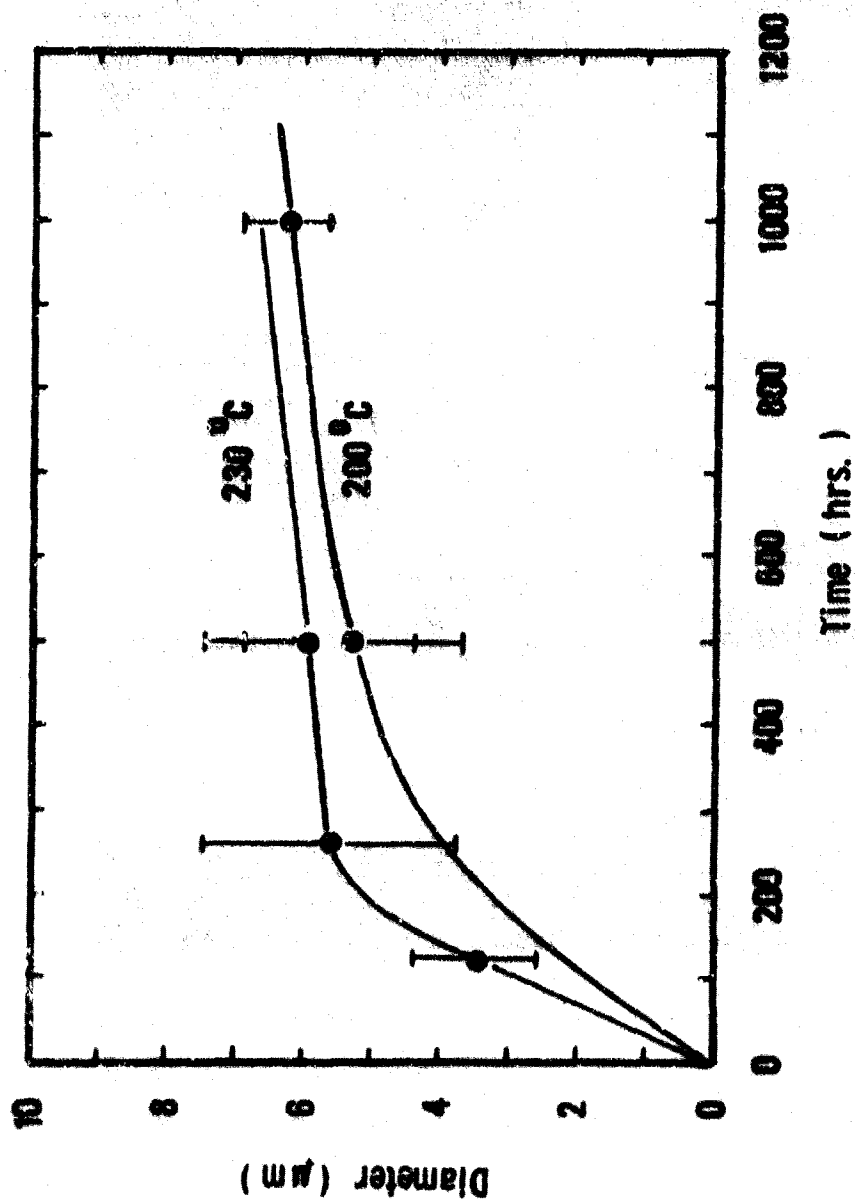
Figure 12. Diameter of larger silver globules on No. 20 (19/32) Rapton insulated unilay wire as a function of time and temperature.

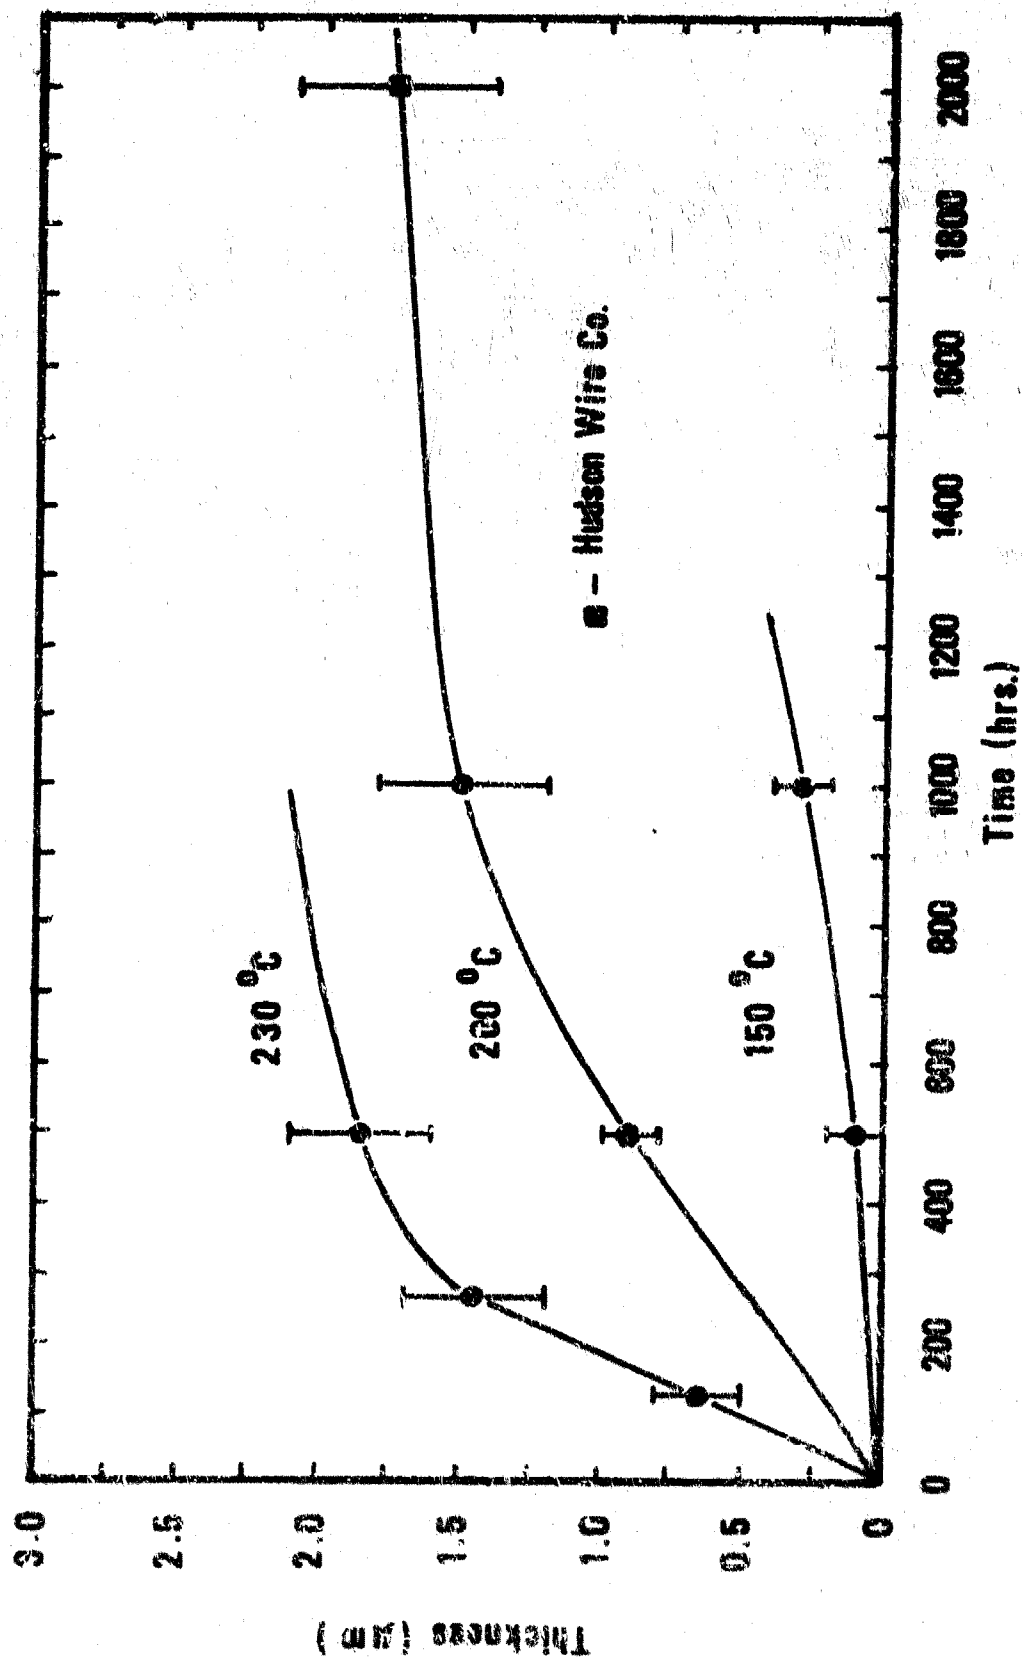
Figure 21. Thickness of cuprous oxide layer on No. 20 (19/32) Kapton insulated unilay wire as a function of time and temperature.
