UNCLASSIFIED

LIMITATION CHANGES

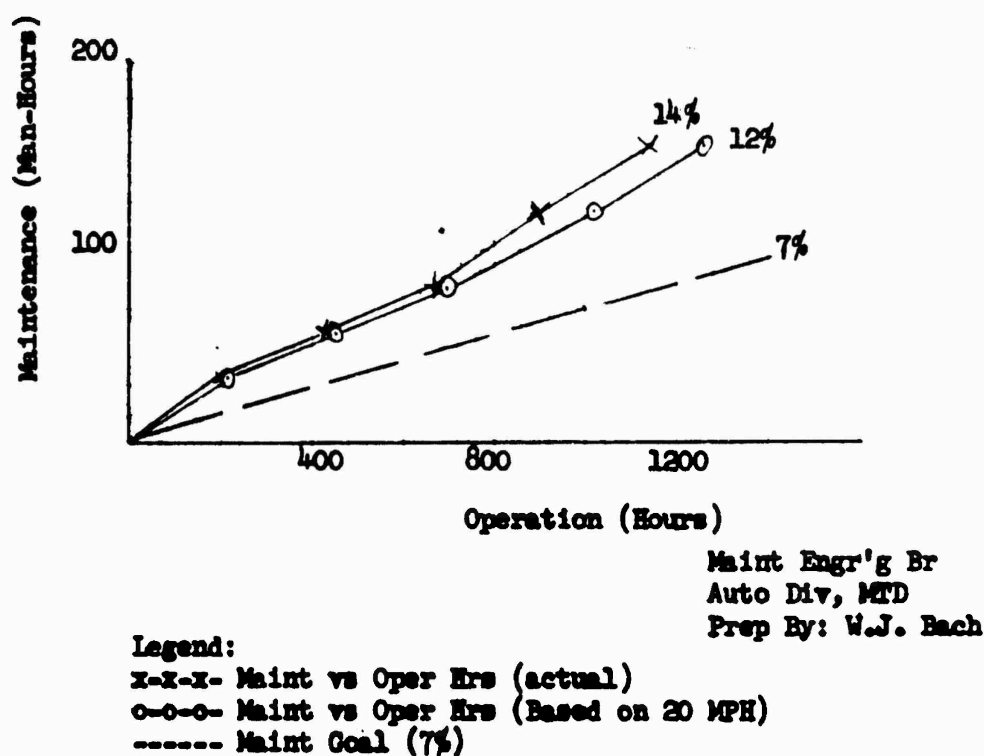
Figure 2.12-1. Maintenance versus Operation Truck Utility: 1/4-Ton, 4X4, M151A1.

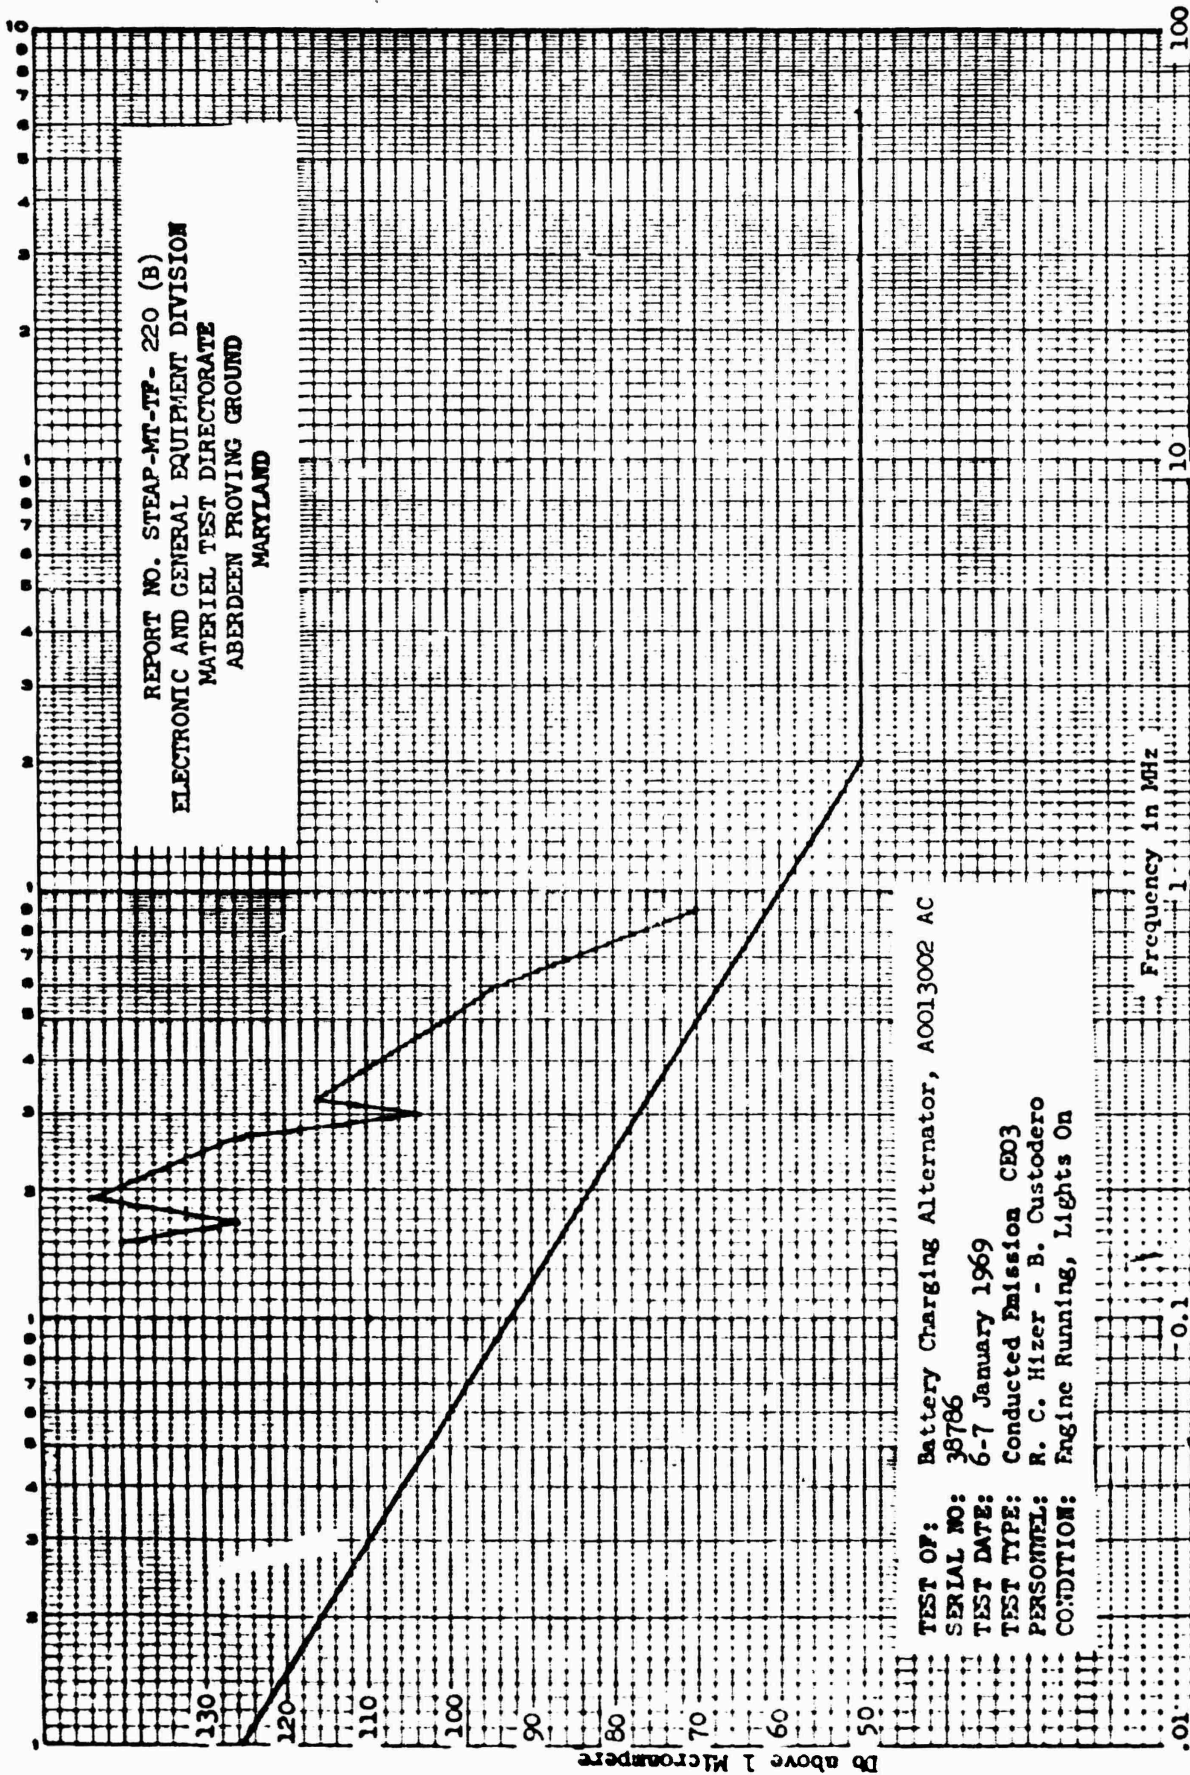
VEHICLE FUEL AND OIL CONSUMPTION

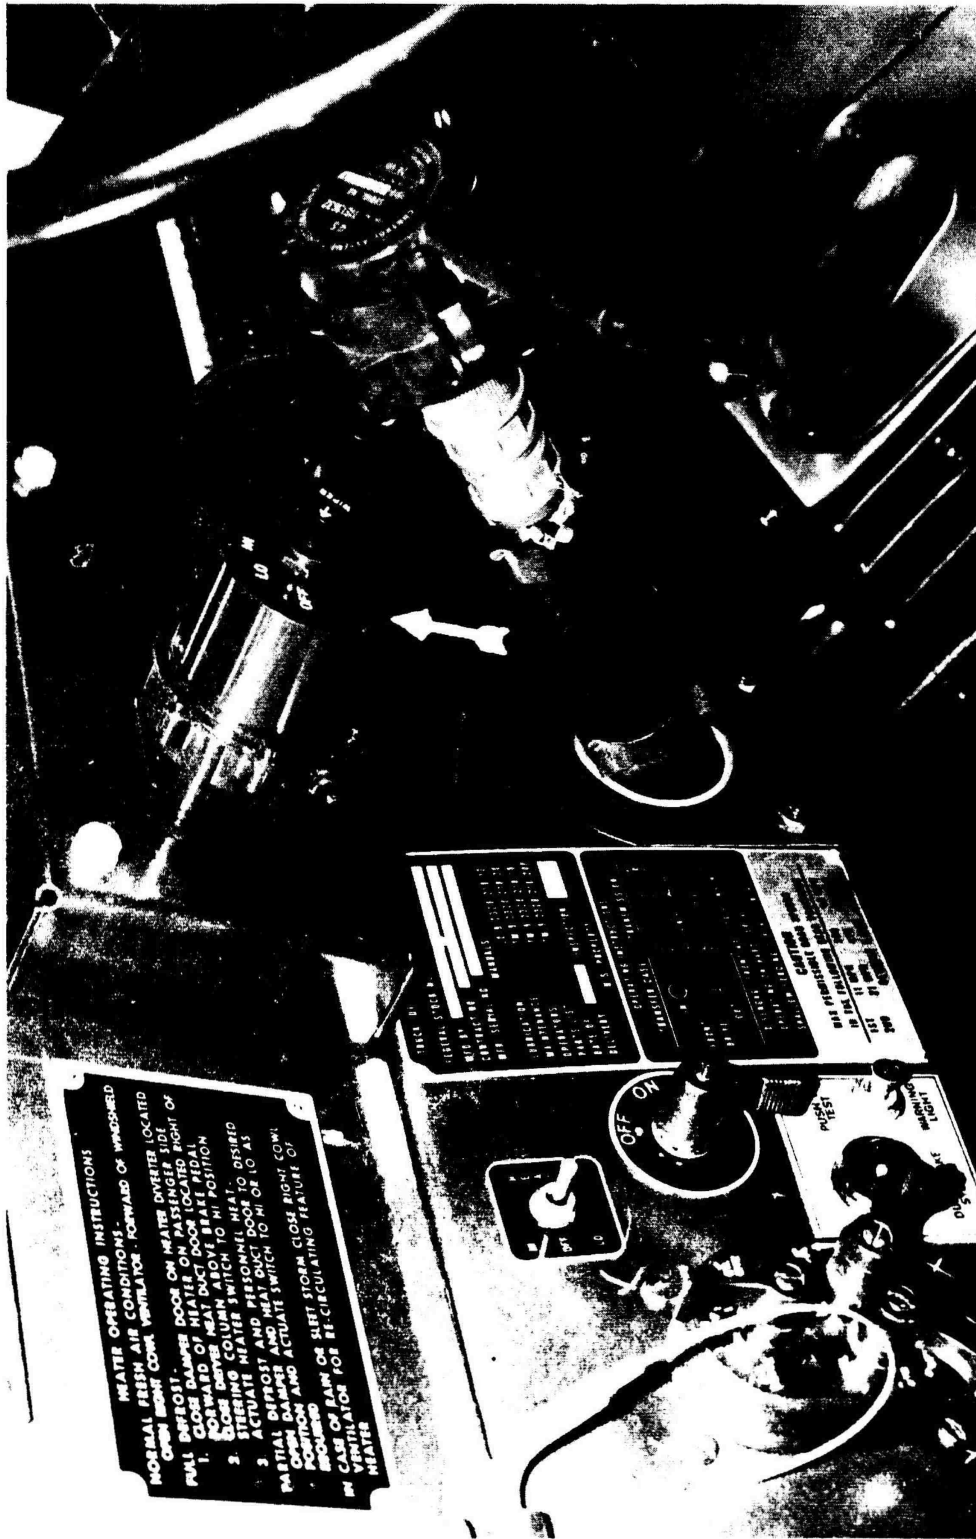
HEATER OPERATING INSTRUCTIONS
 NORMAL FRESH AIR CONDITIONS - FORWARD OR WINDSHIELD
 CHIMNEY FRONT COMP. VENTILATOR - FORWARD OR WINDSHIELD
 FULL DEFROST - JAMMER DOOR ON PASSENGER SIDE
 CLOSE DAMP OF HEATER ON PASSENGER SIDE
 FORWARD OR HEAT DUCT DOOR FOR MEDIAL
 CLOSE DAMP COLUMN SWITCH TO HEAT
 1. STEERING HEATER SWITCH TO HEAT
 2. ACTUATE HEATER PERSONNEL HEAT TO DESIRED
 PARTIAL DEFROST AND HEAT DUCT DOOR TO DESIRED
 POSITION AND ACTUATE SWITCH TO HEAT OR LO AS
 REQUIRED
 3. CASE OF FAN OR SLEET STORM CLOSE RIGHT COMP.
 VENTILATOR FOR RECIRCULATING FEATURE OF
 HEATER

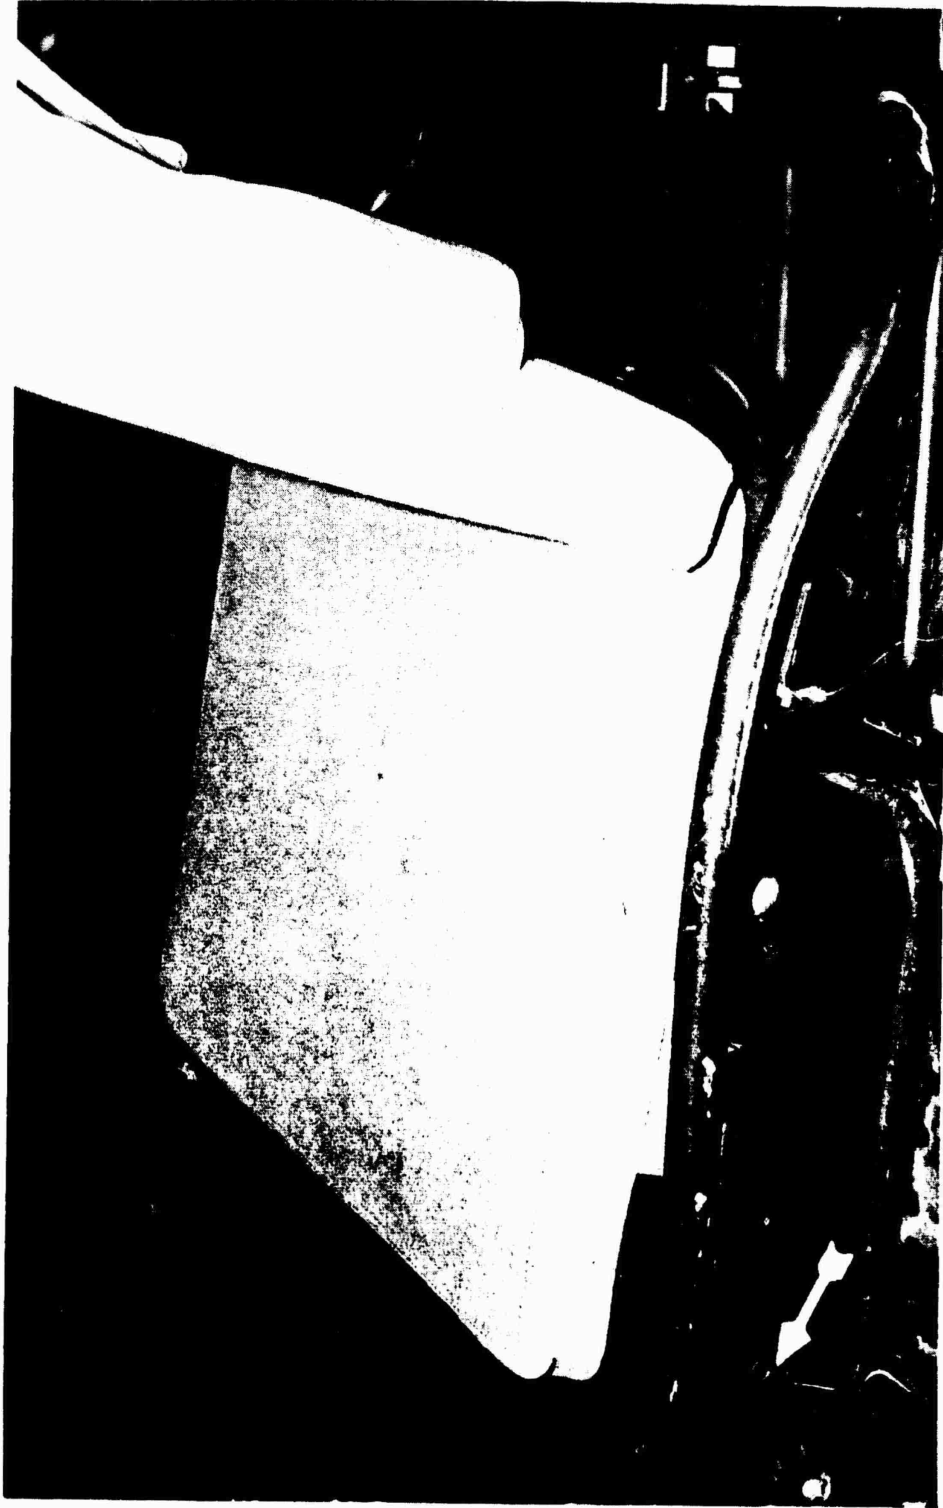
Figure III-9: White Arrow Denotes 40° Pin-Angle Slot for Seat Removal, Black Arrow Denotes Front Seat Rear Latch, Automatic Lock.

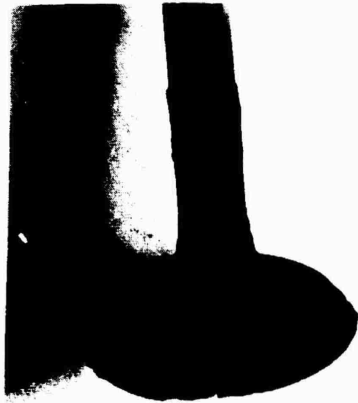
Figure III-14: Burnt Exhaust Valve, Cylinder No. 1, M151A1 after 25,276 Test Miles.

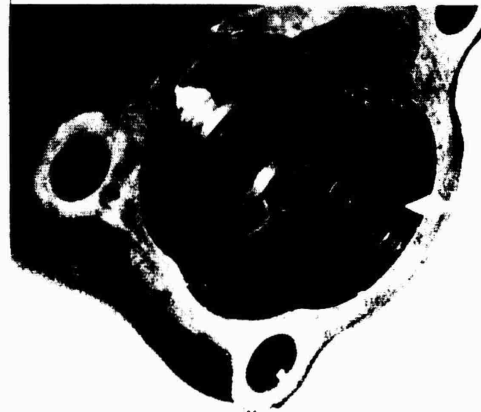
Figure III-15: Arrow Shows Worn Engine Oil Pump Housing On M151A1 after 25,276 Test Miles.

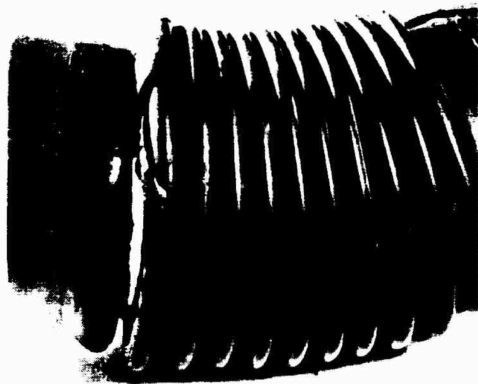
Figure III-16: Torn Air-Intake Hose (Air Cleaner to Carburetor) on M151A1 after 25,276 Test Miles.

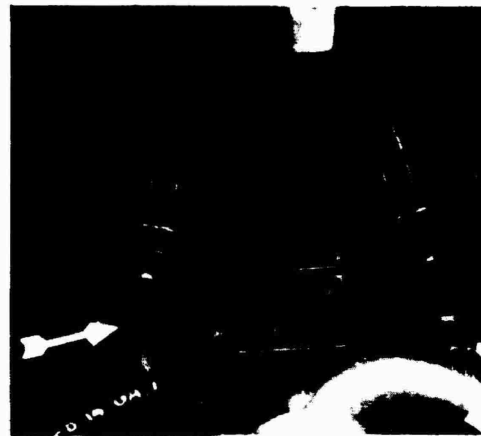
Figure III-17: Arrow Shows One Ground Connection Missing from Front and Rear Class A Light Assemblies

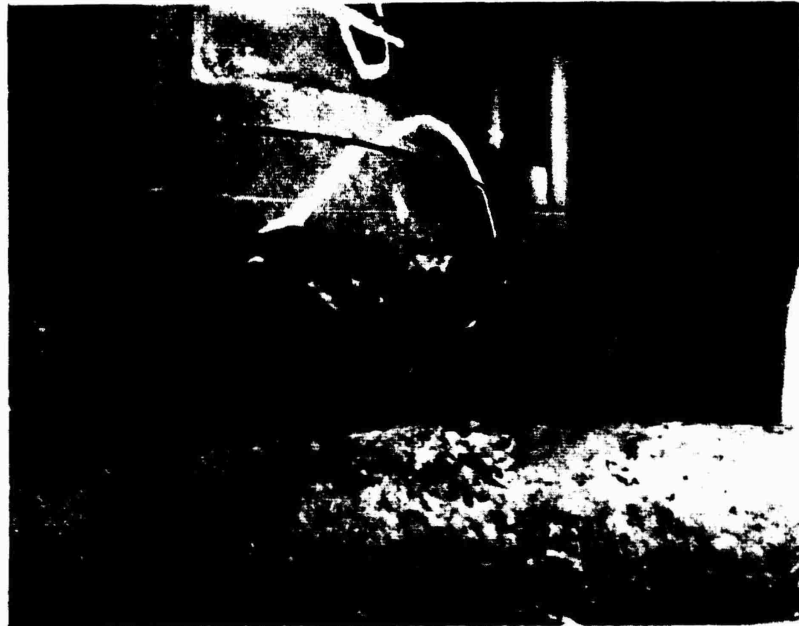
Figure III-18: Circled Area Shows Melted Left Rear Taillight and Stoplight Assembly Cover Caused by Exhaust Tail Pipe On M151A1 after 25,276 Test Miles.

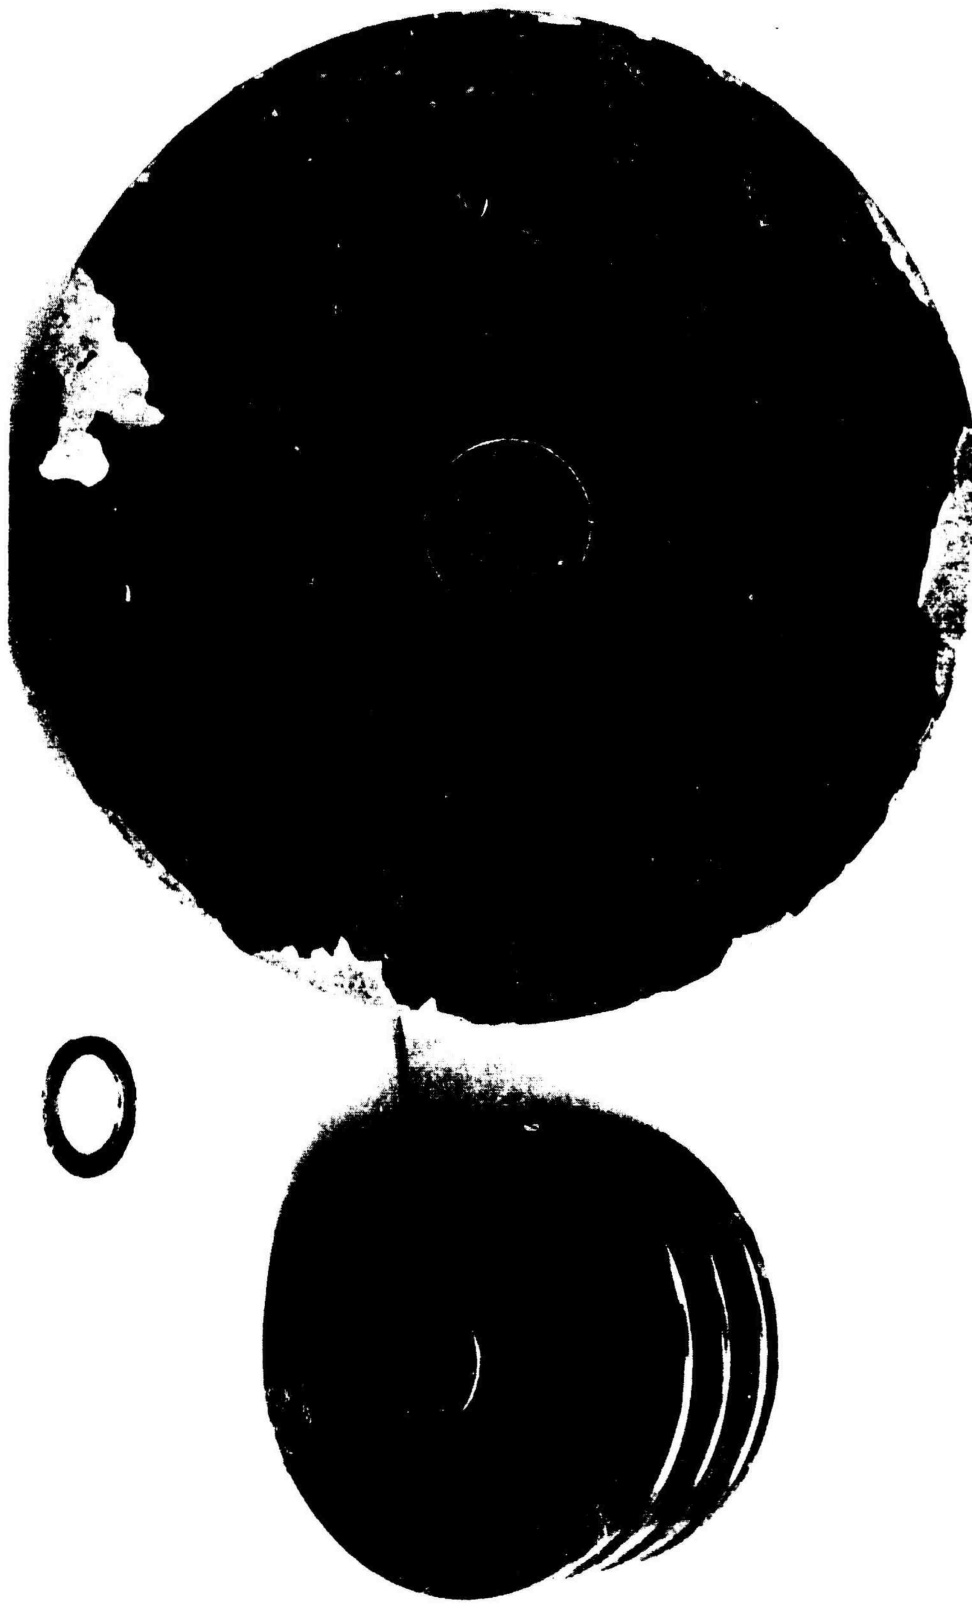
Figure III-19: Alternator Fan Showing Concentric Washer Broken from the Center On M718 after 17,296 Test Miles.

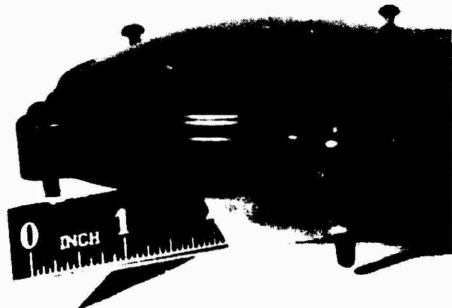
Figure III-20: Right Front Turn Signal-Assembly Cover Cracked, Allowing Water to Accumulate In the Assembly On M151A1C after 10,101 Test Miles.

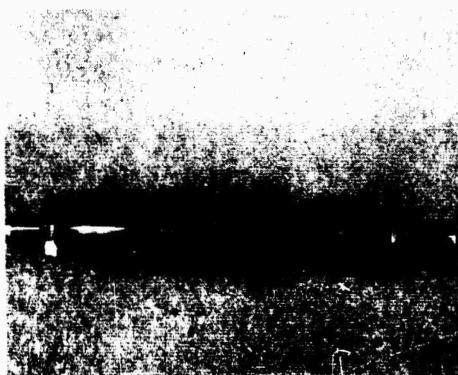
Figure III-21: Speedometer Drive Gear Failed when Parking-Brake Drum Retaining Nut Came Loose On M151A1 after 11,741 Test Miles.

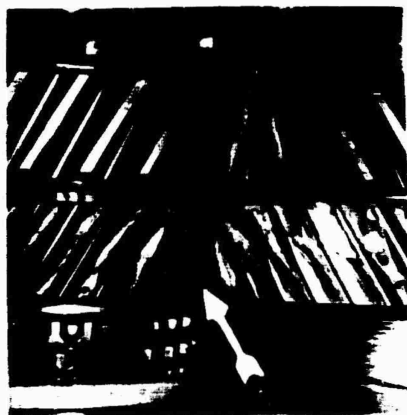
Figure III-22: Arrow Shows Teeth Broken from Transmission Third Speed and Countershaft Cluster Gears On M718 after 9130 Test Miles.

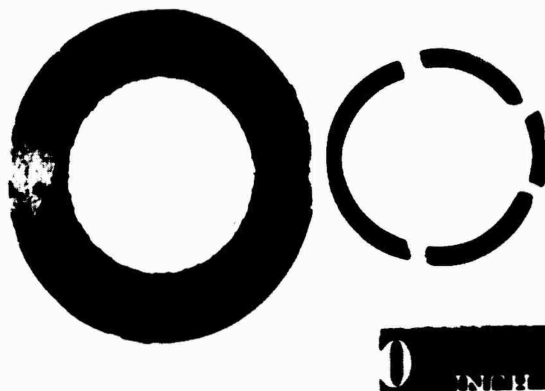
Figure III-23: Broken Transmission-Output Shaft Snap Ring and Snap-Ring Retainer On M151A1C after 9625 Test Miles.

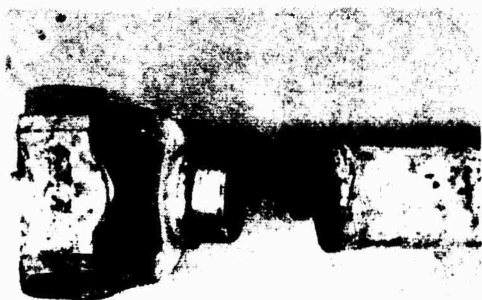
**Figure III-24: Weld Failure
On Front Propeller Drive Shaft
On M151A1 after 3475 Test Miles.**

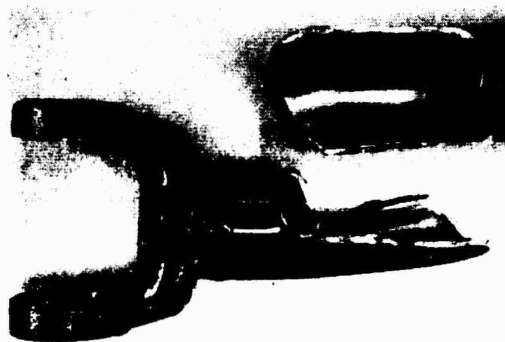
**Figure III-25: Broken Front
Propeller Shaft On M151A1 after
1037 Test Miles.**

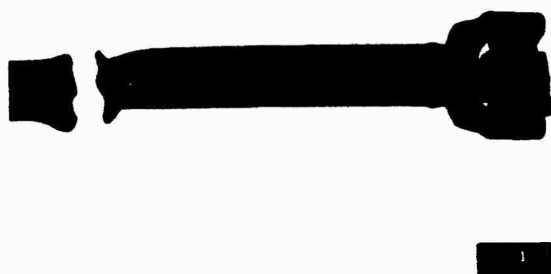
**Figure III-26: Broken Front
Propeller-Drive Shaft On M151A1C
after 8247 Test Miles.**

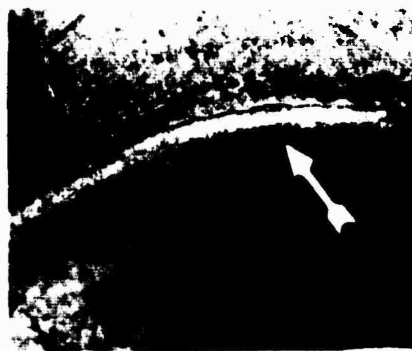
**Figure III-27: Arrow Denotes
1/4-Inch Cracks In Bottom of Left
Front Wheel Lower Suspension Arm
Assembly Near Shock Absorber
Mounting Bracket Rear Hole On
M151A1 after 25,276 Miles.**

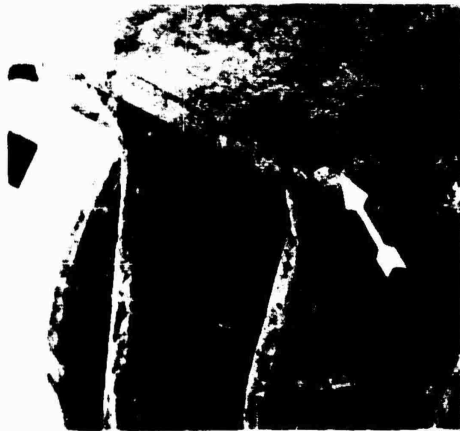
Figure III-28: Arrow Denotes 1/2-Inch Crack On Bottom of Left Front Wheel Lower Suspension Arm Assembly On M151A1 after 25,276 Test Miles.

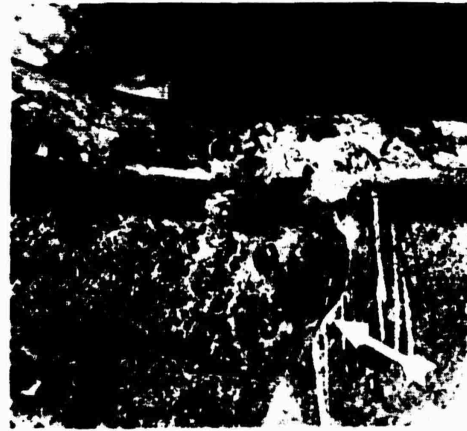
Figure III-29: Arrow Denotes 2-Inch Crack On Bottom of Right Front Wheel Lower Suspension-Arm Assembly In Front of Shock-Absorber Mounting Bracket Hole On M151A1 after 25,276 Test Miles.

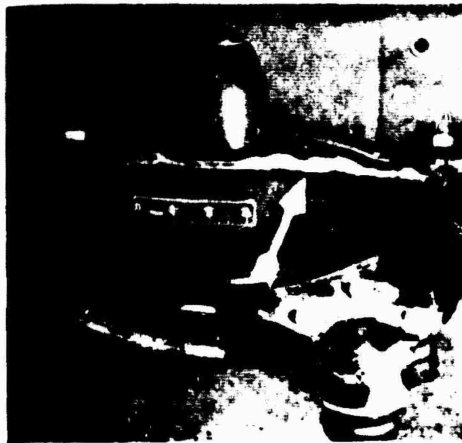
Figure III-30: Arrow Shows Left Front Crossmember Top Front Flange Damaged by Contact with Front Upper Arm Assembly On M151A1C after 5090 Test Miles.

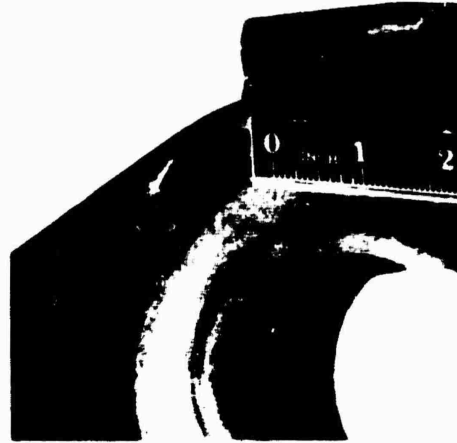
Figure III-31: Arrow Denotes Right Front Lower Suspension-Arm Crack Outboard the Spring Seat On M151A1C after 10,101 Test Miles.

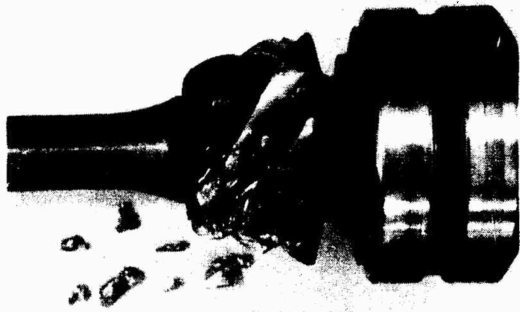
Figure III-32: Broken Rear-Differential Pinion Gear On M151A1 after 6930 Test Miles.

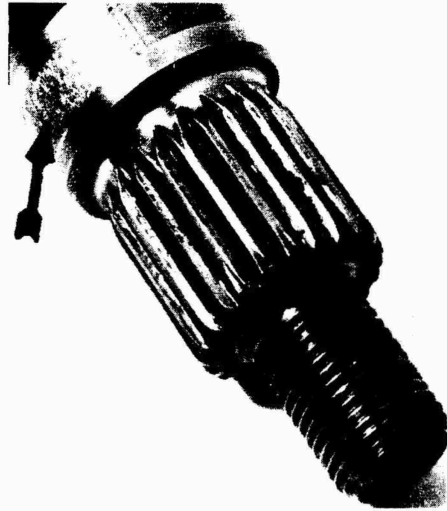
Figure III-33: Arrow Shows Worn Rear-Differential Pinion-Gear Shaft On M151A1 after 18,341 Test Miles.

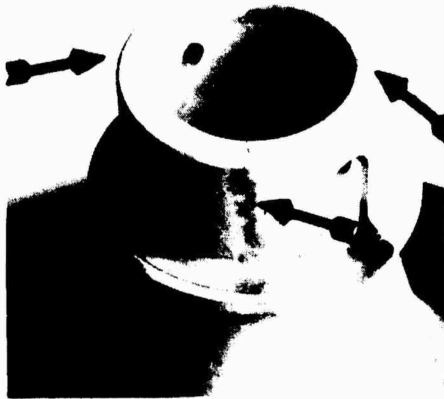
Figure III-34: Arrows Denote Cracks, 1/4-, 1-, and 1-1/4-Inches, On Rear-Differential Ring-Gear Carrier (Case) Bearing End On M151A1 after 18,341 Test Miles.

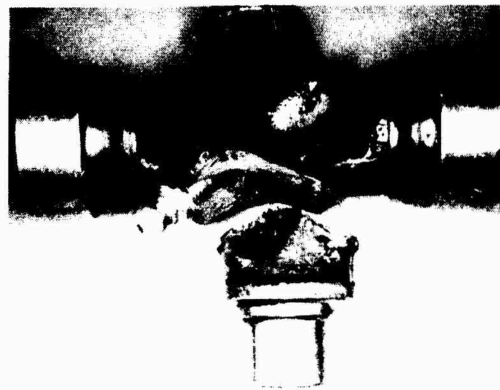
Figure III-35: Broken Right Rear Wheel-Drive Shaft Outboard Universal Joint Cross On M151A1 after 2144 Test Miles.

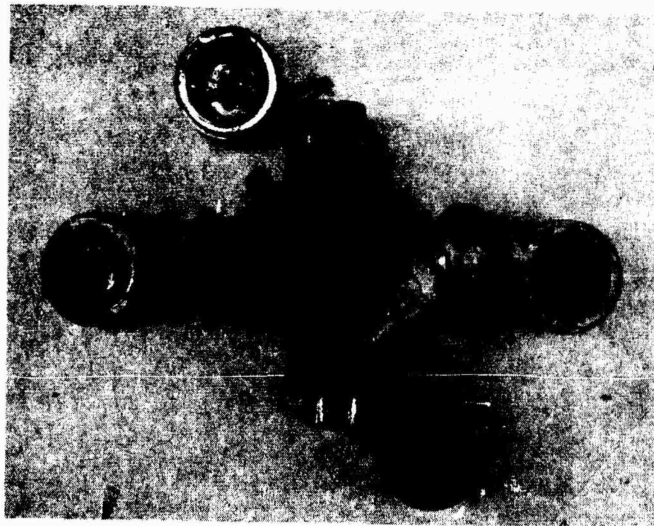
Figure III-36: Two Races of Left Rear-Wheel Drive Shaft Outboard Universal Joint Failed On M151A1 after 11,686 Test Miles.

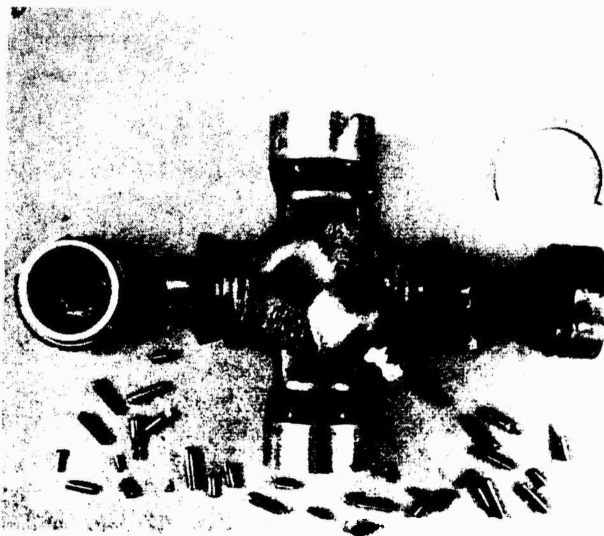
Figure III-37: Broken Race and Rollers of Right-Rear Wheel-Drive Shaft Inboard Universal Joint On M151A1 after 4155 Test Miles.

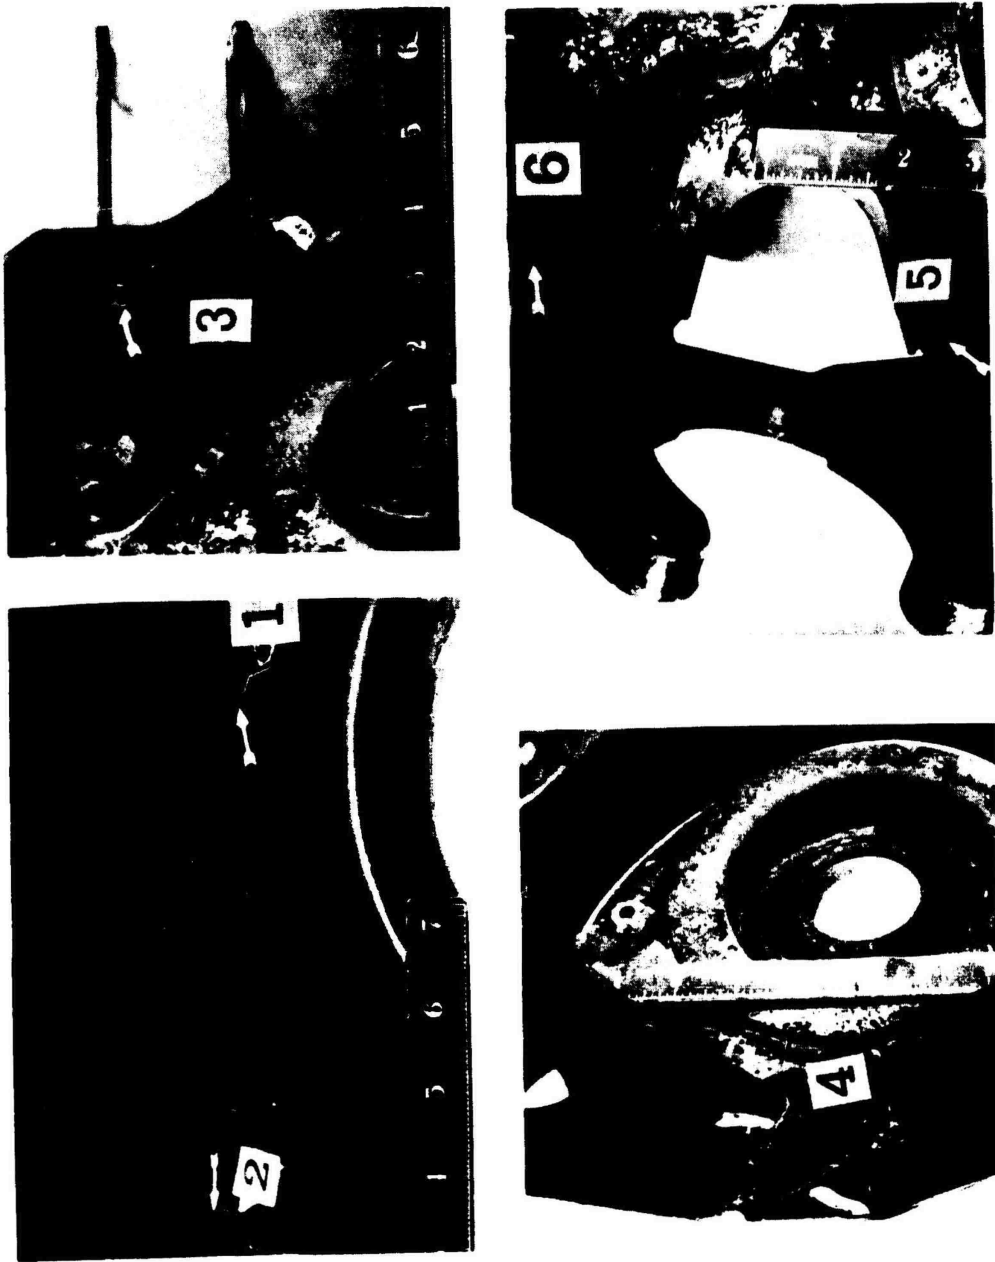
Figure III-39: Right Rear Suspension Arm (Top Detail View of Figure III-38).

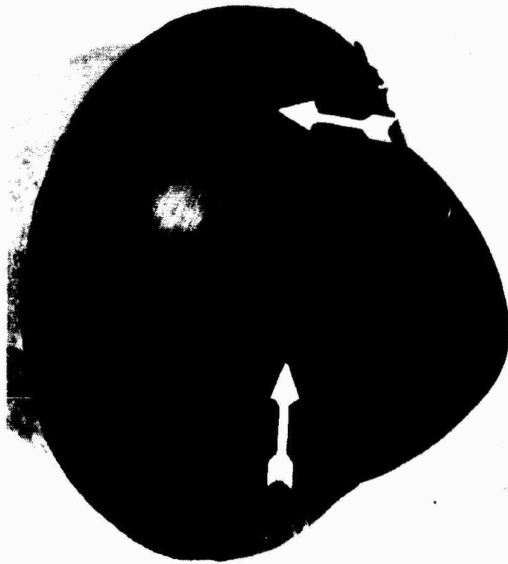
Figure III-43: Arrows Show Cracks, 1/2- and 1-3/4-Inch, In Right Rear Bump Stop On M151A1 after 25,276 Test Miles.

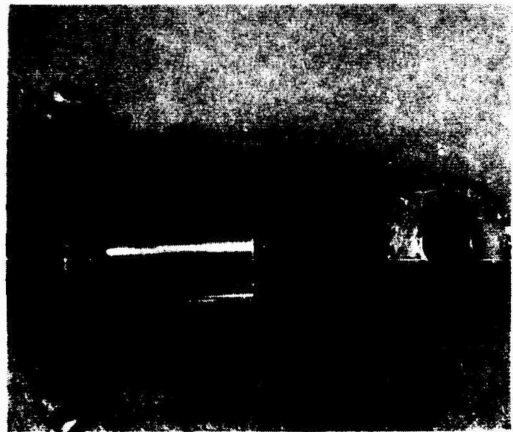
Figure III-44: Broken Rear Differential Left-Wheel Output Short-Side Gear Shaft On M718 after 163 Test Miles.

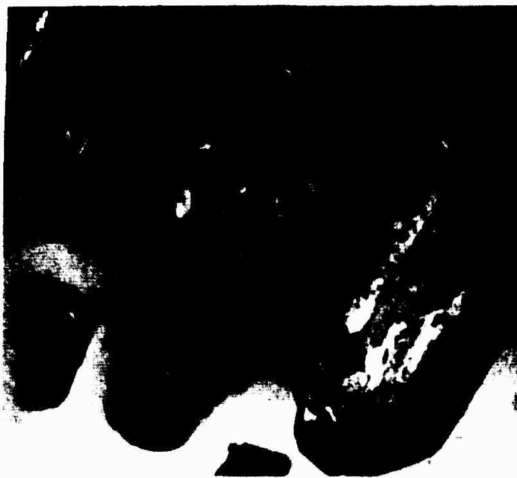
Figure III-45: Broken Left Rear Wheel Drive Shaft Inboard Universal Joint Cross On M718 after 1062 Test Miles.

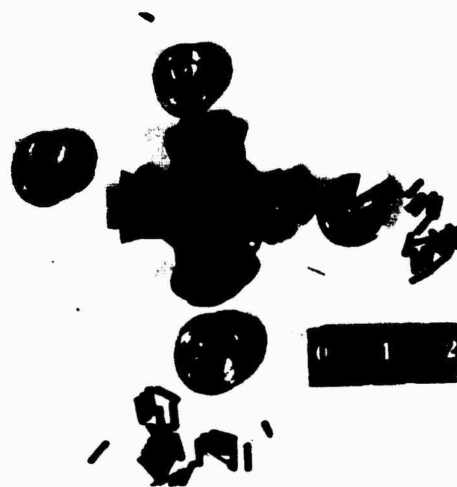
Figure III-46: Arrow Denotes End-Loading Wear Found In All Four Races of Right Rear-Wheel Drive-Shaft Universal Joint On M718 after 7166 Test Miles.

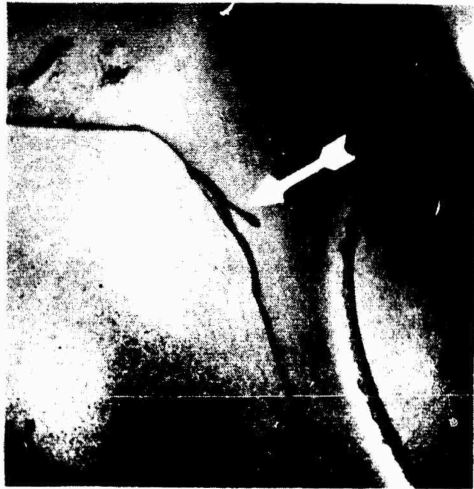
Figure III-47: Arrow Denotes 1-Inch Crack In Left Rear Suspension-Arm Assembly In the Spring Seat On M718 after 8307 Test Miles.

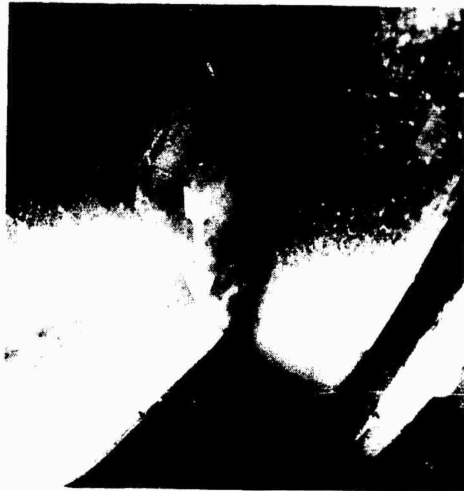
Figure III-48: Arrow Shows 3/4-Inch Crack In Left Rear Suspension-Arm Assembly In Front of the Forward Wheel-Mounting Flange On M718 after 8307 Test Miles.

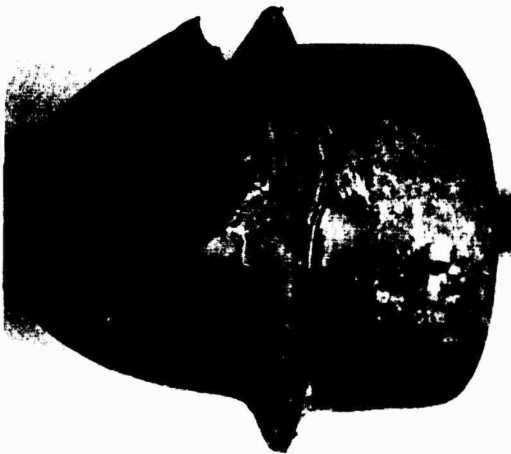
Figure III-49: Left Rear Bump Stop Failed On M718 after 17,671 Test Miles.

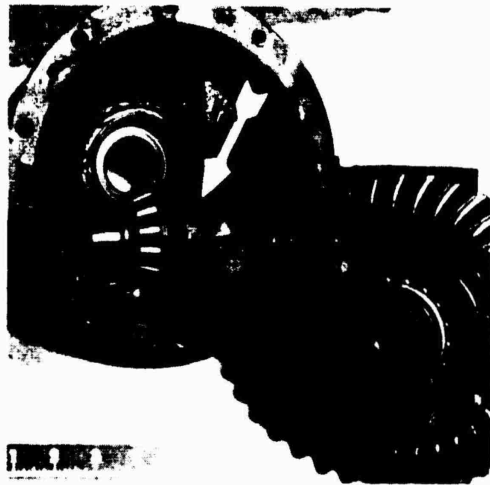
Figure III-50: Arrow Denotes Teeth Worn from Rear-Differential Pinion-Shaft Gear On M151A1C after 9625 Test Miles.

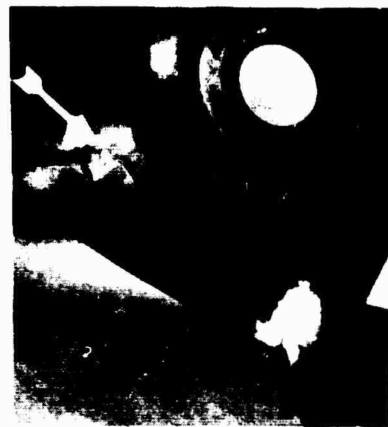
Figure III-54: Arrow Denotes 1-1/4-Inch Crack In Left Rear Suspension-Assembly Spring Seat On M151A1C after 5090 Test Miles.

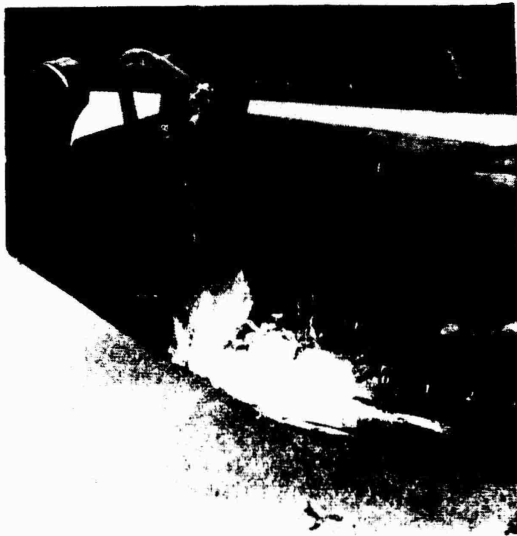
Figure III-55: Arrow Denotes 1-1/2 Inch Crack in Right Rear Suspension-Arm Assembly M151A1C after 5090 Test Miles.

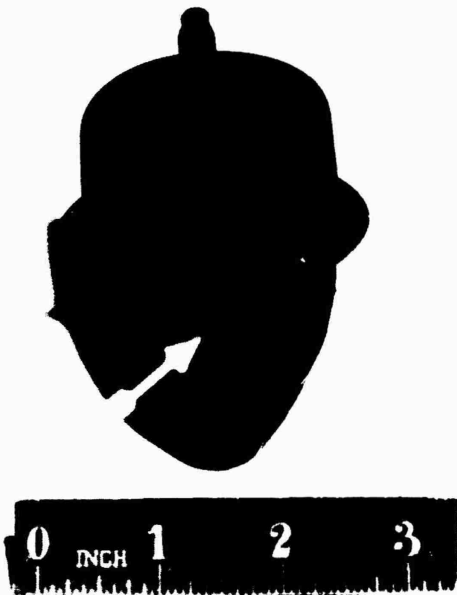
Figure III-57: Cracked Left Rear Bump Stop on M151A1C after 6872 Test Miles.

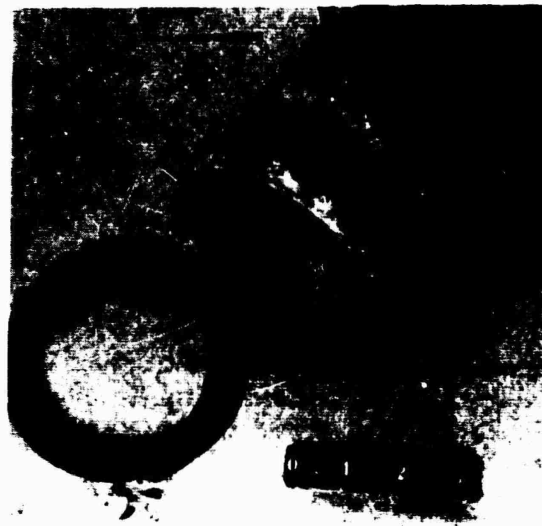
Figure III-58: Broken Left Rear Spring One Coil from Bottom on M151A1C after 5090 Test Miles.

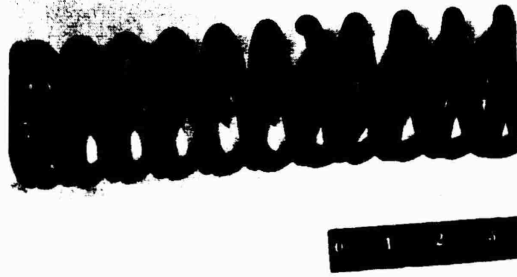
Figure III-59: Broken Left Rear Overload Spring on M151A1C after 6872 Test Miles.

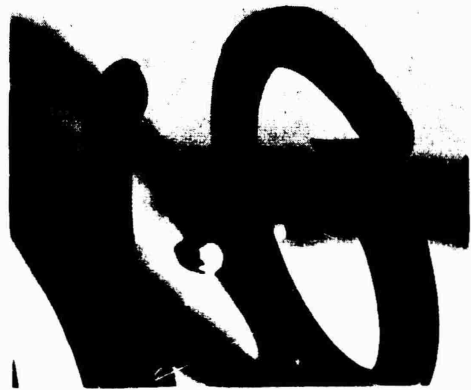
Figure III-60: Right Rear Coil Spring Broke One Coil from the Top on M151A1C after 10,101 Test Miles.

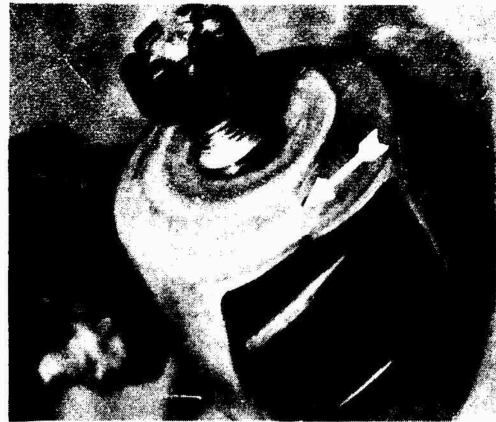
Figure III-64: Arrow Denotes 1/2-Inch Crack in Right Tie Rod-End Nylon Cover on M151A1 after 25, 276 Test Miles.

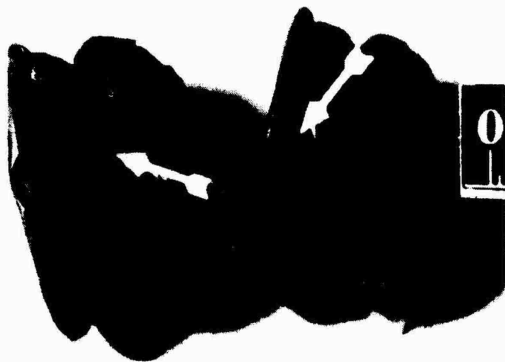
Figure III-65: Arrows Denote Cracked Rubber Cover on Pregreased (Lube-for-Life) Upper and Lower Arm Ball Joints of Right Front Suspension and Steering Assembly on M151A1C after 10,101 Test Miles.

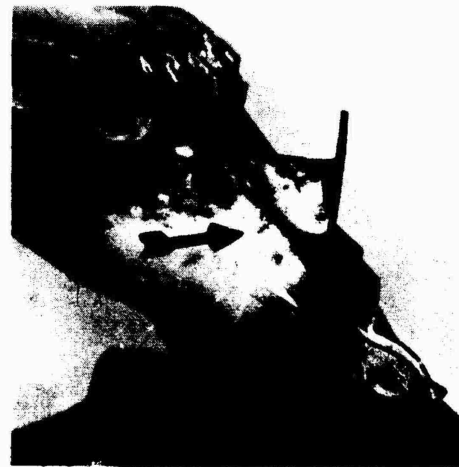
Figure III-66: Arrow Denotes Crack in Front Crossmember on M718 after 22,000 Test Miles and on M151A1C after 10,101 Test Miles.

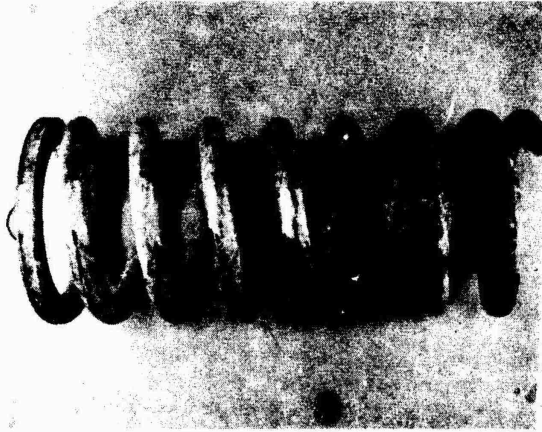
Figure III-67: Broken Right Front Spring Three Coils from Bottom On M151A1C after 2459 Test Miles.

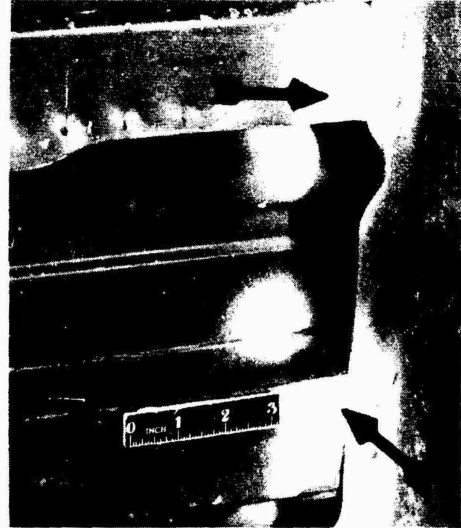
Figure III-68: Arrows Denote Inner-Frame Rail Cracks In Front of the Rear Crossmember On M151A1 at Right Inner Rail (Top Arrow) after 20433 Test Miles and Left Inner Rail (Bottom Arrow) after 23,200 Test Miles and On M718 at Right Inner Rail (Top Arrow) Similar after 19,168 Test Miles.

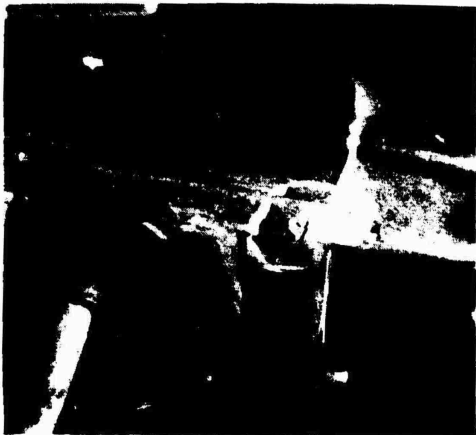
Figure III-69: Circled Area Denotes Crack On Left Side of the Fire Wall to Cowl On M151A1 after 25,276 Test Miles.

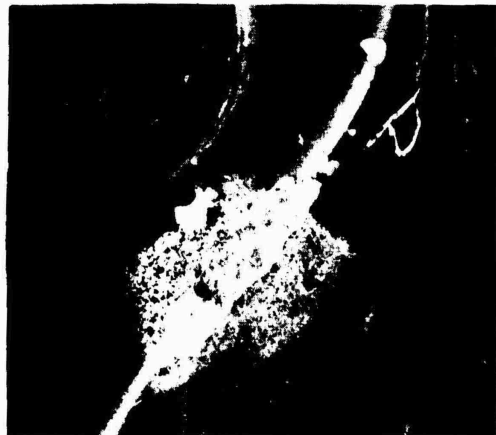
Figure III-70: Frame Distress Near Rear Wheel Caused by Contact with Wheel Drive Shaft On M151A1 after 25,276 Test Miles and On M718 after 22,000 Test Miles.

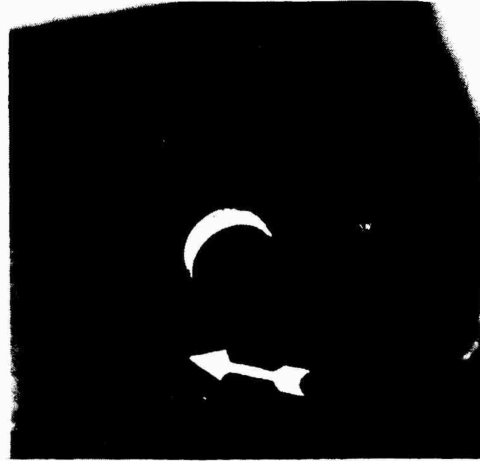
Figure III-72: Arrow Shows Inside View of Crack On Rear-Differential Right Rear Mounting Bracket On M151A1 after 25,276 Test Miles.

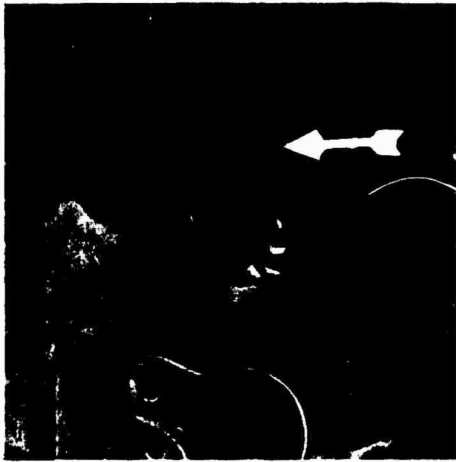
Figure III-73: Arrow Denotes Crack In Windshield Panel at Left Top Rod-Mounting Bracket Upper Screw On M718 after 19,168 Test Miles.

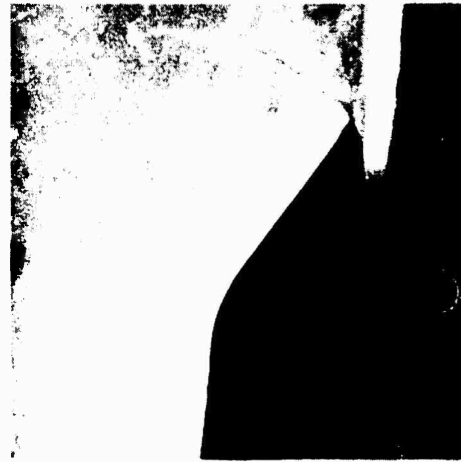
Figure III-74: Arrow Shows Cracked Spare-Tire Mounting-Bracket Flange On M718 after 12,430 Test Miles.

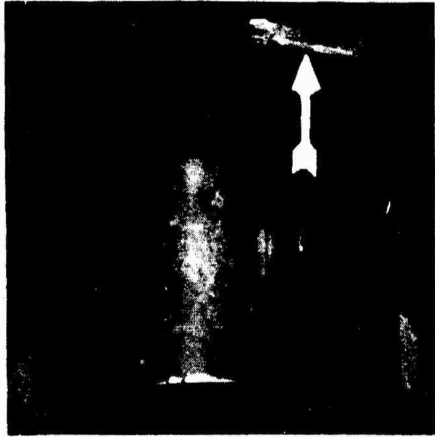
Figure III-75: Broken Left-Front Seat Rear-Latch Handle On M718 after 19,168 Test Miles.

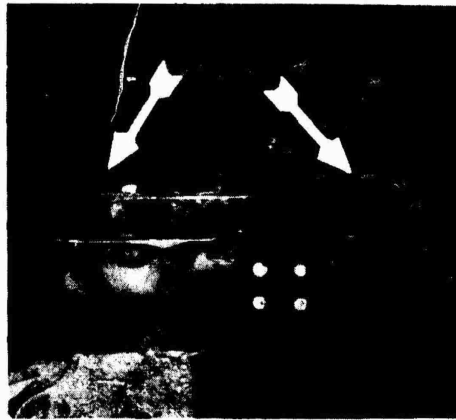
Figure III-76: Arrows Show 2-1/2-Inch Rips In Right Front Side Panel at the Fuel-Carrying Bracket Top Mounting Bolts On M718 after 4320 Test Miles. The M151A1C Left Side Panel Developed Similar Crack after 833 Test Miles.

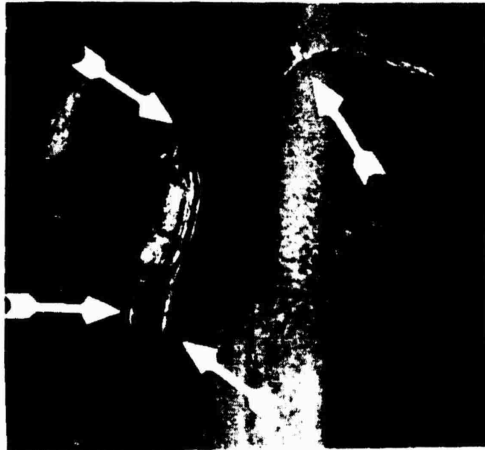
Figure III-77: Arrow Denotes Cracks In Rear End Panel Right Side Near Right Rear Litter-Rail Support-Socket Mounting Bolt On M718 after 19,168 Test Miles.

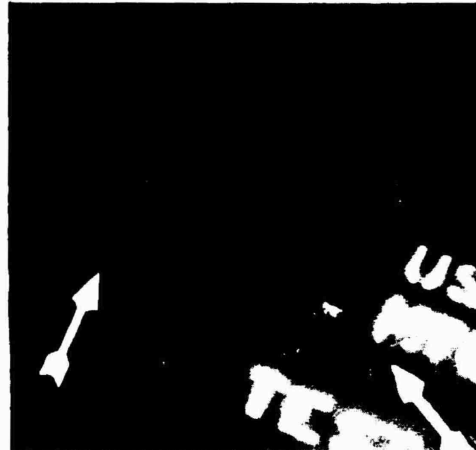
Figure III-78: Arrows Show Vehicle Right Side Panel Cracks at and Near Attachment to Middle Crossmember On M718 after 22,000 Test Miles.

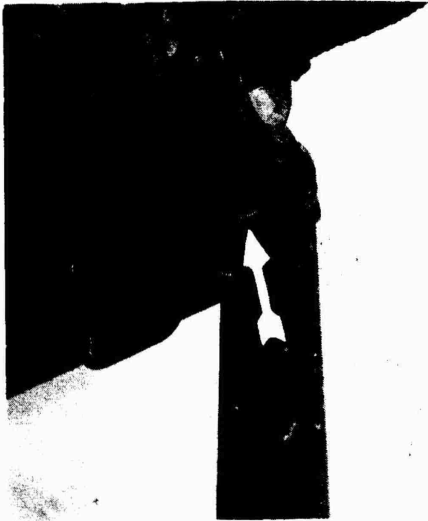
Figure III-79: Top Weld of Rear Extension Left Mounting Bracket Failed On M718 after 22,000 Test Miles.

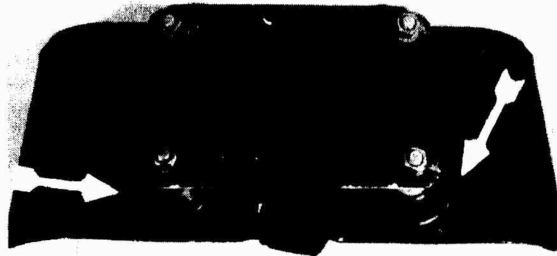
Figure III-80: Fuel-Carrying Bracket Cracked 2-1/2-Inches Outside Both Top Mounting Bolts On M718 after 22,000 Test Miles.

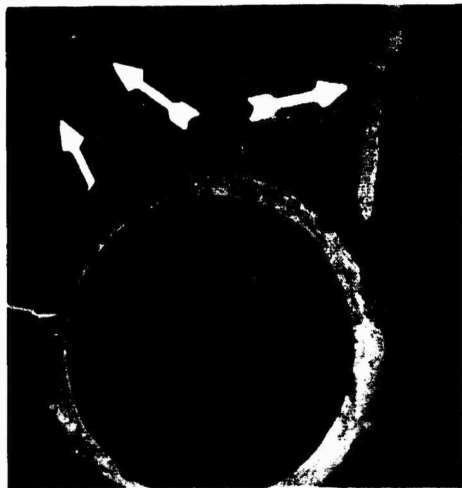
Figure III-81: Arrows Denote Broken Right Rear Litter-Support Socket Flanges On M718 after 12,430 Test Miles.

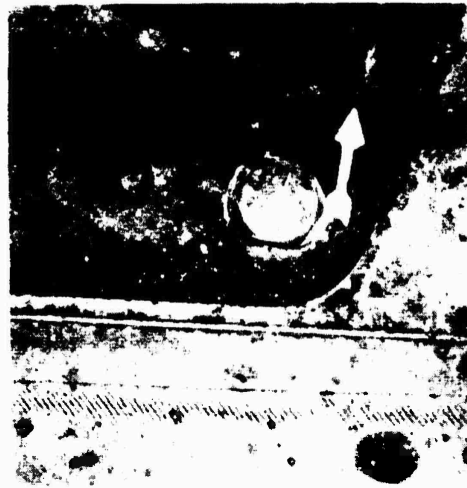
Figure III-82: Arrow Denotes Left Front Litter-Support Socket-Mounting Flange Crack Inboard from the Rear Mounting Bolt On M718 after 12,430 Test Miles.

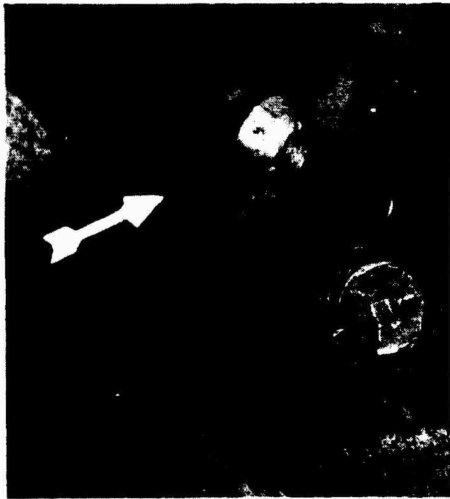
Figure III-83: Arrow Shows 1-3/4-Inch Crack In Left Front Litter-Rail Support-Socket Mounting Flange On M718 after 6738 Test Miles.

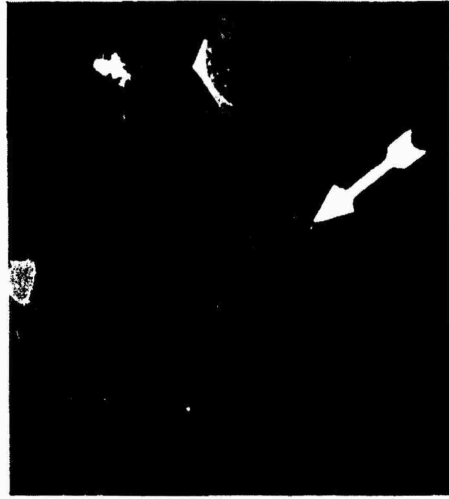
Figure III-84: Arrow Denotes Crack In Right Front Litter-Rail Support-Socket Mounting Flange On M718 after 19,168 Test Miles.
