UNCLASSIFIED

LIMITATION CHANGES

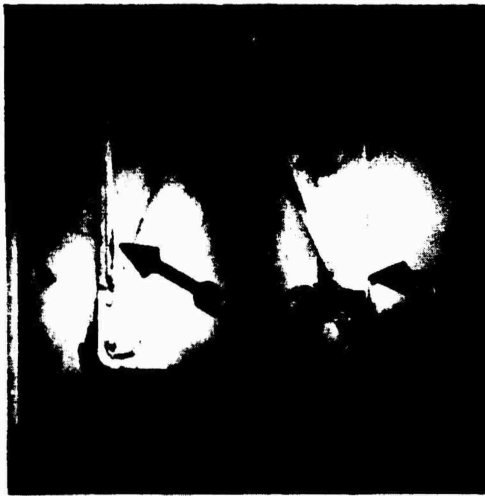
Figure III-85: Arrows Denote Right Front Litter Support-Socket Cracks On M718 after 22,000 Test Miles.

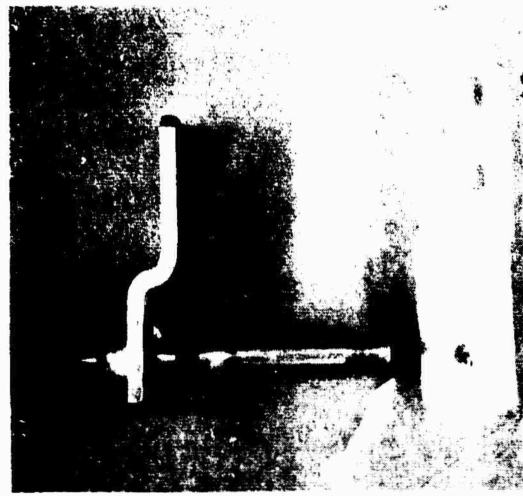
Figure III-86: Arrow Denotes Broken Drive Rod of Windshield-Wiper Electric Motor On M151A1C after 3182 Test Miles.

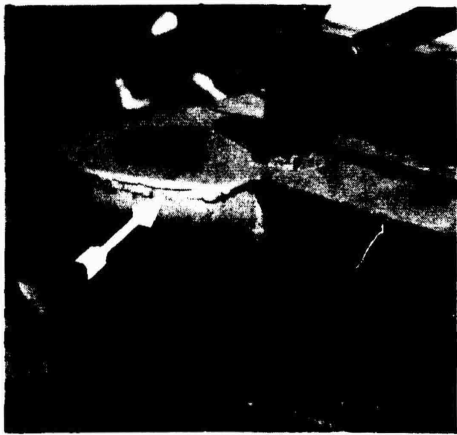
Figure III-87: Arrow Shows 3-Inch Crack in Top Flange of Right Rifle-Mount Leg-Securing Socket, on M151A1C after 5090 Test Miles. Similar Crack Found Left Mount after 10,101 Test Miles.

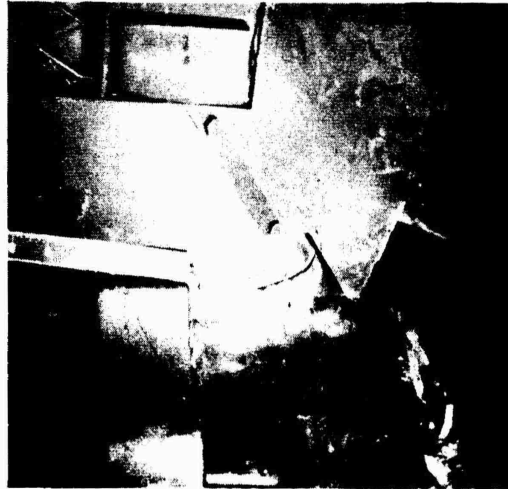
Figure III-88: Arrow Denotes Cracks in Base of Left Rear Wheel Well on M151A1C after 10,101 Test Miles.

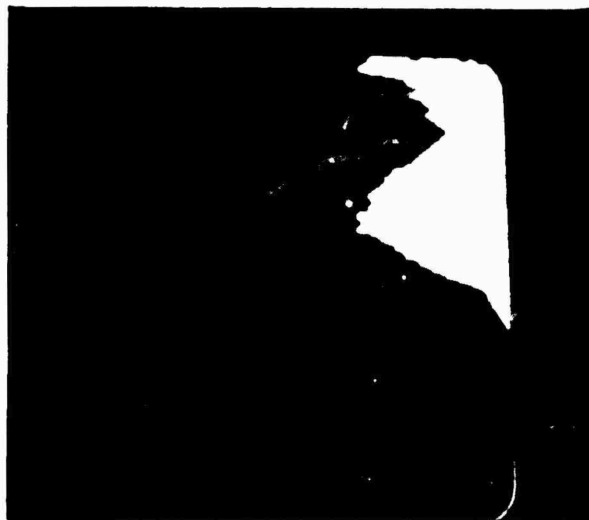
Figure III-89: White Area Shows Left Rear (Right Rear Similar Pattern) Side Stick-On Reflector Material Worn Off Forward Lower Corner on M151A1 after 12,242 Test Miles. Deterioration of Rear Reflector, M151A1C Found after 10,101 Test Miles.
