AGDA (M) (21 Apr 70) FOR OT UT 701264 23 April 1970  
SUBJECT: Operational Report - Lessons Learned, Headquarters, 520th Transportation Battalion, Period Ending 31 January 1970

SUBJECT: Operational Report - Lessons Learned, 520th Transportation Battalion  
(AM&S) (GS), Period Ending 31 January 1970, RCS CSFOR-65 (R2)

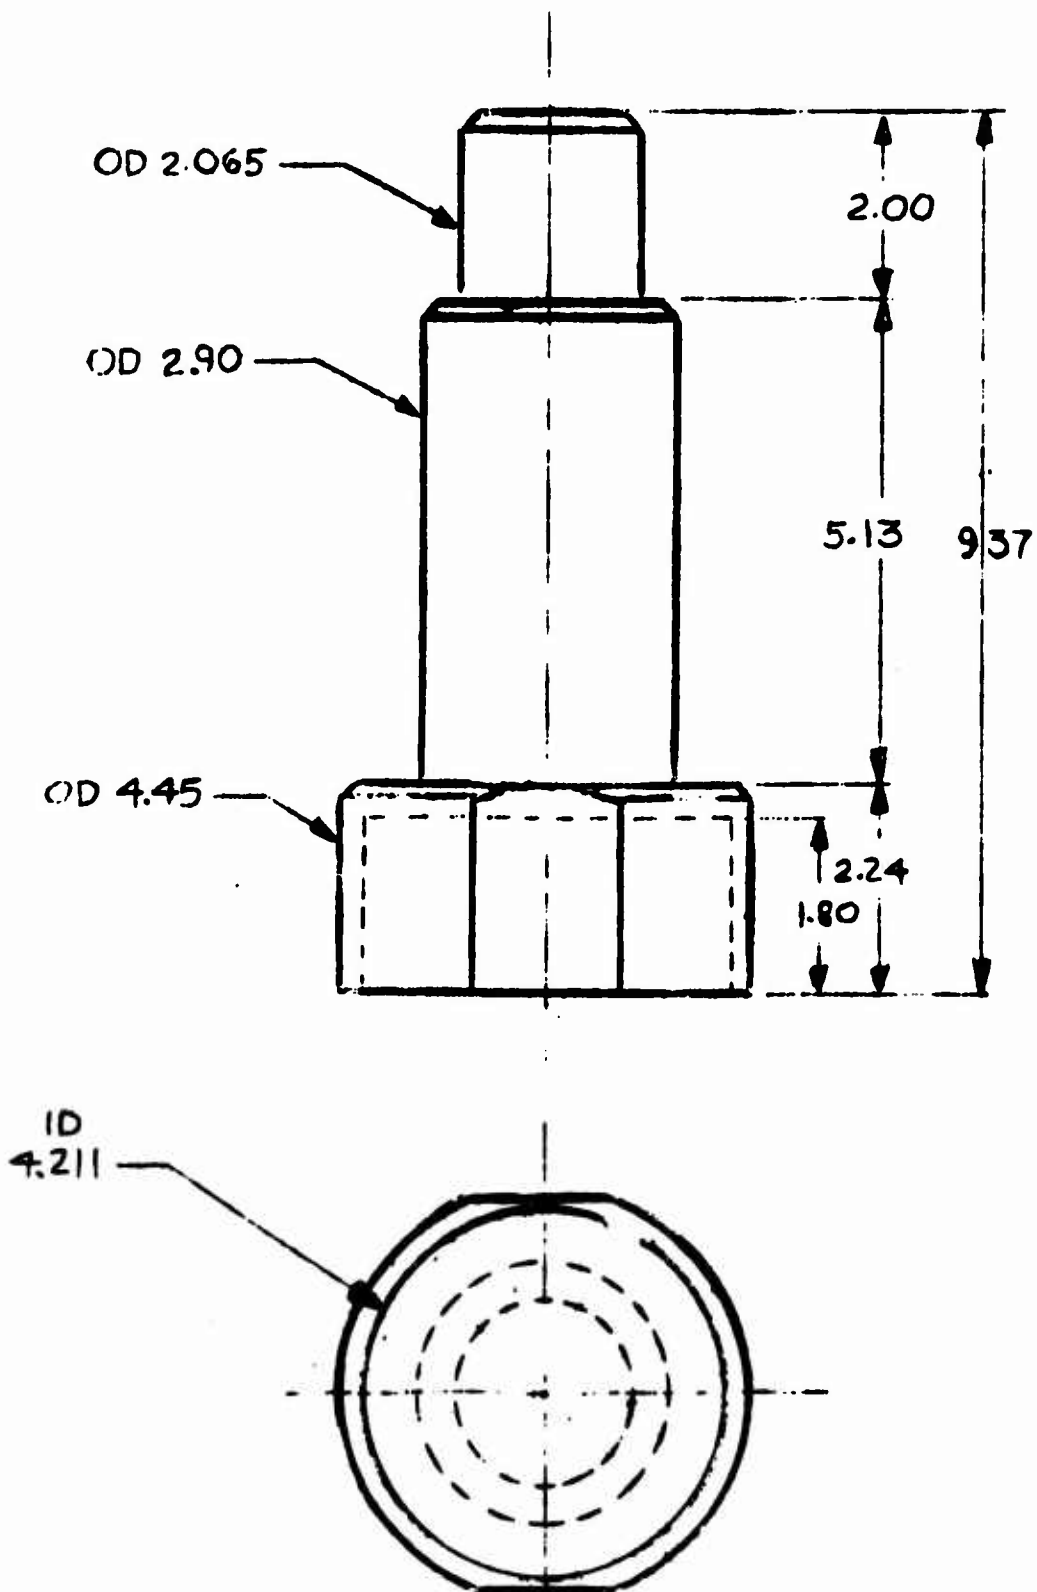
Incl 1

(a) Observation: The rotor head stand issued with the OH-58 special tool set for use on a balance stand has not proven practicable in the field. A locally manufactured stand, designed to adapt to the UH-1 rotor stand (FSN 4920-678-5431), is more suitable.

(b) Evaluation: The stand, as designed and illustrated (see Incl 1), can be easily manufactured in any DS machine shop from 7075 T6 aluminum bar stock. The base portion is machined within the inner base diameter to fit snugly over the UH-1 rotor stand and secured with a set screw (not illustrated). To adapt the hub holding portion to a table or other type stand, a larger diameter of bar stock must be used. By reducing the length of the resulting wider base portion, a butt plate with four bolt holes is fabricated to allow for a stable mounting of the stand on any flat surface.

b. Reference item concerning "Rotor Head Stand, OH-58A Helicopter", page 4, paragraph 2c(2); nonconcur. The observation cites no reason as to why the issued rotor head stand is impracticable. The evaluation describes a rotor head stand which does not incorporate the rotor head balancing features presently found in the issued item. Unit has been advised that an EIR should be submitted if the issued item is impracticable. No action by higher headquarters is recommended.

(c) Recommendation: That design specifications for this OH-58 rotor head stand be distributed by AVSCOM, especially to maintenance units supporting both the UH-1 and OH-58A helicopters.

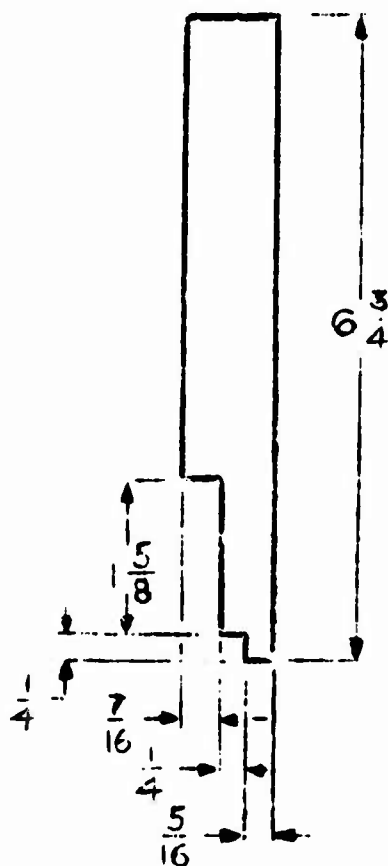
Incl 2

(a) Observation: Redistribution and removal of excess grease while packing a UH-1 or AH-1 short shaft cannot be done effectively by hand.

(b) Evaluation: The packing of a UH-1 or AH-1 short shaft, in accordance with TM 55-1520-210-35-2 and TM 55-1520-210-20, requires a .020 - .030 inch grease wall above the top of the splines. To accomplish this accurately and efficiently, a field expedient tool has been developed (see Incl 2). This tool is cut from standard .054 sheet aluminum or similar soft metal. The step design of the tool follows the inside contour of the short shaft and its spline teeth. After coating the splines with an excessive amount of grease, the tool is inserted so that the first step of the tool rests on the smooth wall portion of the short shaft's inner coupling. By using the smooth wall as a guide and rotating the tool around the shaft, the excess grease is removed.

(c) Recommendation: That the design of this tool be disseminated for local fabrication and use to all aviation maintenance units as an interim measure until a standard tool is developed and distributed.
