**USAAMRDL TECHNICAL REPORT 72-52**

**INVESTIGATION AND EVALUATION OF  
NONFLAMMABLE, FIRE-RETARDANT MATERIALS**

November 1972

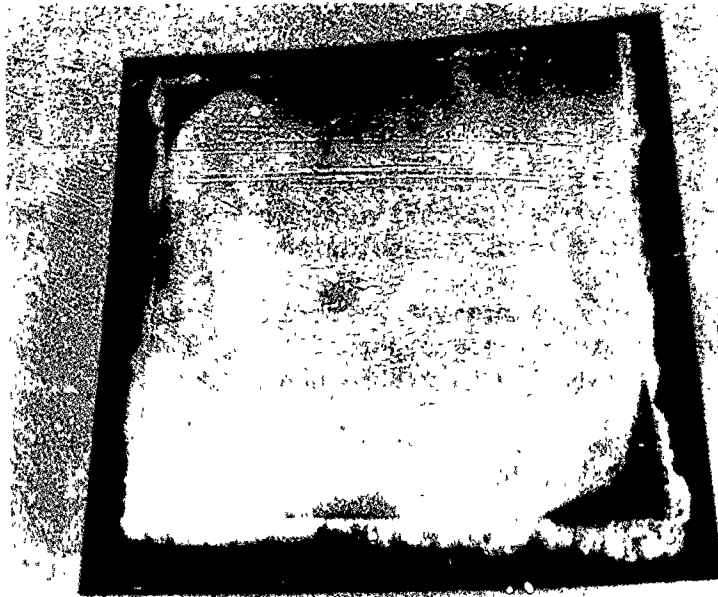
Figure 6. Photograph of Interior Plexiglas of Window After 9 Minutes of Fire Exposure.

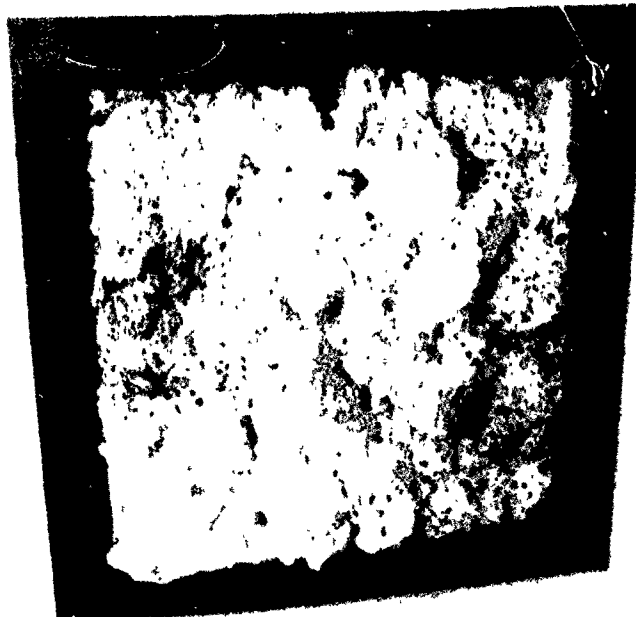
Figure 7. Photograph of Side Exposed to Fire (Exterior Plexiglas Layer Had Been Burnt).

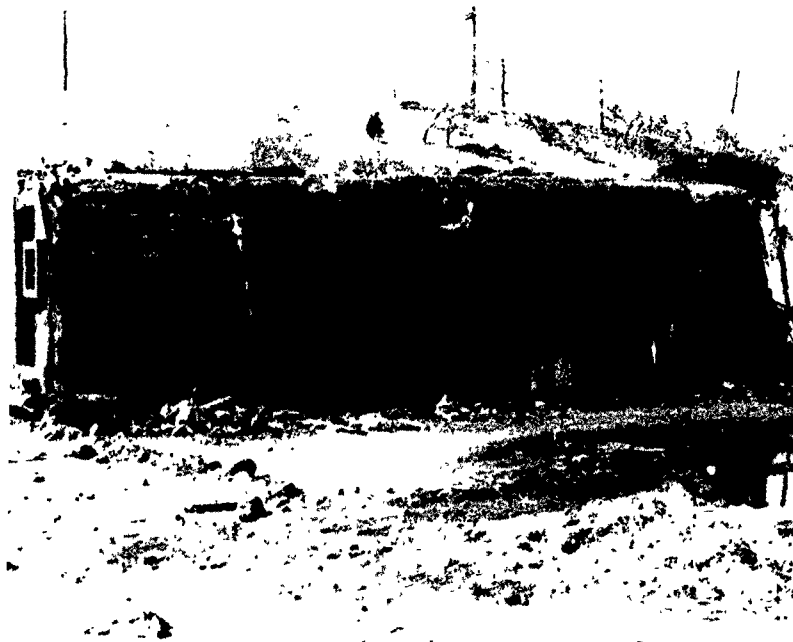
Figure 38. Right Side of CH-47 After Fire.

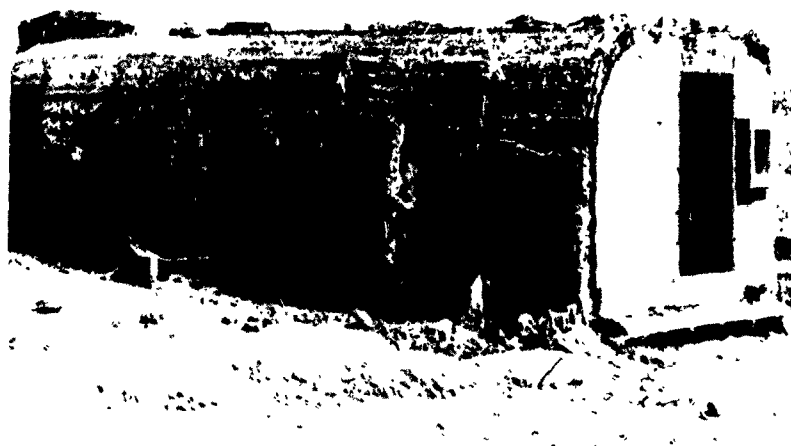
Figure 39. Left Side of CH-47 After Fire.
