**US Army Corps
of Engineers®**
Engineer Research and
Development Center

ERDC
INNOVATIVE SOLUTIONS
for a safer, better world

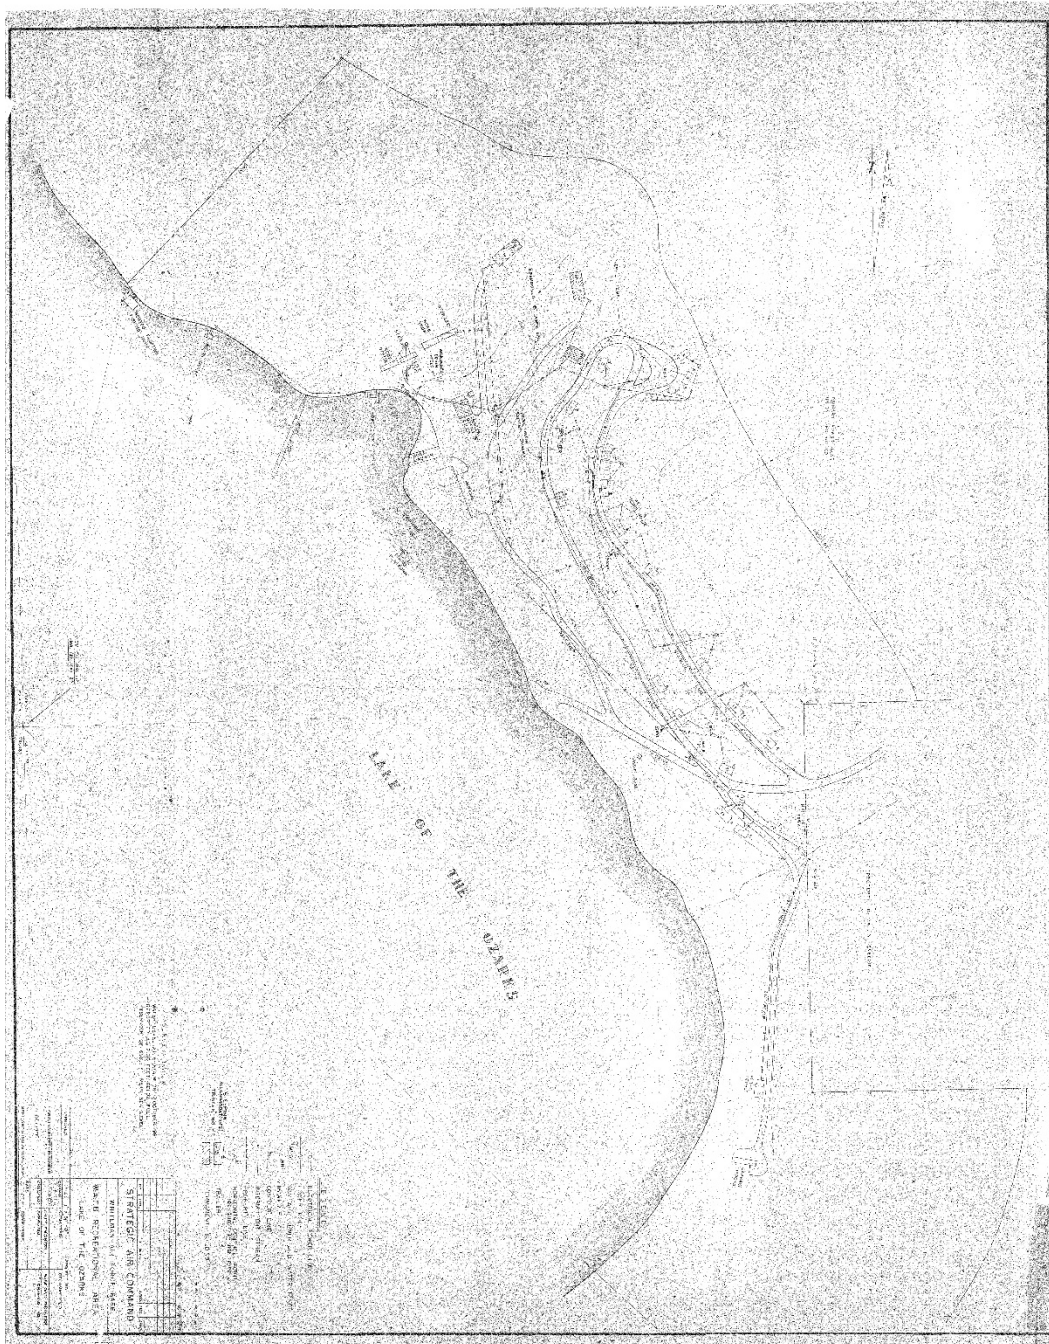
Early construction in 1961 at LORA (north recreation area) included a post exchange building (Building 550), a main office (Building 500), barracks (Building 560), latrine (demolished and replaced with Building 529), storage buildings, (Buildings 505, 506, and 528), and a bath house (demolished). In 1961, the setting of LORA offered several campsites and trailer sites, a lakefront pavilion (Building 549), a swimming beach, a court

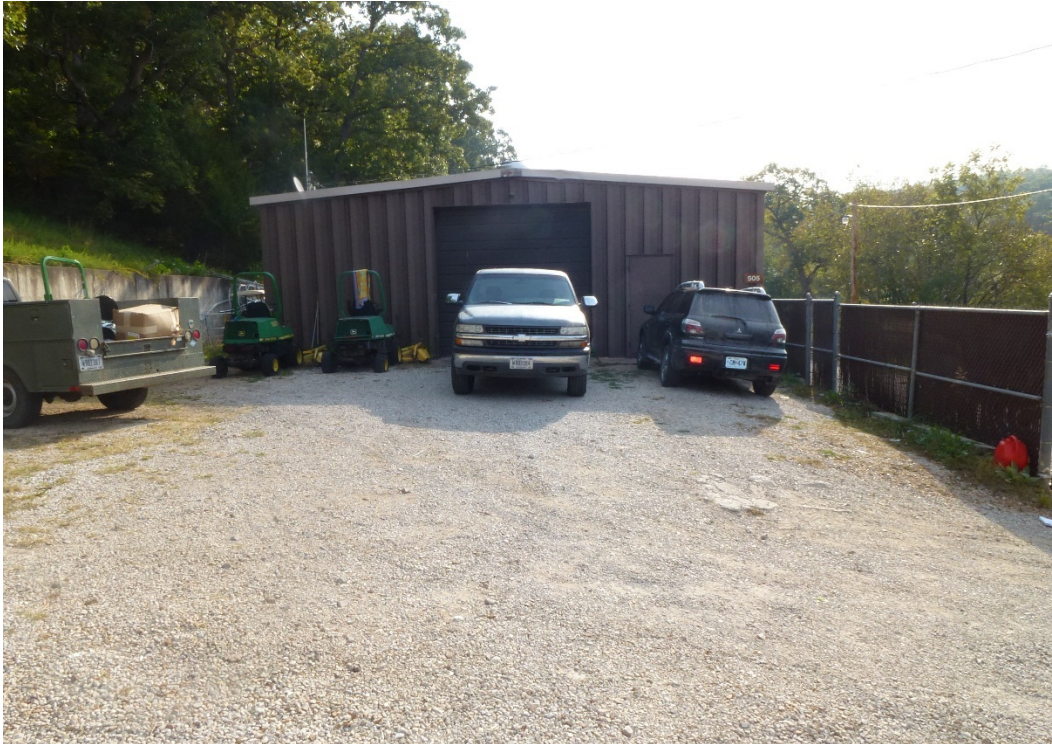
Figure 32. South elevation of Building 505 (ERDC-CERL, 2015).

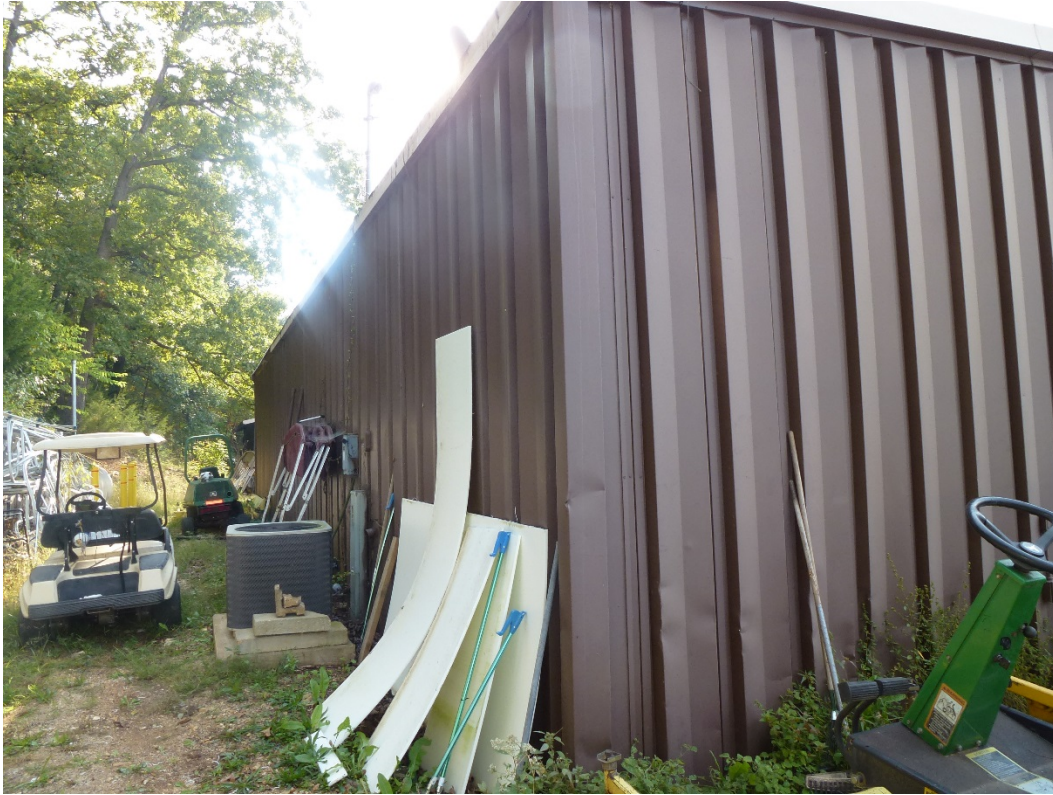
3.1.6 Building 506 (general item repair), 1961

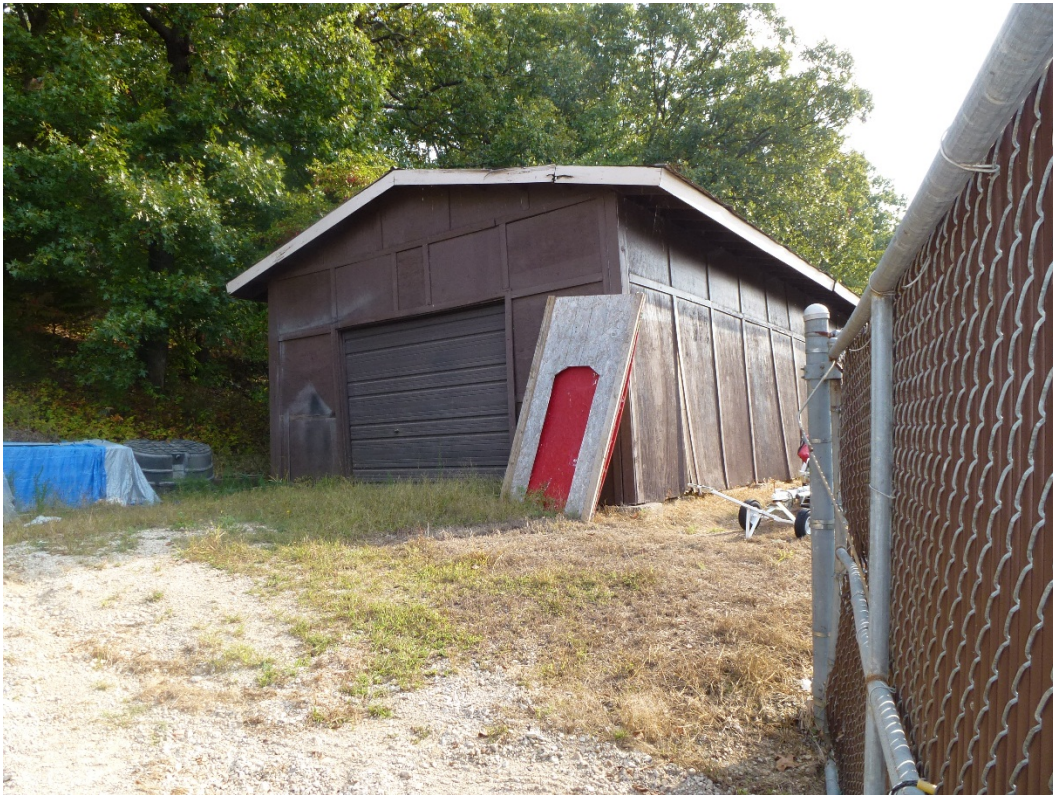
Figure 37. South elevation of Building 506 (ERDC-CERL, 2015).

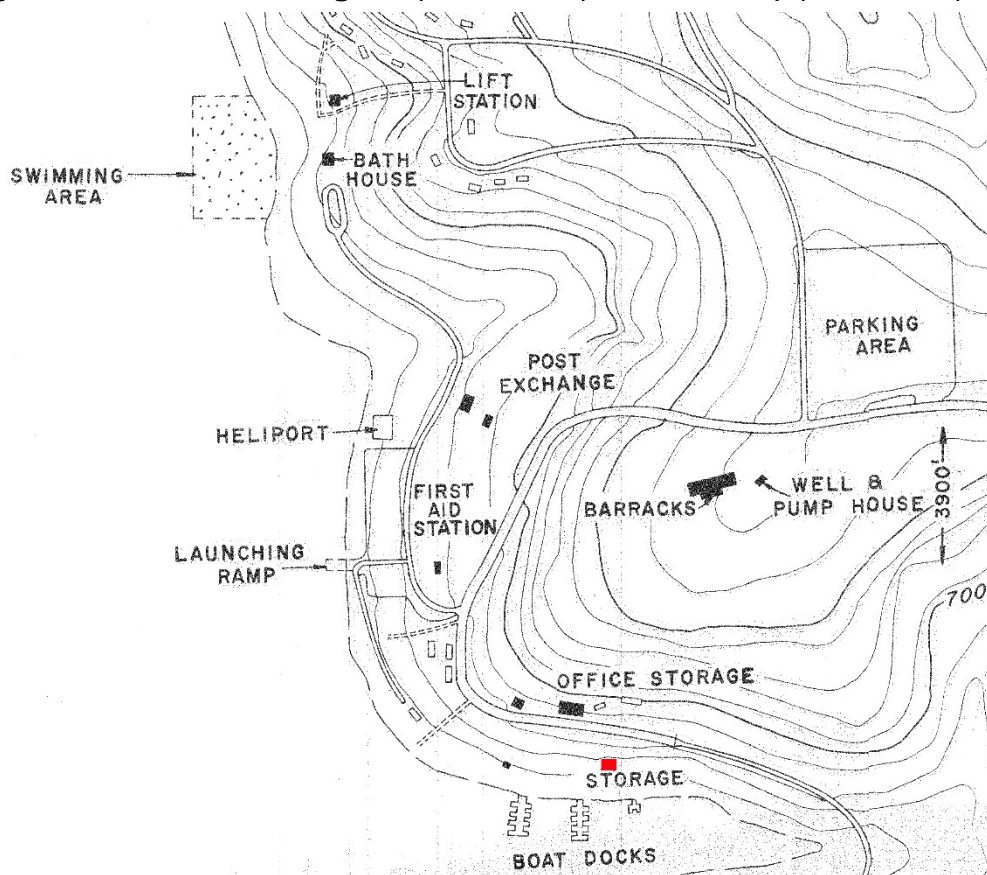
Building 528 is set within the slope of a hill. The raised concrete foundation is visible on the south side of the building (Figure 41). A poured concrete walkway encompasses the building on the east, south, and west sides. A set of poured concrete steps lead off the south elevation down to the marina. A wood-framed deck wraps around the building the left side of the south elevation and the west sides (Figure 42).

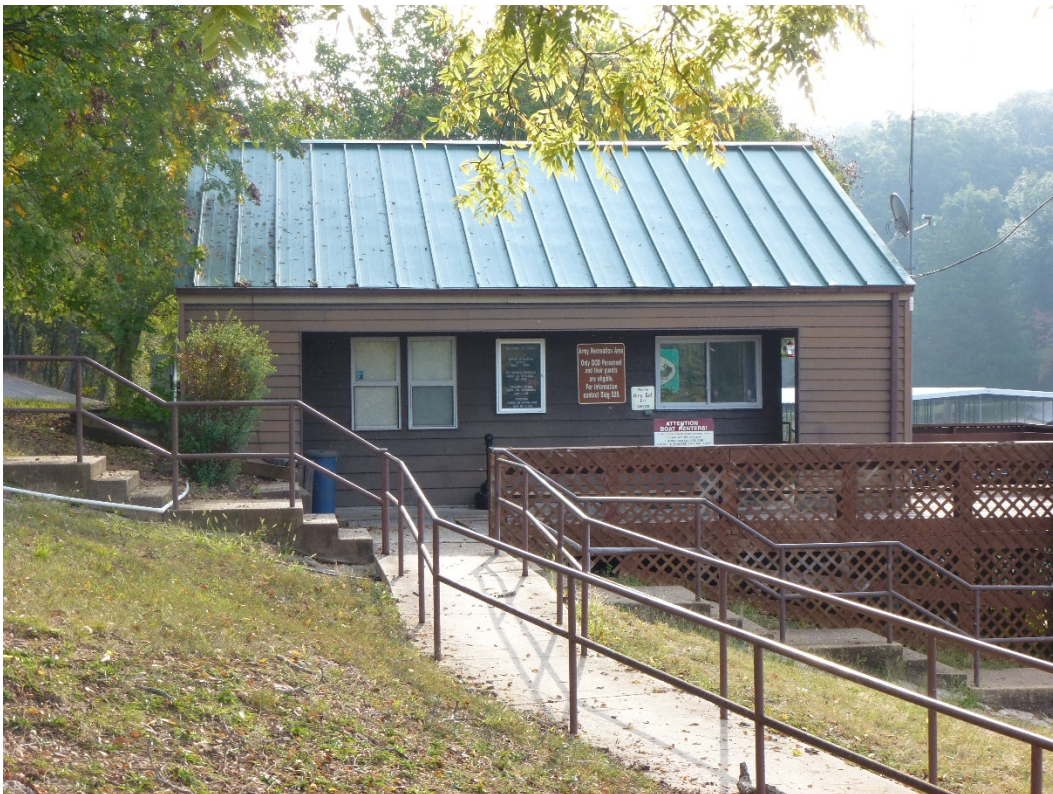
Since there is no actual property record card for this building, the dates for changes to the building are unknown; however, it appears to the researchers that a larger gable roof structure was constructed and “placed” over the smaller original rectangular building, creating the incised walkway and explaining why there are two different types of metal siding used. The original windows have all been removed and replaced.

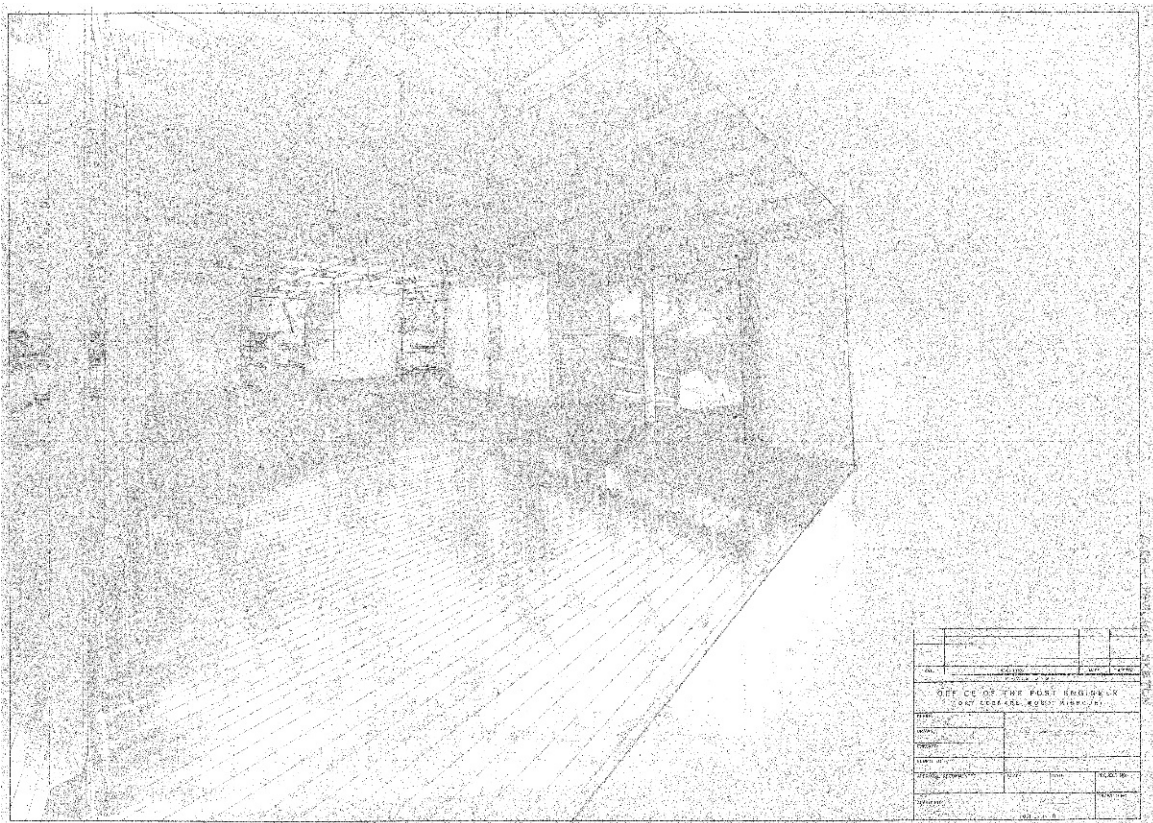
Figure 51. Looking at the southeast and southwest sides of Building 549, with the poured concrete foundation visible at the shoreline (ERDC-CERL, 2015).

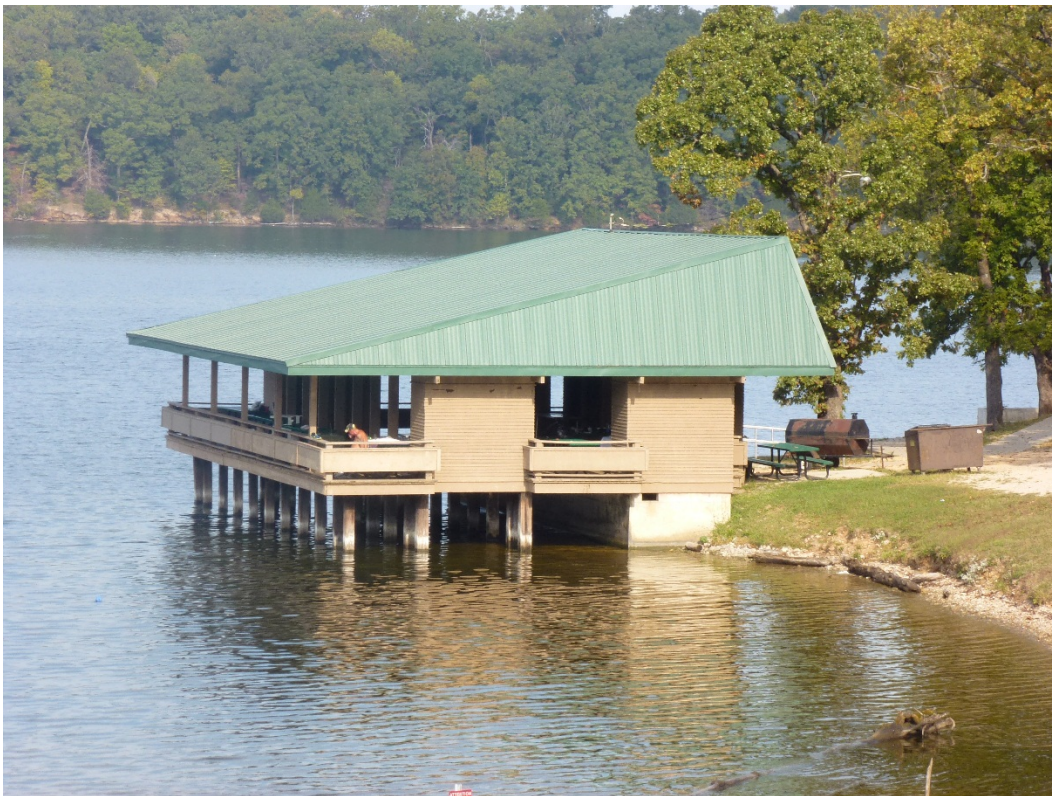
Figure 52. North oblique of Building 549 (ERDC-CERL, 2015).

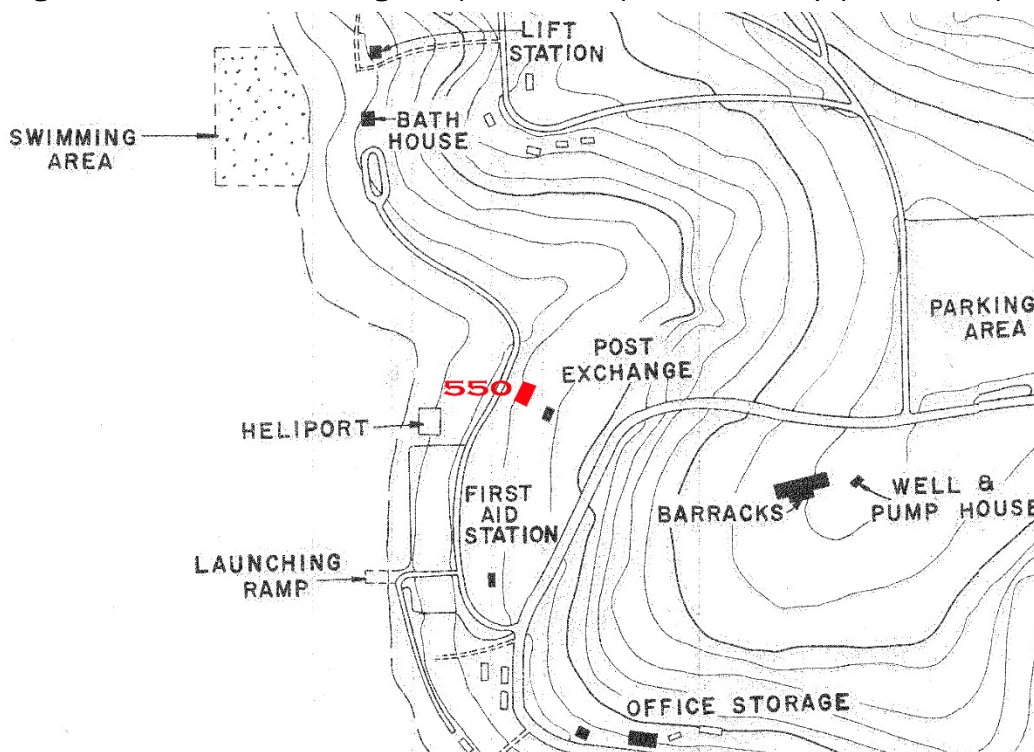
Building 550 is a small one-story structure with a rectangular footprint, a built-up gable roof with overhanging eaves with wood and metal fascia, concrete block exterior walls, replacement vinyl awning windows, and concrete windowsills. The south (front) elevation is divided into five bays by concrete pilasters (Figure 59). Four of the bays are each filled with a large window that is comprised of a single-pane fixed window in the middle that is flanked by a one-over-one awning window on either side (Figure 60). The fourth bay on the south elevation is filled with a single-entry door. The east and west elevations mirror each other. Each elevation has a large window opening nestled under the gable end that has been covered

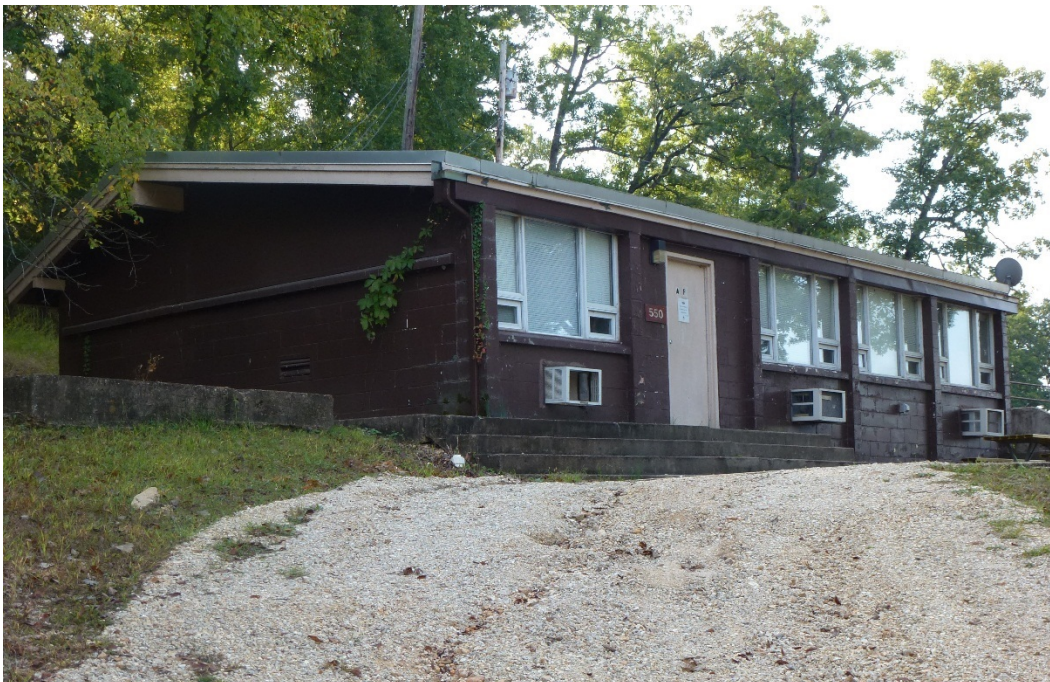
Figure 60. Close-up of a replacement vinyl window on the south elevation of Building 550 (ERDC-CERL, 2015).

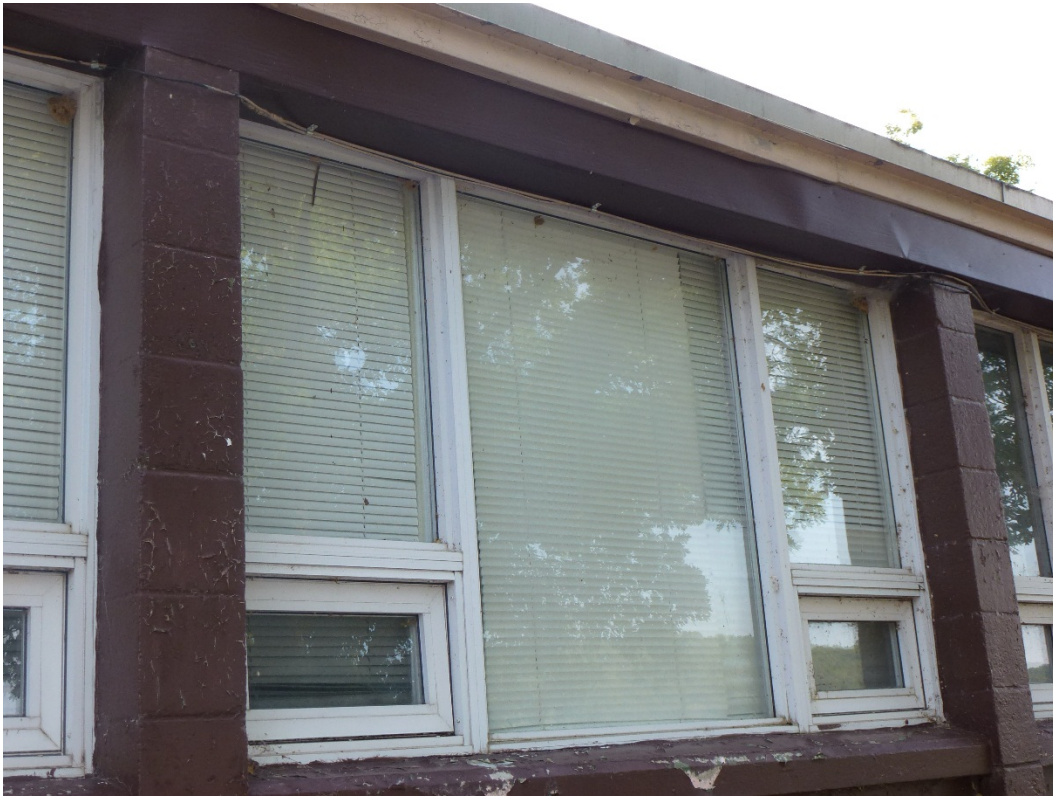
A poured concrete sidewalk with retaining wall runs along the east side of the building (Figure 61). The sidewalk connects Building 550 to Building 555. The north elevation faces the hill and another concrete retaining wall. A long narrow window opening located in the middle of the elevation has been covered with wood (Figure 62).

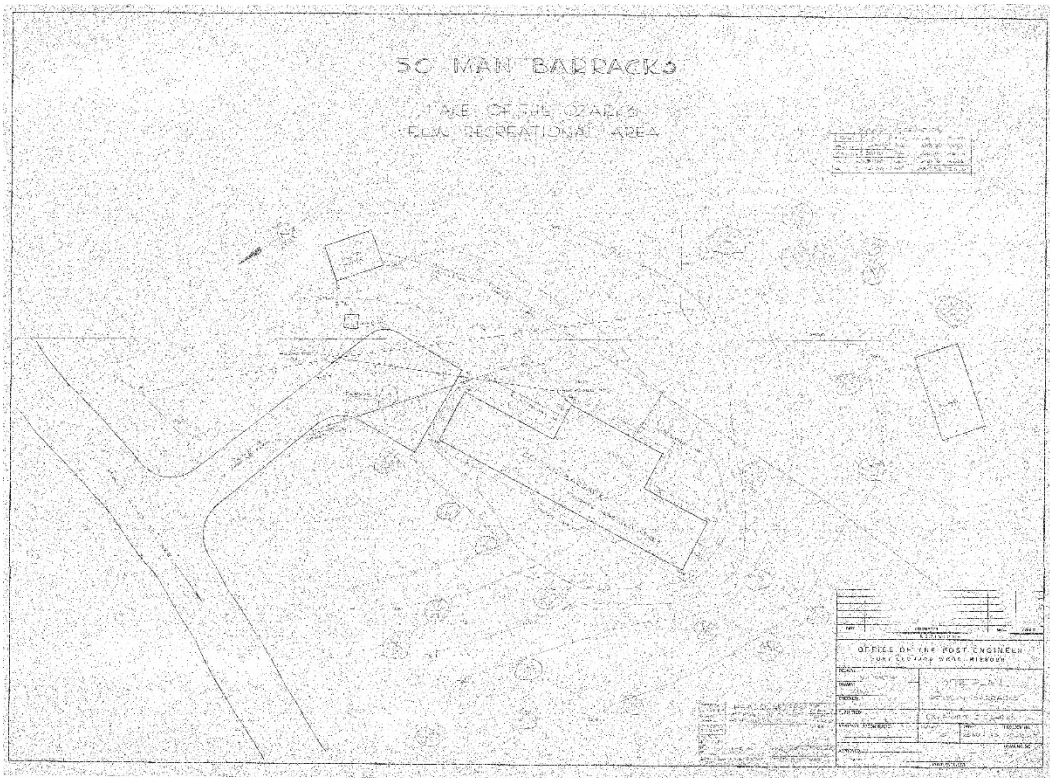
The north elevation faces Olney Circle. There are seven one-over-one windows on this elevation (Figure 68 and Figure 69). The east elevation is two-part: the right side projects outward and there is a single-entry door and a smaller original metal-sash one-over-one window on this part of the elevation, and the left side is recessed with a small narrow slider window on that portion of the wall (Figure 70). The middle section of the south elevation projects outward from the left and right sides (Figure 71).

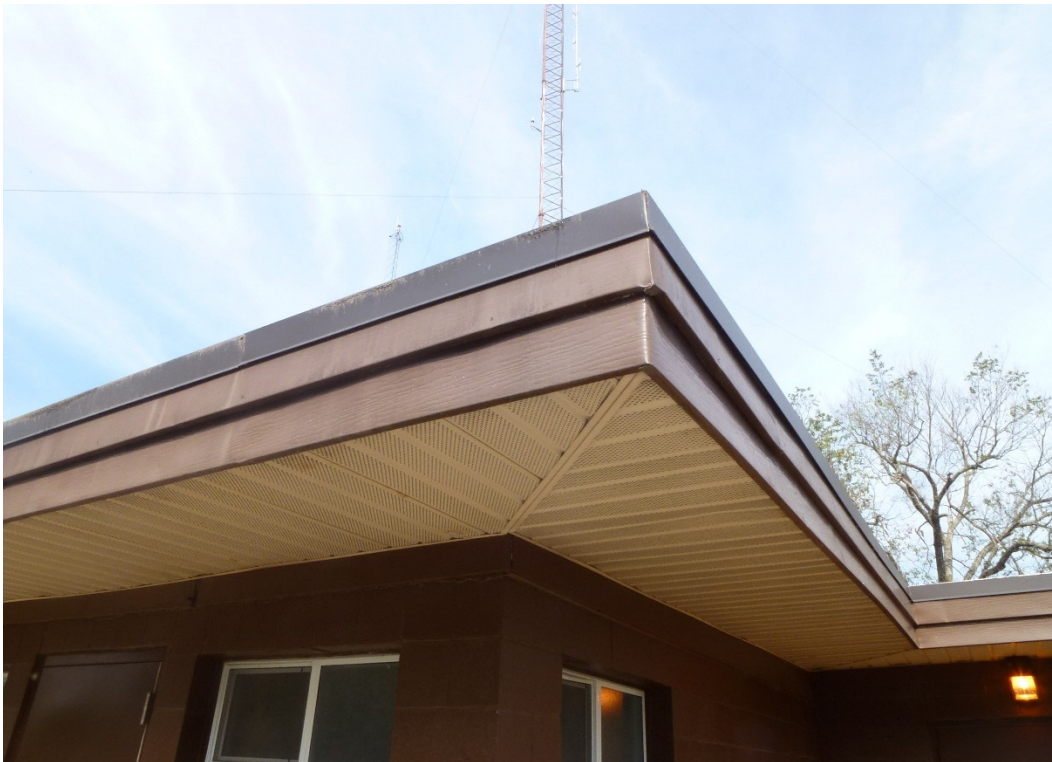
Figure 73. Close-up of a replacement vinyl one-over-one window on the south elevation of Building 560 (ERDC-CERL, 2015).

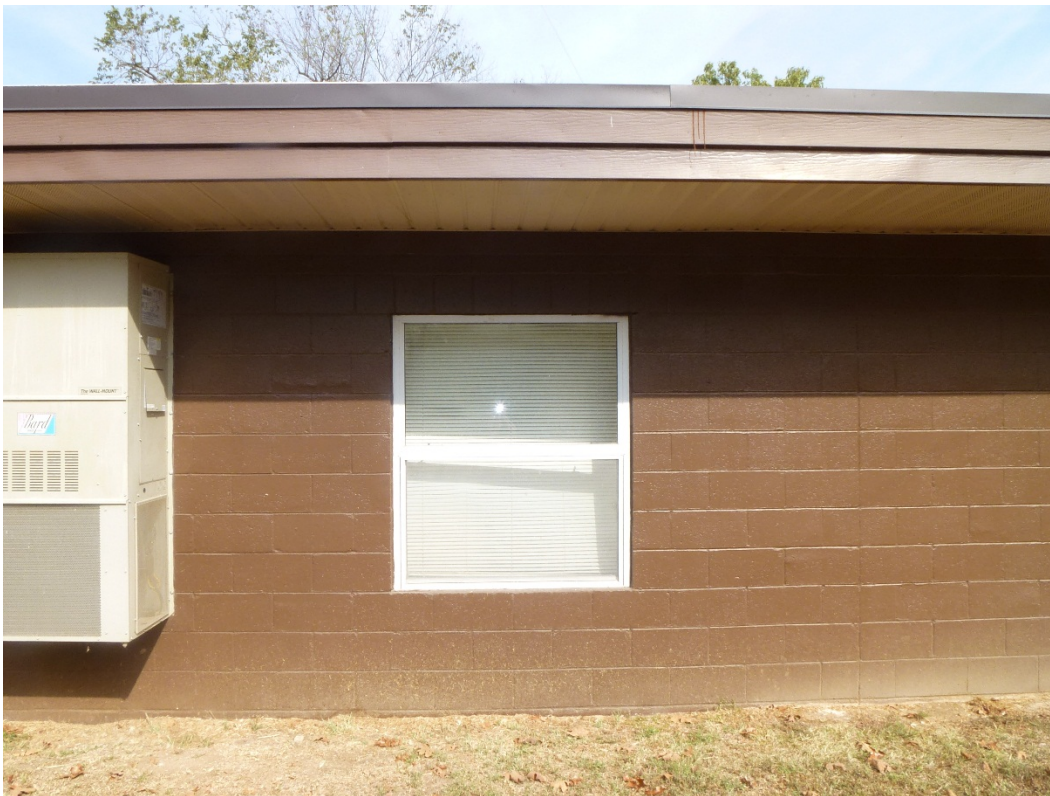
Figure 74. Close-up of a replacement two-pane slider window on the south elevation of Building 560 (ERDC-CERL, 2015).

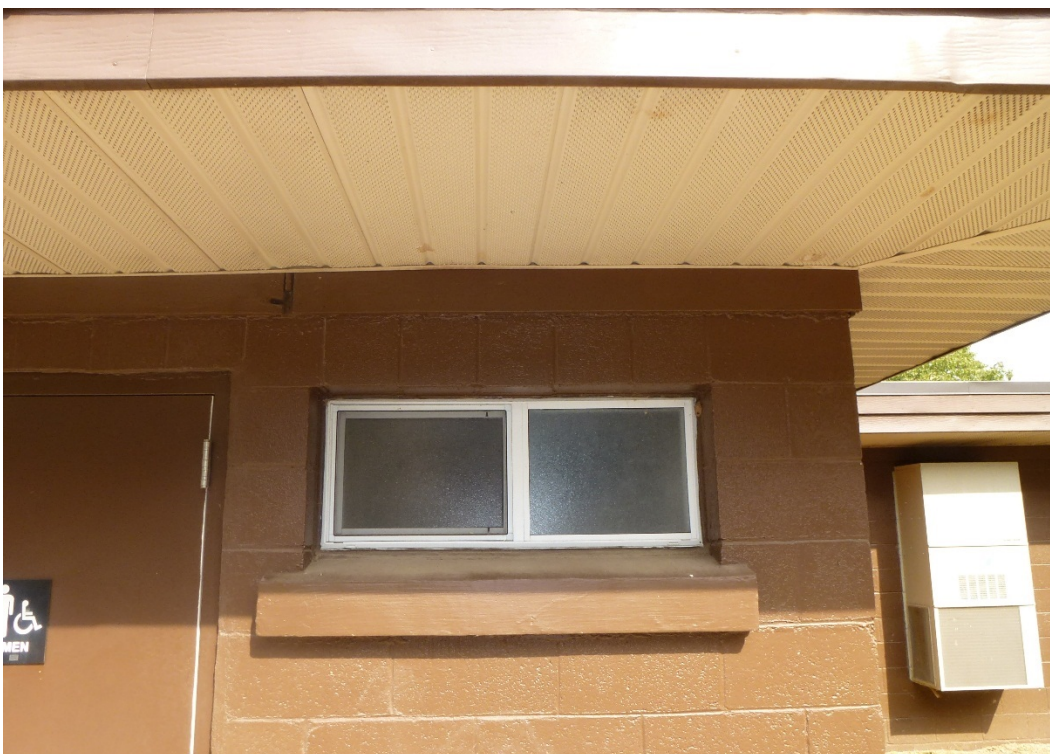
Figure 75. Left side of the south elevation of Building 560 (ERDC-CERL, 2015).

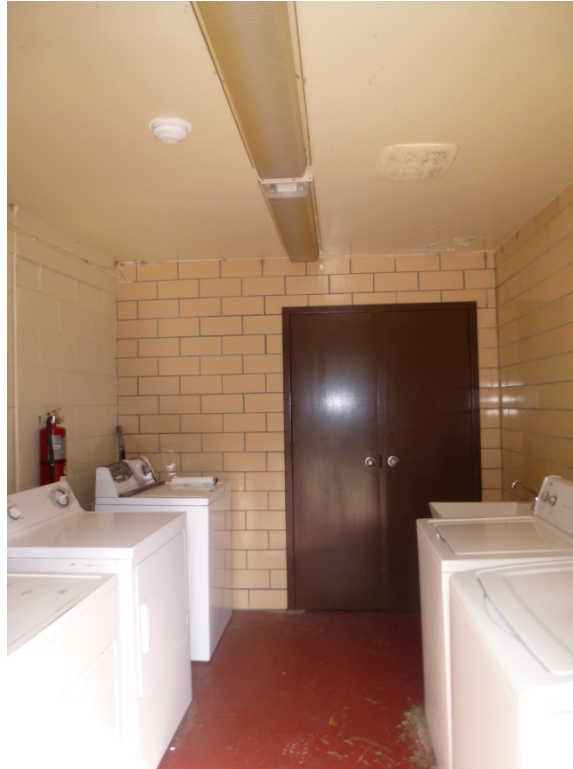
3.2 Accommodation sites

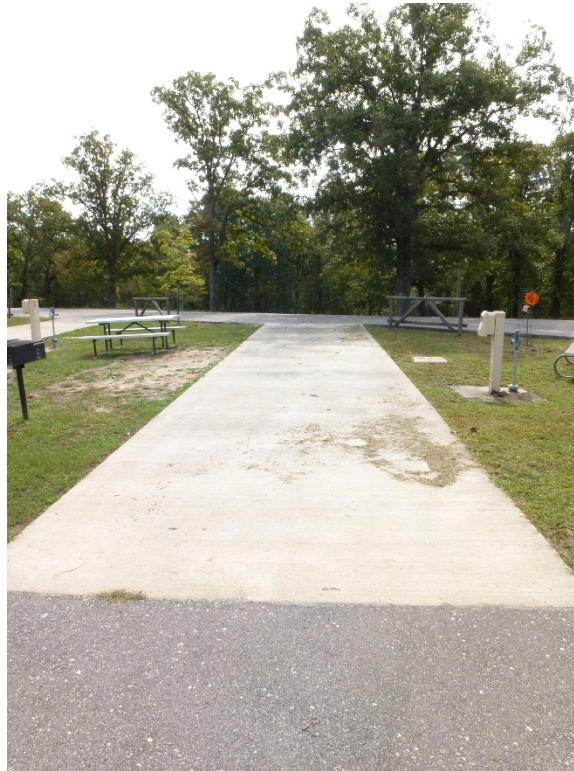
3.2.3 Rustic campsites

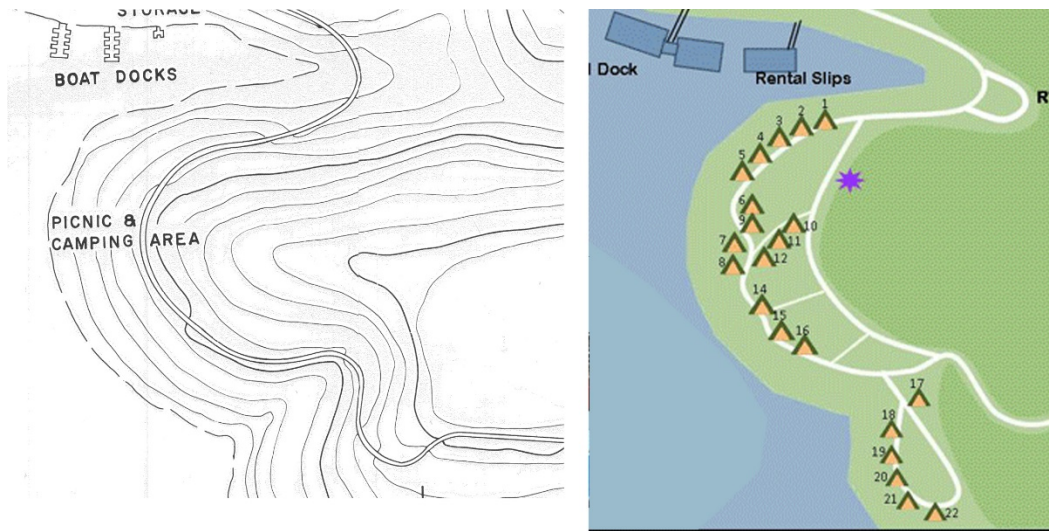
Figure 89. Example of a rustic campsite (ERDC-CERL, 2015).

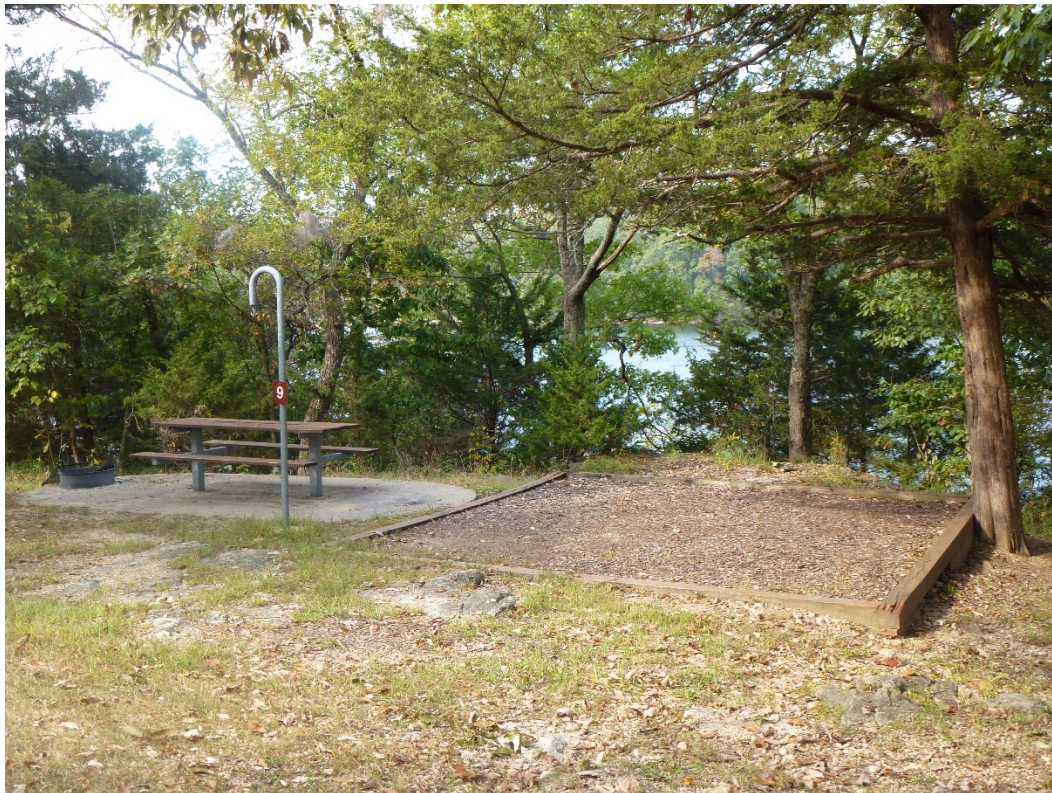
3.3 Support utilities

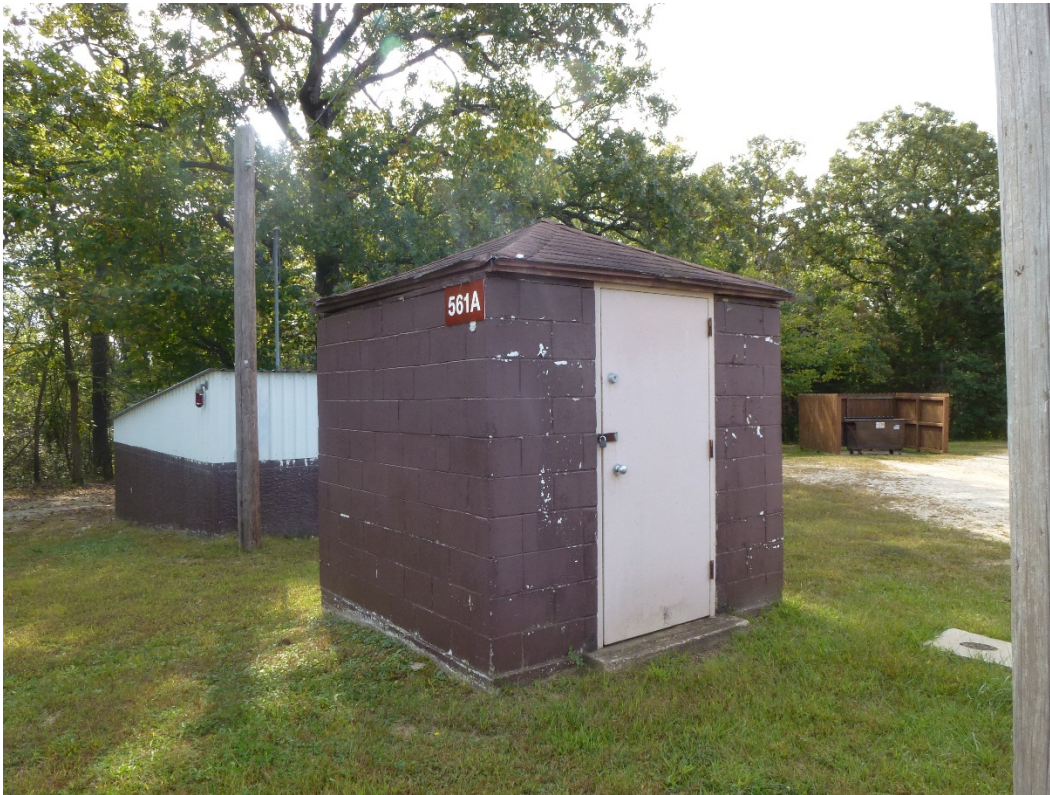
Figure 97. Southwest oblique of Building 561B [right] and south elevation of Building 561A [left] (ERDC-CERL, 2015).

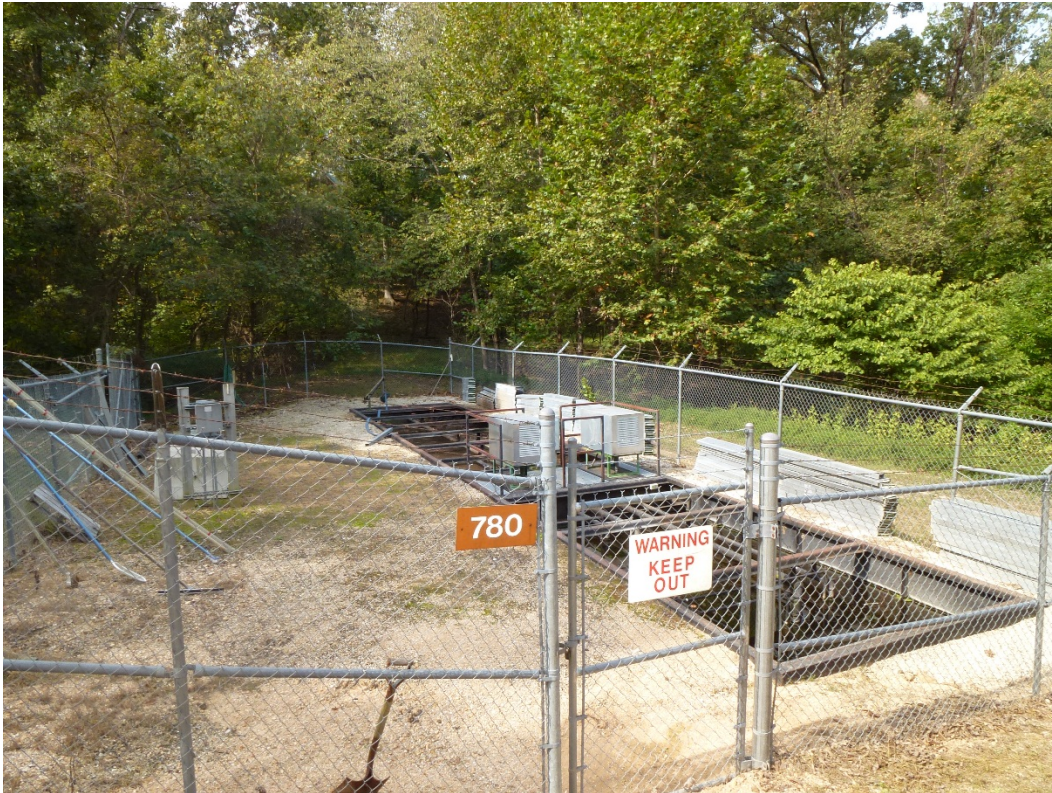
3.3.8 Building 781 (IND waste treatment), 1961

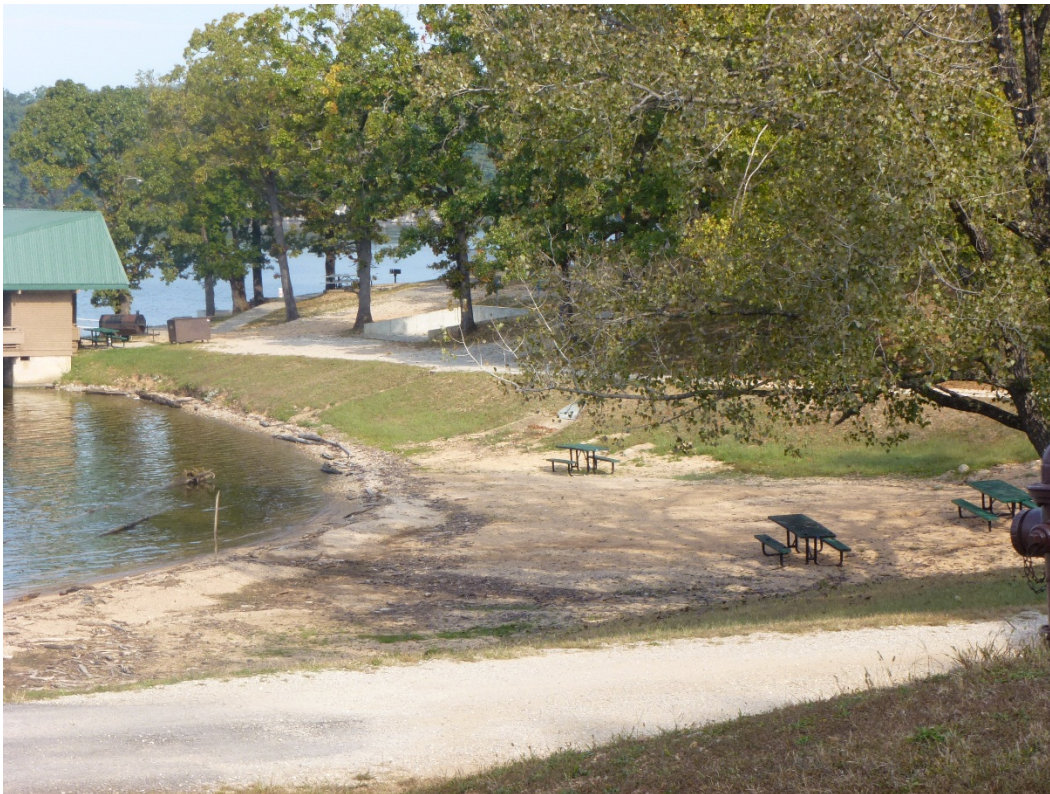
There is a small covered pavilion area located off Fleet Lane near the rental cabins. The pavilion was constructed in early 1970s as a simple four-post structure with a metal gable roof and a concrete pad foundation (Figure 130).

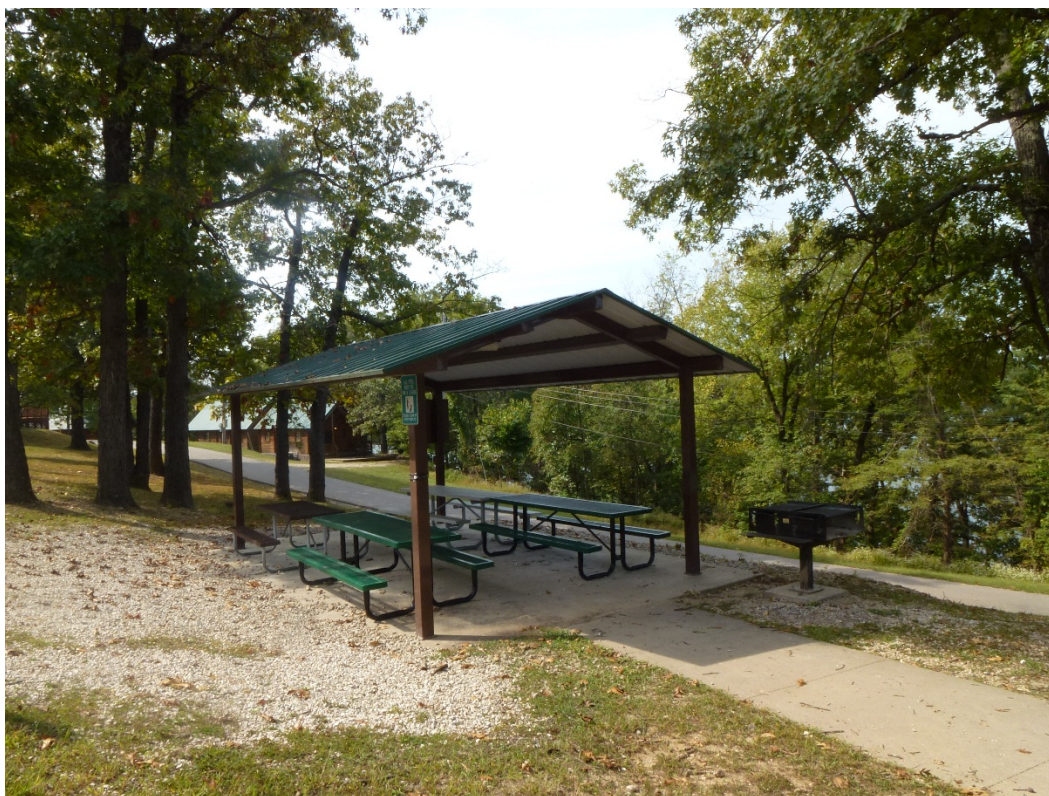
A newly constructed play-structure is located near the helipad and boat-launch ramp on the west side of LORA (Figure 131). The play area is nestled into the hillside and supported by a concrete-block retaining wall. A newly constructed bath house is located to the north.

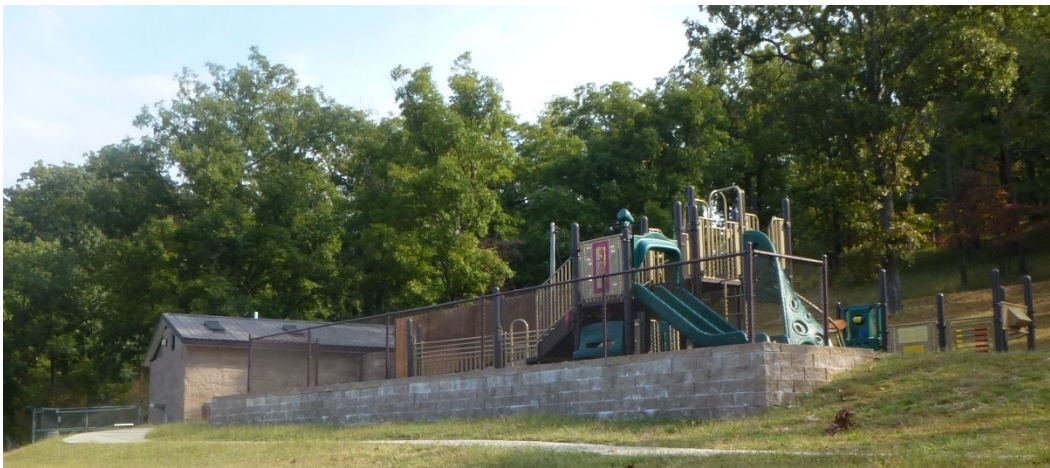
Figure 131. Newer playground area located near the swimming area, with newer bath house to the left of the photo (ERDC-CERL, 2015).

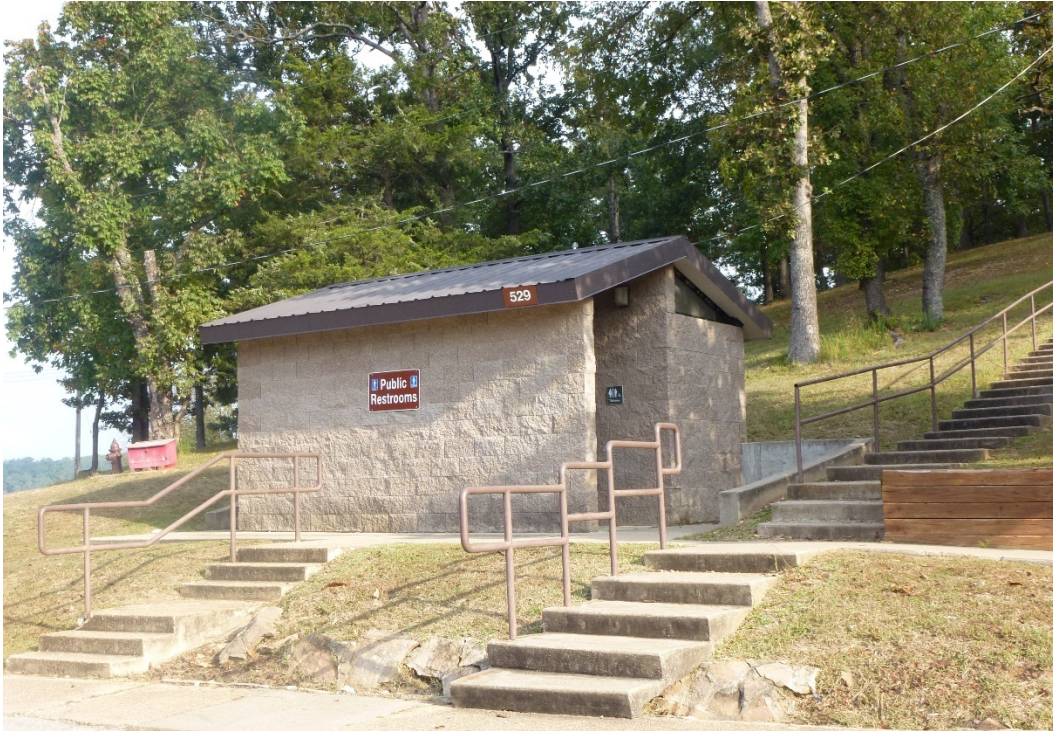
Figure 133. Newer bath house facility located near the boat launch (ERDC-CERL, 2015).
