Stormwater Management Practices, Monitoring, and Maintenance Plan for US Army Garrison at West Point, NY

Darixa D. Hernandez-Abrams, Bruce Pruitt,
Samantha R. Wiest, and S. Kyle McKay

April 2023

Final report

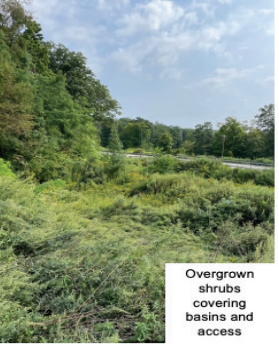
<p>Grass covering outlet</p>

<p>Overgrown shrubs covering basins and access</p>

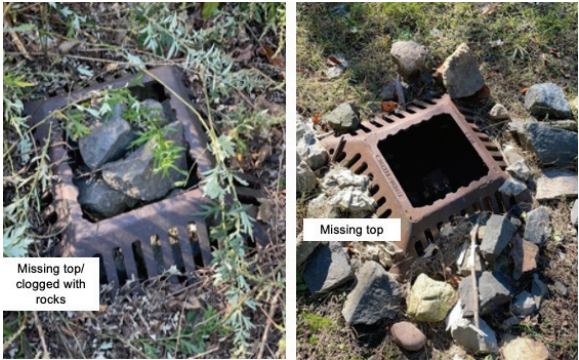
<p>4. Missing or broken grates/drain – this may cause trash and large debris to get in the underground system, leading to structural damage, clogging, and ponding. Uncovered drains and pipes are also a human and domestic animal safety hazard, especially in residential areas or near sidewalks.</p>

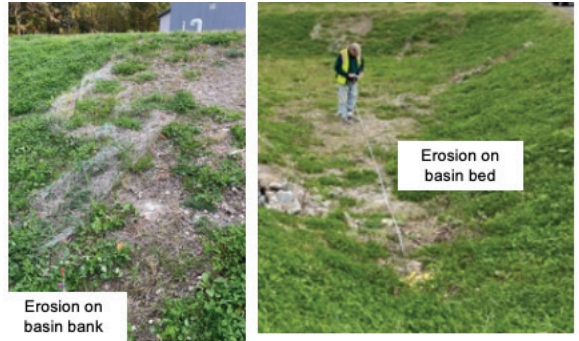
<p>5. Erosion – high stormwater runoff velocities and volumes may cause erosion to basin slopes, beds, and around inlets and outlets. If left untreated, this may cause structural safety issues. All outfall and bank stability problems should be corrected according to the NY Standards and Specifications for Erosion and Sediment Control (NYS Department of Environmental Conservation 2016).</p>

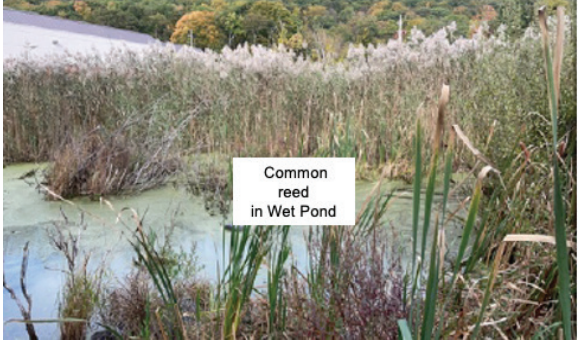
<p>6. Invasive plant species – terrestrial and aquatic nonnative plant species outcompete native vegetation, cause diversity loss, habitat loss, affect water and soil quality, and cause changes in topography. If left untreated, they may damage or affect SMP structures and functionality. Common invasive plants in NYS are <i>Hydrilla</i>, Common reed, Eurasian watermilfoil, and Kudzu (NYS 2022).</p>

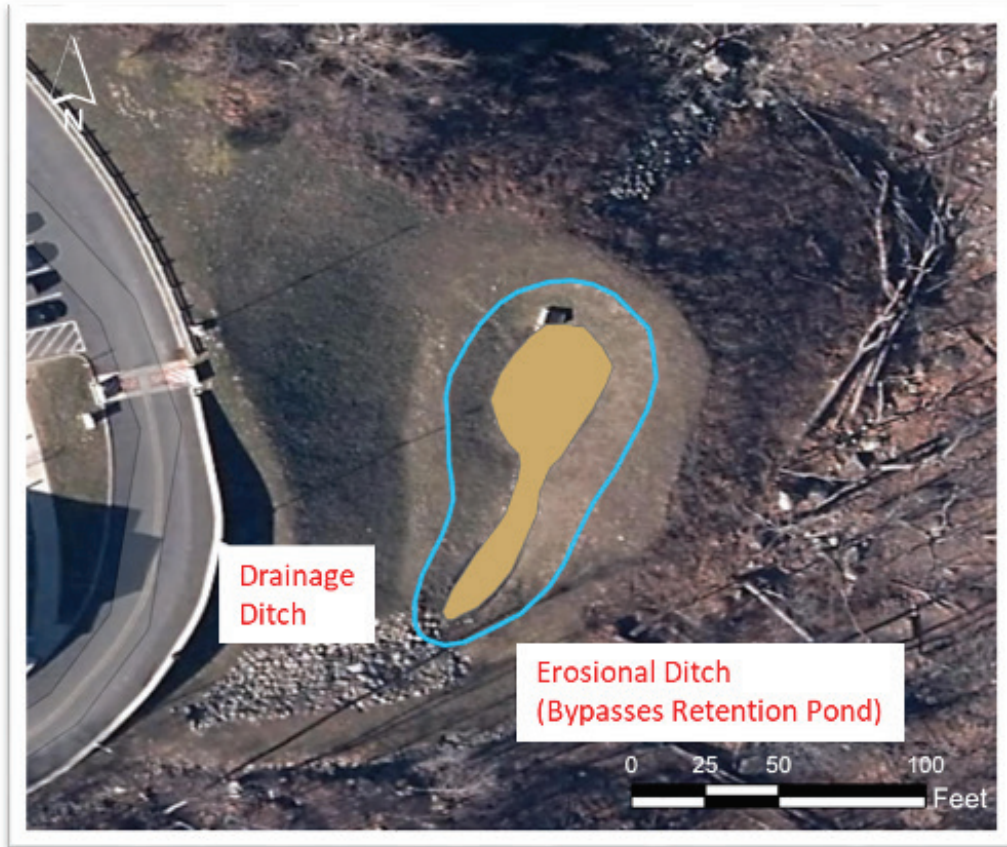
Figure D-4. USMAPS Detention Pond at Pipeline Trail off Reynolds Rd., US Military Academy, West Point, NY. GPS surface assessment. Note erosional ditch does not discharge to detention pond.
