AD-A032 365

NAVAL POSTGRADUATE SCHOOL MONTEREY CALIF  
MICROSCOPIC INVESTIGATION OF INTERFACE CORROSION OF STEEL-ALUMI--ETC(U)  
SEP 76 M R KEELEAN

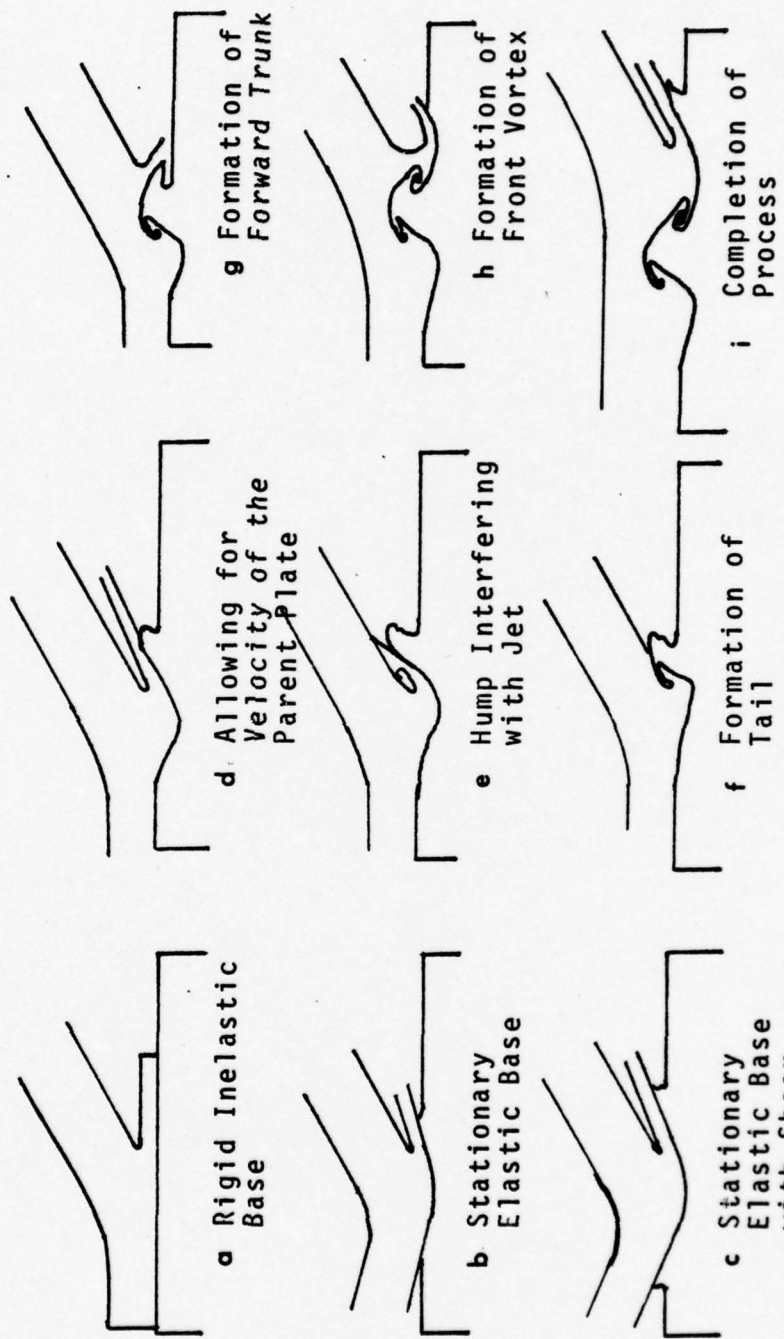
Figure 1. Illustration of rippling phenomenon during explosive bonding.

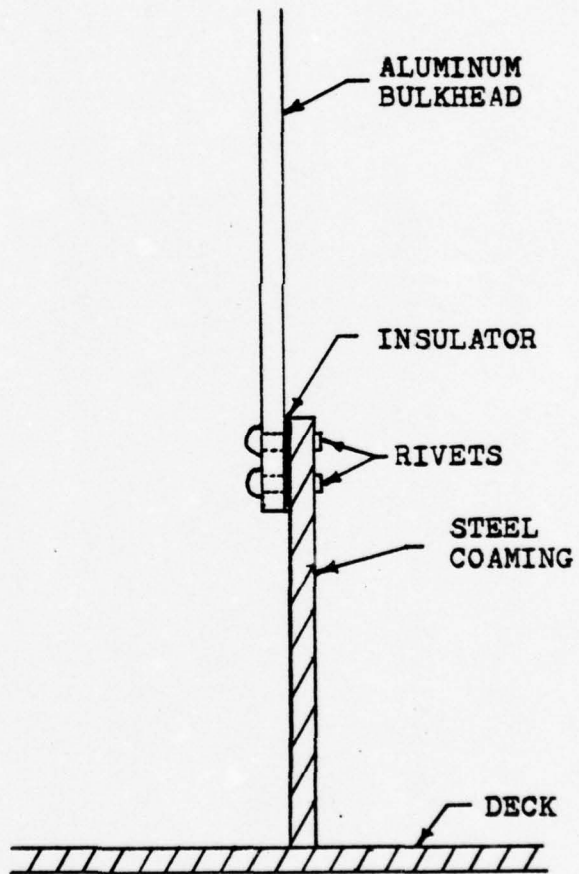
Figure 3. Mechanical fastening technique.

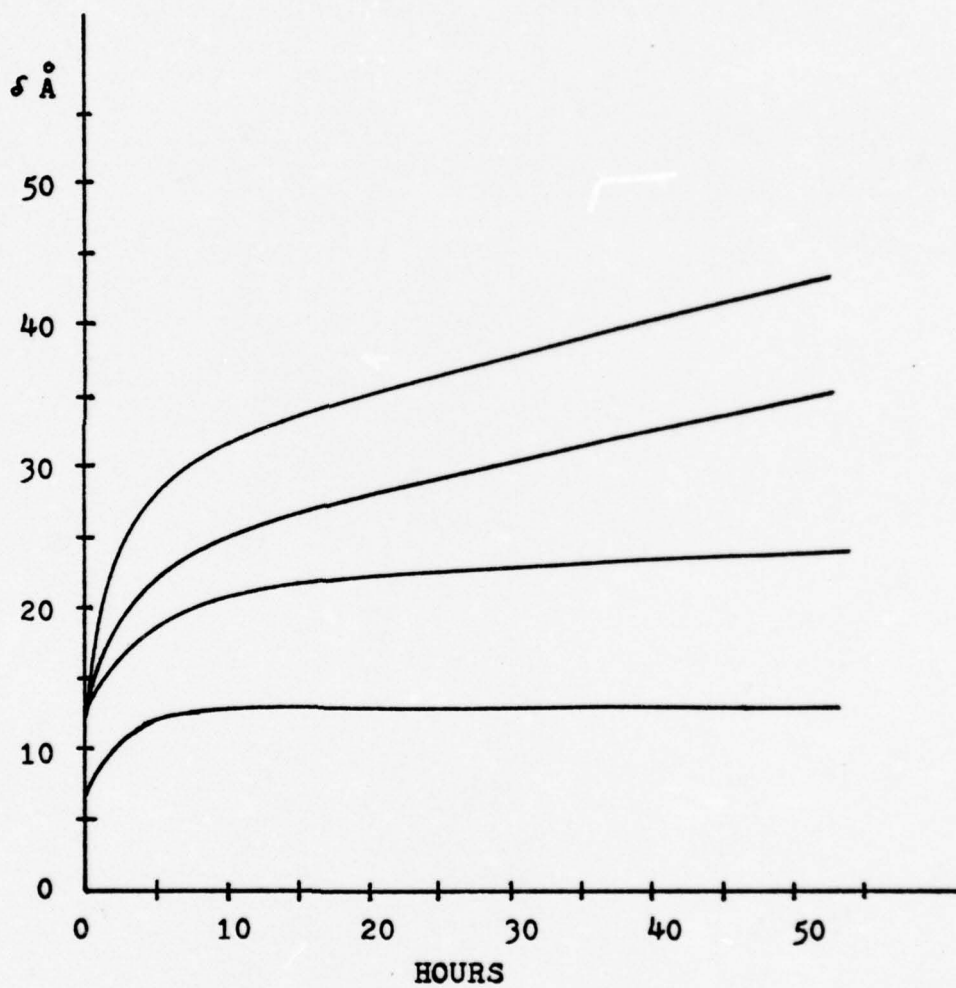
Figure 6. Kinetics of the growth of oxide films on various metals at room temperature in oxygen or dry air.

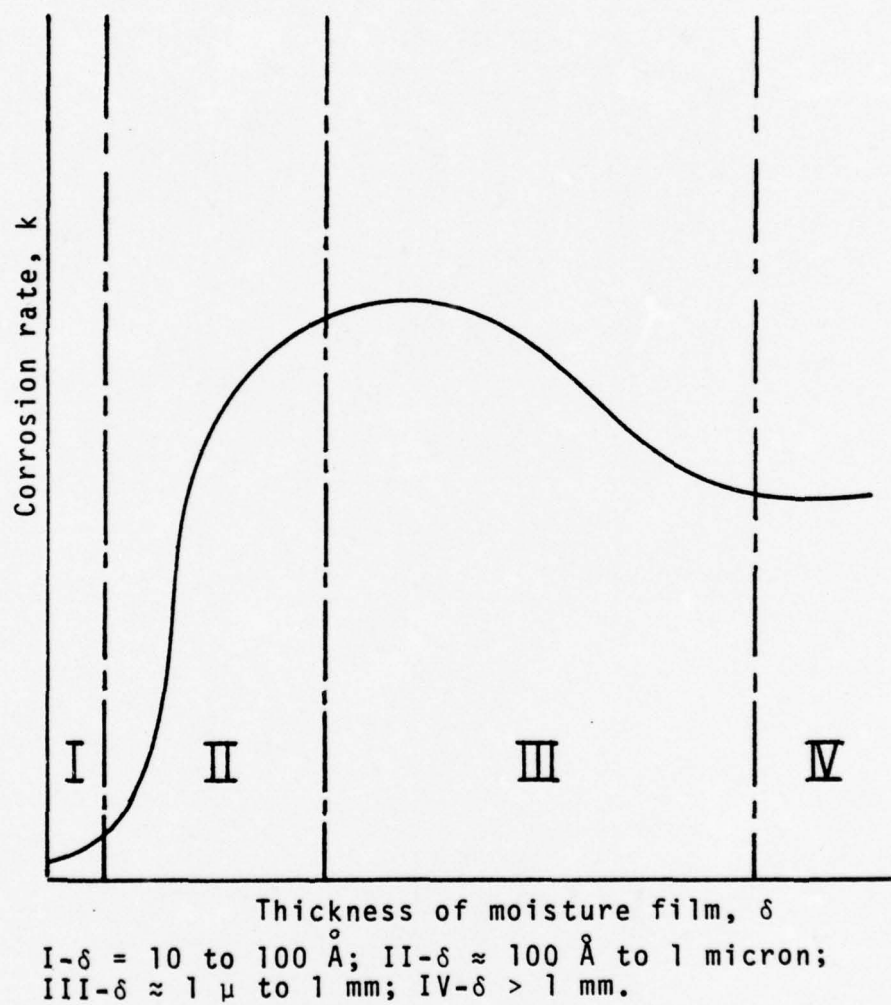
Figure 7. Dependence of atmospheric corrosion on thickness of the moisture film on the metal surface.

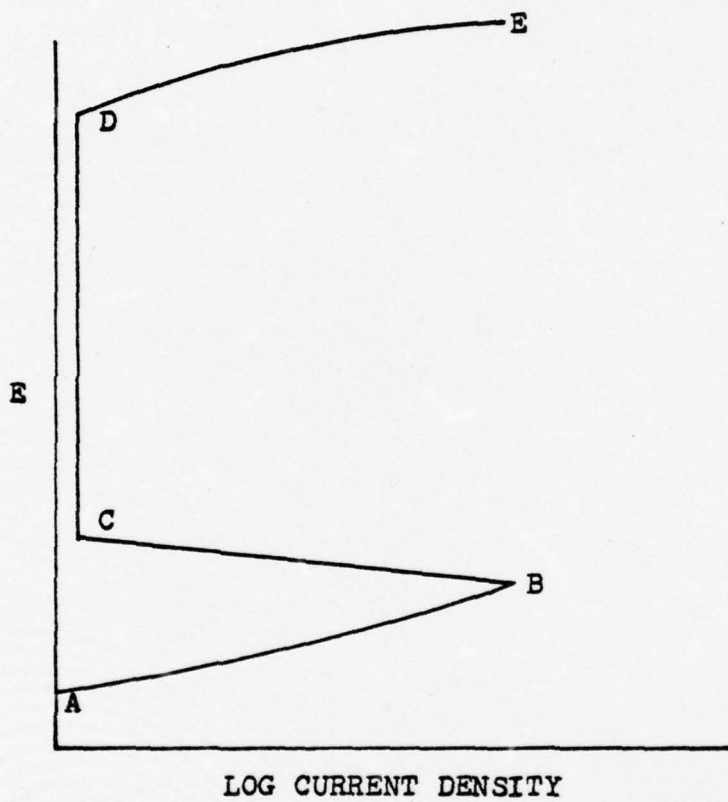
Figure 8. Anodic polarization curve for a specimen exhibiting passivity, determined potentiostatically.

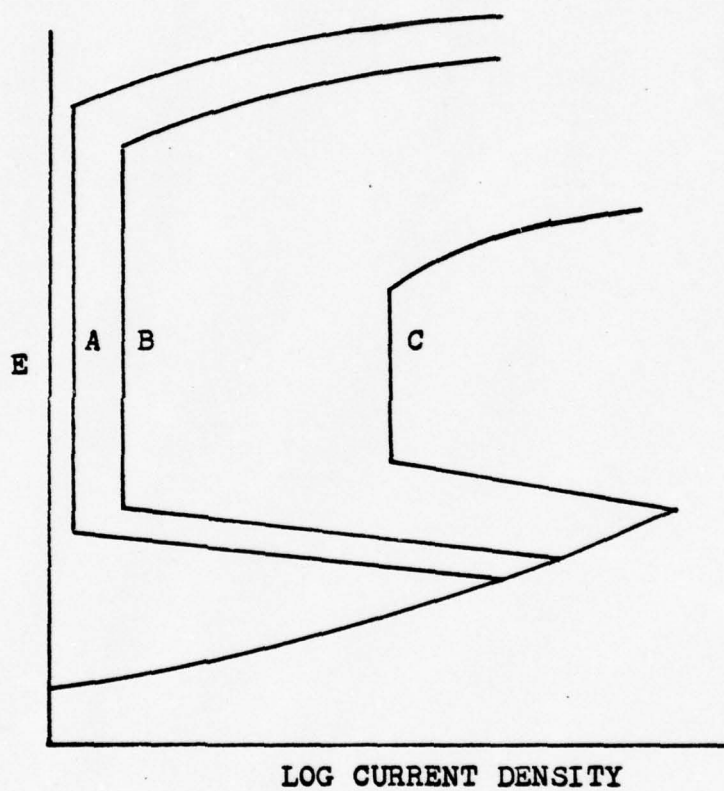
Figure 9. The effect of chloride ion upon the anodic polarization curve for a metal that exhibits passivity.

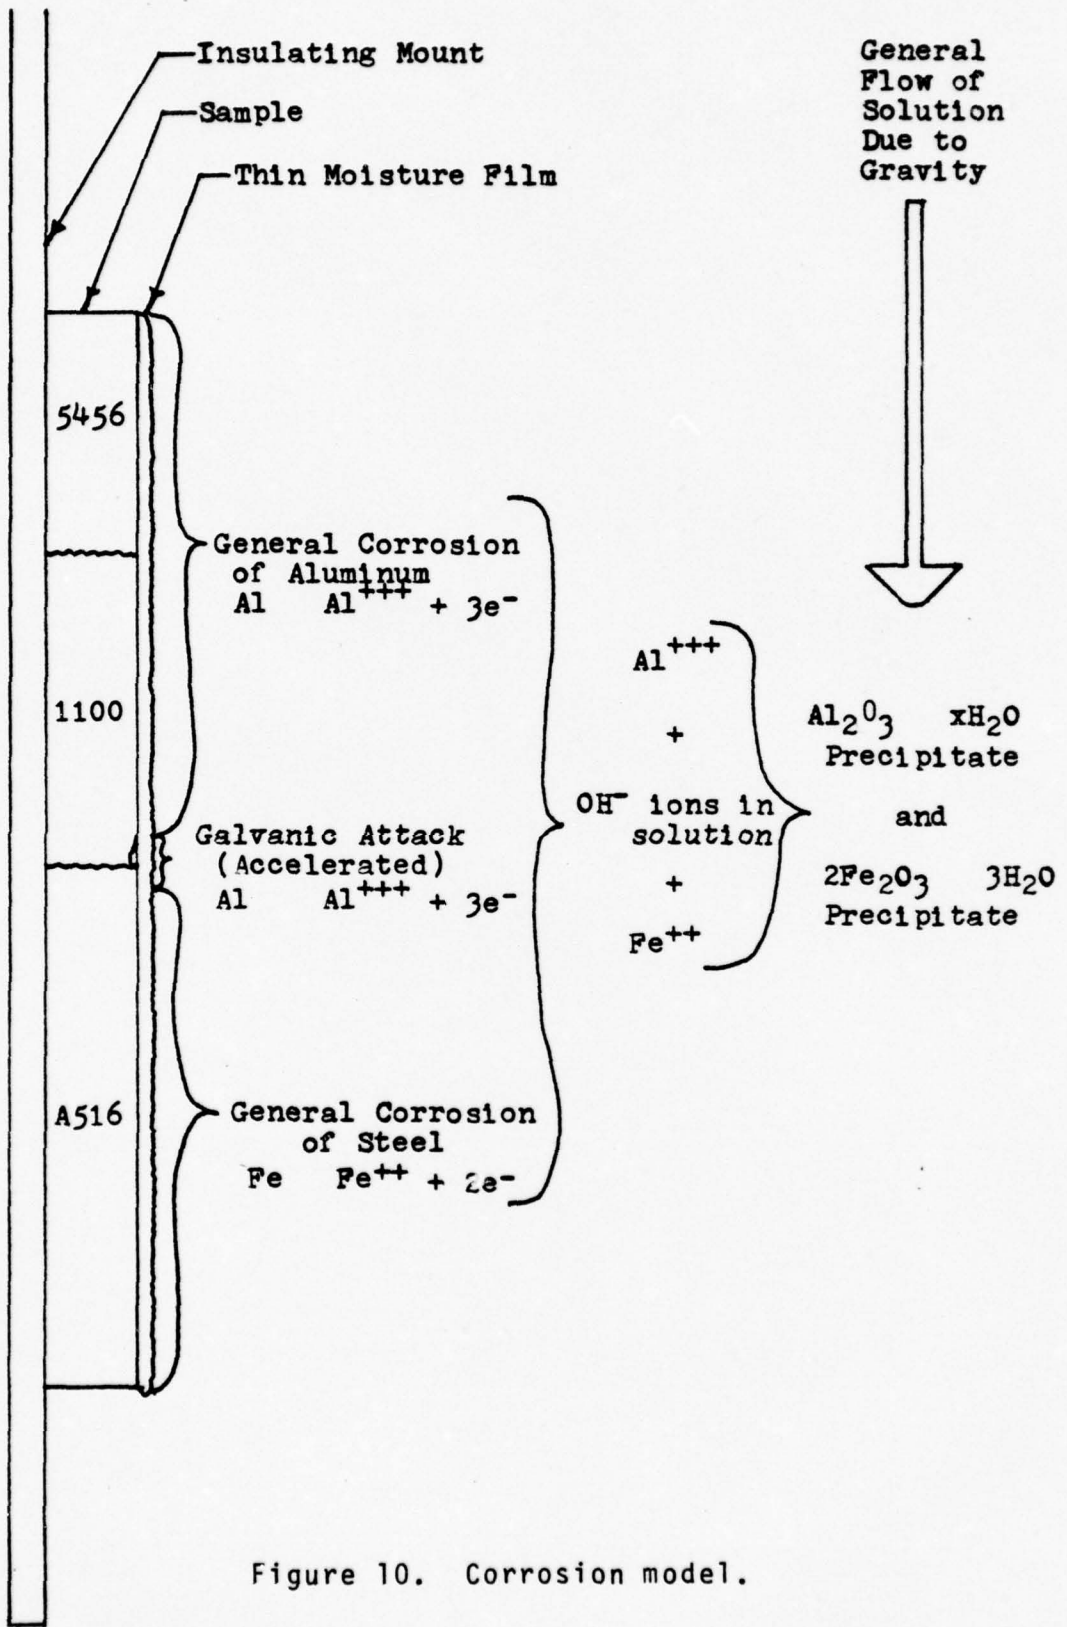
Figure 10. Corrosion model.

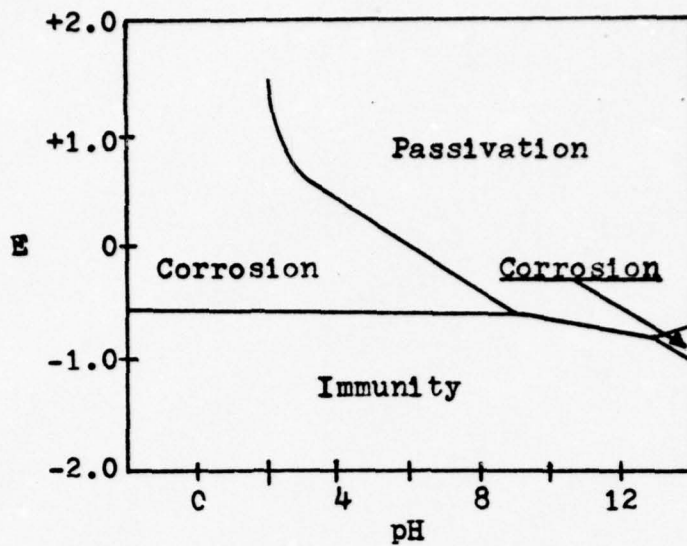
Figure 11. Pourbaix diagram shows theoretical conditions for corrosion of metallic iron.

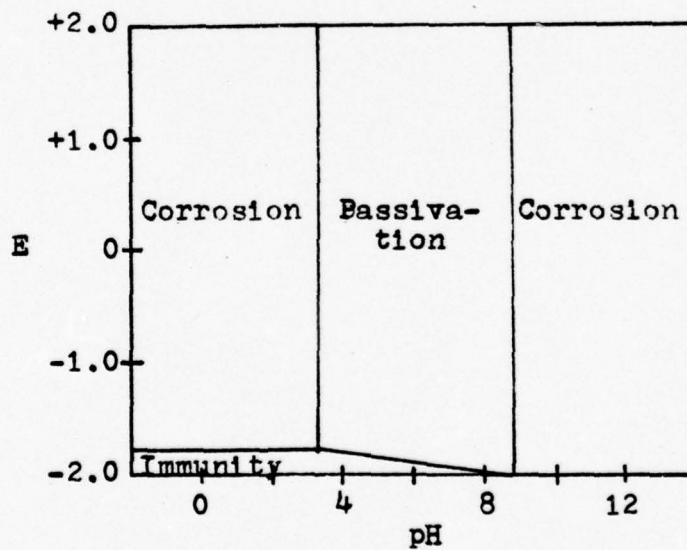
Figure 12. Pourbaix diagram shows theoretical conditions for corrosion of metallic aluminum.

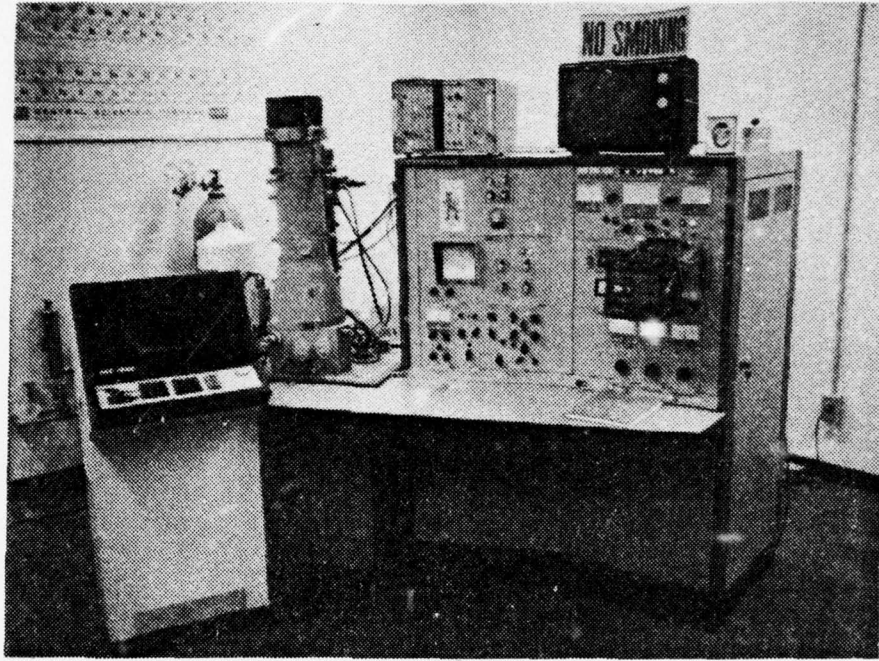
Figure 16. Cambridge Model S4-10 Scanning Electron Microscope (SEM) and attached Princeton Gamma-Tech PGT-1000 X-ray Analyzer.

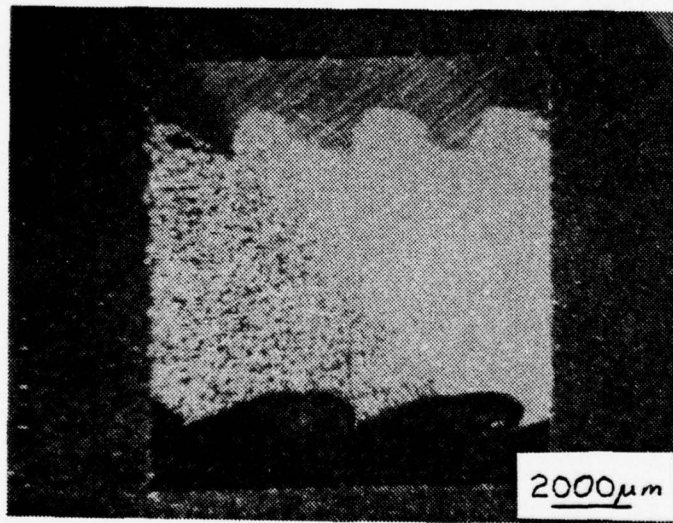
Figure 17. 5.5x binocular photomicrograph of a polished 12.5 mm-square segment of standard test sample (5456 Al-top, 1100 Al-middle, ASTM A516 Steel-bottom).

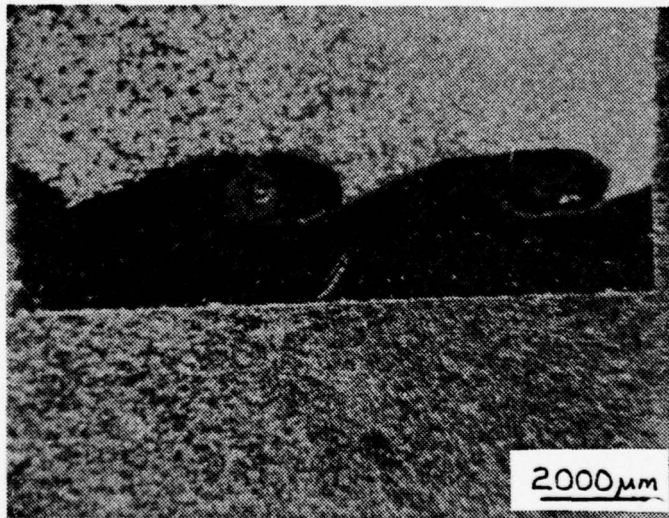
Figure 18. 7x binocular photomicrograph of steel-aluminum bond (aluminum-top, steel-bottom). Sample held in bakelite mount.

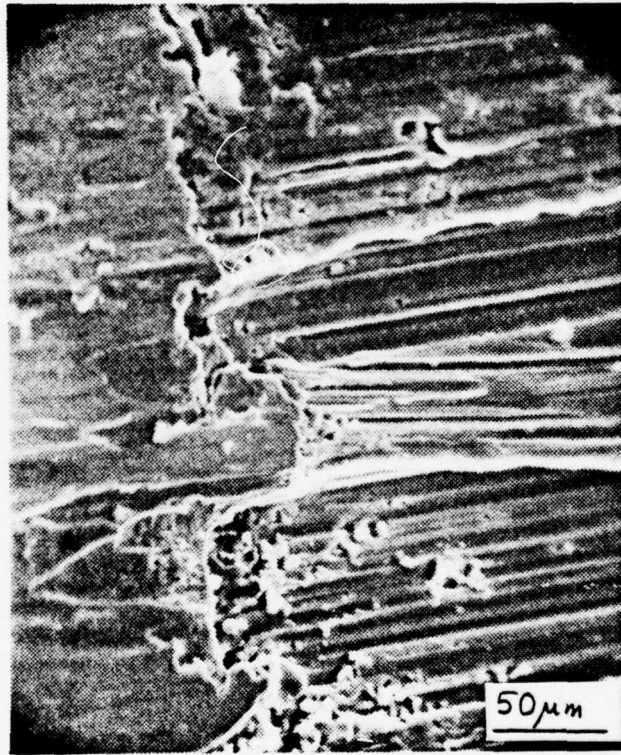
Figure 21. 320x SEM photograph of steel-aluminum interface in the as-sanded condition (Steel $\longleftrightarrow$ Al).

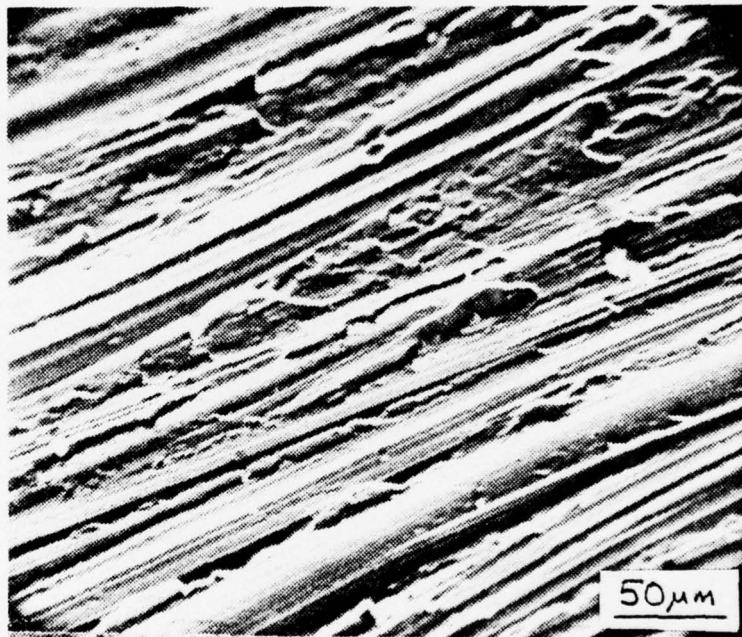
Figure 22. 320X SEM photograph of unexposed aluminum half of typical sample in an as-sanded condition.

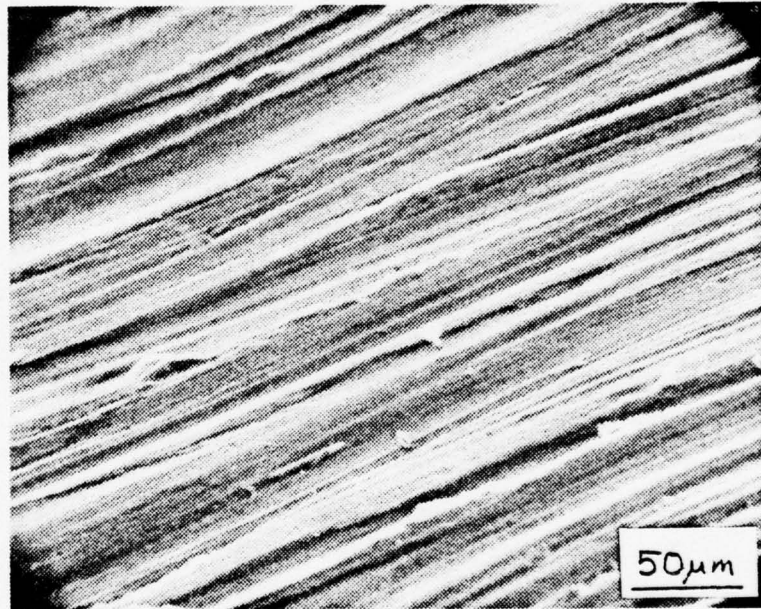
Figure 23. 320X SEM photograph of unexposed steel of a typical sample in an as-sanded condition.

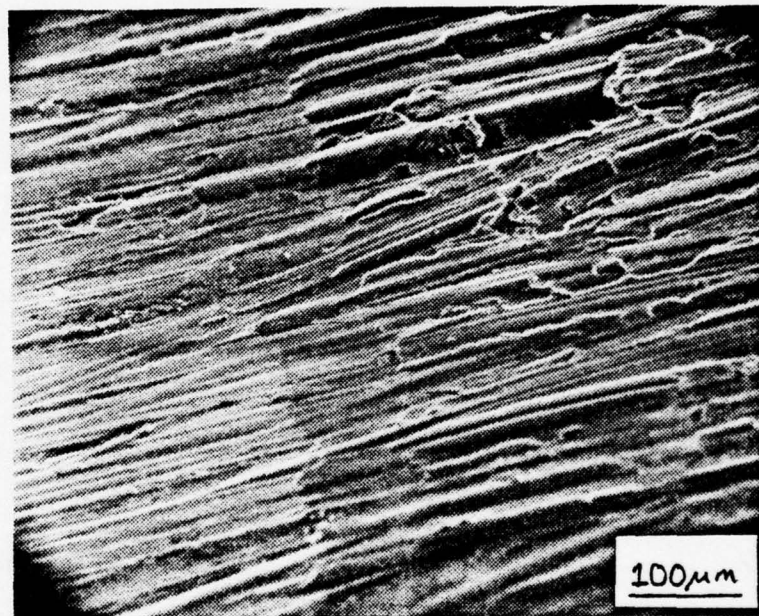
Figure 24. 160x SEM picture of the interface region showing corrosion band after 30-minute exposure and six sprayings (Steel←→Al).

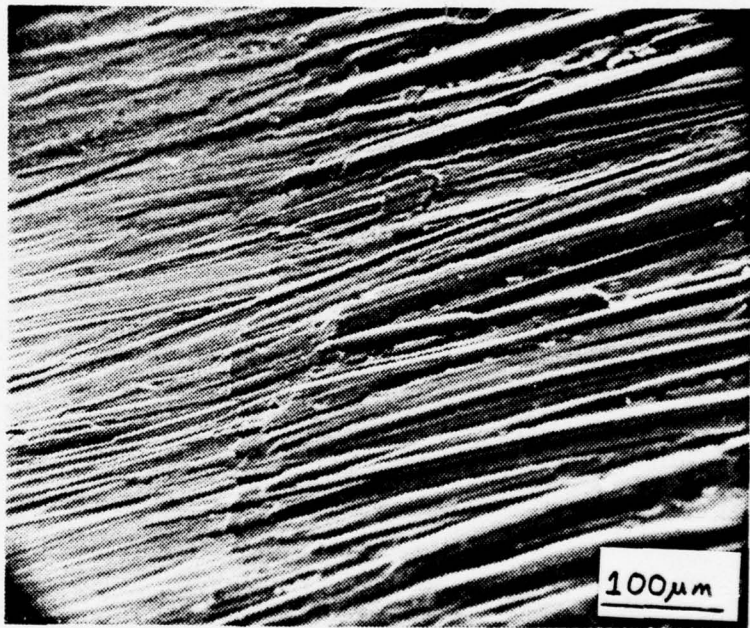
Figure 25. 170x SEM picture of the interface region showing corrosion band after 30-minute exposure and 15 sprayings (Steel $\leftrightarrow$ Al).

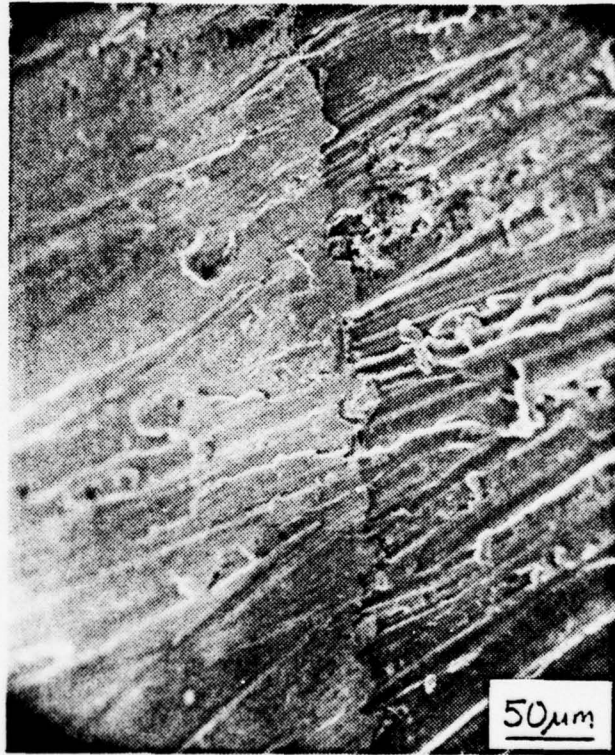
Figure 26. 250x SEM picture of bond area and corrosion belt showing localized anodic dissolution after 30-minute exposure and 15 sprayings (Steel  $\longleftrightarrow$  Al).

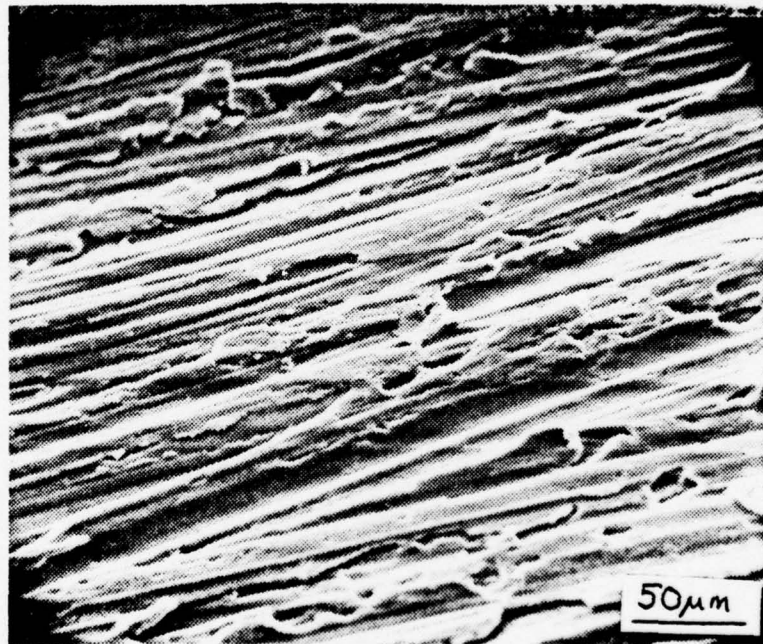
Figure 27. 320x SEM photograph of aluminum away from interface after 30-minute exposure and 15 sprayings.

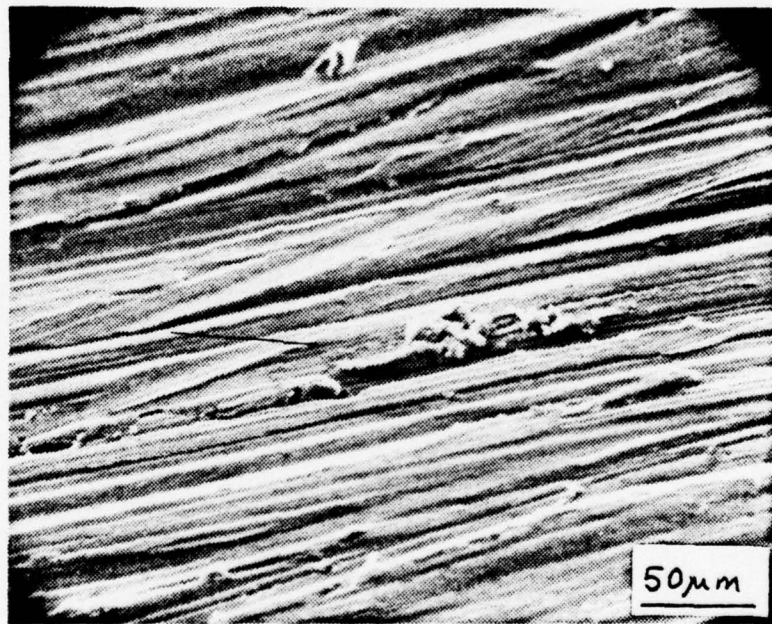
Figure 30. 320x SEM picture of steel away from bond showing initiation of rust deposits after 30-minute exposure and 15 sprayings.

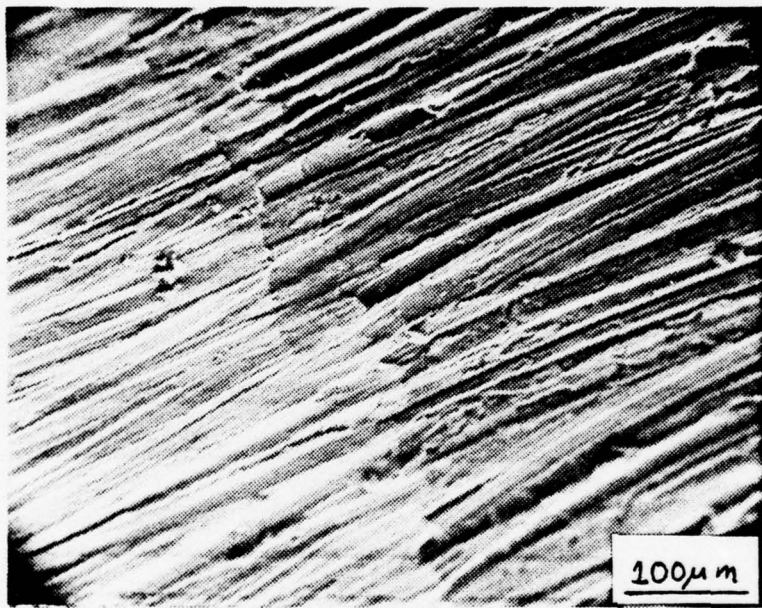
Figure 31. 175x SEM photograph of the interface illustrating the corrosion band and small clumps of rust after one-hour exposure and 30 sprayings (Steel  $\longleftrightarrow$  Al).

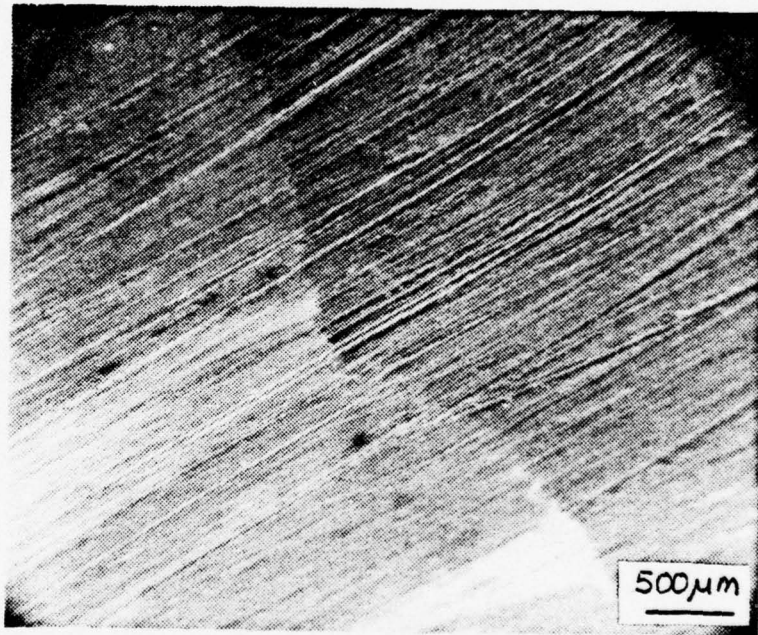
Figure 32. 25x SEM photograph showing the bond interface with trail of white deposits on the steel after one-hour exposure and 12 sprayings (Steel ← → Al).

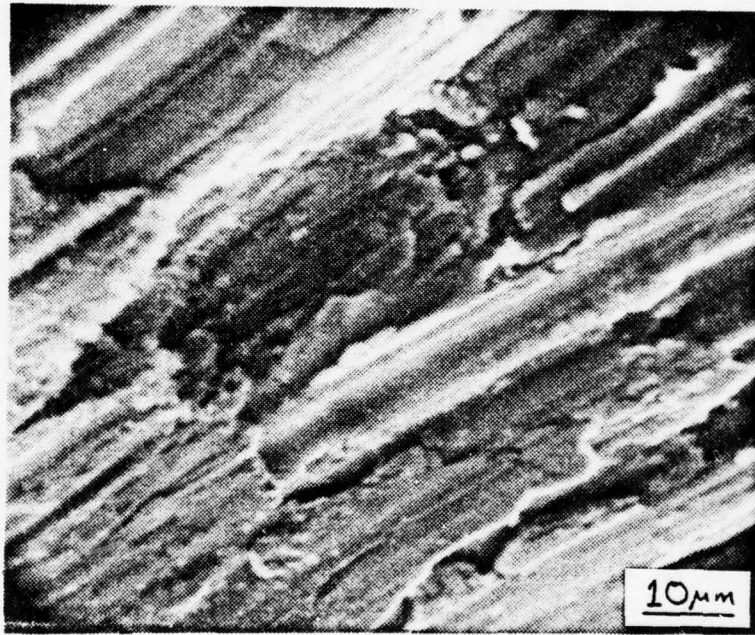
Figure 35. 1300x SEM picture of interface after one-hour exposure and 12 sprayings shows microanodic valley.

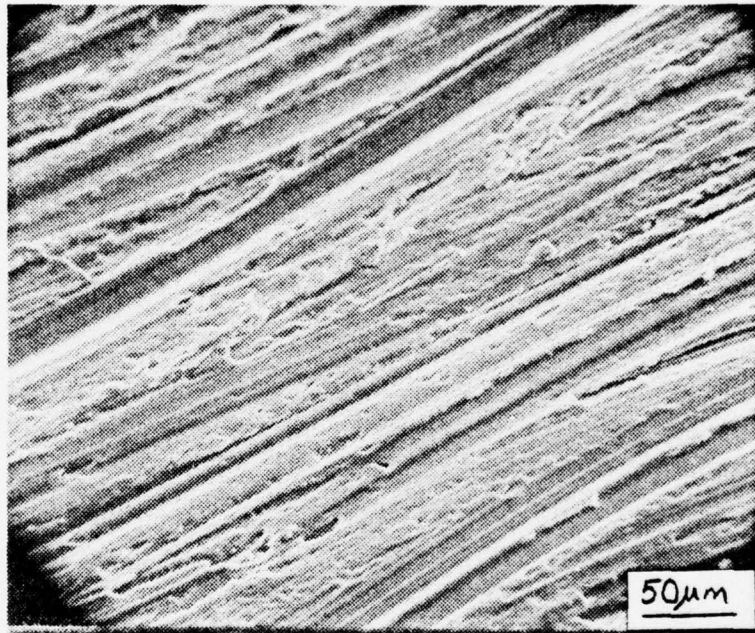
Figure 36. 260x SEM photograph of aluminum taken after one-hour exposure and 12 sprayings. It shows slightly hazed tone of fringes.

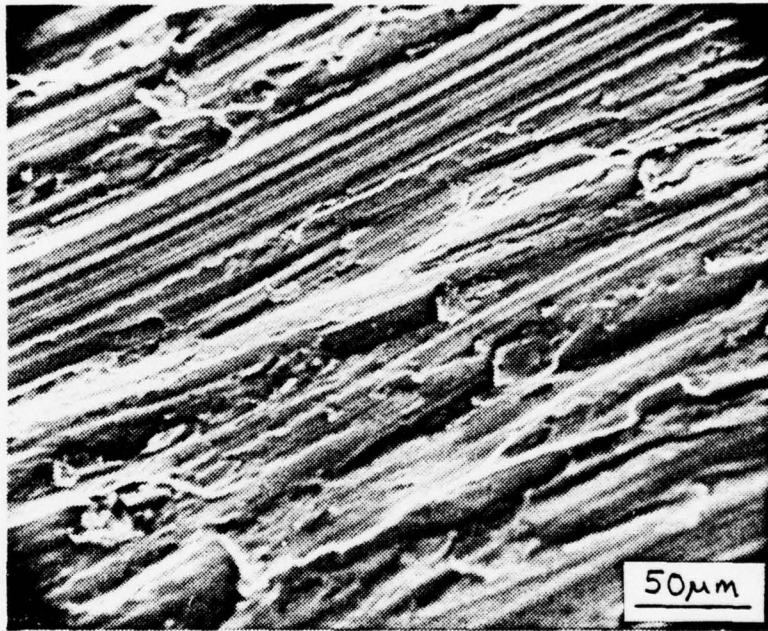
Figure 37. 320x SEM picture of aluminum taken after a one-hour exposure and 30 sprayings. Shows hazy tone of fringes.

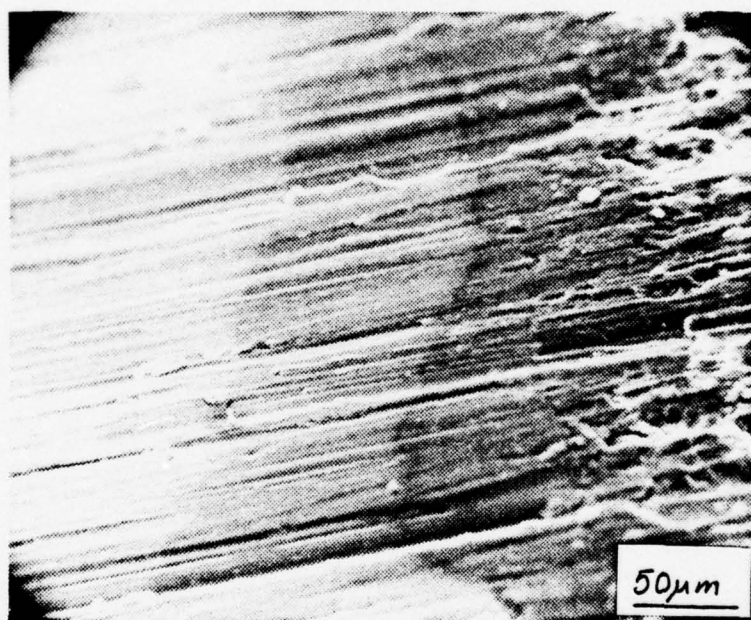
Figure 38. 290x SEM photograph of interface after two-hour exposure showing belt zone and adjacent films (Steel $\longleftrightarrow$ Al).

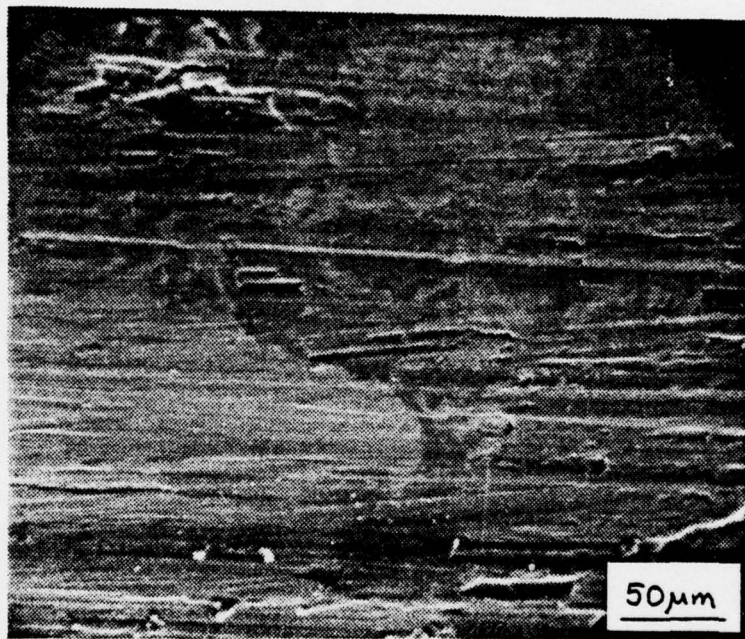
Figure 39. 300x SEM picture of interface after two-hour exposure showing hazy film coverage over most areas (Steel ← → Al).

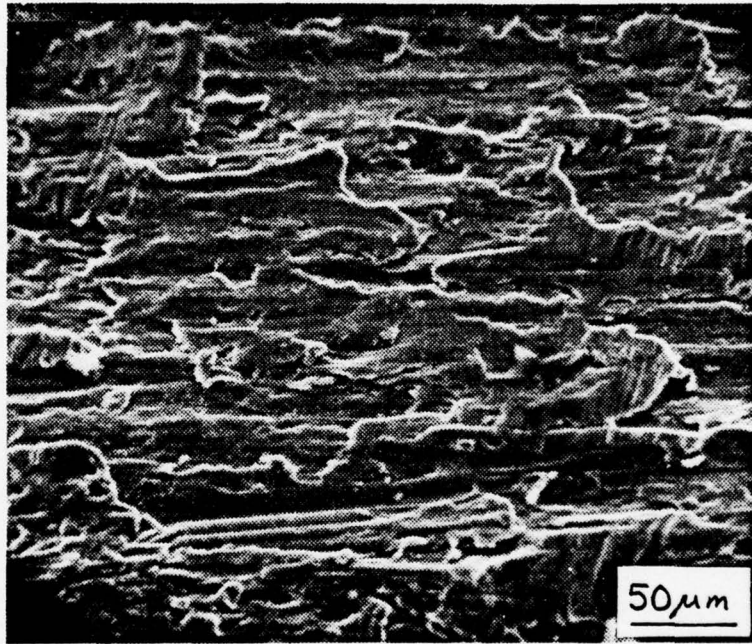
Figure 40. 300x SEM photograph of aluminum after two-hour exposure. It shows general surface deterioration and loss of features.

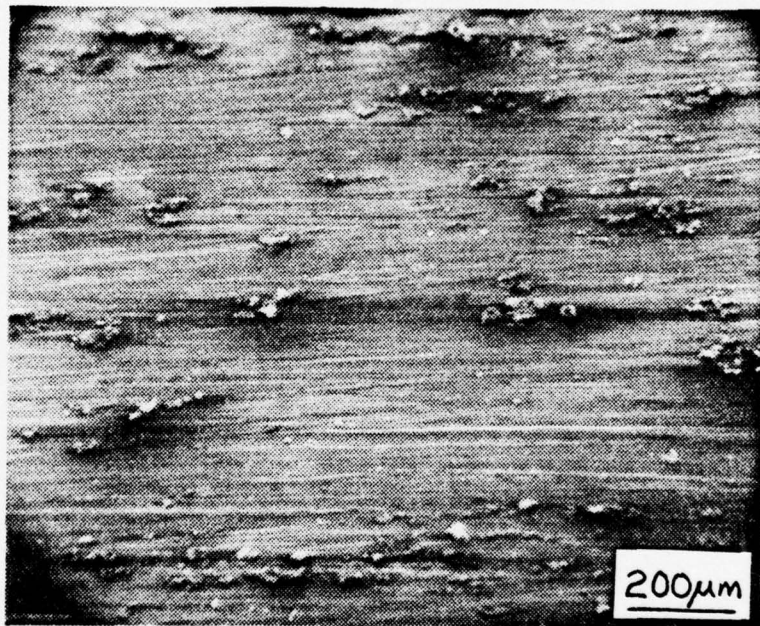
Figure 41. 75x SEM picture of rust nodules formed over layer of alumina film on steel after two-hour exposure.

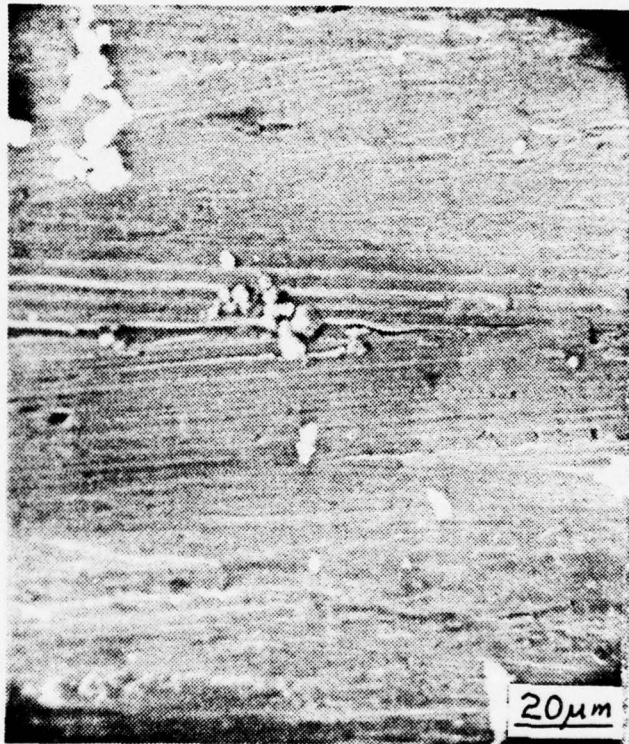
Figure 42. 700x SEM picture of beginning of rusting at surface deformity on steel after two-hour exposure.

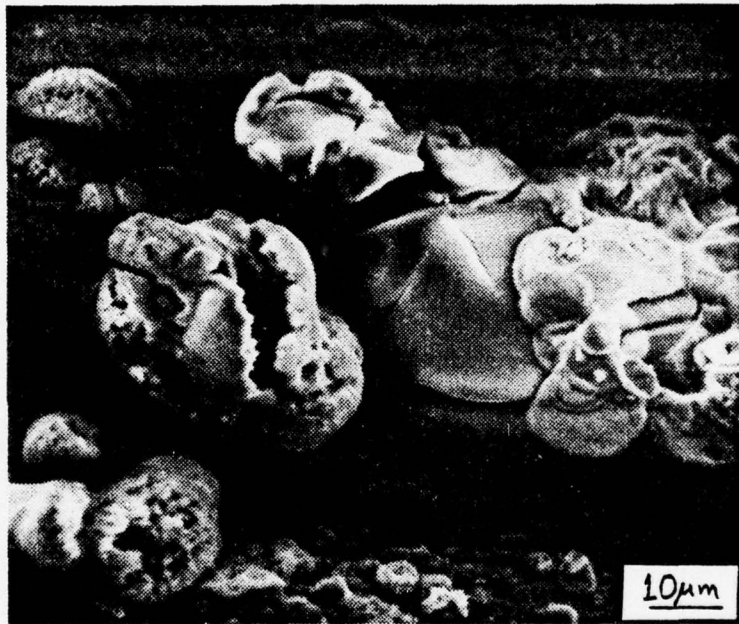
Figure 43. 1050x SEM picture of rust particles on steel surface after two-hour exposure.

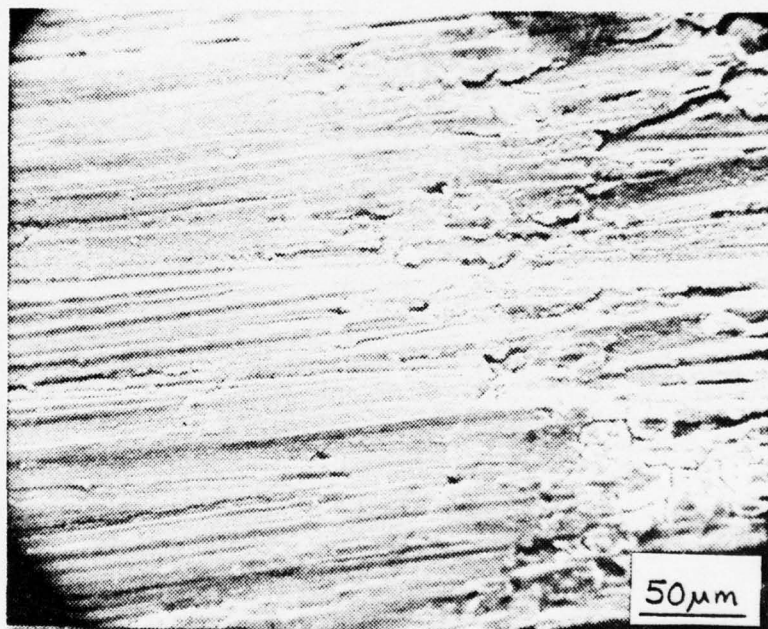
Figure 44. 305x SEM picture of bond area after six-hour exposure shows heavy corrosion obscuring the interface (Steel ↔ Al).

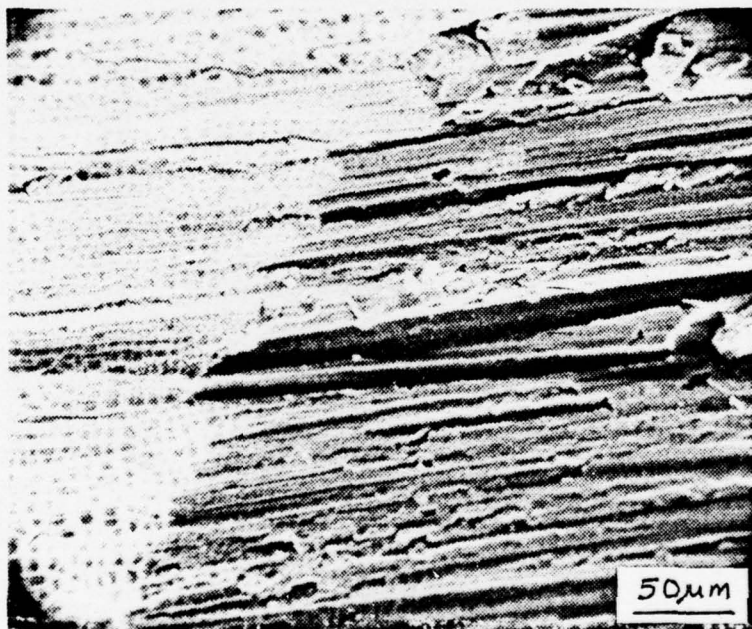
Figure 49. 280x SEM picture of the bond interface area after 12-hour exposure (Steel ↔ Al).

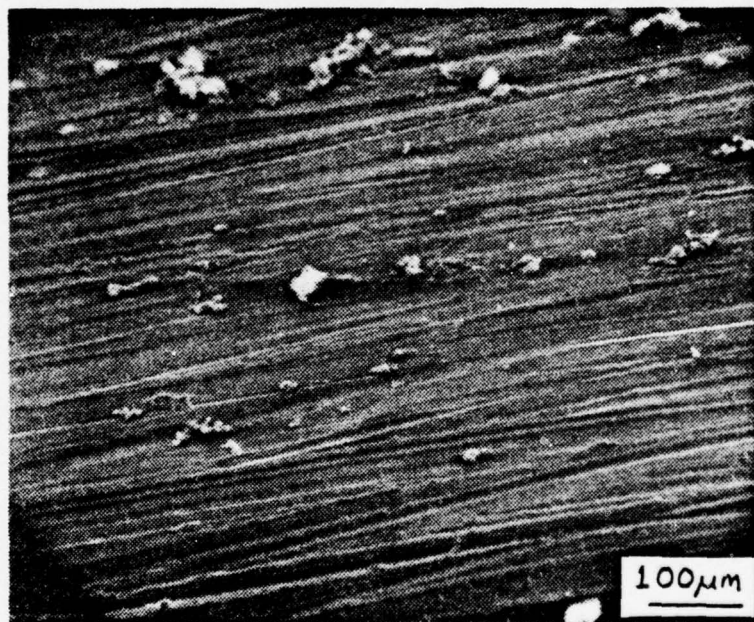
Figure 53. 130x SEM picture of steel with coating of alumina and rust nodules after 12-hour exposure.

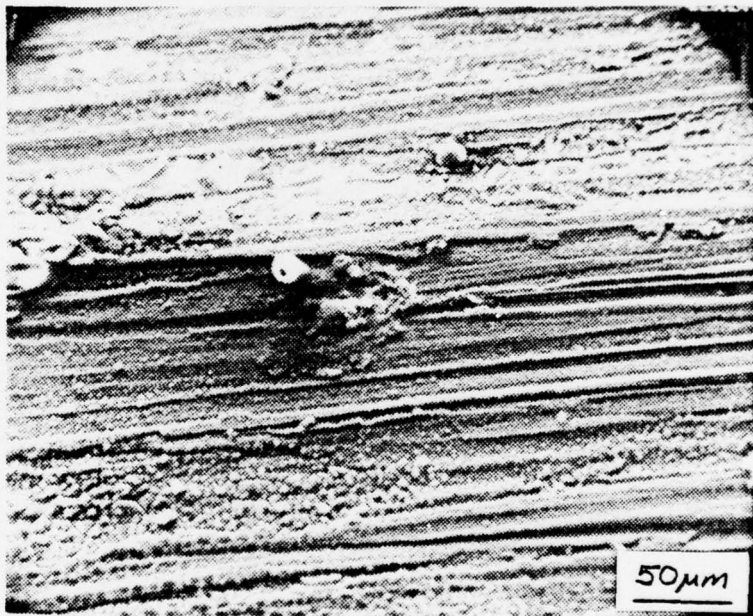
Figure 54. 280x SEM picture showing iron oxide growth in alumina coating on steel after 12-hour exposure.

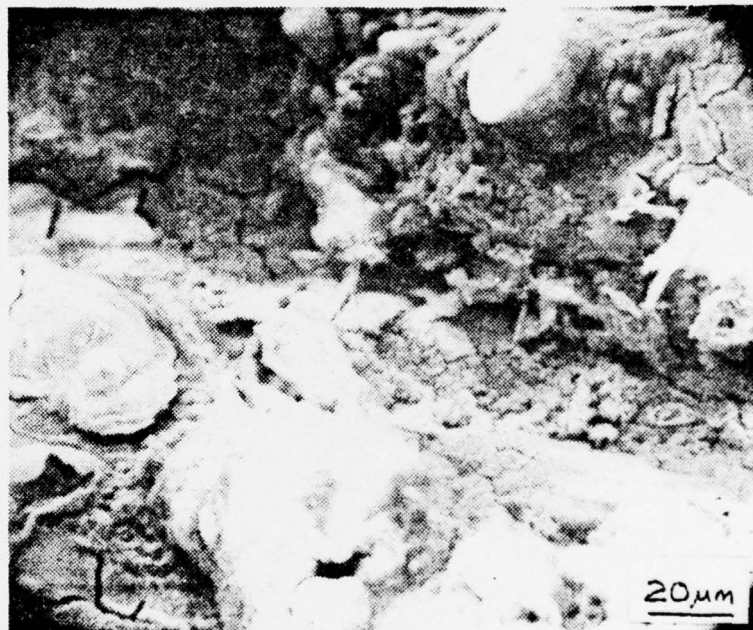
Figure 56. 600x SEM photograph of rust and alumina formation on steel after 12-hour exposure.

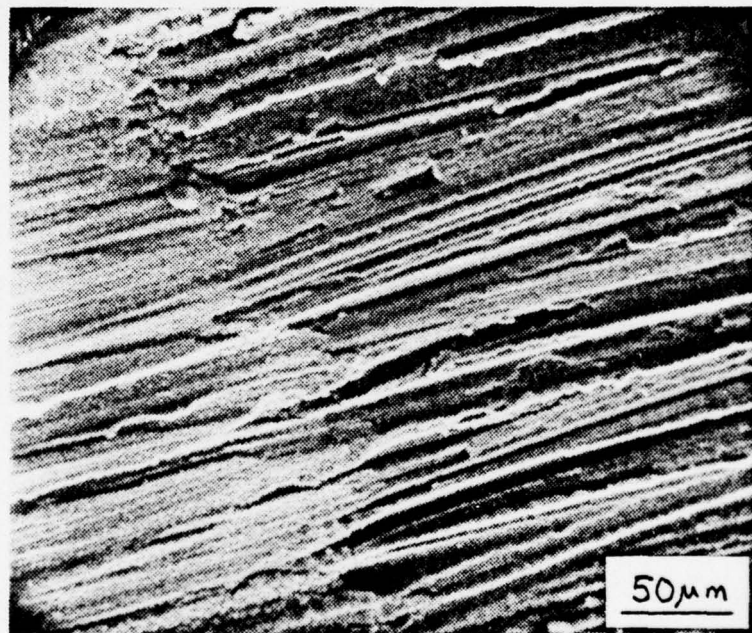
Figure 57. 320x SEM picture of bond interface area after one-day exposure (Steel ↔ Al).

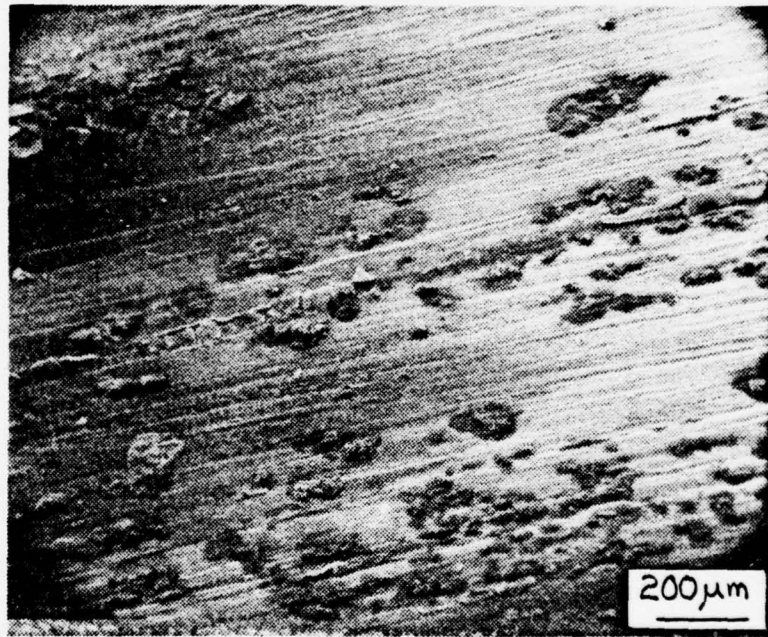
Figure 60. 65x SEM picture of rusting on steel half of sample after two-day exposure.

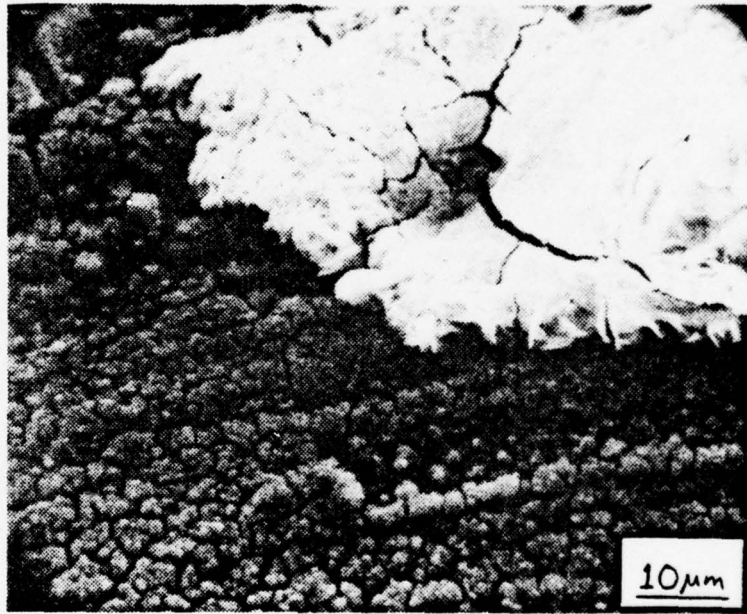
Figure 61. 1300x SEM picture of rust exploding through layer of alumina scale after two-day exposure.

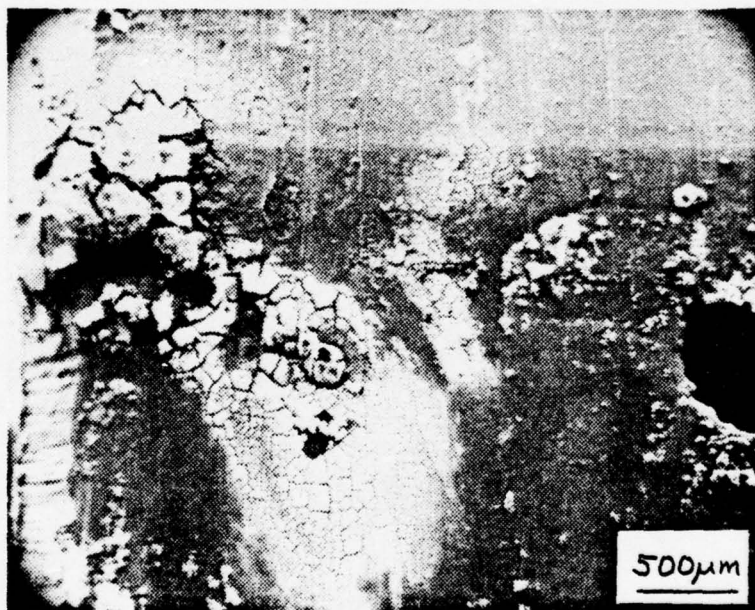
Figure 62. 28x SEM picture of bond zone on five-week exposure specimen showing scaly corrosion product and void (Al over Steel).
