AD-A032 365

NAVAL POSTGRADUATE SCHOOL MONTEREY CALIF  
MICROSCOPIC INVESTIGATION OF INTERFACE CORROSION OF STEEL-ALUMI--ETC(U)  
SEP 76 M R KEELEAN

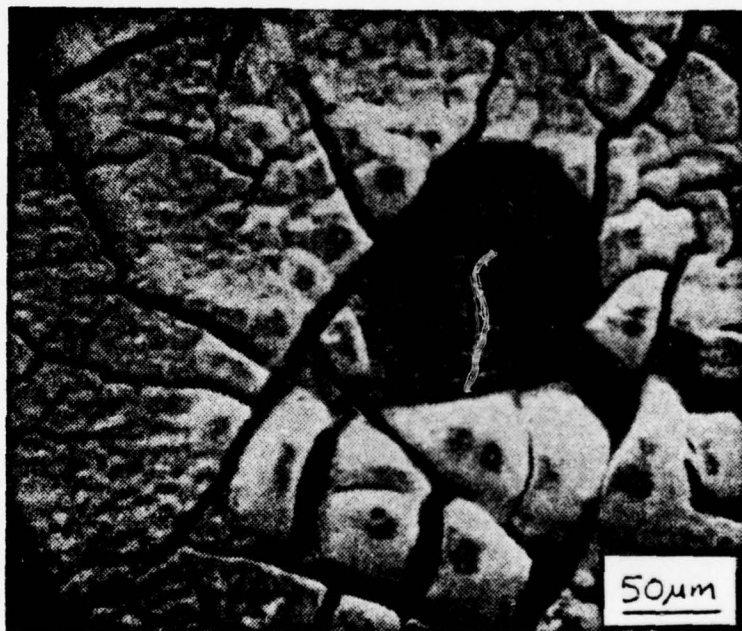
Figure 63. 280x SEM picture of alumina layer beneath second corrosion product film on five-week exposure sample (Steel surface).

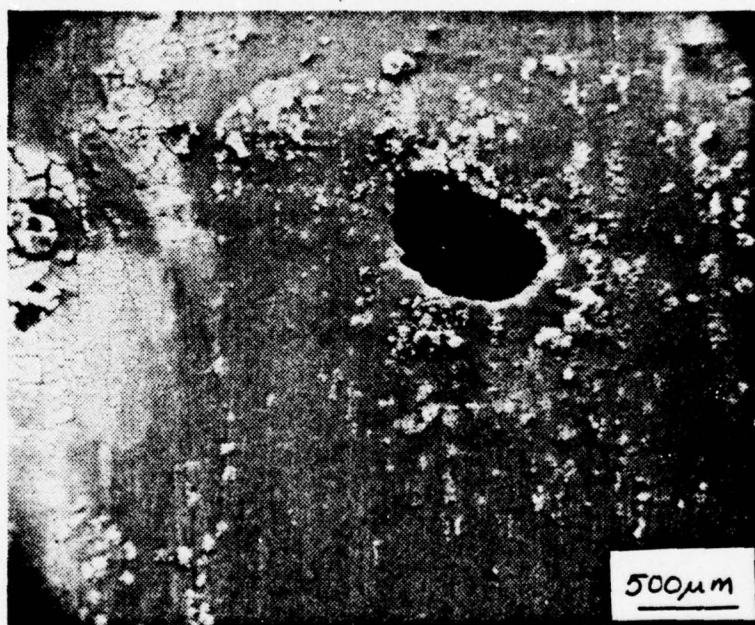
Figure 64. 28x SEM photograph of bond zone on five-week exposure sample showing void and wave outline (Al over Steel).

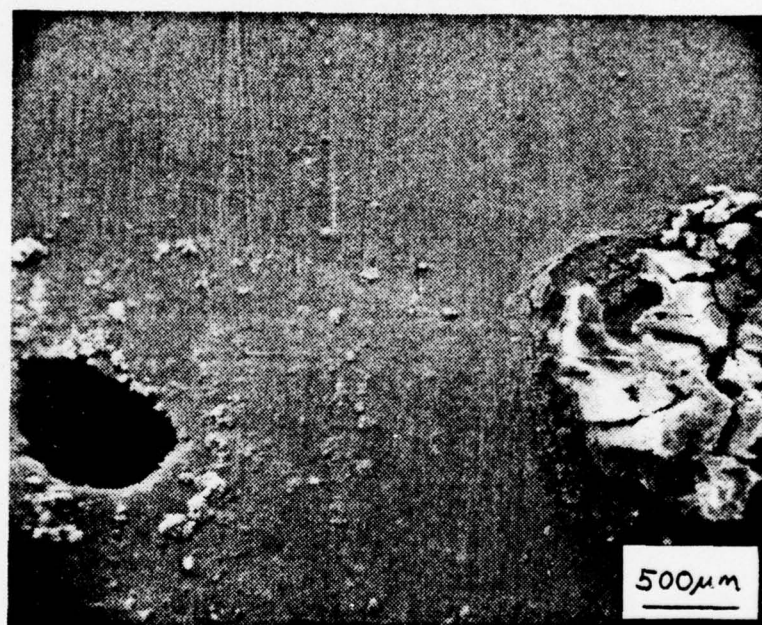
Figure 65. 28x SEM picture of bond zone on five-week exposure sample with void, wave outline, and mushroom-shaped formation (Al over Steel).

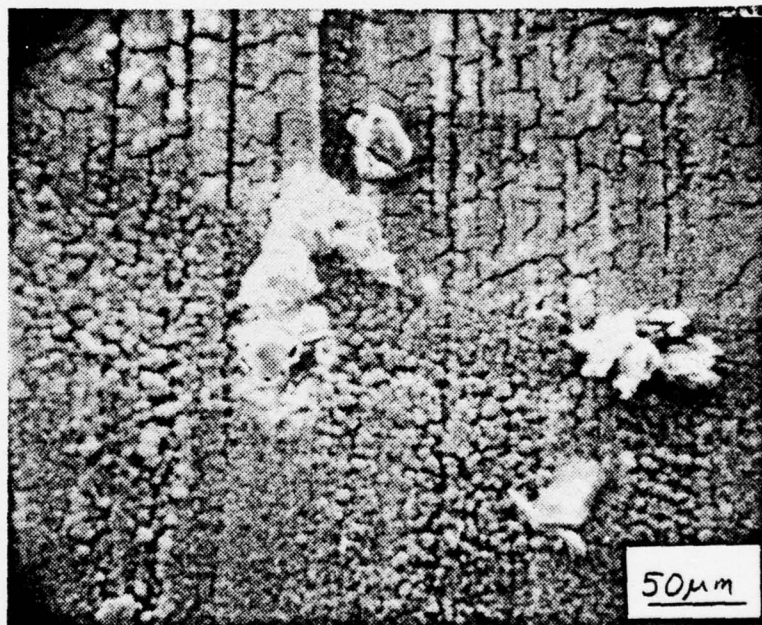
Figure 66. 280x SEM picture of bond zone passivation at trailing edge of wave of five-week exposure sample (Al over Steel).

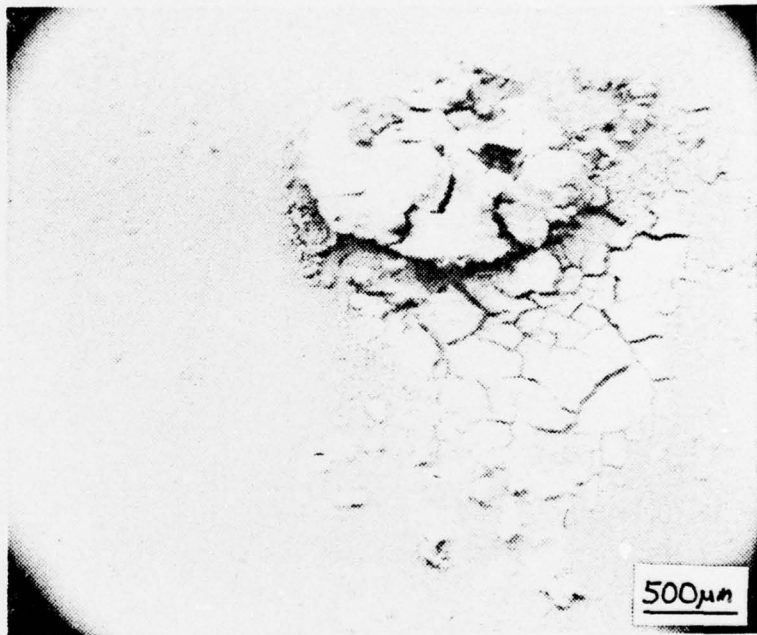
Figure 67. 27x SEM photograph of mushroom-shaped corrosion product on five-week exposure sample.

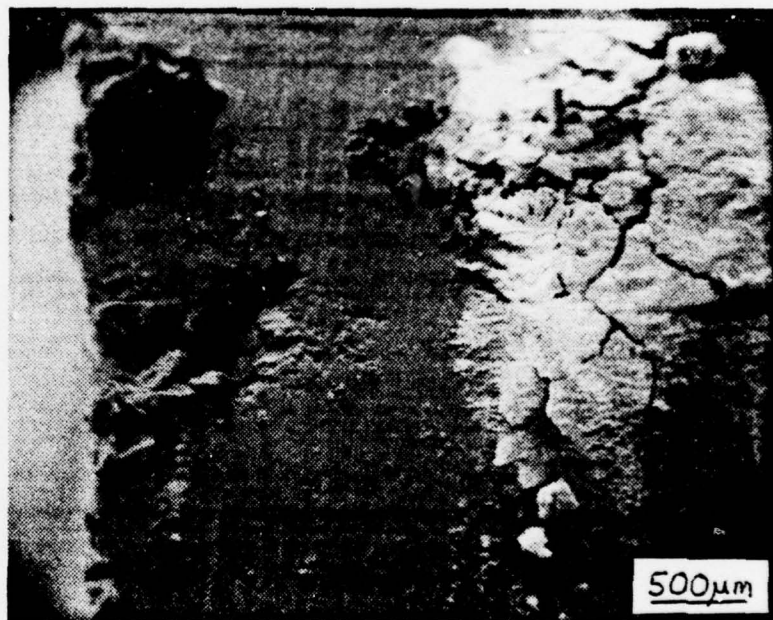
Figure 68. 27x SEM picture of nine-week exposure sample showing pitting and mushroom corrosion product build-up (Al over Steel).

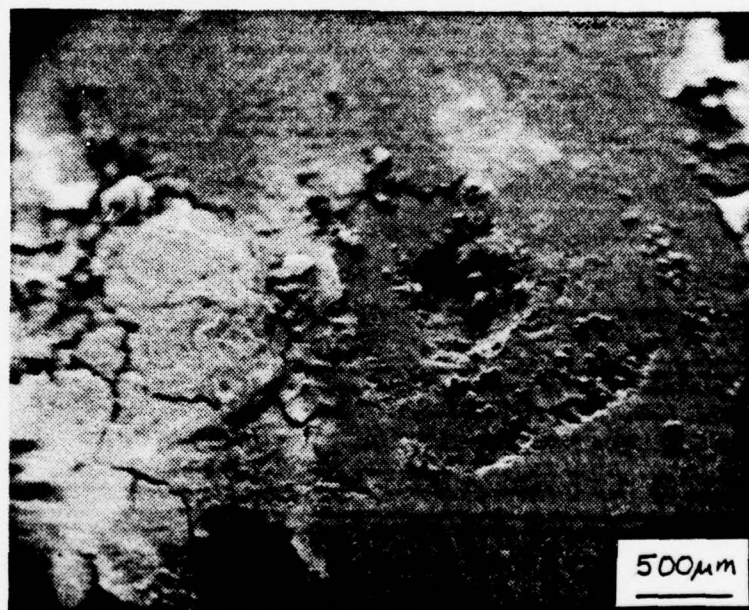
Figure 69. 27x SEM picture of nine-week exposure sample showing mushroom corrosion growth and melt pitting in wave (Al over Steel).

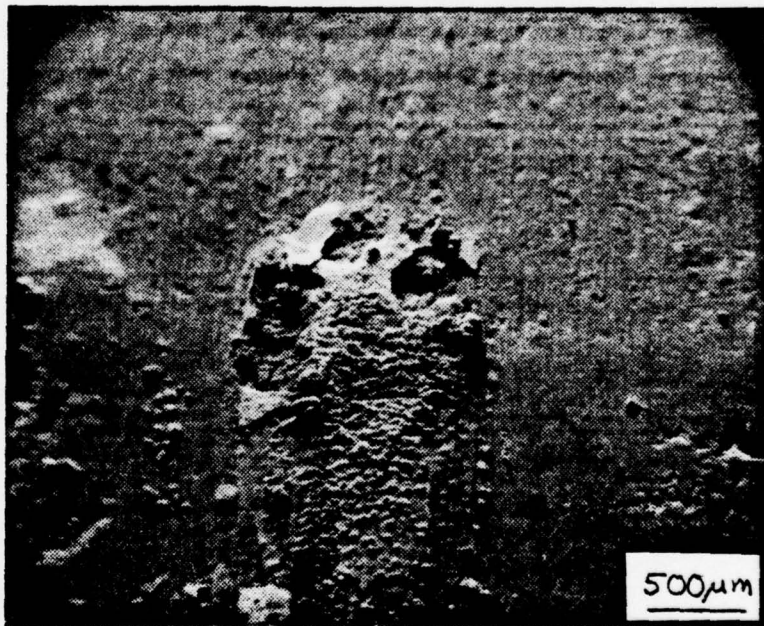
Figure 70. 27x SEM picture of nine-week exposure sample showing pitting, corrosion product growth, and wave outline (Al over Steel).
