NWC-TP-5812

Baseline Data From an A-4 Cockpit in Simulated Carrier Deck Fire

by
Anthony San Miguel
Systems Development Department

AUGUST 1976

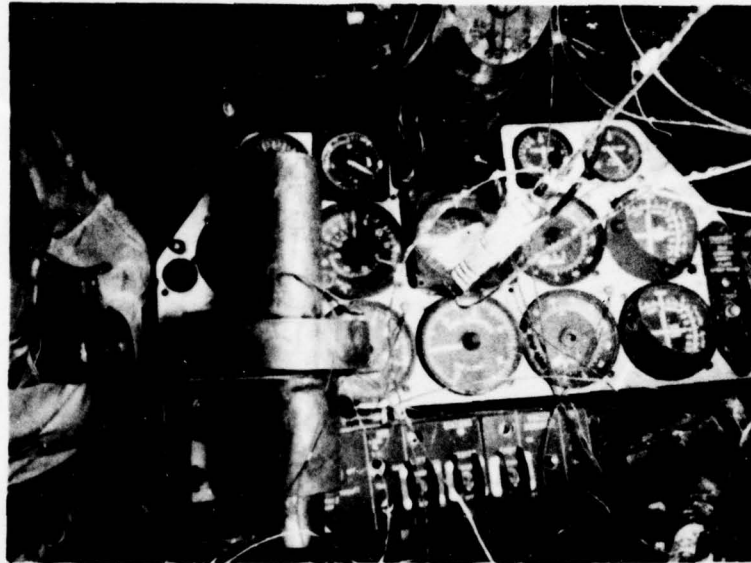
FIGURE H-6. Post-Test Photo of Smoke Transducer Mounted in Cockpit of Navy A-4. (Neg. LHL 187342)

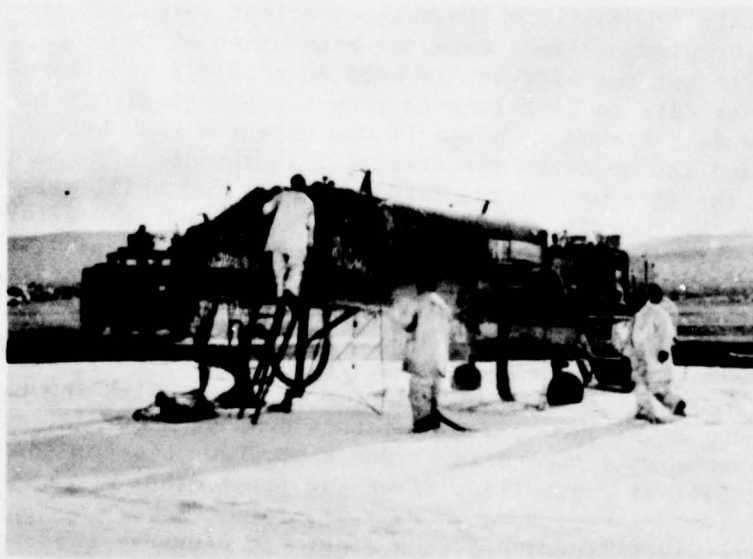
Firemen extinguished the fire within seconds, preserving the evidence of the fire damage for post-test inspection (Appendix L).

FIGURE L-2. View of Test Site Just After Fire Was Extinguished.
(Neg. LHL 187347)

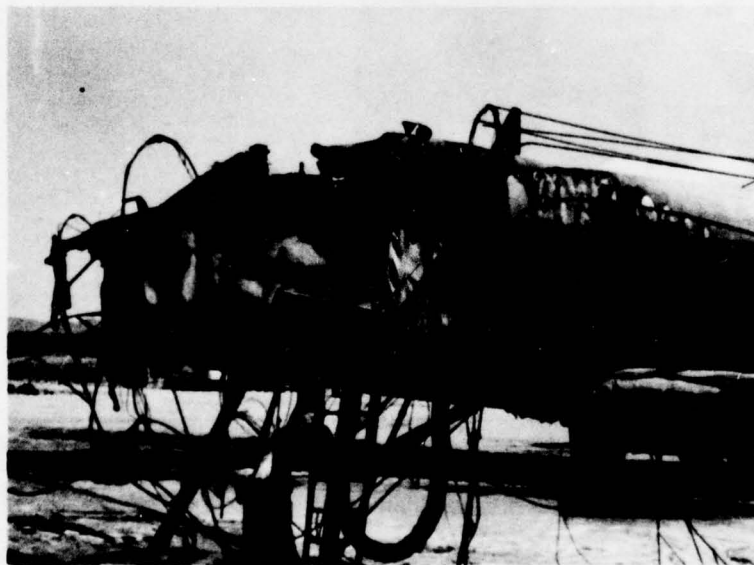
Significant structural failure occurred in the canopy, the nose cone, the sheet aluminum on both sides and under the floorboard station housing electrical and hydraulic lines (Appendix M). Buckling and melting caused separations that could admit flames at the juncture of the floorboard and the forward bulkhead and under the seat. The rubber fuel tank full of JP-5 fuel just behind the cockpit was directly exposed to flames from below, but suffered no damage.

FIGURE M-1. Port Side of A-4 Aircraft After Fire Test. (Compare with Figure A-3 before fire.) (Neg. LHL 187322)

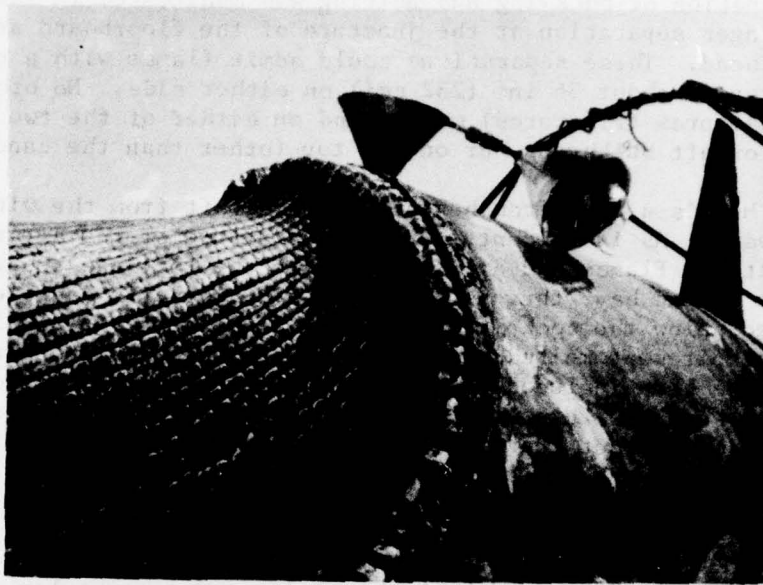
FIGURE M-4. Post-Test View of Canopy From Port Side. Note broken TM antenna on top of A-4. (Neg. LHL 187329)

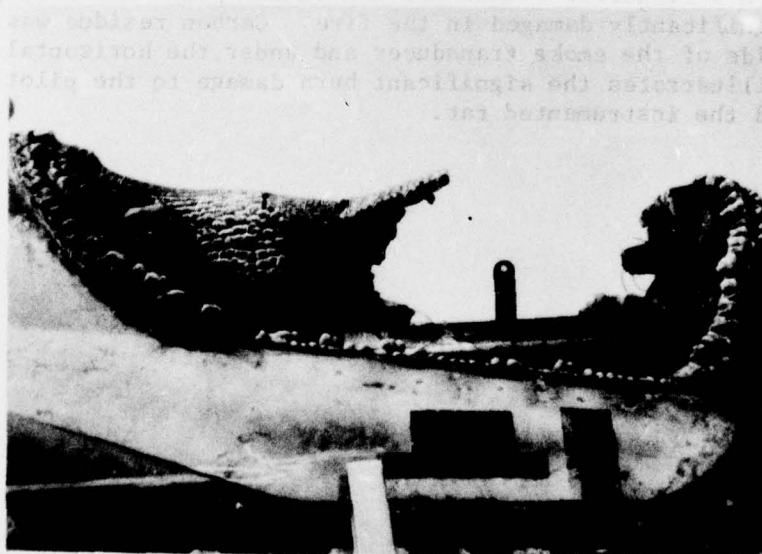
Thermocouples were also placed inside the canopy along the periphery; one on the port side, one on the starboard, and one at the top. The response of these thermocouples is shown in Figures E-41, E-42, and E-43. It is apparent that little heat transmits through the canopy to the pilot before the canopy fails. Again, evidence is found that the canopy failure occurred in the top starboard quadrant of the canopy.

FIGURE M-5. Post-Test View of Canopy From Starboard Side. (Neg. LHL 187331)
