# PULSED PLASMA PROPULSION TECHNOLOGY

FINAL REPORT FOR PERIOD 10 MARCH 1972 - 30 MAY 1977

AUTHORS: DOMINIC J. PALUMBO  
WILLIAM J. GUMAN

FAIRCHILD INDUSTRIES, INC.  
FAIRCHILD REPUBLIC COMPANY  
FARMINGDALE, N.Y. 11735

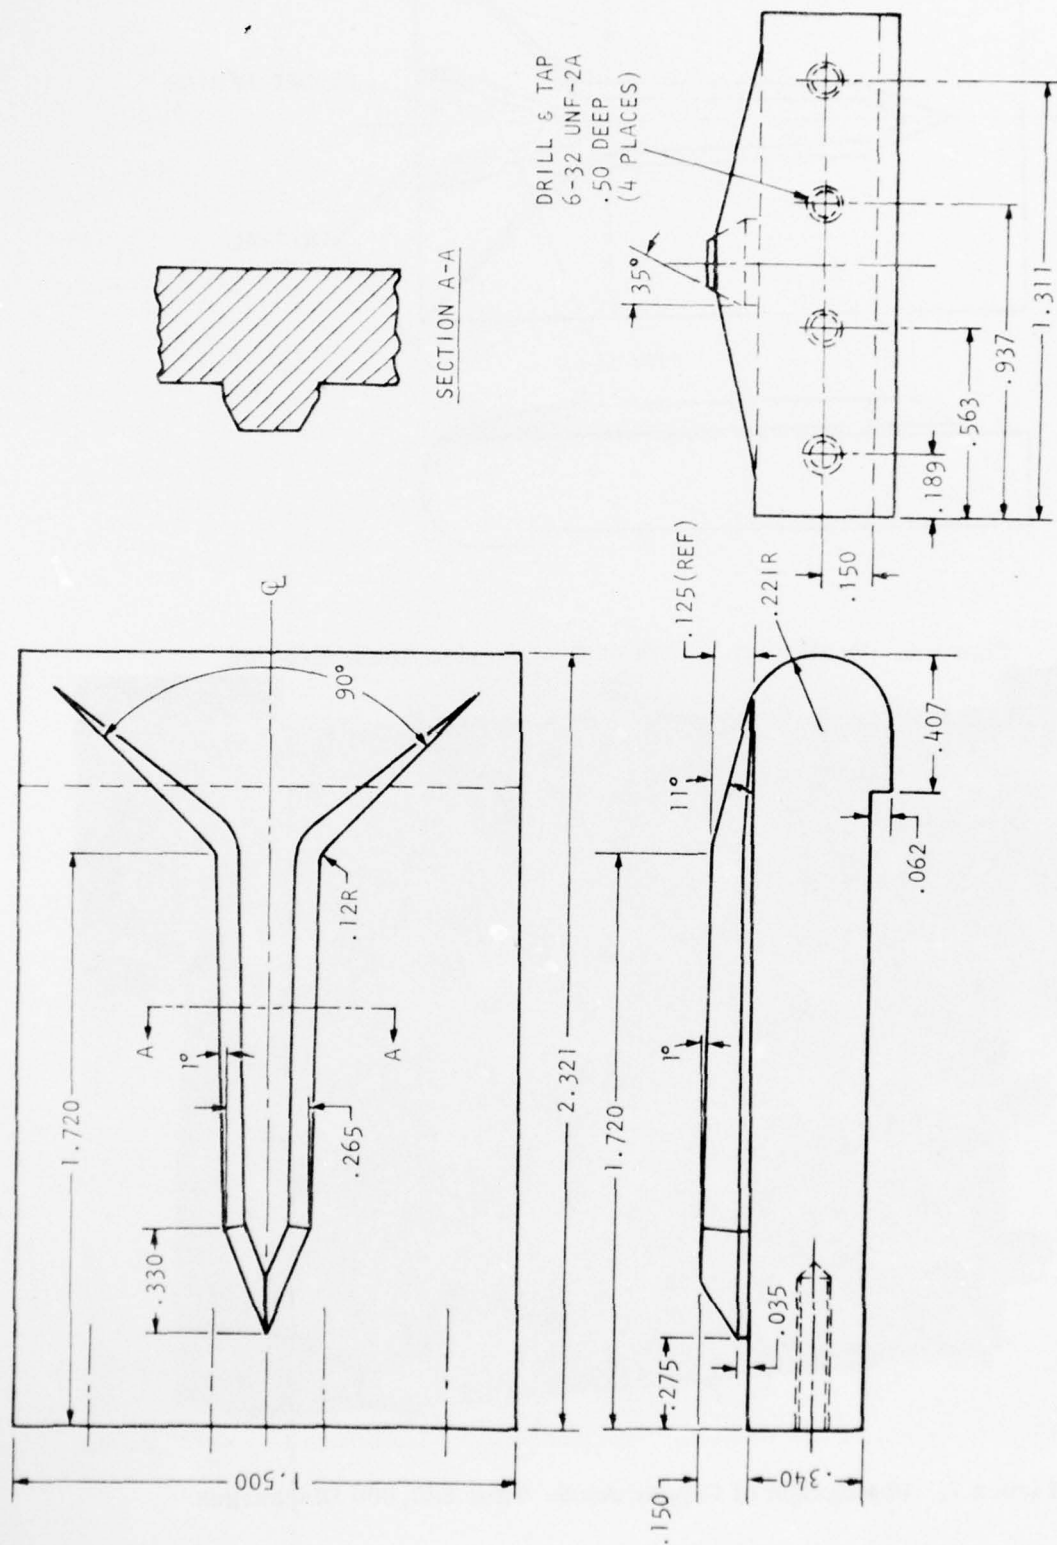
Figure 5. Original Anode Design

cathode design was incorporated in attempting to eliminate carbon build-up within the ignitor plug cavity. Erosion of the thruster anode could be considered severe enough to represent a potential failure mode for the system because of the resulting reduction in height of the propellant retaining shoulder in the vicinity of the outermost (i.e., furthest downstream) propellant section. It is interesting to note that the majority of the anode surface exposed to the discharge remains practically erosion free. Erosion begins to become visually apparent at the downstream end of the electrode and the eroded area very slowly propagates upstream as discharges accumulate. An engineering drawing of the anode electrode as initially manufactured for this test is presented in Figure 5. A qualitative picture of the erosion pattern as it has been observed to progress during testing is presented in Figure 6 to illustrate the above statements. The area of severe erosion begins to enter the region between propellant rods after approximately 6 - 700,000 discharges and continues to propagate into this region as time goes on. A photograph of one of the electrodes used during the test is presented in Figure 7 showing the degree of erosion after approximately 820,000 discharges. Anode electrodes were manufactured from copper, tungsten, and Molybdenum during this program to assess the relative erosion resistance of each under actual long-term thruster operating conditions. Quantitative data on the degree of erosion was not generated for each of these materials but visual observations at various times during testing were made. On the basis of these observations it can be said that the general character of the erosion pattern depicted in Figure 6 was the same regardless of which material was used and that thruster propulsive performance remained unchanged with material substitution. Indications were that Molybdenum would last longer than either copper or tungsten. Presently it is questionable whether any of these materials would survive the required life for the system with the original geometric configuration that was tested and as a result a program will be carried out to investigate the problem of erosion as it relates specifically to this thruster system. A certain amount of basic independent research will be performed during that program but the major portion of the work will be an experimental evaluation of several different approaches to elimination of anode erosion of the fuel retaining shoulder as a potential failure mode for this system over its design life. The electrode erosion program is scheduled to commence in the immediate future. The prognosis for developing a solution to this problem is excellent at this time because of several ideas of significant merit.
