REPORT NO. CG-D-24-77

EVALUATION OF PROTECTIVE  
COATINGS SYSTEMS FOR BUOYS

May 31, 1977

FINAL REPORT

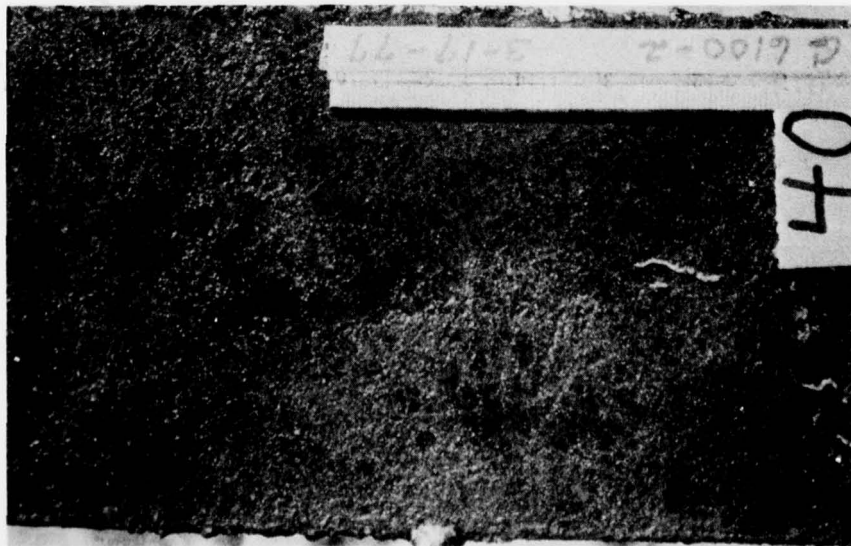
Panel No. 40  
System No. CG-19  
Type 121/63 Vinyl High  
Rosin Control on Steel

18 Months' Exposure

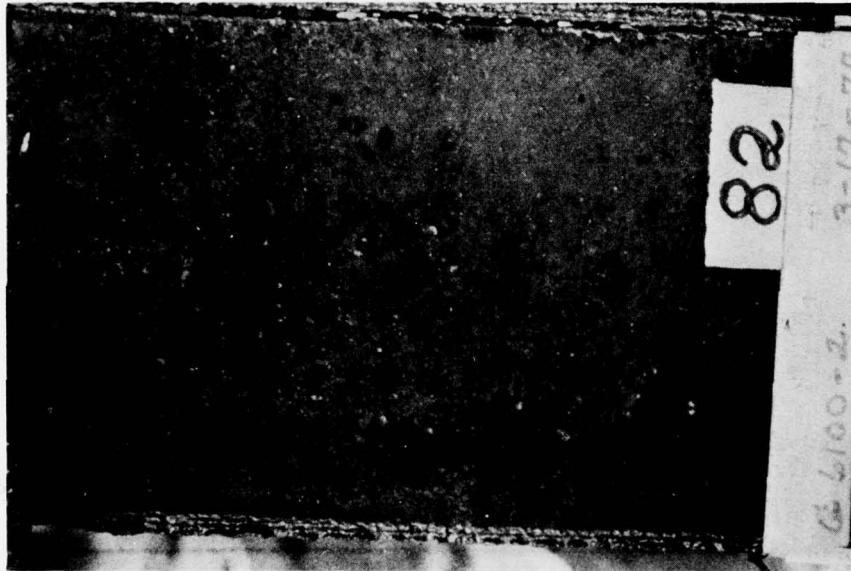
Panel No. 82  
System No. CG-20  
Elastomeric Sheet With Organotin  
Toxicant on Steel

- (2) Elastomeric Sheet with Organotin Toxicant. This system (CG-20 and 30 in present study and CG17 in prior study) possesses the greatest service life potential of any system in both studies. It would appear to offer potential for the 10 years' resistance to fouling and corrosion desired by the USCG. The actual performance mechanism is not fully understood. In addition to the slow dissolution of toxicant in seawater, its success is probably due to a combination of factors such as the inability of macroscopic fouling organisms to establish a firm attachment on the elastomeric sheet.

18 Months' Exposure

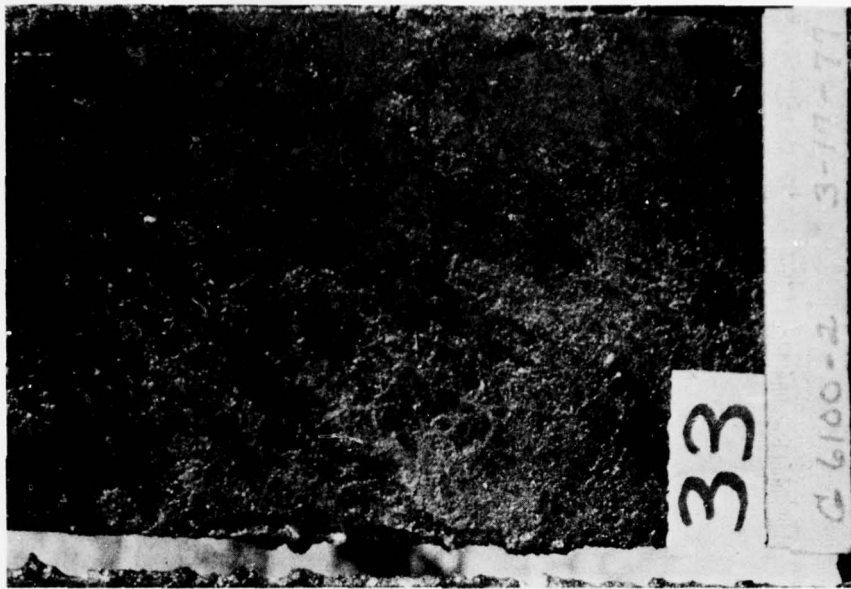
Panel No. 33  
System No. CG-21  
Type 121 Standard Vinyl  
Rosin Control on Steel

18 Months' Exposure

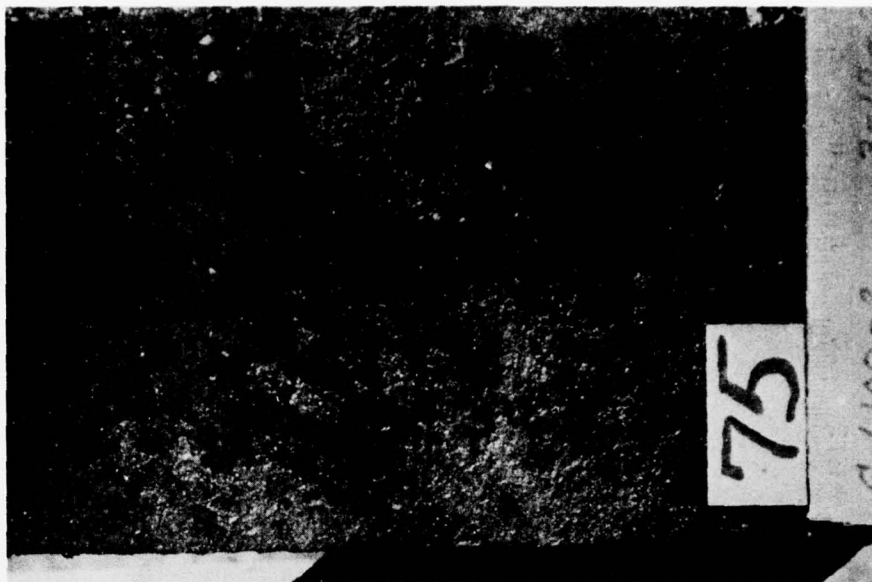
Panel No. 75  
System No. CG-24  
Epoxy Primer Standard Vinyl  
Rosin Control on Steel

18 Months' Exposure

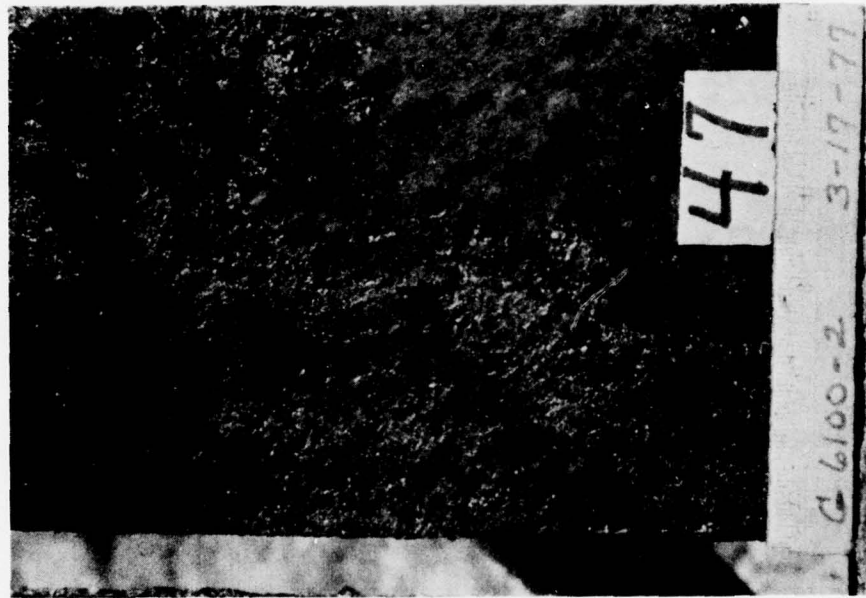
Panel No. 47  
 System No. CG-26  
 Type 121 Applied Over Sanded Polyester Glass Flake Anticorrosive on Steel

18 Months' Exposure

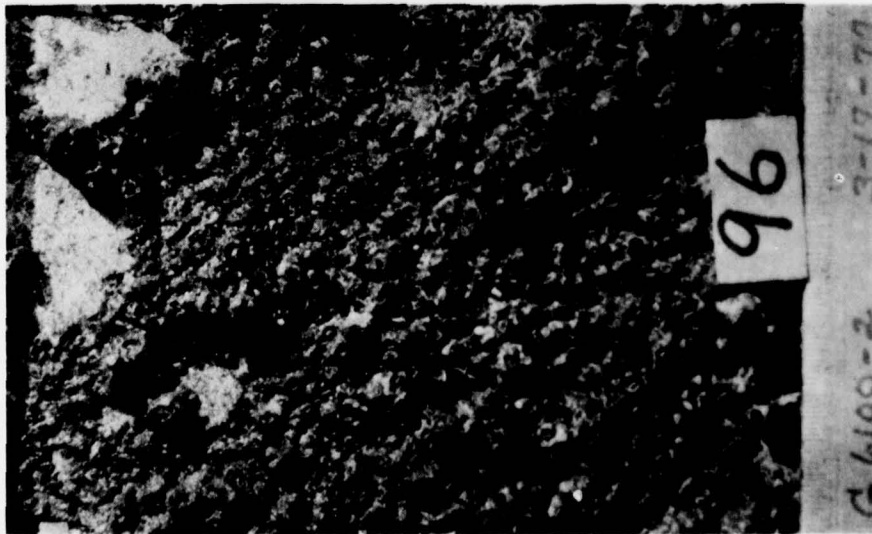
Panel No. 96  
System No. CC-28  
Flame Sprayed Copper  
Cladding over Polyester  
Glass Flake on Steel

All of the copper-coated panels failed by loss of adhesion of the cladding to the substrate.

18 Months' Exposure

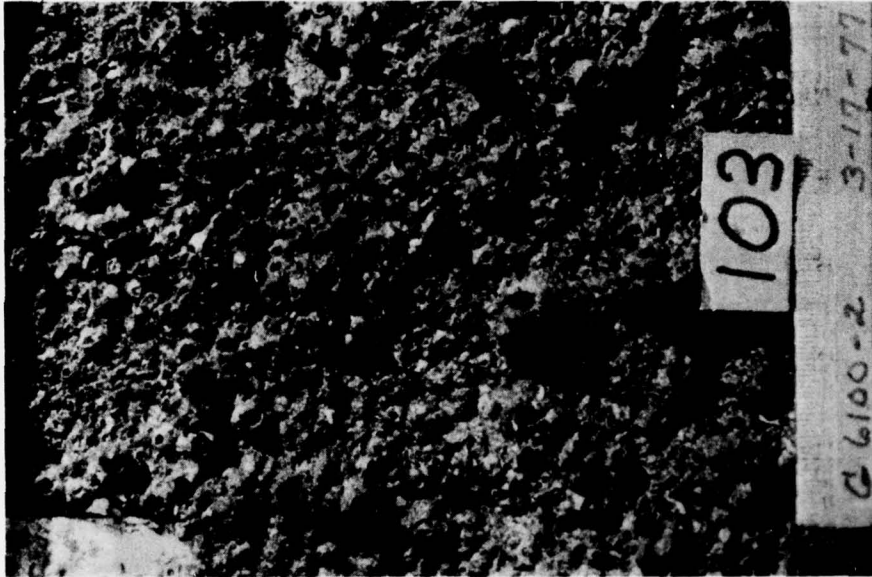
Panel No. 103  
System No. CG-29  
Acrylic-Organometallic Toxic  
Polymer Over Type 119  
Anticorrosive on Steel

It is felt that the acrylic-organometallic polymers offer considerable promise as a new class of antifouling materials. Coatings in the present study failed primarily because they were prepared in the laboratory as an early, one-time attempt to obtain satisfactory pigmentation. Large-scale pigmentations studies are currently in progress which could resolve most or all of the problems encountered here. The upgraded materials should be considered for additional buoy studies because they appear to be excellent candidates for meeting all of the U. S. Coast Guard's stringent requirements for buoy materials.

18 Months' Exposure

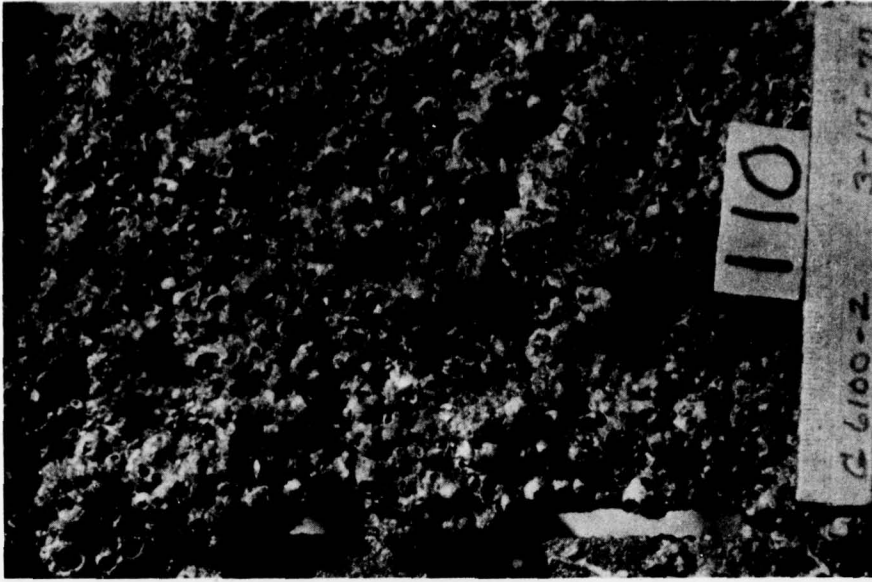
Panel No. 110  
-----  
Uncoated Steel Control Panel

18 Months' Exposure

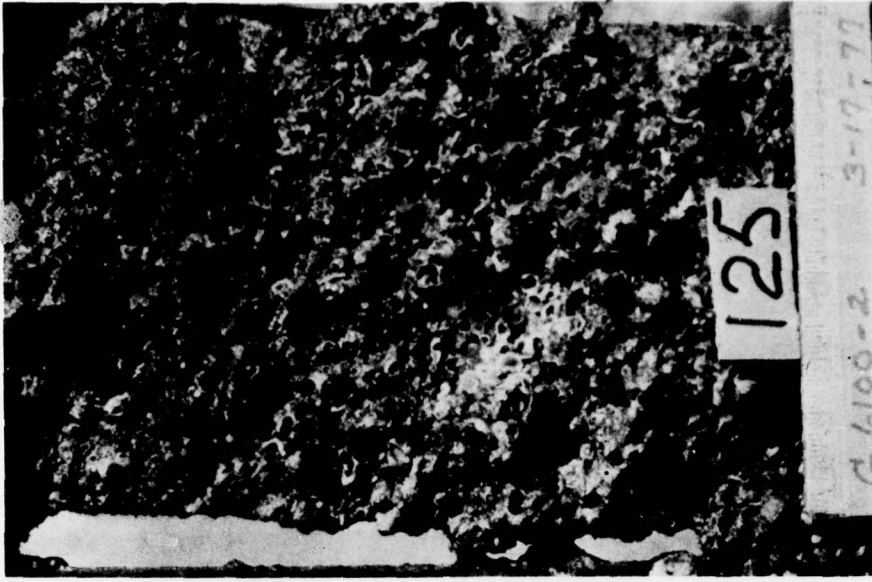
Panel No. 125  
System No. CG-32  
Acrylic-Organometallic Toxic  
Polymer on Aluminum

18 Months' Exposure

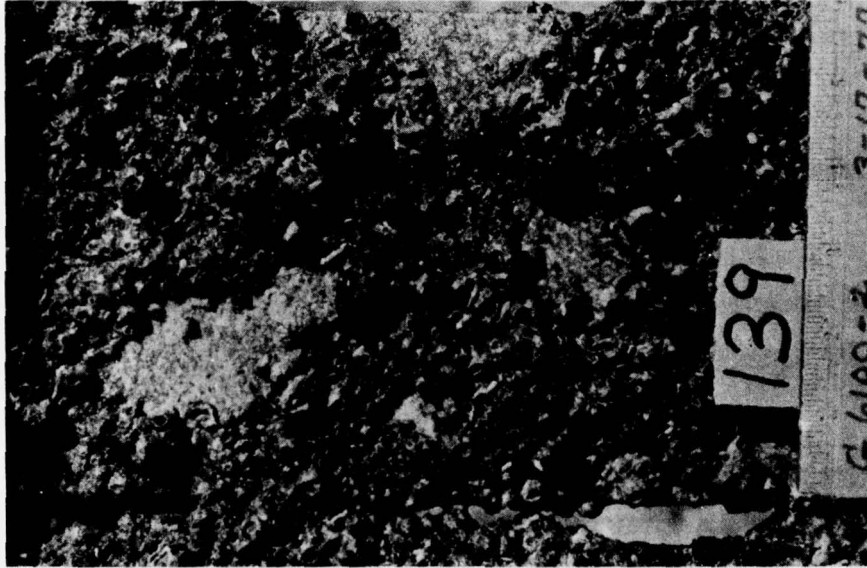
Panel No. 139  
 ---  
 Uncoated Aluminum Control Panel

18 Months' Exposure

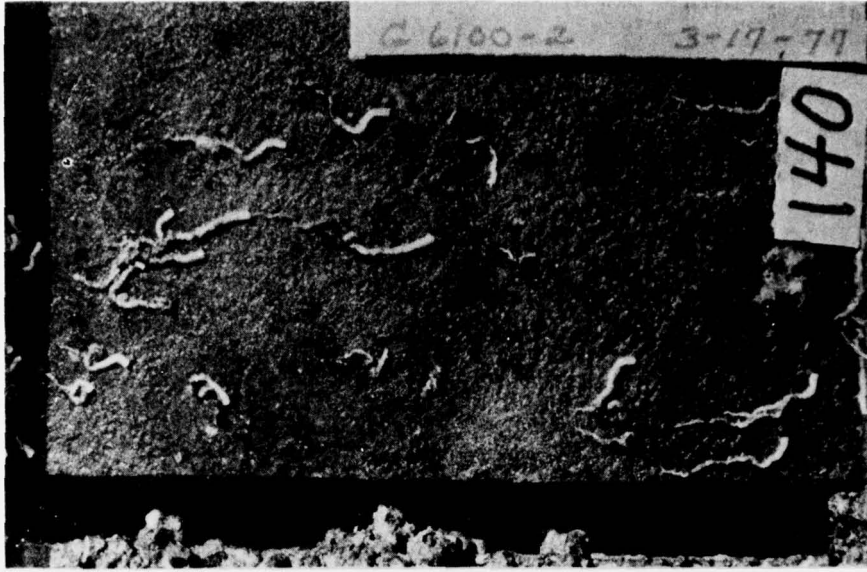
Panel No. 140  
 System No. CG-34  
 Type 121/63 Vinyl-High  
 Rosin Control on Plastic

Of interest is the performance of the Type 121/63 system on plastic substrate (System CG-34). After 18 months of immersion, three of the damaged CG34 panels are rated 10- but one is rated 8 and two others are rated 7 for fouling. There is a trace of peeling present which indicates that there may be a long-term adhesion problem over plastic. Further study is required before valid conclusions can be made.

18 Months' Exposure

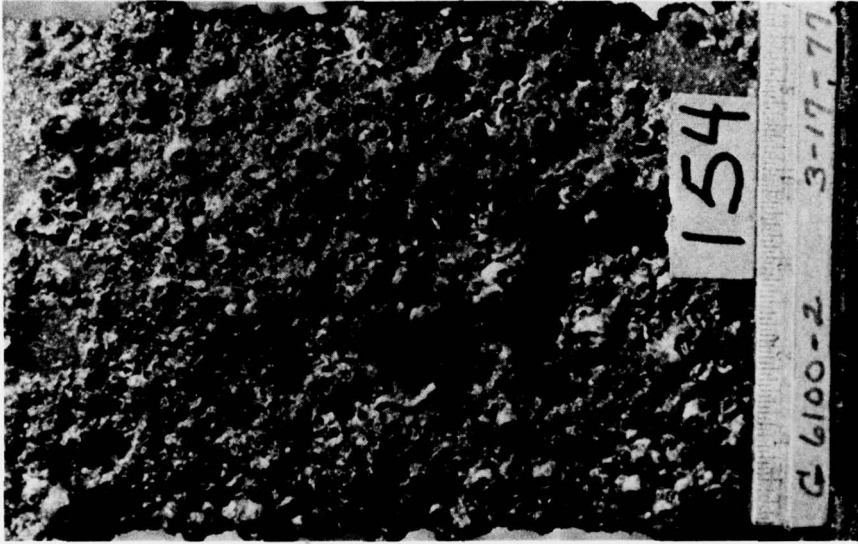
Panel No. 154  
System No. CG-36  
Acrylic-Organometallic Toxic  
Polymer on Plastic

18 Months' Exposure

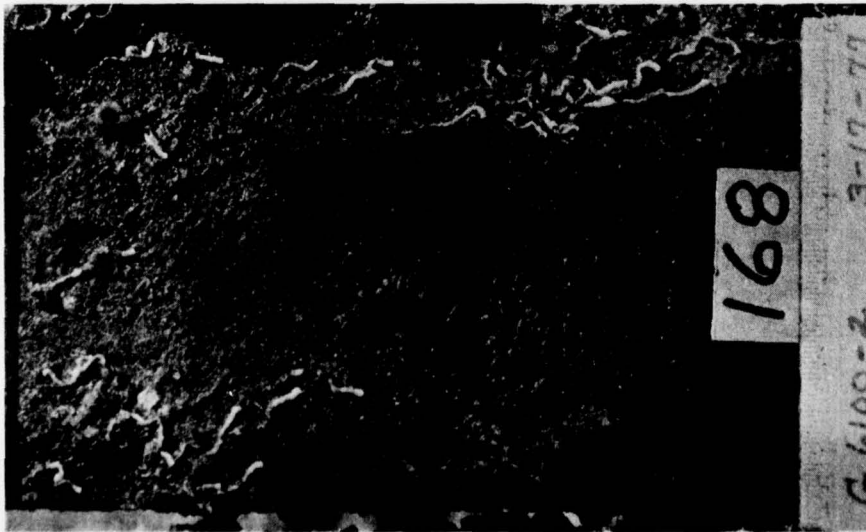
Panel No. 168  
System No. CG-38  
Flame-Sprayed Copper  
Cladding on Plastic

18 Months' Exposure

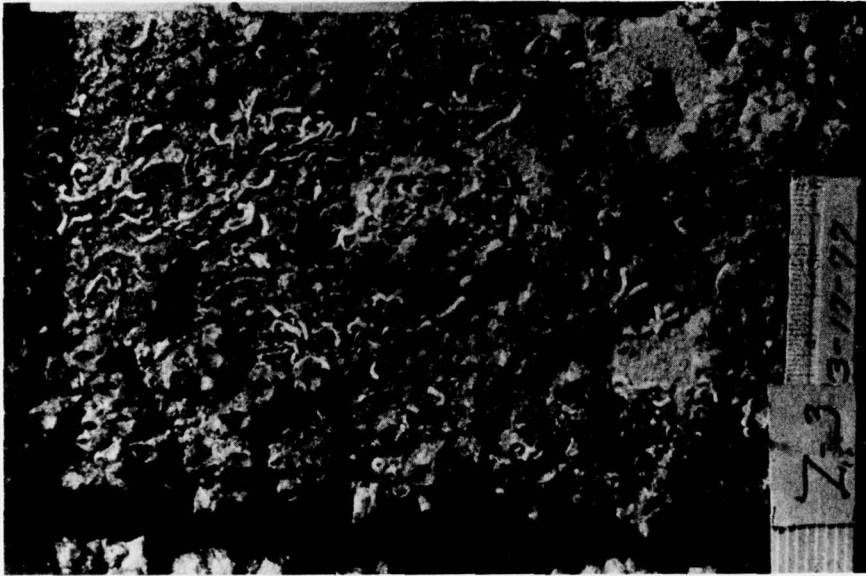
Panel No. Z3  
System No. CG-40  
Nonsolvent Polyurethane  
on Steel

The nonsolvent polyurethane was found totally lacking in antifouling properties. However, its physical and anti-corrosive properties are outstanding and may justify some effort to obtain antifouling properties as well.

18 Months' Exposure

Second priority should be placed on improving the performance of systems which failed early in the present program. A modest program could be undertaken to provide some measure of fouling resistance to the nonsolvent polyurethane system. The U. S. Navy toxic organometallic polymer has been the subject of several pigmentation studies and the most successful formulation could be added to the buoy program. Inquiries could be made into the possibility of increasing the film density and the topcoat adhesion of the flame-sprayed copper cladding. In addition, the door should be left open to enter new commercial materials into the program as they became available.

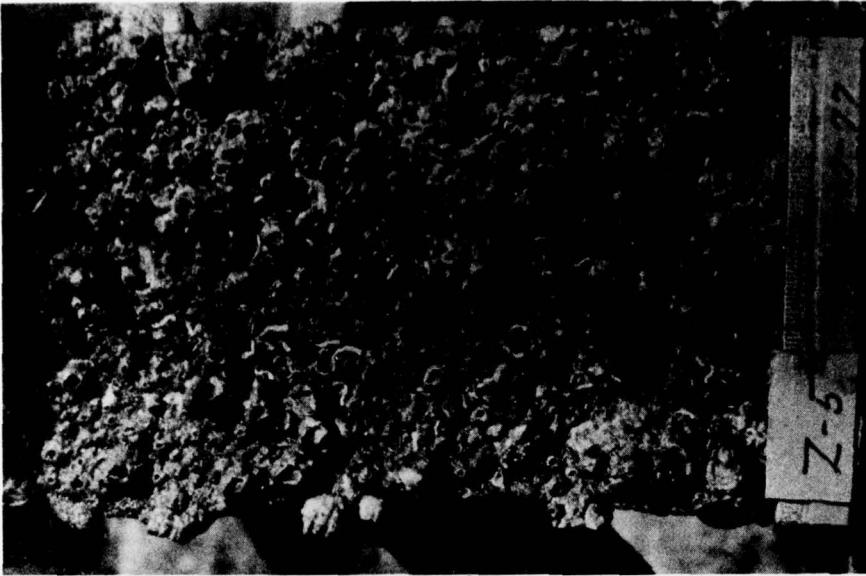
Panel No. Z5  
System No. CG-41  
Nonsolvent Polyurethane  
on Aluminum

18 Months' Exposure

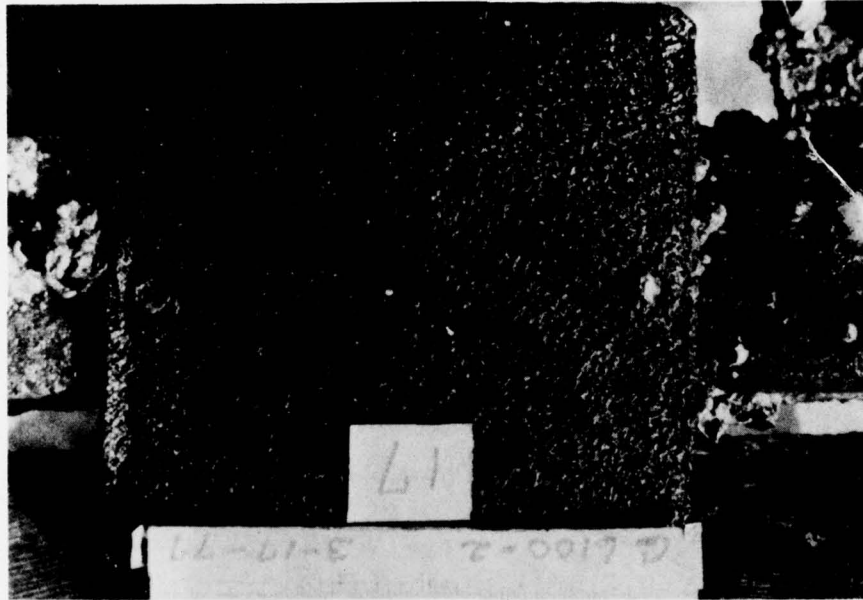
Panel No. 17  
System No. CG-17  
Elastomeric Sheet With  
Organotin Toxicant

77 Months' Exposure

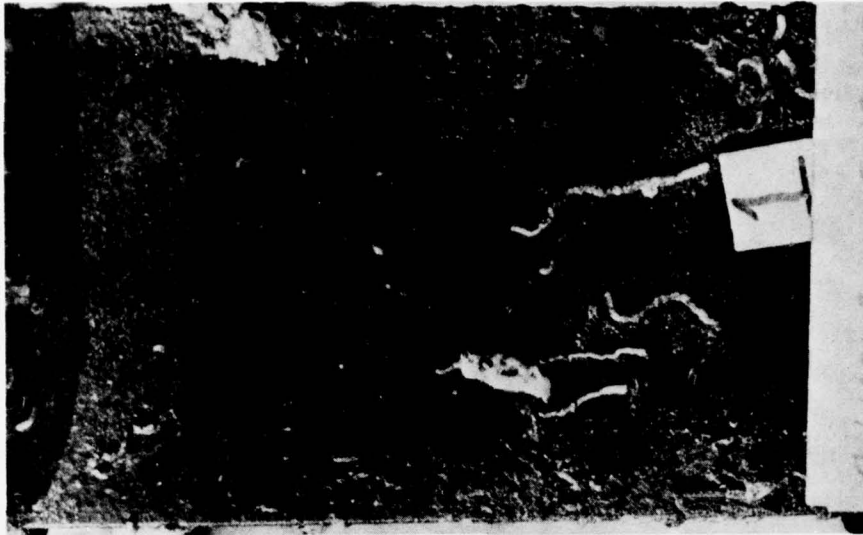
Panel No. 1  
System No. CG-1  
Type 121 Standard Vinyl-  
Rosin Control

77 Months' Exposure

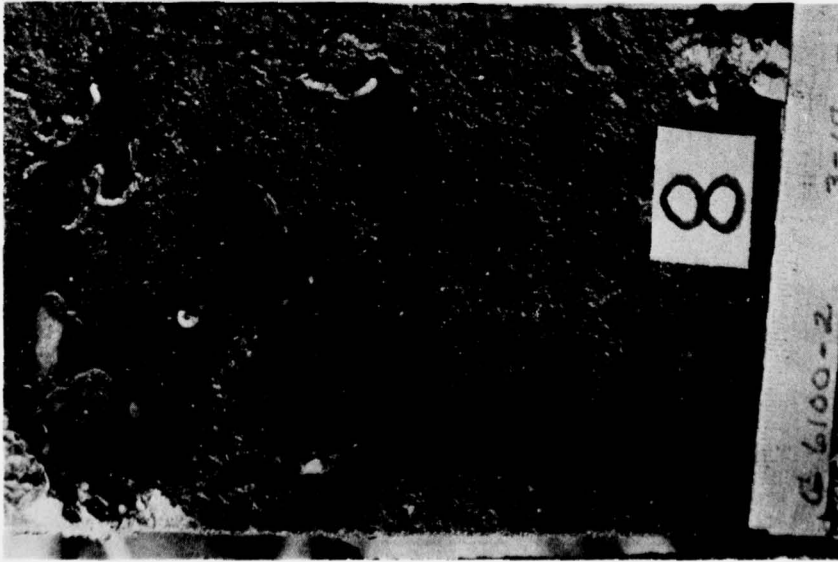
Panel No. 8  
System No. CG-4  
Self-Cure Zinc Silicate High-Build  
Vinyl, Type 121 Antifoul

77 Months' Exposure

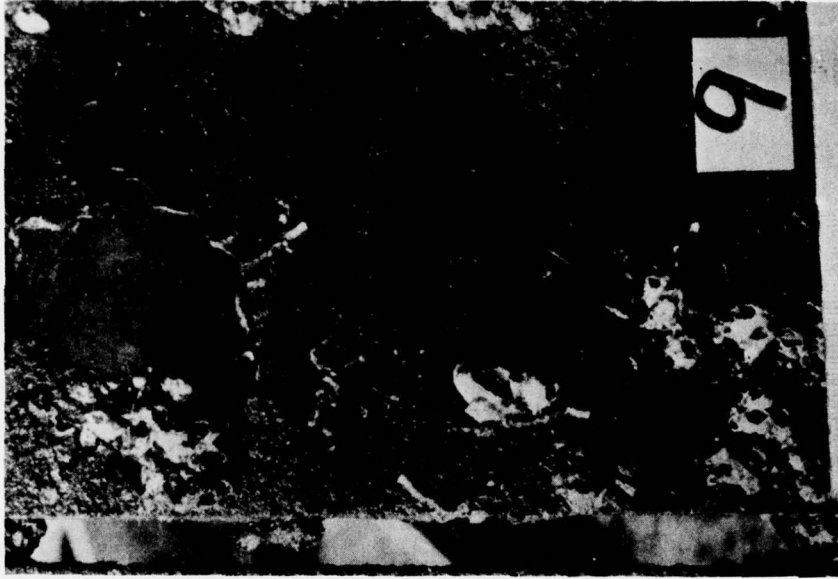
Panel No. 9  
System No. CG-1  
Postcure Zinc Silicate, High-Build  
Vinyl, Type 121 Antifoul

77 Months' Exposure

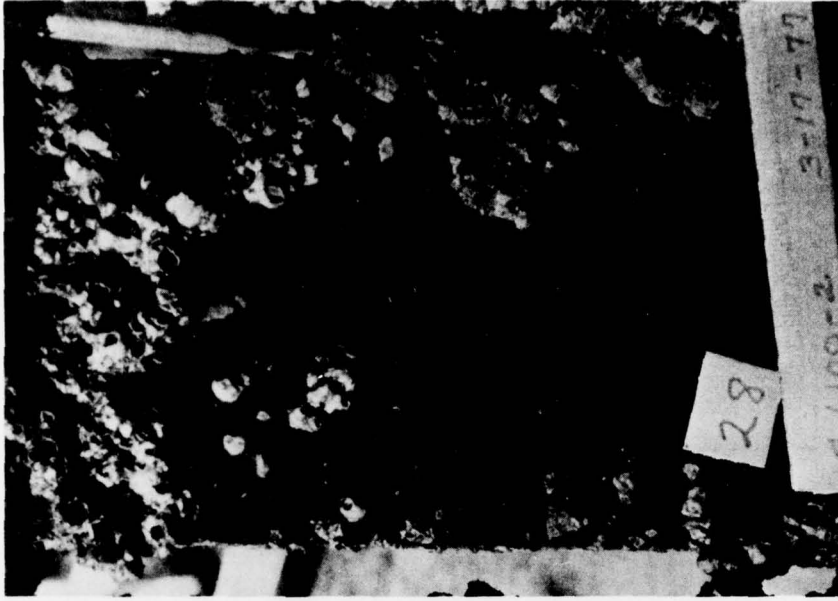
Panel No. 28  
System No. CG-14  
Vinyl-Rosin with Organotin (TBTF)  
Toxicant, Aluminum Substrate

77 Months' Exposure

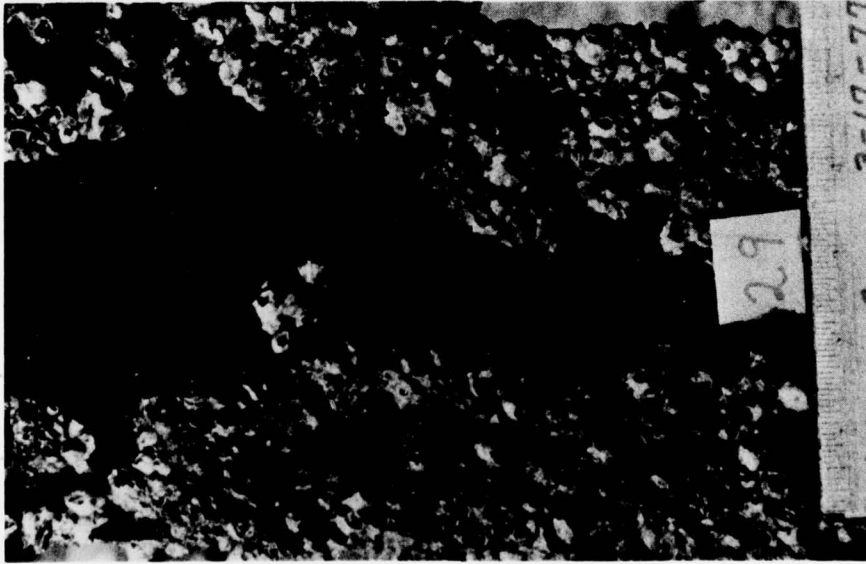
Panel No. 29  
System No. CG-15  
Vinyl-Rosin With Organotin (TBTF)  
Toxicant, Fiberglass Substrate

77 Months' Exposure

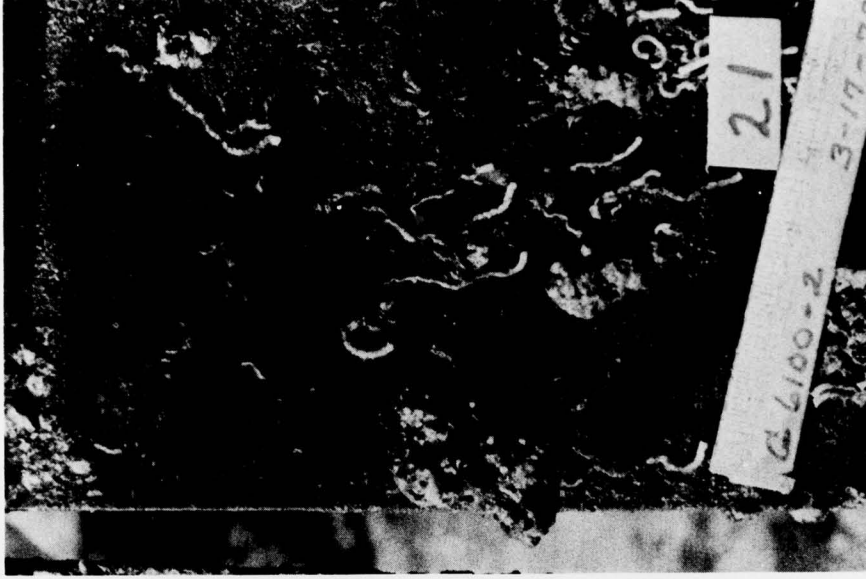
Panel No. 21  
System No. CG-11  
Epoxy Primer, Epoxy-Coal  
Tar Anticorrosive and Antifoul

77 Months' Exposure
