MODEL OH-58A

REPORT No. 206-099-788	DATE 3-4-77
TITLE GREASED MAIN ROTOR HUB ASSEMBLY OH-58A HELICOPTER

20. ABSTRACT (Continue on reverse side if necessary and identify by block number) THE OBJECTIVE OF THIS REPORT IS TO PROVIDE DATA FOR THE SUBSTANTIATION OF MIL-G-81322 GREASE IN LIEU OF SAE 10W-30 OIL AS THE LUBRICANT FOR THE GRIP AND TRUNNION IN THE OH-58A MAIN ROTOR HUB ASSEMBLY.

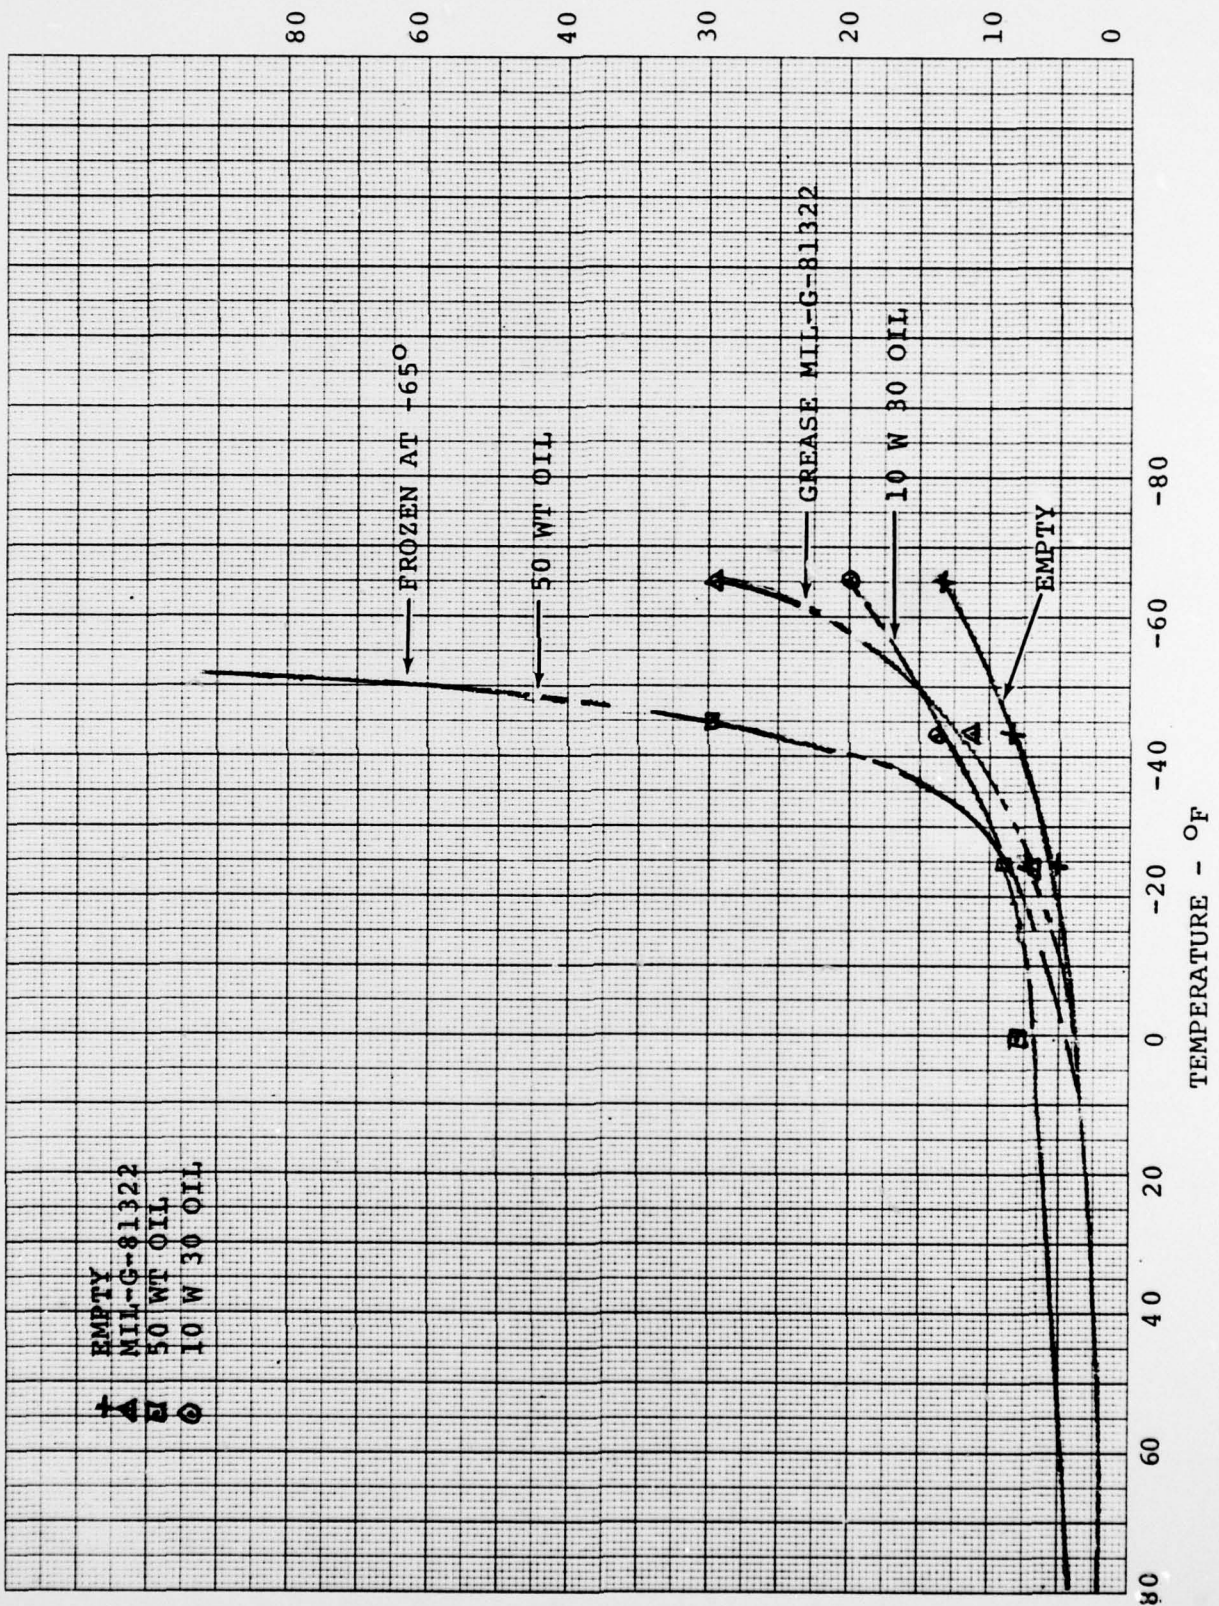
BREAK AWAY FORCE AT PITCH HORN - LB

10W-30 Oil does not freeze at low temperatures. At -65°F only six (6) additional pounds of "break away" force is required to move the grip with oil vs. the empty or baseline grip. MIL-G-81322 Grease required the same force as SAE 10W-30 Oil at -25°F, at -65°F MIL-G-81322 required ten (10) pounds more force. After cycling the grip the force dropped to seven (7) pounds. The difference between SAE 10W-30 and MIL-G-81322 will not affect the loads on the OH-58A rotating controls. 50 Weight Oil was slightly higher than 10W-30 at -25°F. At -65°F it was frozen solid and could not be moved. The critical point is -30°F to -35°F which agrees with previous reports from commercial operators.
