AD-A060 728

ADVANCED RESEARCH AND APPLICATIONS CORP SUNNYVALE CA  
IMPROVEMENT IN GAAS DEVICE YIELD AND PERFORMANCE THROUGH SUBSTR--ETC(U)  
OCT 78 T J MAGEE, J PENG, J HONG  
ARACOR-19-1

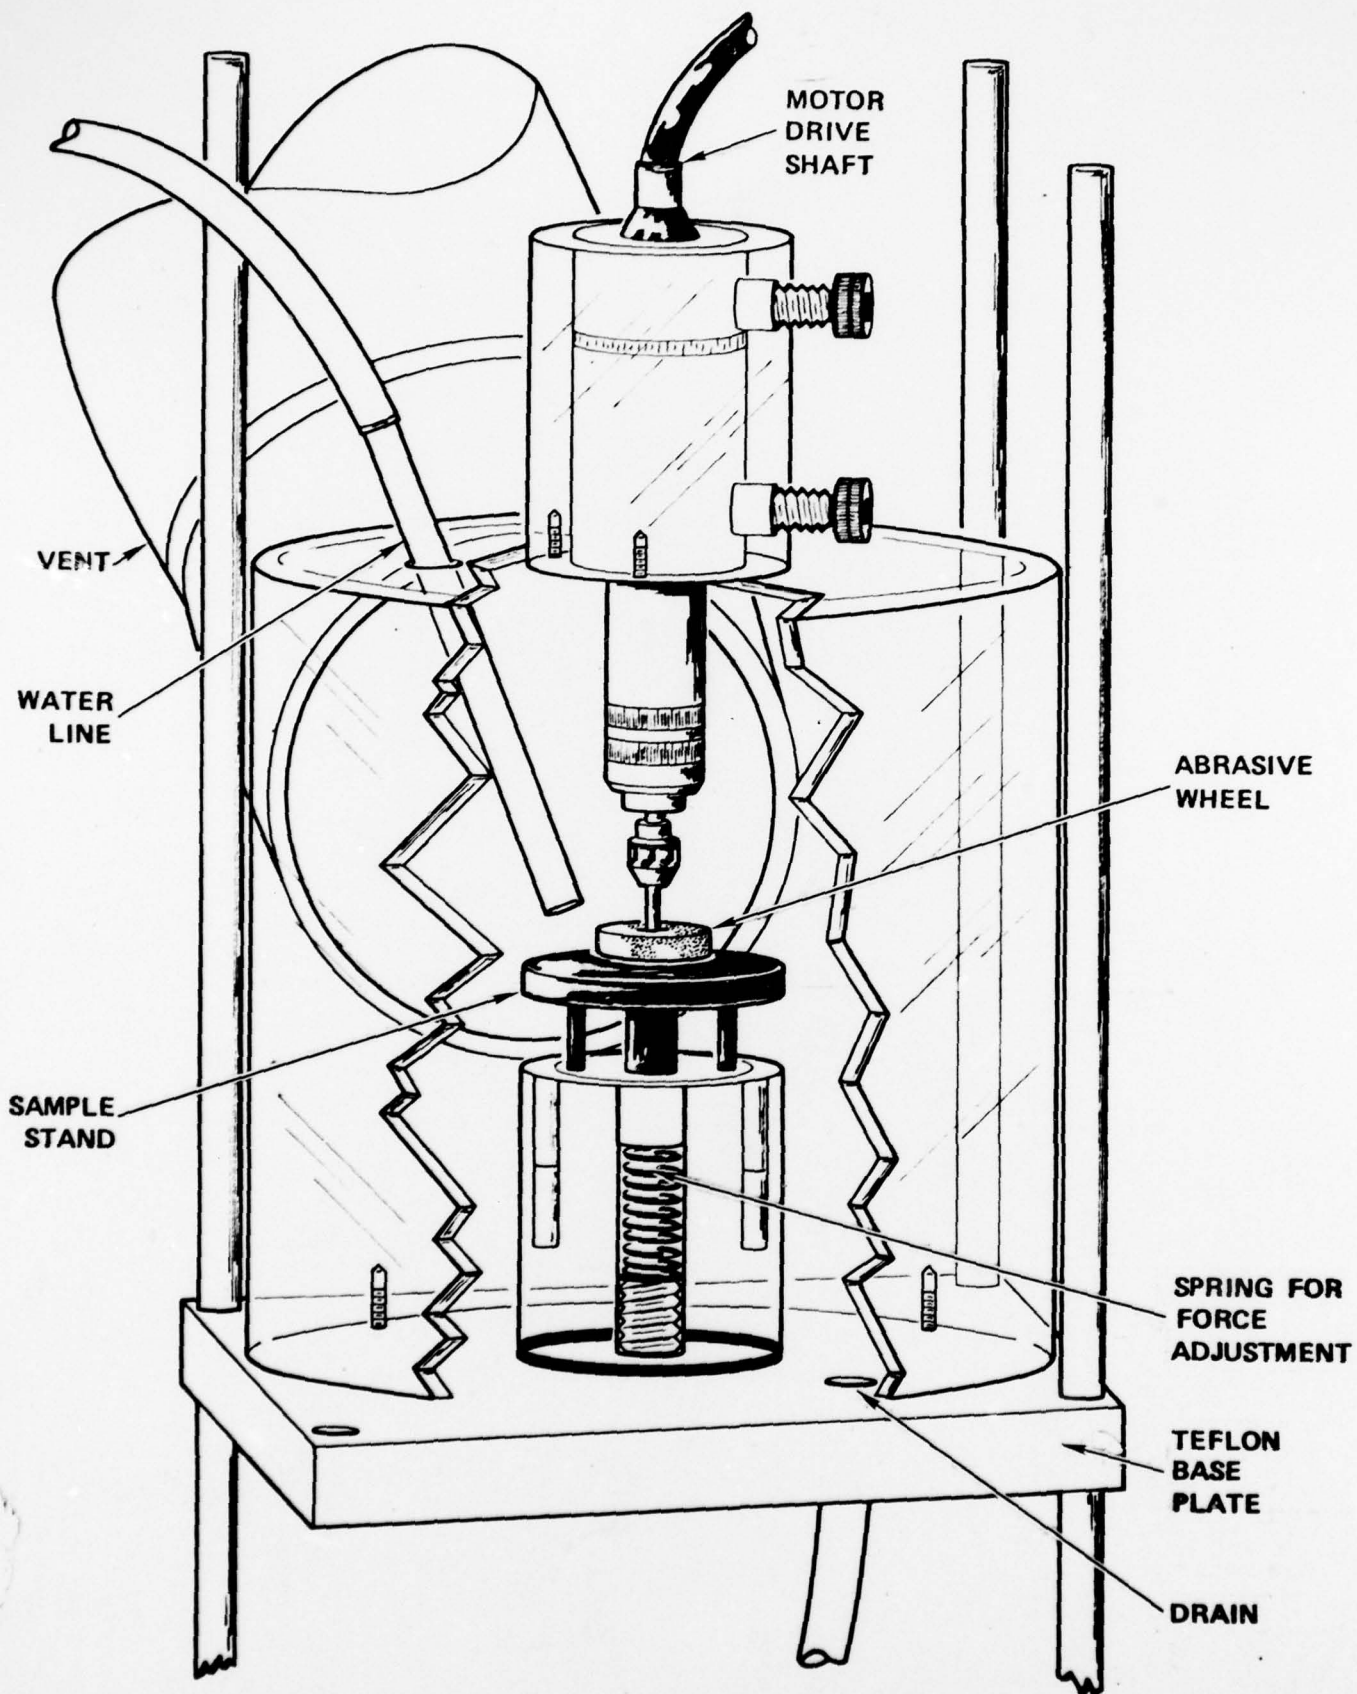
FIGURE 1. EXPERIMENTAL APPARATUS FOR CREATING BACK-SURFACE MECHANICAL DAMAGE

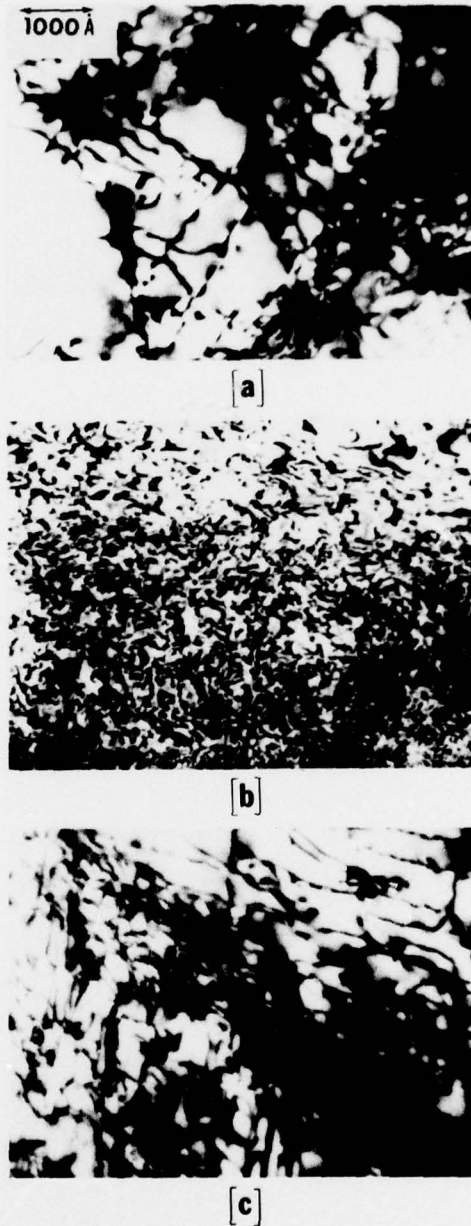
FIGURE 2. BRIGHT FIELD TRANSMISSION ELECTRON MICROGRAPHS OF BACK-SURFACE-DAMAGED GaAs WAFERS (PARTICLE SIZE= 30  $\mu\text{m}$ , 8000 rpm). a) 30 sec exposure time; b) 1 min exposure time; c) 3 min exposure time

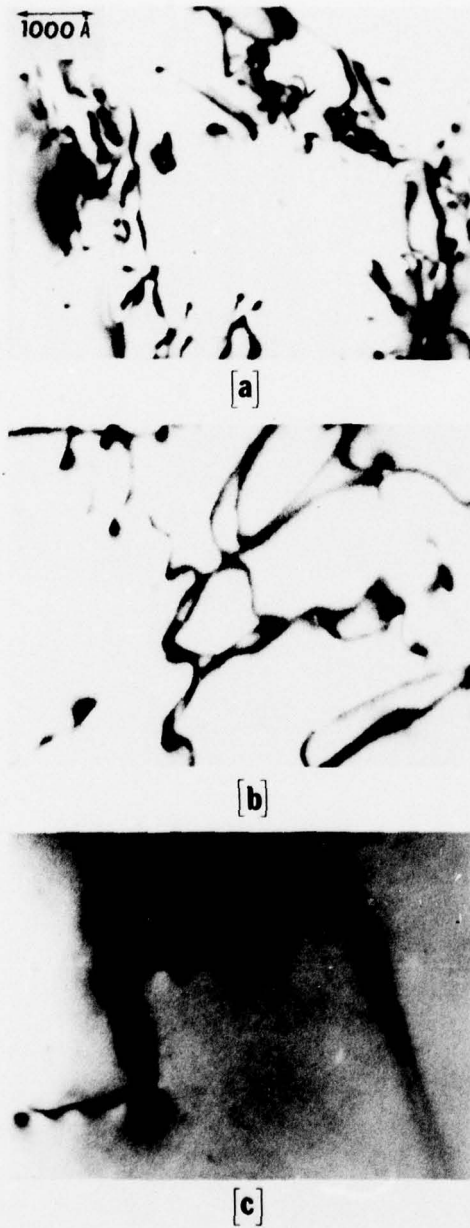
FIGURE 3. BRIGHT FIELD TRANSMISSION ELECTRON MICROGRAPHS OF SECTIONED WAFERS SHOWING DAMAGE AT DEPTH ( $0.3 \mu\text{m}$  ABRASIVE PARTICLES); a)  $d = 1000 \text{ \AA}$ ; b)  $d = 7000 \text{ \AA}$ ; c)  $d = 1.4 \mu\text{m}$ .

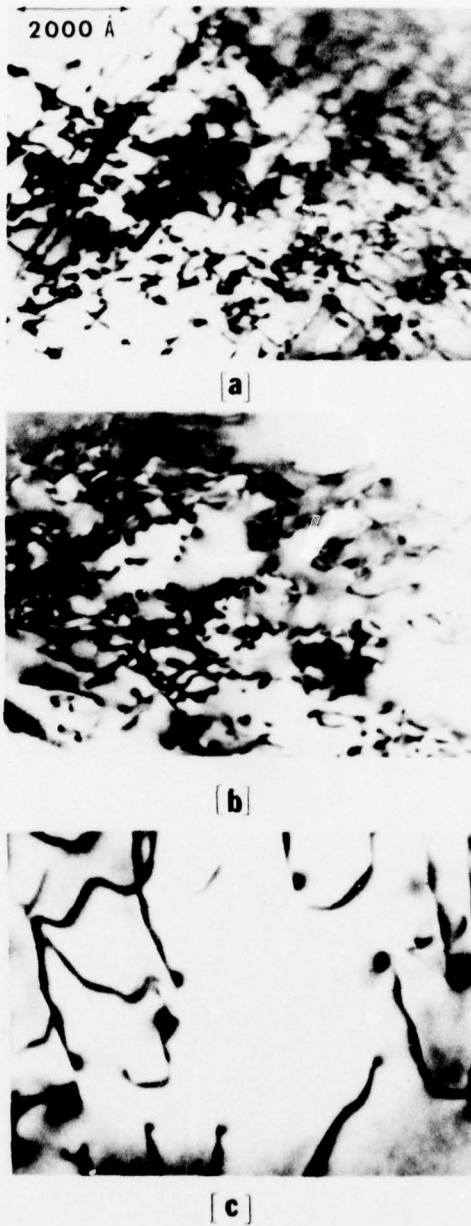
FIGURE 5. BRIGHT FIELD TRANSMISSION ELECTRON MICROGRAPHS OF SECTIONED WAFERS SHOWING DAMAGE AT DEPTH ( $30\ \mu\text{m}$  ABRASIVE PARTICLES); a)  $d = 1000\ \text{Å}$ ; b)  $d = 4000\ \text{Å}$ ; c)  $d = 1\ \mu\text{m}$ .

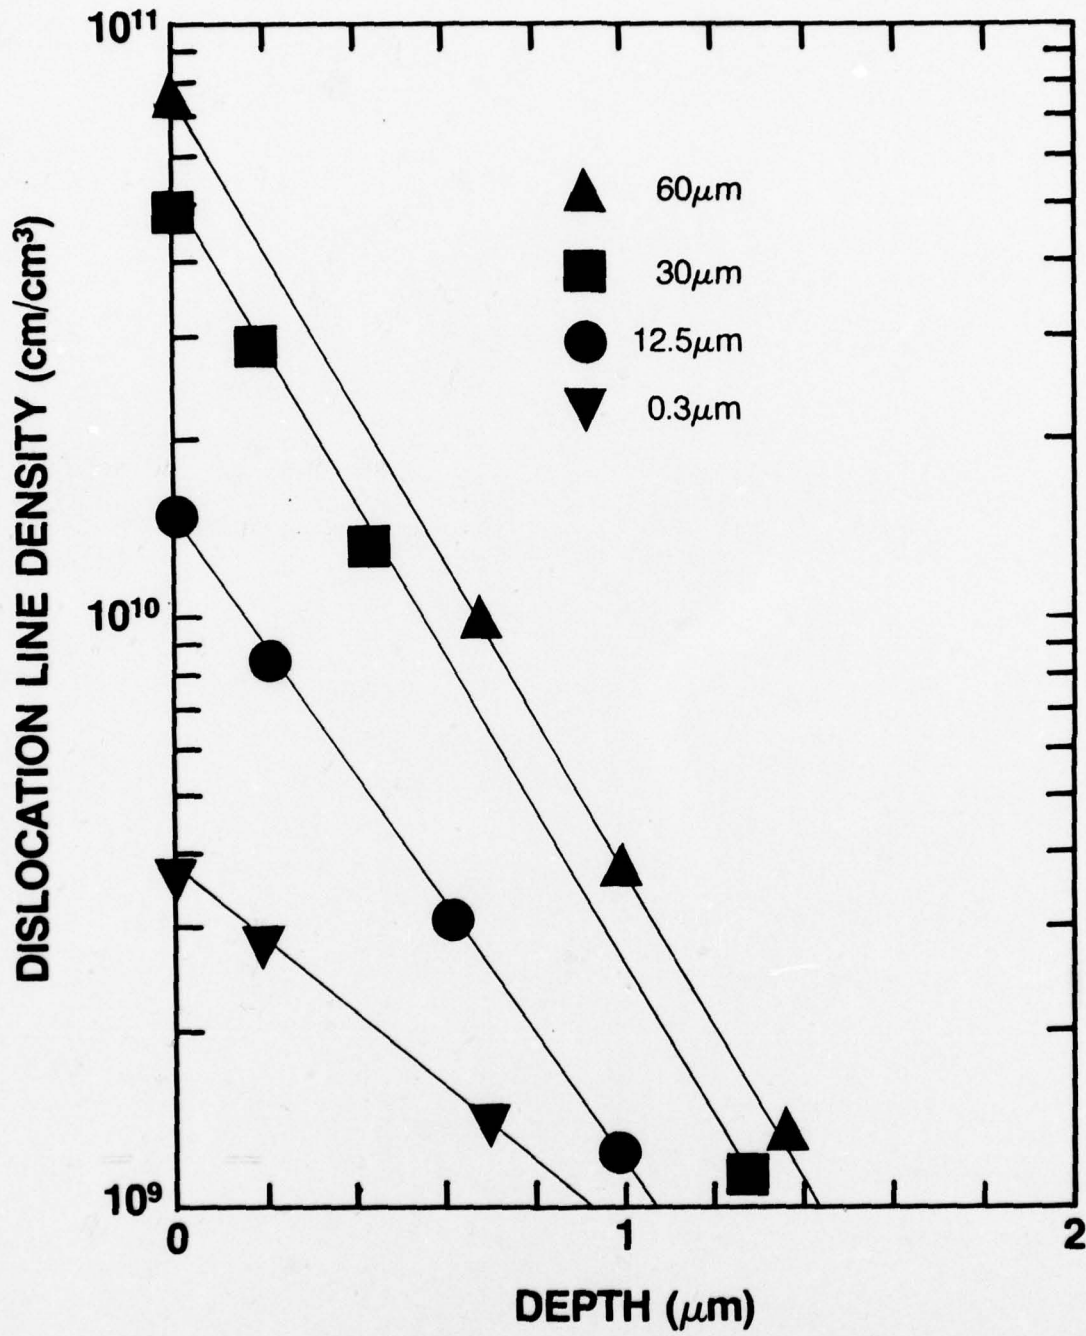
FIGURE 7. DISLOCATION LINE DENSITY VS DEPTH FOR VARIOUS PARTICLE SIZES (8000 rpm, 30 sec).

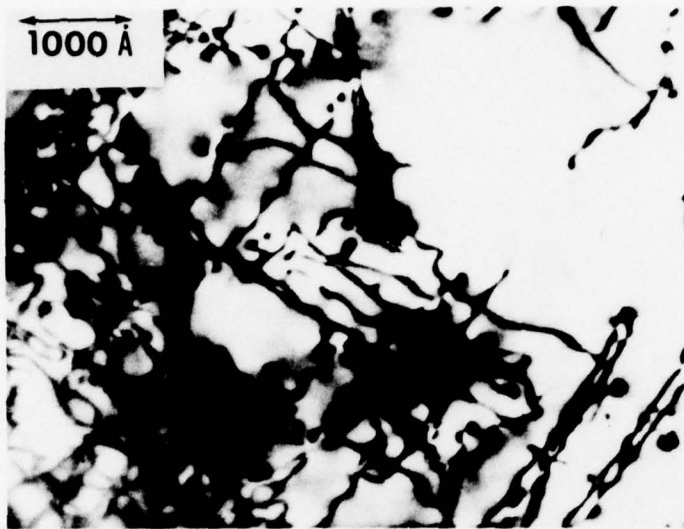
$$\left( \frac{\sum_{i=1}^n \rho_i(x)}{\sum_{i=1}^n \rho_0(x)} \right)$$

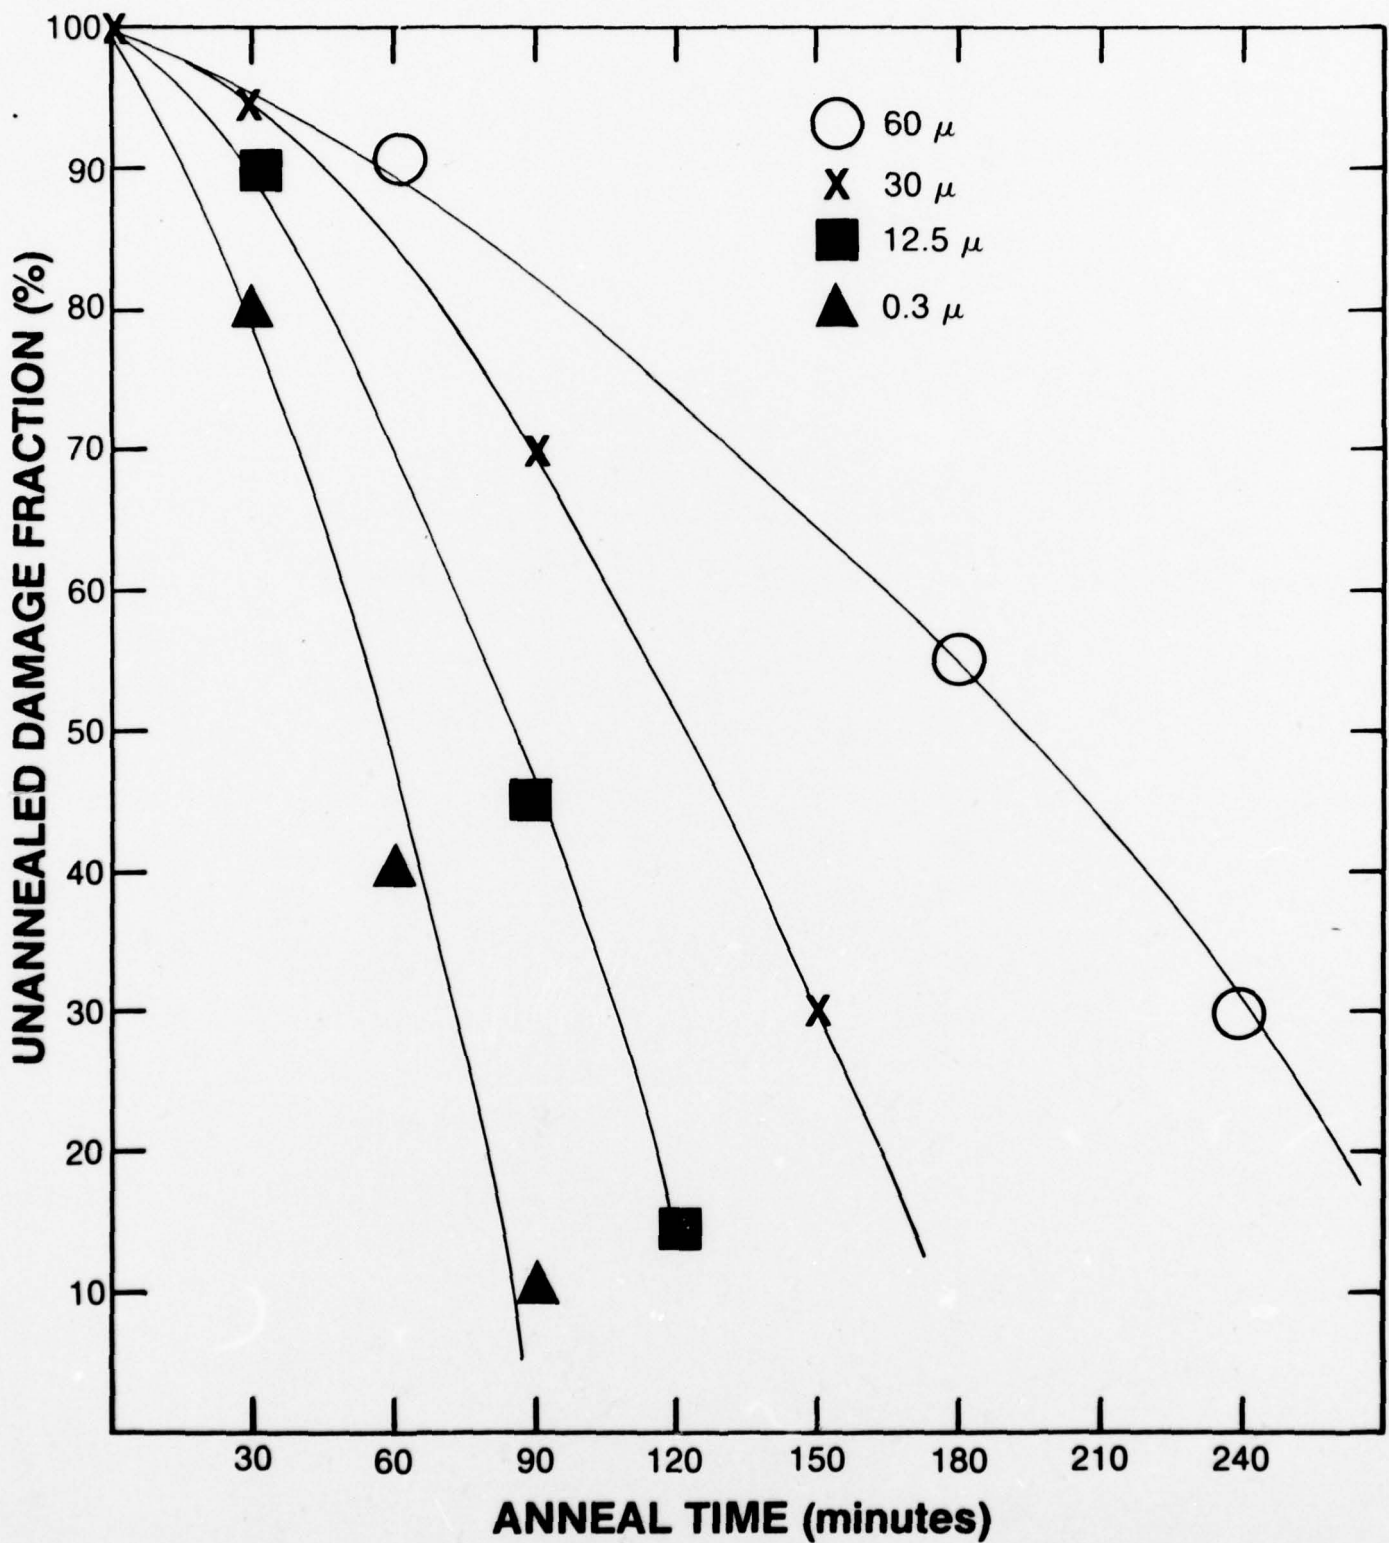
FIGURE 9. UNANNEALED FRACTION OF DAMAGE REMAINING AS A FUNCTION OF ANNEALING TIME.

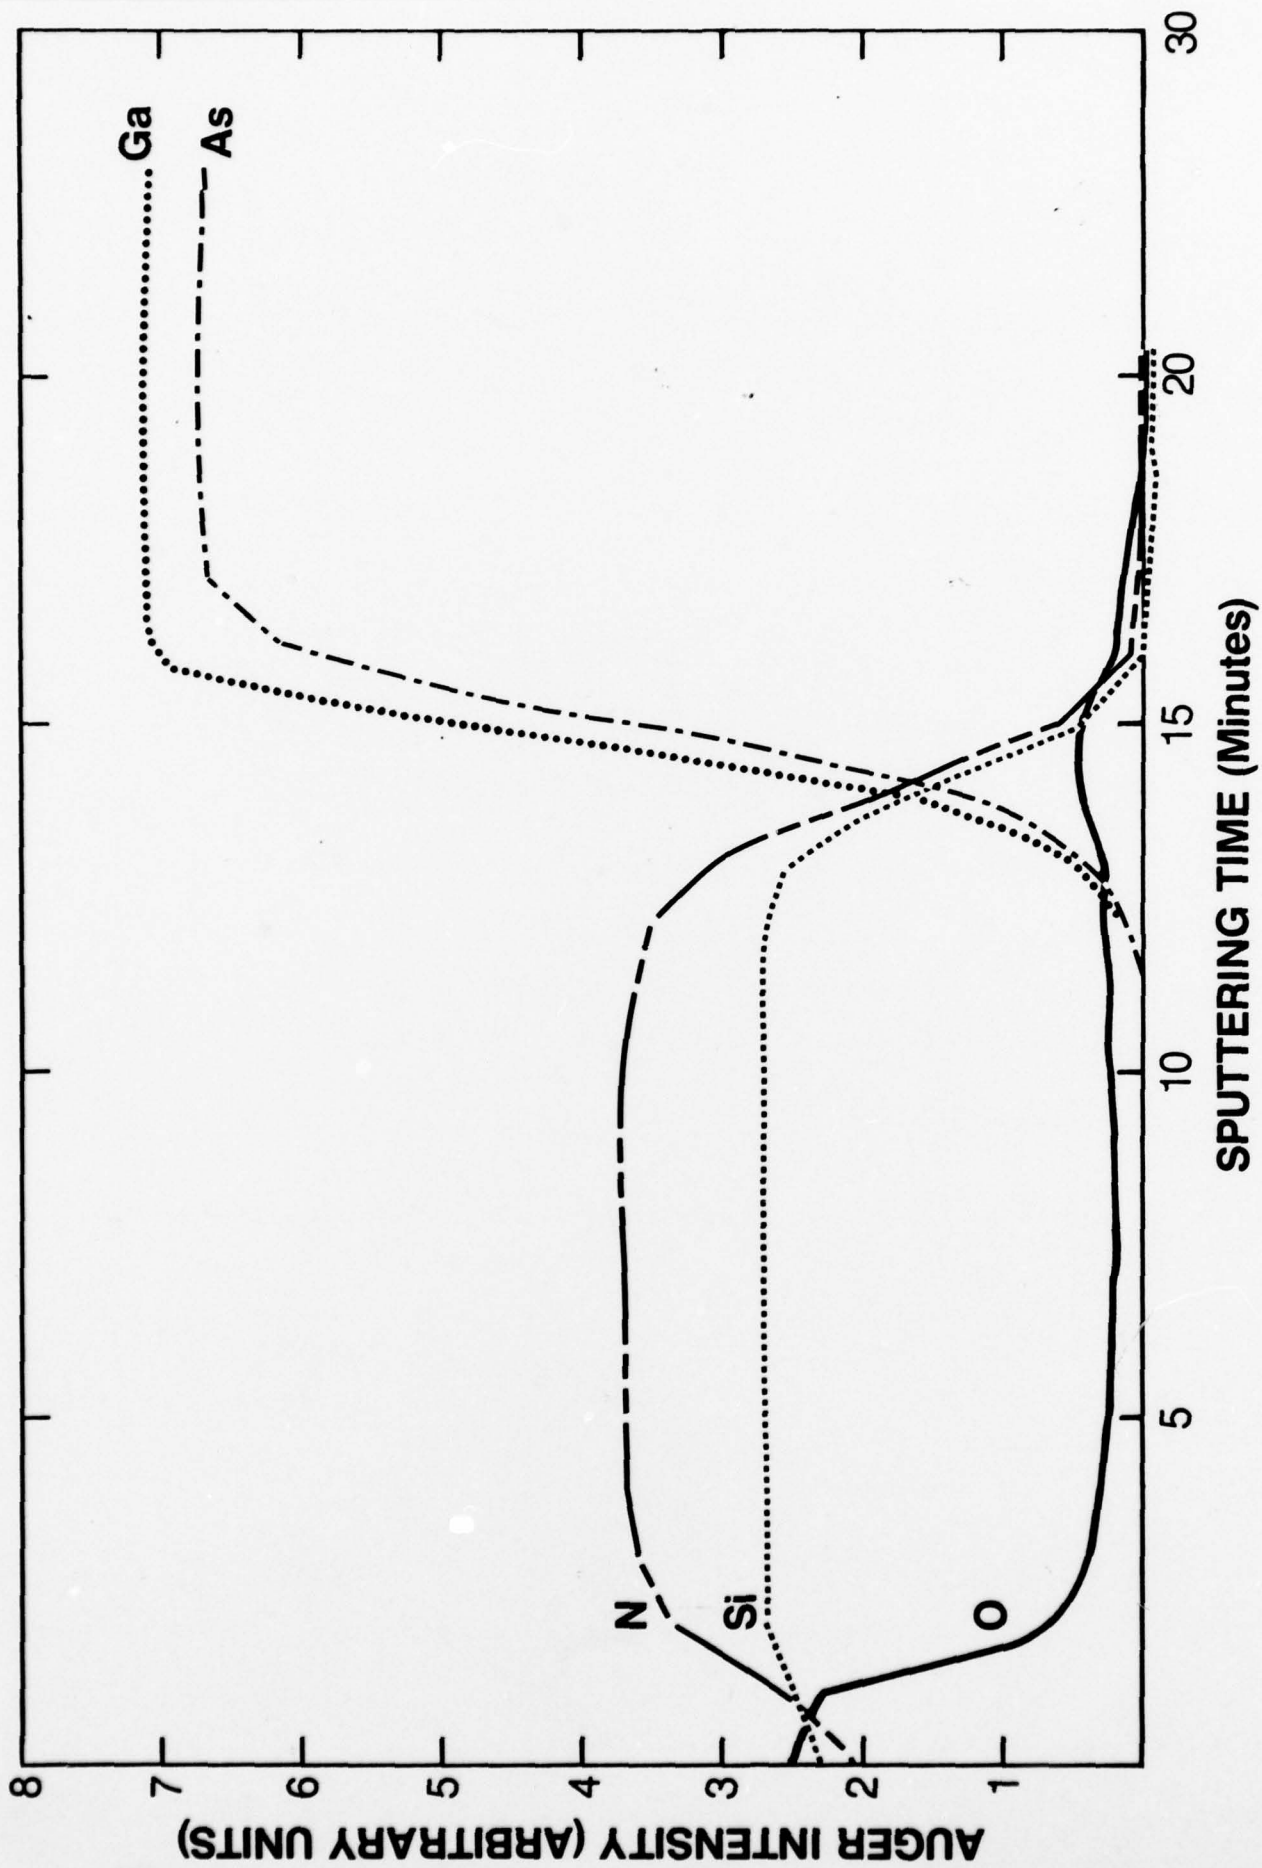
FIGURE 10. AES CHEMICAL DEPTH PROFILE (NORMALIZED) OF AS-DEPOSITED  $\text{Si}_3\text{N}_4$  FILM ON GaAs.

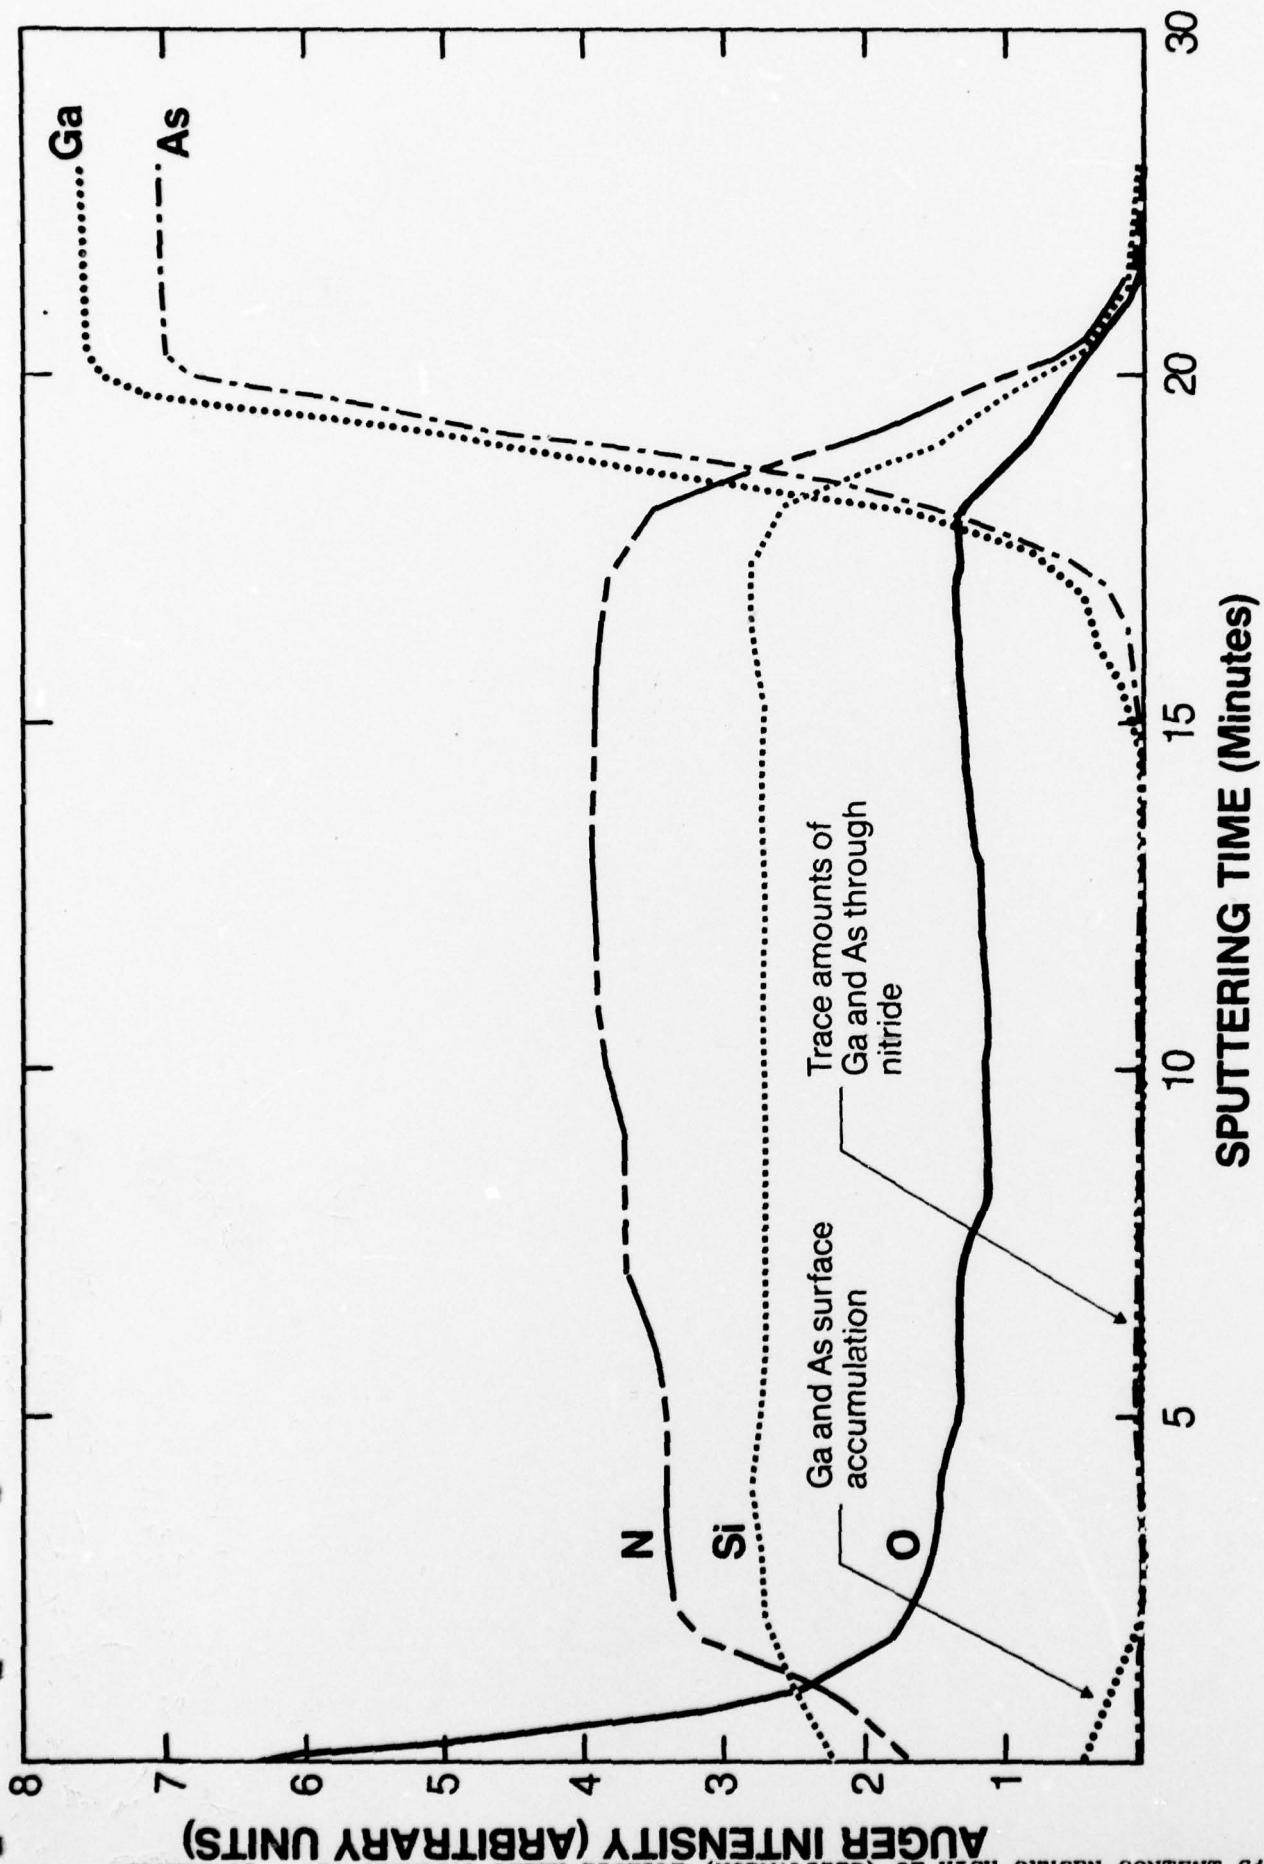
FIGURE 12. AES CHEMICAL DEPTH PROFILE (NORMALIZED) OF HIGH OXYGEN CONTENT  $Si_3N_4$  FILMS ON GaAs AFTER ANNEALING (30 min,  $850^\circ C$ ).

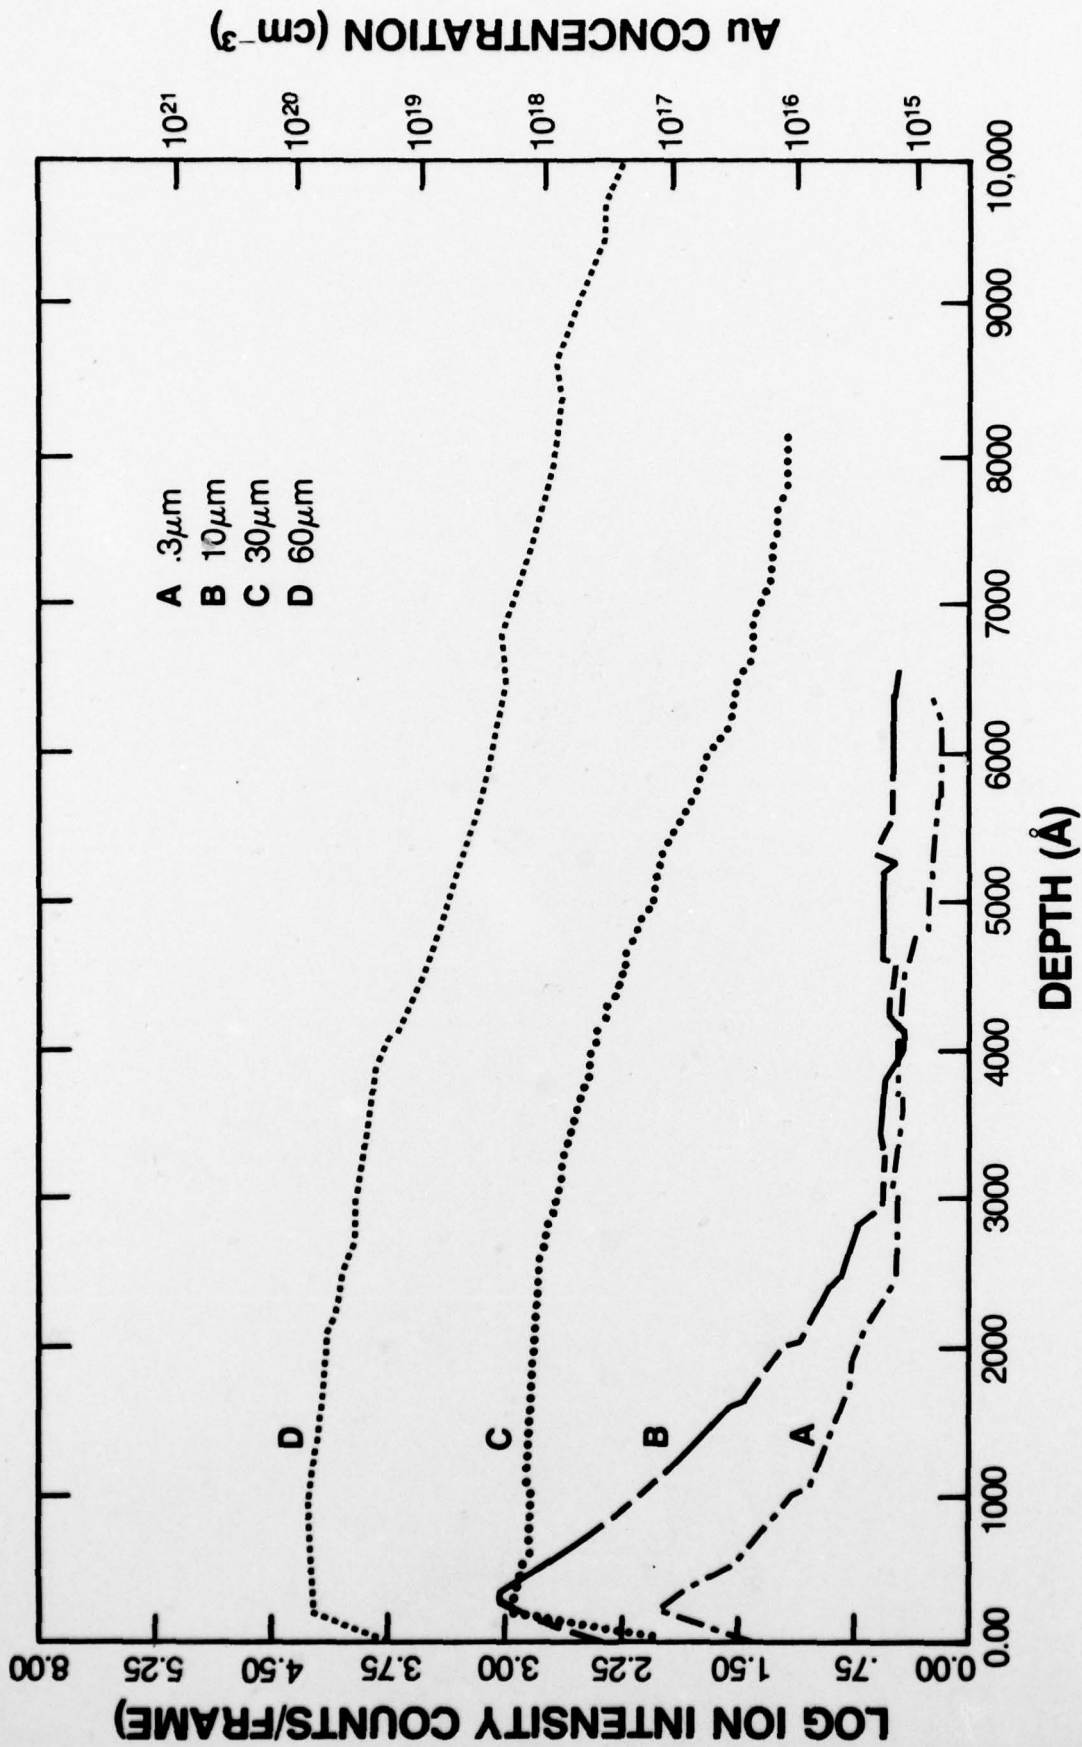
FIGURE 17. SIMS PROFILES OF Au AT BACK SURFACES OF DAMAGED WAFERS.

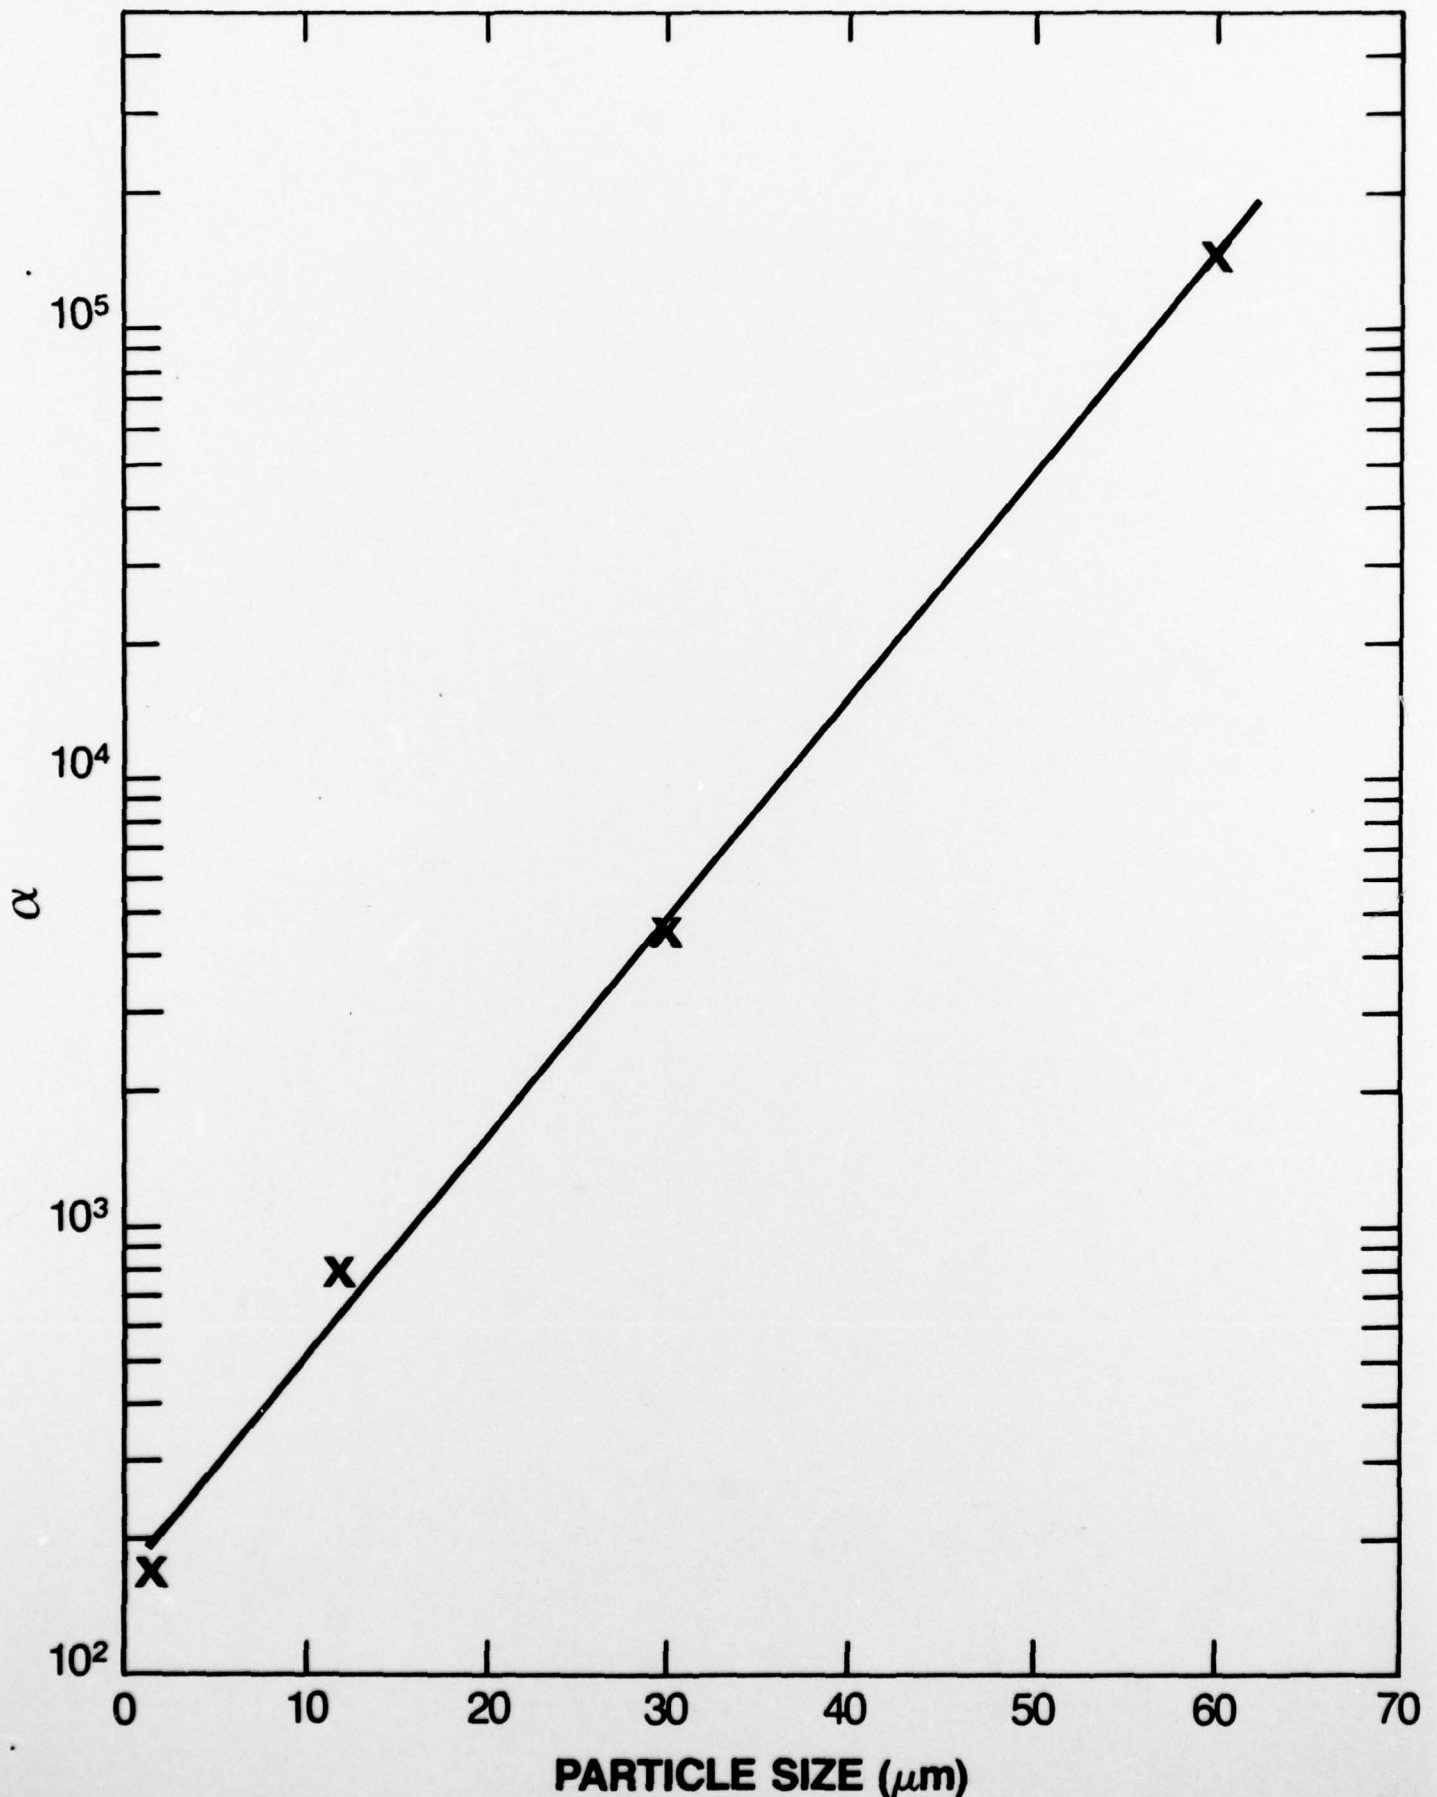
FIGURE 18. GRAPH OF α VS PARTICLE SIZE.

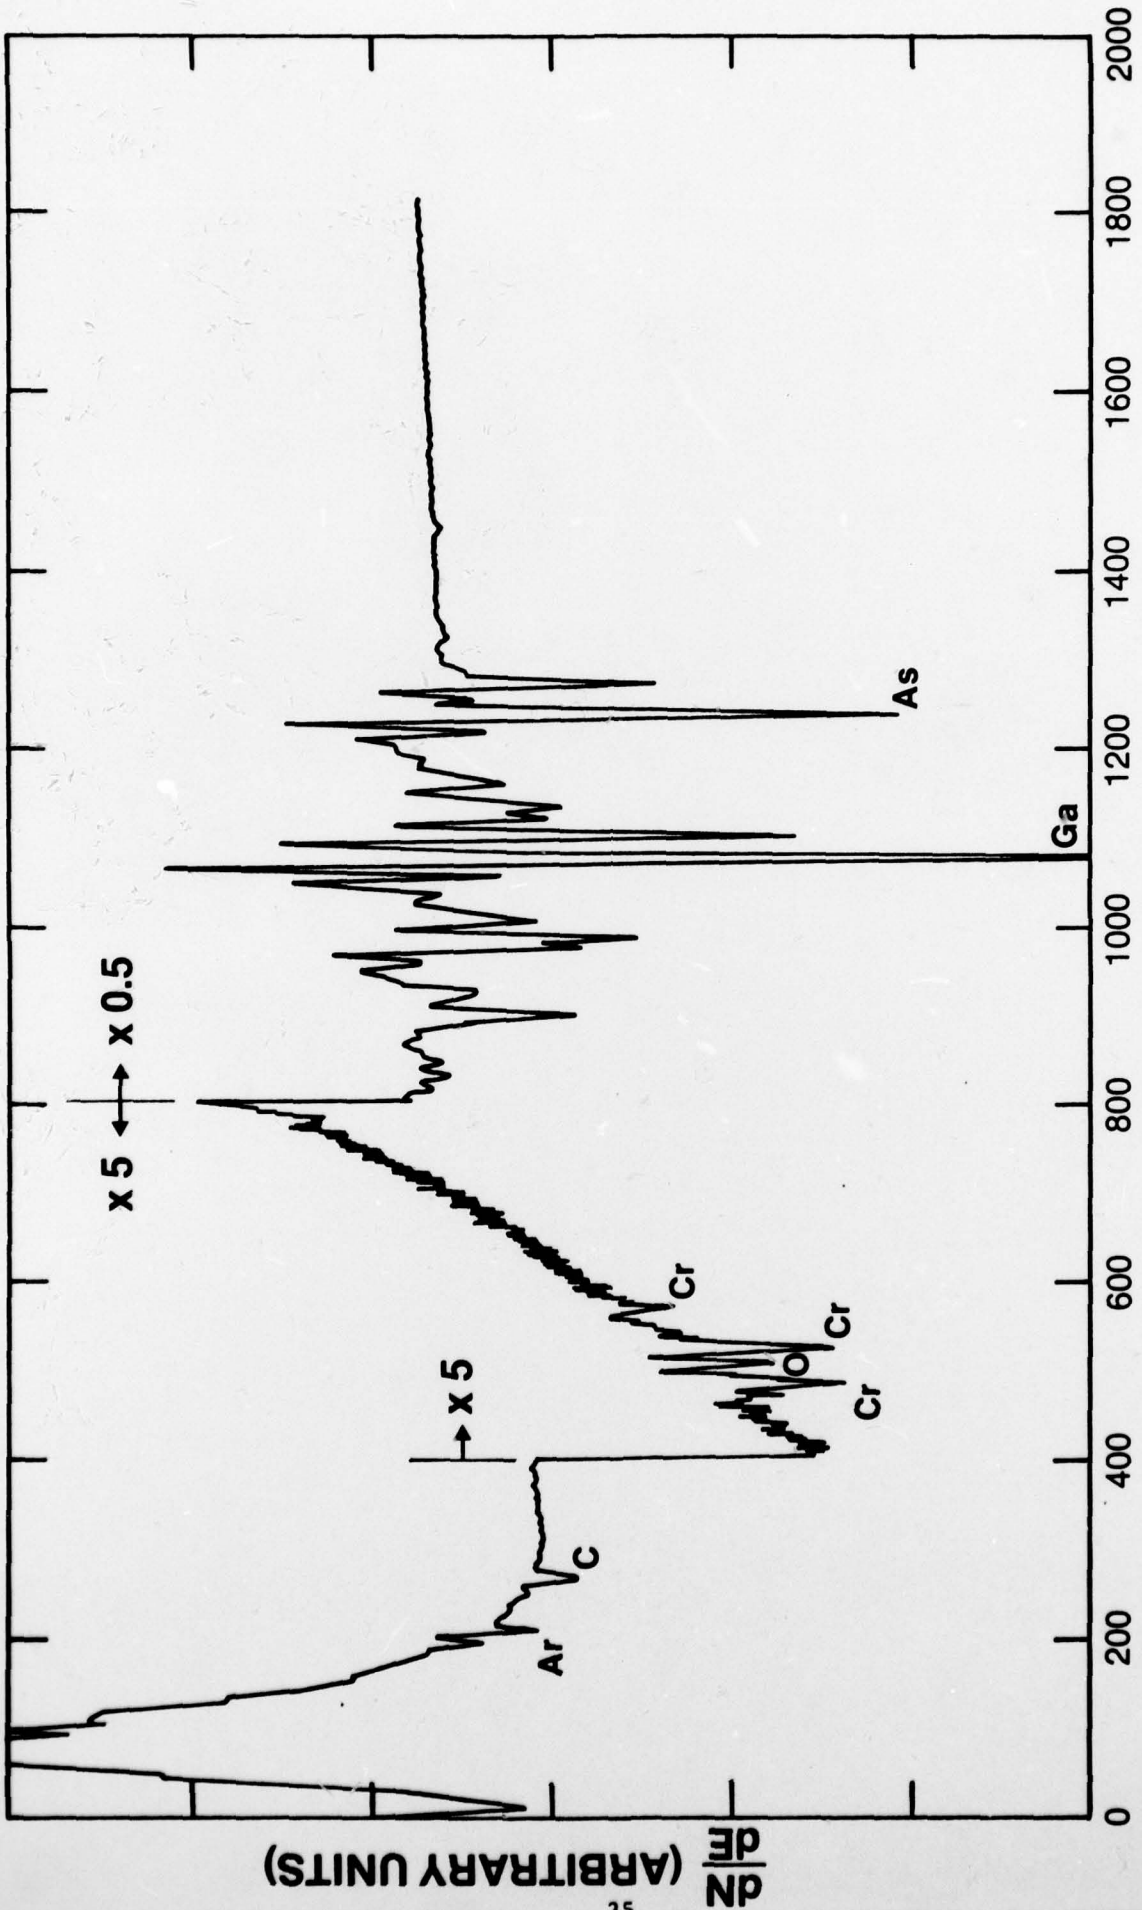
FIGURE 20. AES CHEMICAL DEPTH PROFILE OF BACK-SURFACE-DAMAGED WAFER AT DEPTH OF 1000 Å SHOWING THE PRESENCE OF Cr GETTERED BY DISLOCATIONS.
