NSWC/DL-TR-3904

| REPORT DOCUMENTATION PAGE | | READ INSTRUCTIONS<br>BEFORE COMPLETING FORM |
|---|---|---|
| 4. TITLE (and Subtitle)<br>FABRICATION AND ASSEMBLY OF A SHIPBOARD MULTI-<br>FUNCTIONAL WASTE INCINERATOR (MFI). PHASE II | 5. TYPE OF REPORT & PERIOD COVERED<br>Final rept. | |
| 11. CONTROLLING OFFICE NAME AND ADDRESS<br>Naval Sea Systems Command<br>Washington, DC 20362 | 12. REPORT DATE<br>April 1979 | |

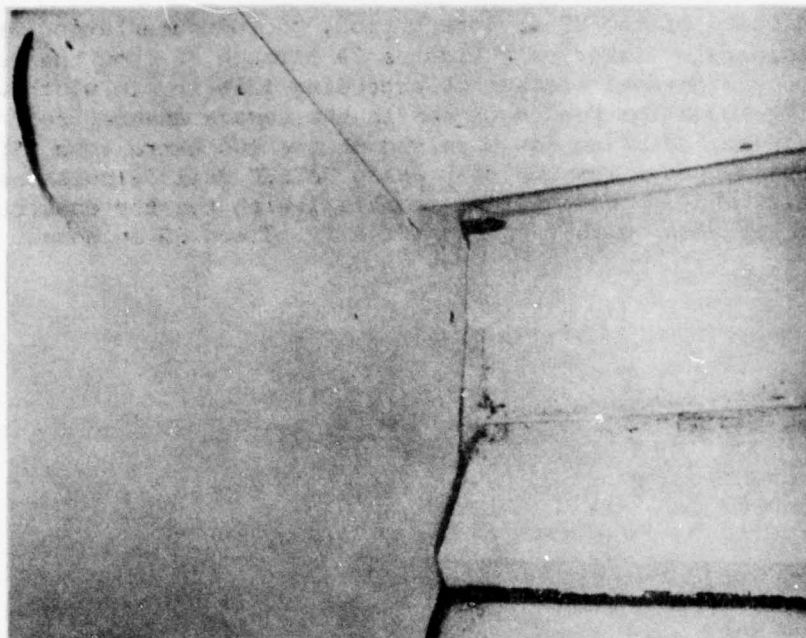
Upon completion of the 88-hr cure period, photodocumentation was again made of the incinerator interior. Figures 29 through 36 show the cracking of the refractory. Several cracks not exceeding 1/16-in. in width were observed primarily above the feed door and in the sewage chamber roof panel. Very minute hairline cracking was observed in the two extra tops (Figures 37 and 38). Figure 37 shows the top cast using NAVSEC Philadelphia design sliding anchors; and Figure 38 shows the top (identical with the top construction on the incinerator) cast with the standard A. P. Green SS anchors.

Figure 30. Ash Drawer Assembly After Curing

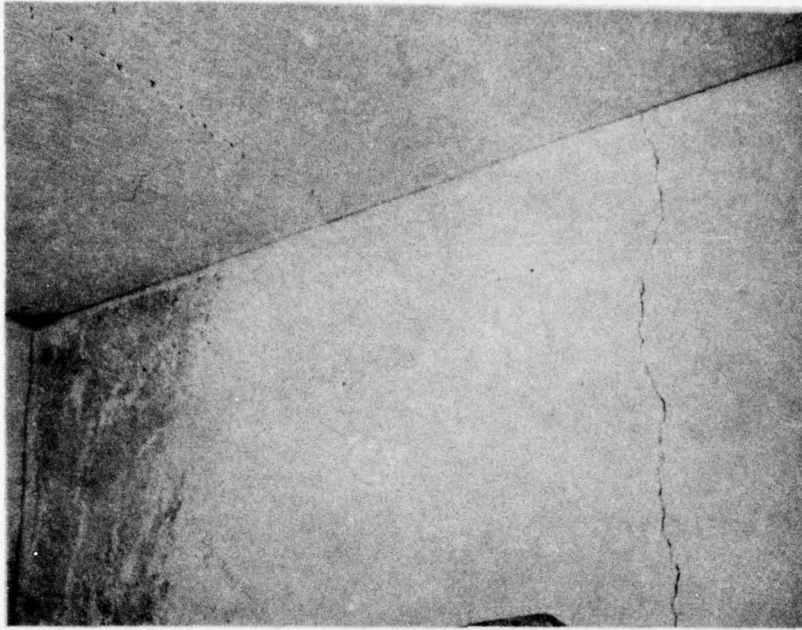
Figure 34. Right Wall of Sewage Chamber After Curing

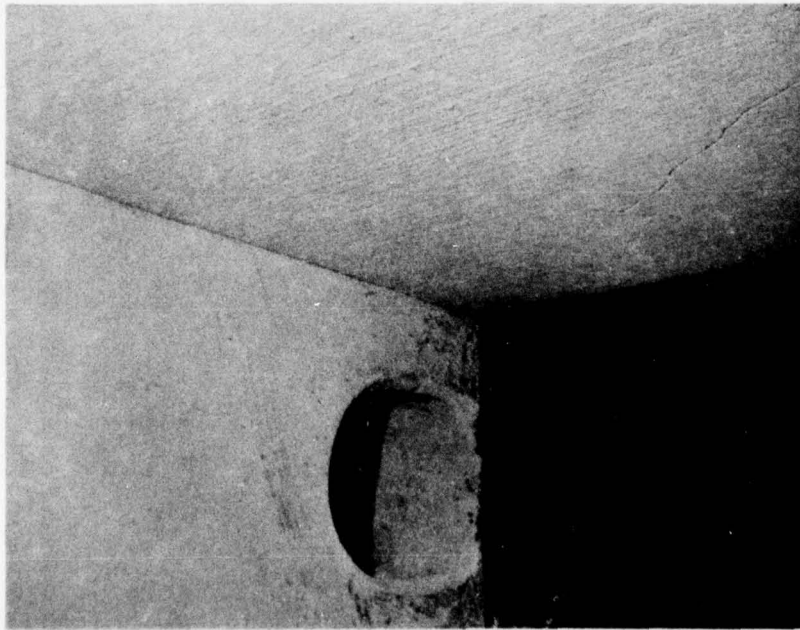
Figure 35. Jade Pak on Rear Wall of Sewage Chamber After Curing

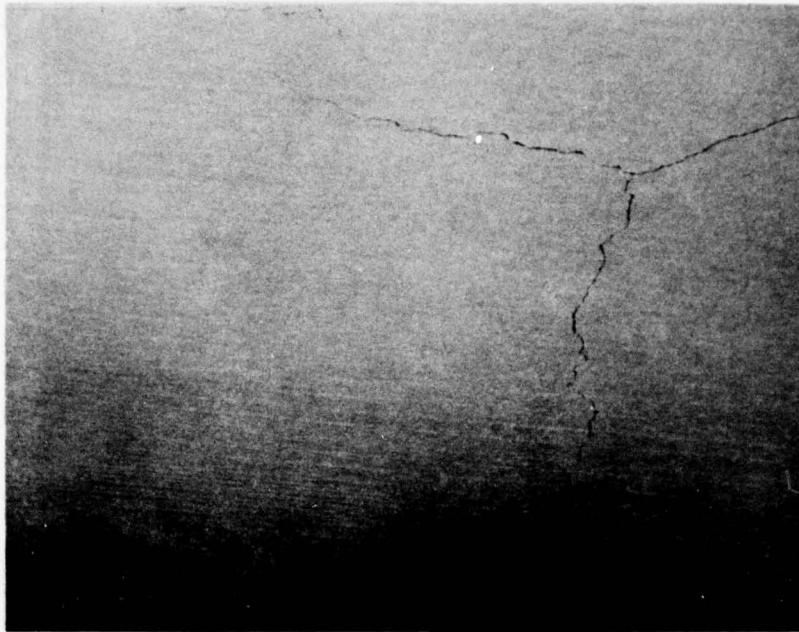
Figure 36. Sewage Chamber Roof Panel After Curing
