HONEYWELL INC ST PETERSBURG FLA
LIMS. LASER INERTIAL MEASUREMENT SYSTEM.(U)
JUL 78

LINS. Laser Inertial Measurement System.

FINAL TECHNICAL REPORT,

July 1978

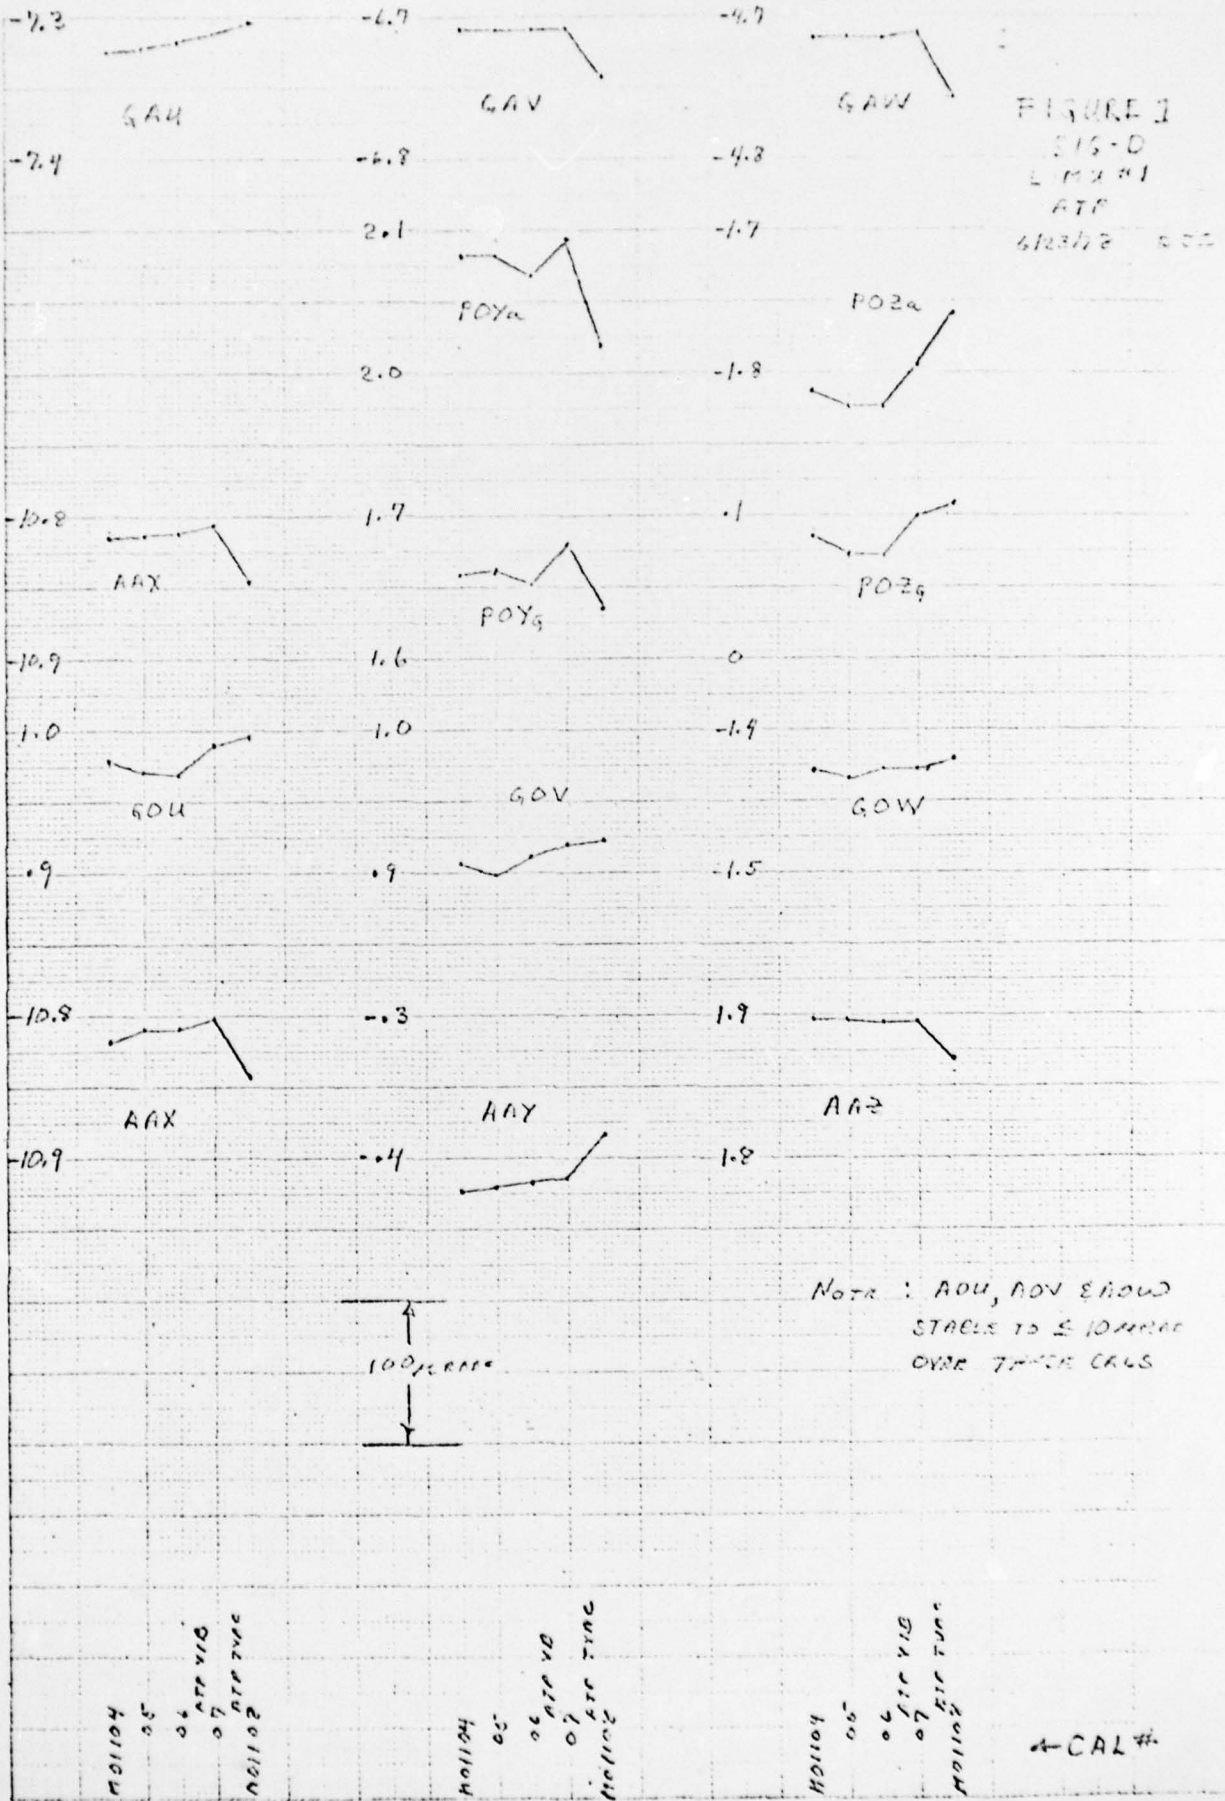
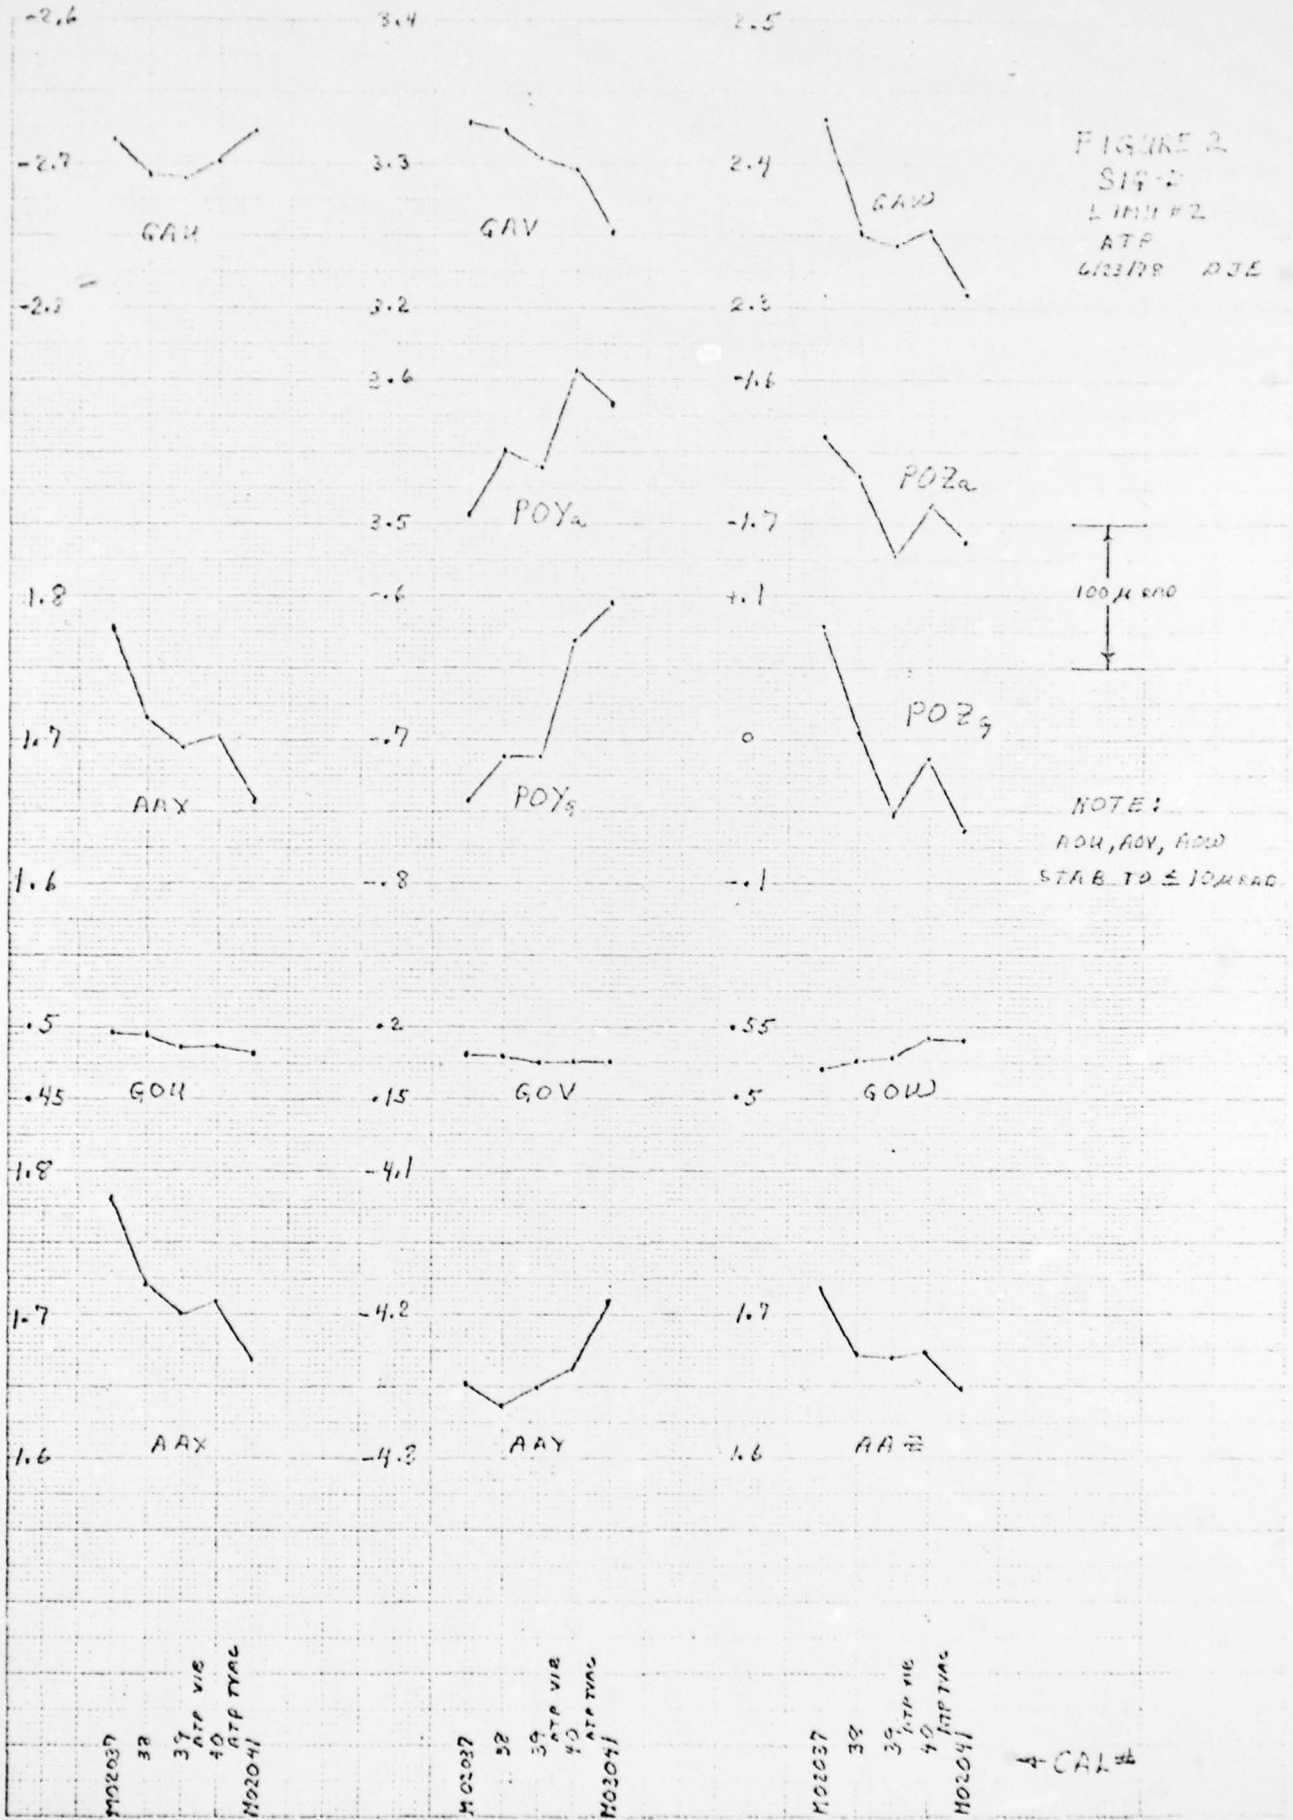
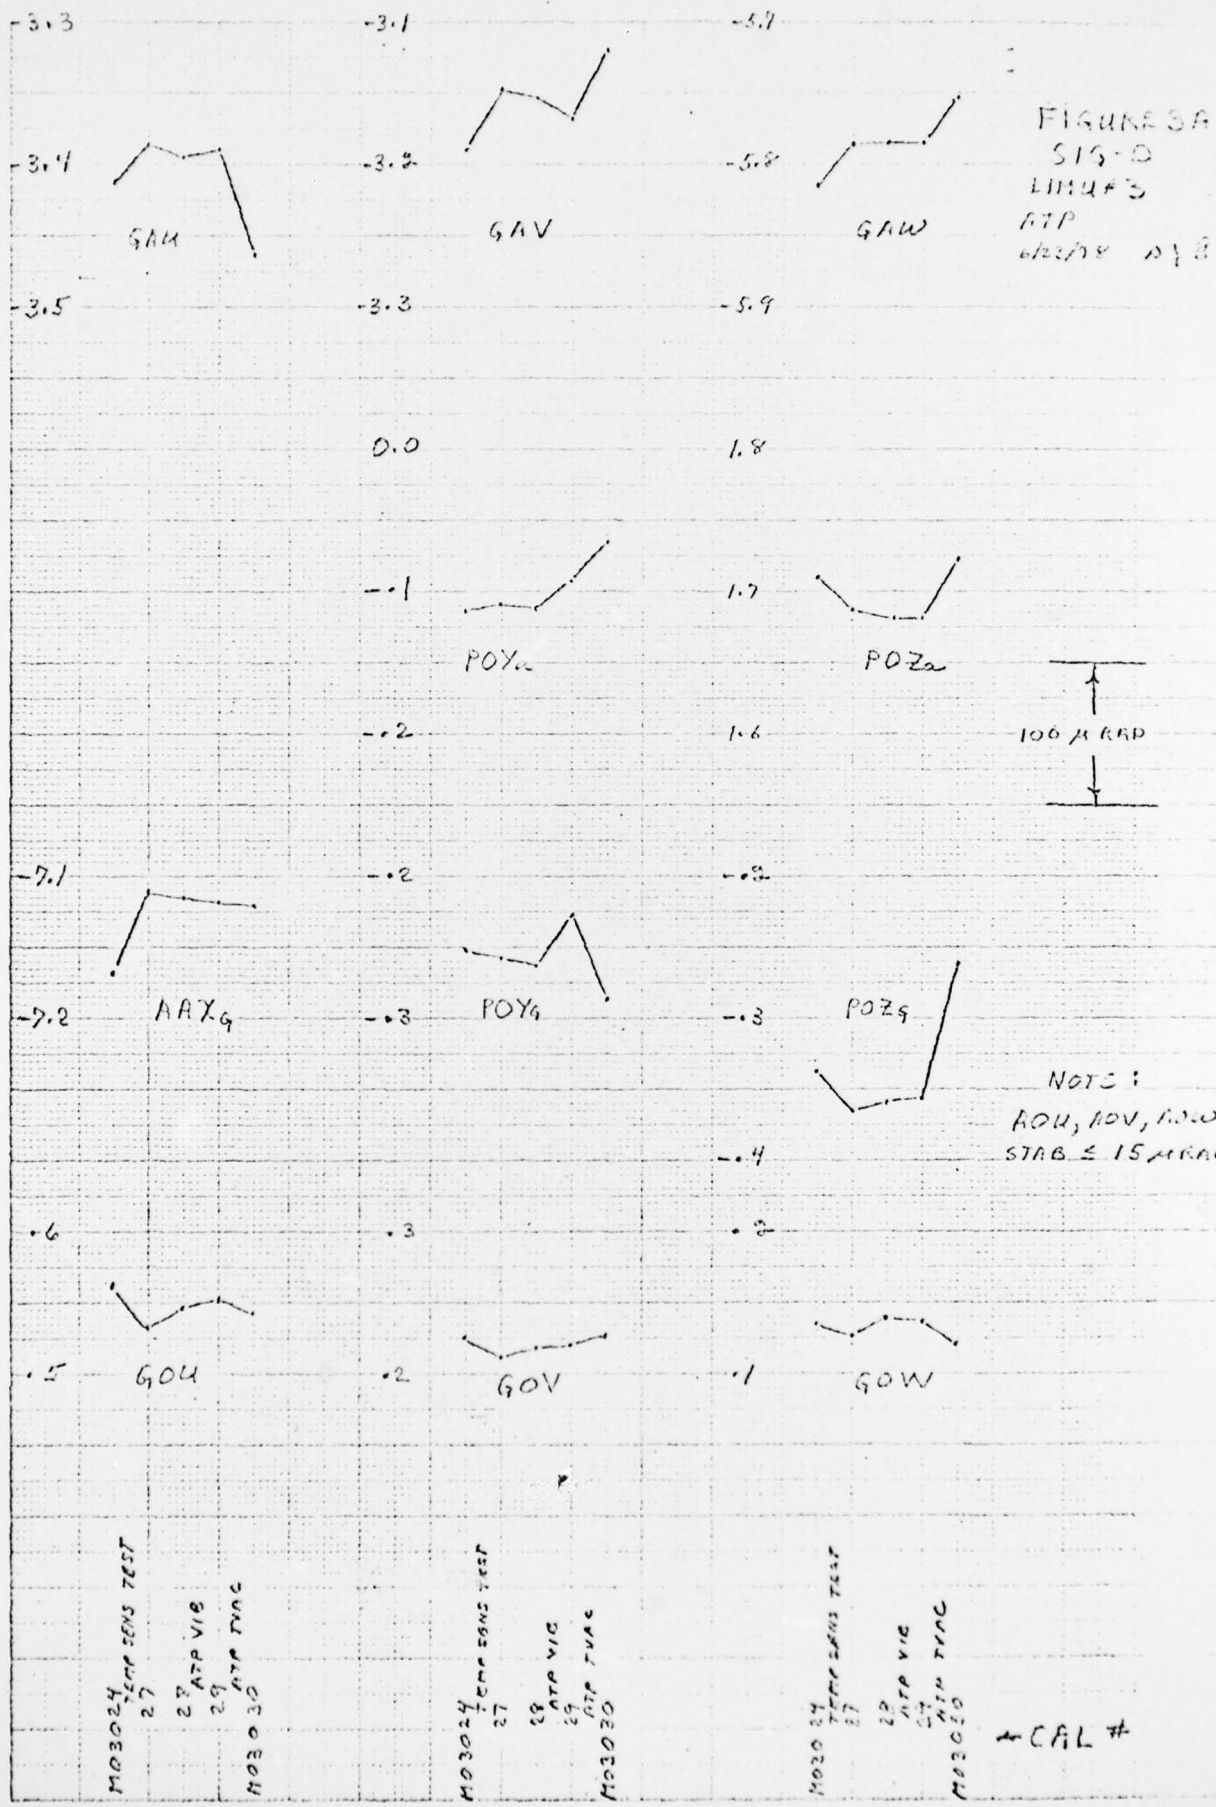
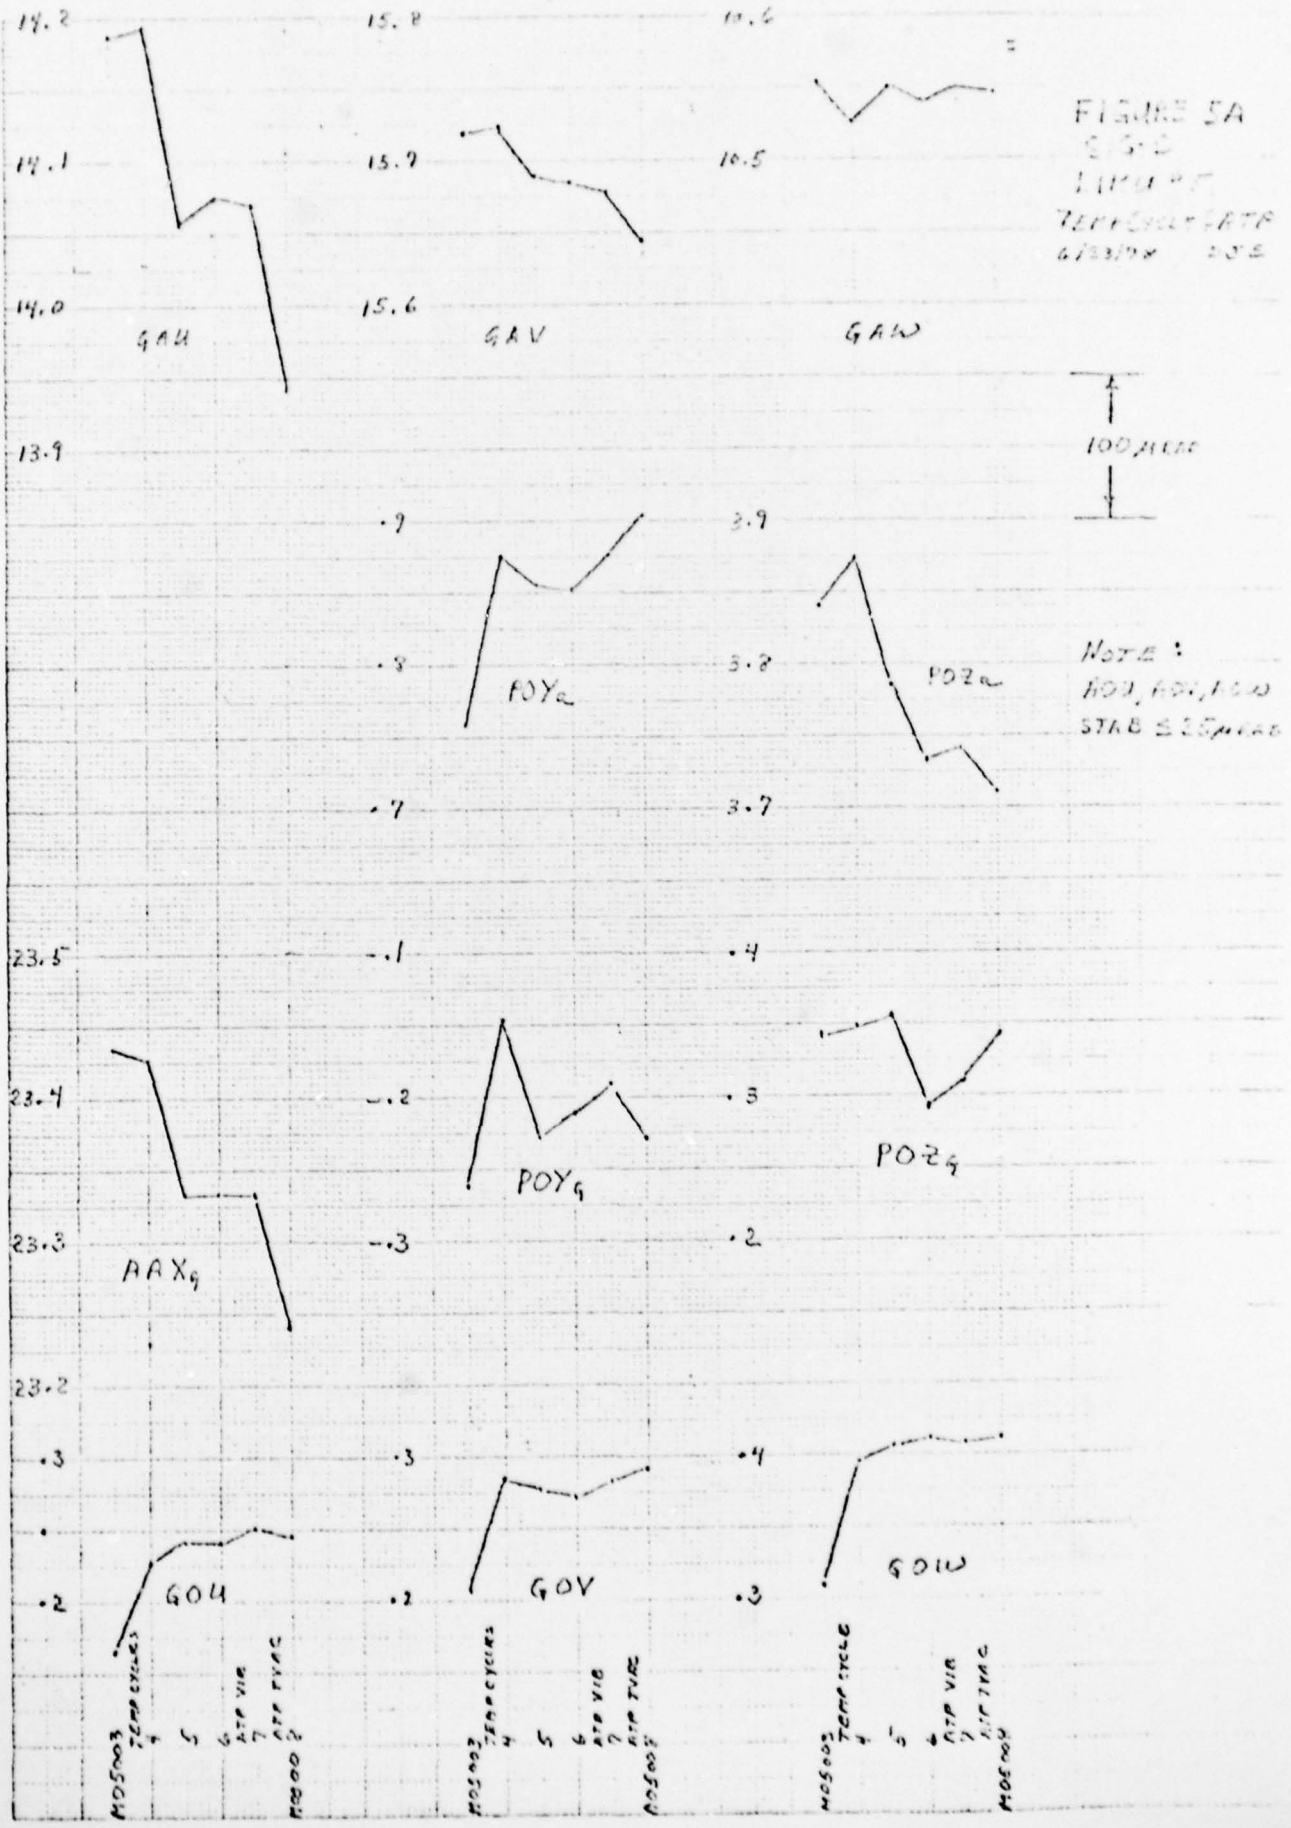
Description - The stability of the alignment of the porro prism with respect to the accelerometer triad, exceeded the 100 micro-radian ATP requirement during acceptance testing of LIMU #4 and LIMU #5. Supporting data is provided in paragraph G of this report.

Figures 1 through 5 were derived from Acceptance Test Calibrations and are relative to the discussion of problem #8 in paragraph B of this report. The acronyms used on these graphs are as follows

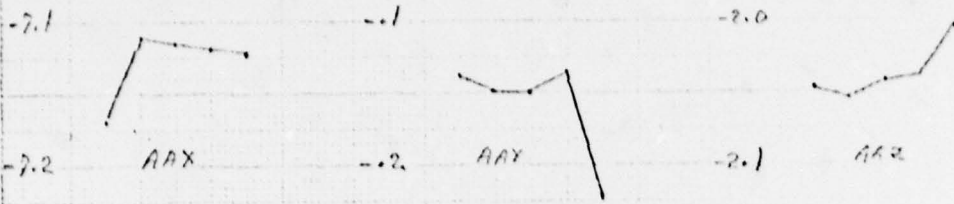
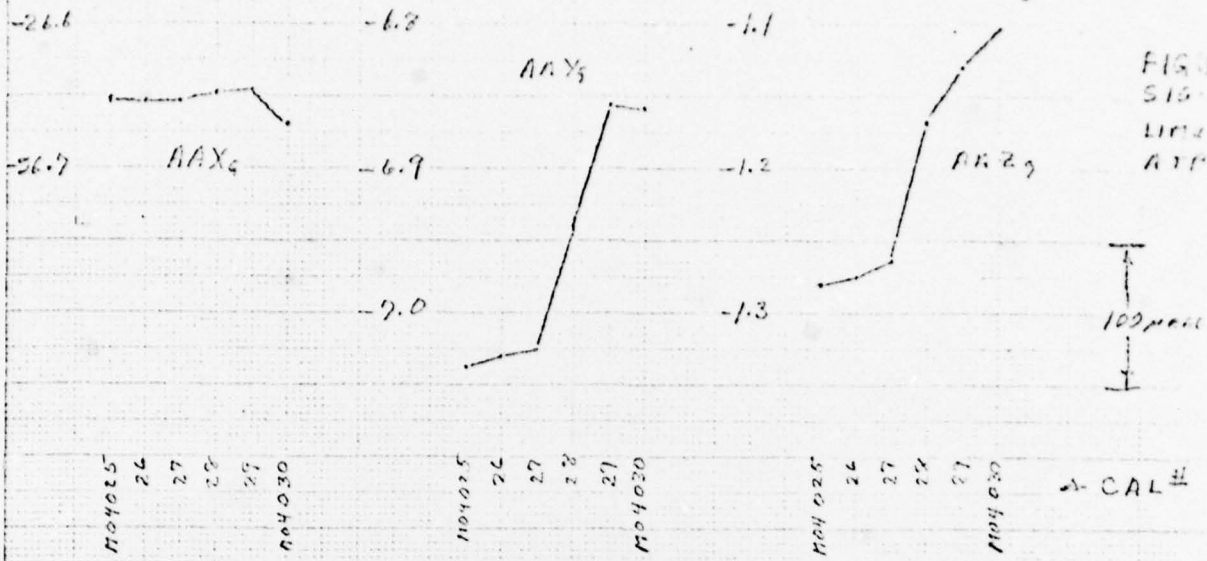
FIGURE 3B

One source of instability was determined to be due to the relaxation of stresses induced during the assembly process. A second source of instability was determined to be porro prism movement as a function of Gyro Triad chassis temperature with a scale factor of approximately $1 \text{ sec}/^\circ\text{F}$. This movement is a result of a bi-metallic effect of the stainless steel prism mounting base in conjunction with the aluminum Gyro Triad chassis. When the LIMU is calibrated in a room ambient of approximately 75°F , the Gyro Triad chassis temperature stabilizes at approximately 115°F . From a cold start, the stabilization time is approximately 3 hours, but at 2 hours the temperature is within 5°F of the stabilized temperature. Optical prism readings taken prior to reaching the stabilized state were therefore divergent from those taken after stabilizing.

Solutions: To overcome instabilities due to relaxation of stresses a procedure was implemented to force the relaxation by performing a minimum of three thermal cycles from -45°F to $+145^{\circ}\text{F}$ on the ISA assembly. These thermal cycles were accomplished on new build, after a gyro removal and installation and after the accelerometer triad was removed and installed.
