AD-A074 323

NEW JERSEY DEPT OF ENVIRONMENTAL PROTECTION TRENTON  
NATIONAL DAM SAFETY PROGRAM. AMPHIBIOUS LAKE DAM (NJ 00457), DE--ETC(U)  
JUN 79 J J WILLIAMS

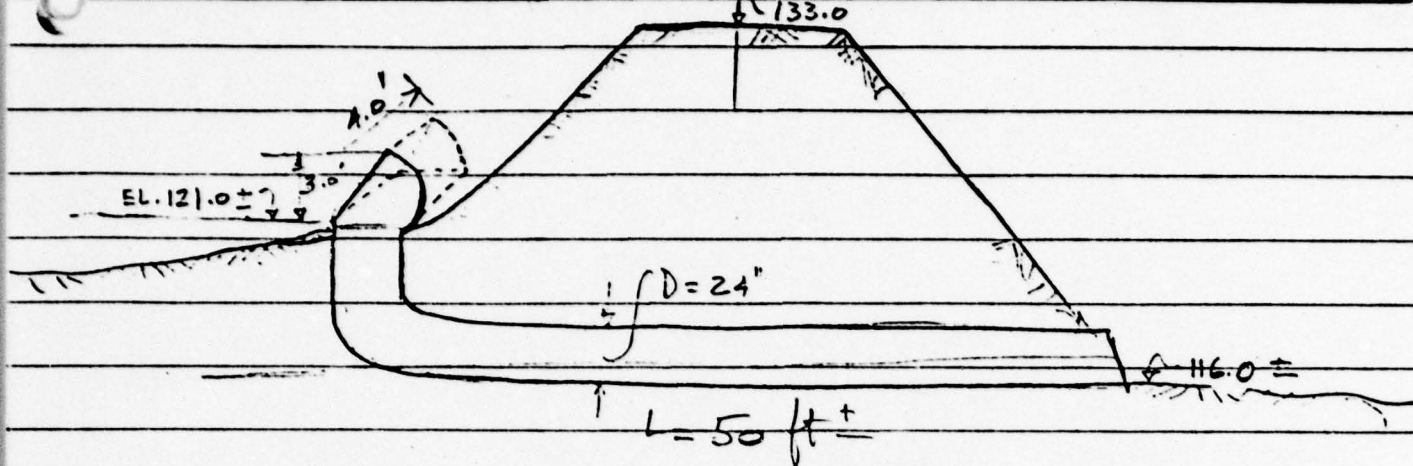
I CREST DISCHARGE (CONDITION I)

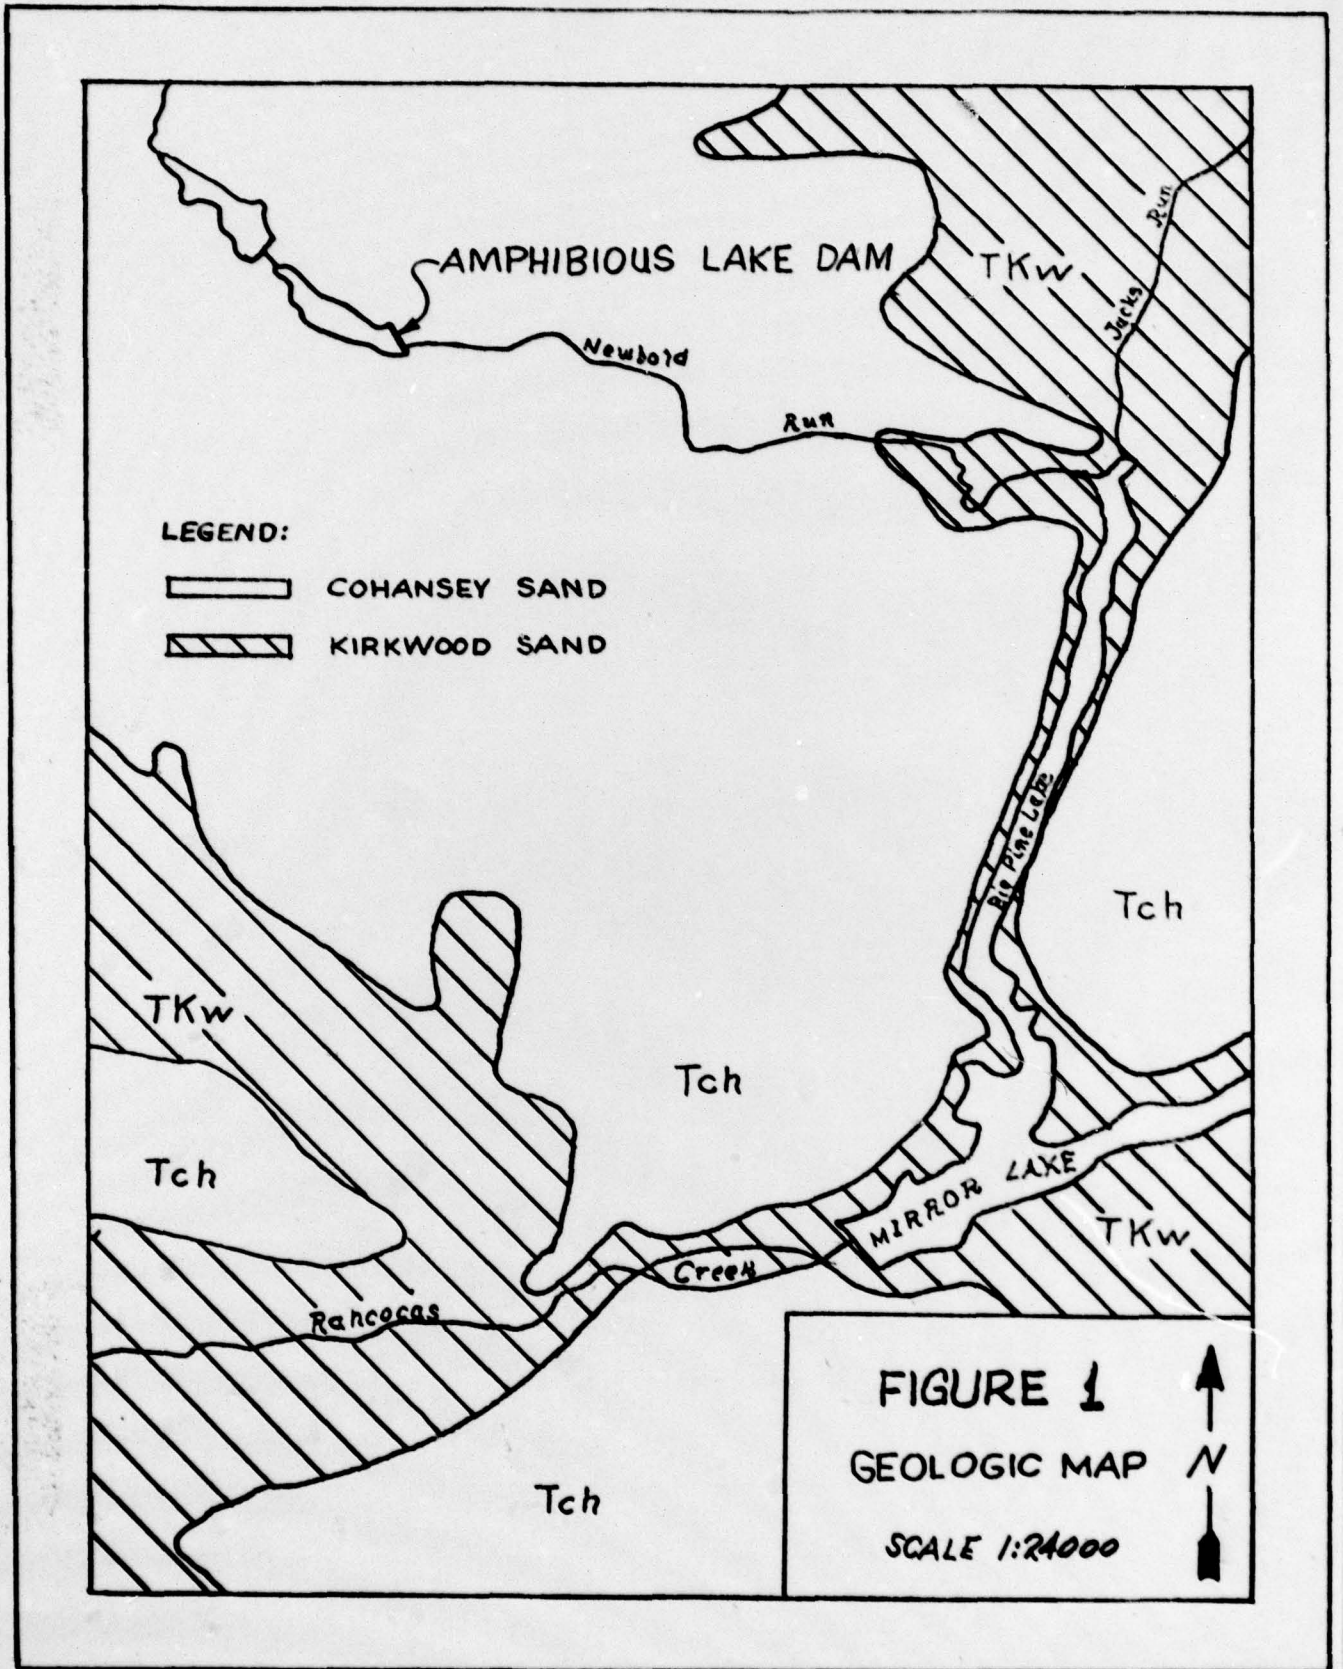
Amphibious Lake is located in the Coastal Plain physiographic province which is composed of unconsolidated sedimentary deposits. These beds form a wedge-shaped mass that is exposed at the fall line and thickens in a southeasterly direction towards the Atlantic Ocean. The surficial deposit at the dam site is a bed of tertiary sands called the Cahanse formation. No faults or major structural defects are noted in the vicinity of the dam or lake.
