✓ **NRL Memorandum Report 4062**  
✓ **NUREG/CR-0968**

**Fractographic and Microstructural Analysis of  
Fatigue Specimens of A302 Grade B Steel  
Tested in Air at Room Temperature**

**G. GABETTA AND V. PROVENZANO**

September 28, 1979

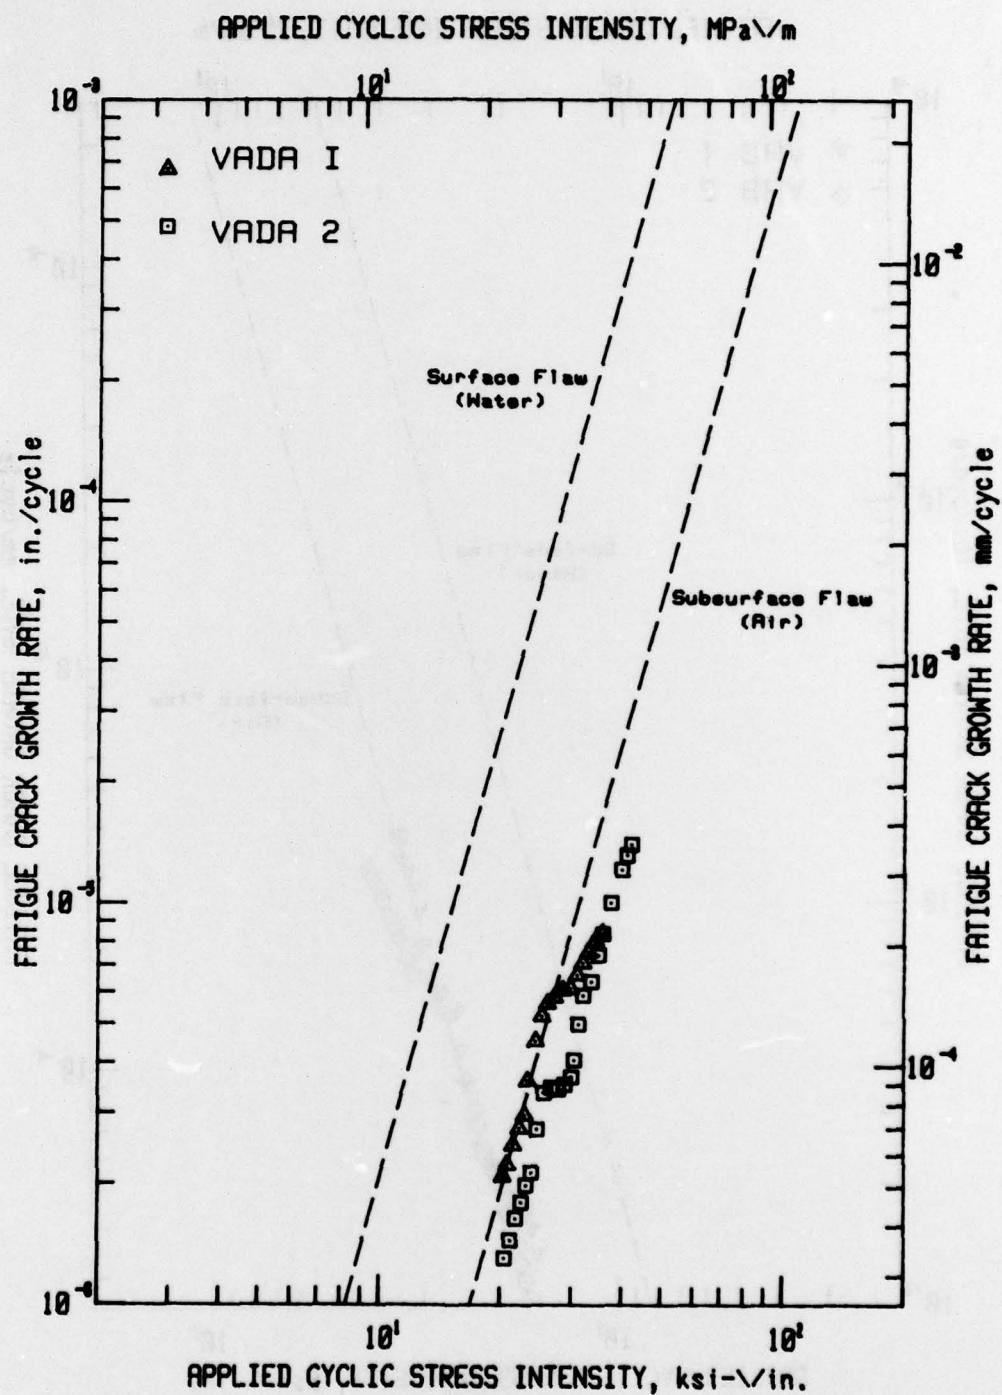
The FCP data obtained from the specimen tests are presented in Figs. 2 and 3. As shown by both figures, all of the crack growth data fell close to the ASME Section XI air line. The crack growth rates for the first set of specimens (Specimen VADA1, cut in the T-L direction, and Specimen VADA2, cut in the L-T direction) ran roughly parallel to each other for most of the  $\Delta K$  range, with the T-L specimen (VADA1) exhibiting the higher crack growth rate (Fig. 2). The crack growth rates for the second set of specimens (VAB1, cut in the T-L direction, and VAB2, cut in the L-T direction) were about equal for  $\Delta K$  values below 33 MPa $\sqrt{m}$  (30 ksi  $\sqrt{in.}$ ). Above this  $\Delta K$  value, the crack growth rate of the T-L specimen

Fig. 2 Fatigue crack propagation data of A302-B ferritic steel tested in air at room temperature both for the T-L (VADA1) and L-T (VADA2) directions with the higher starting  $\Delta K$  value ( $22 \text{ MPa}\sqrt{\text{m}}$ ).

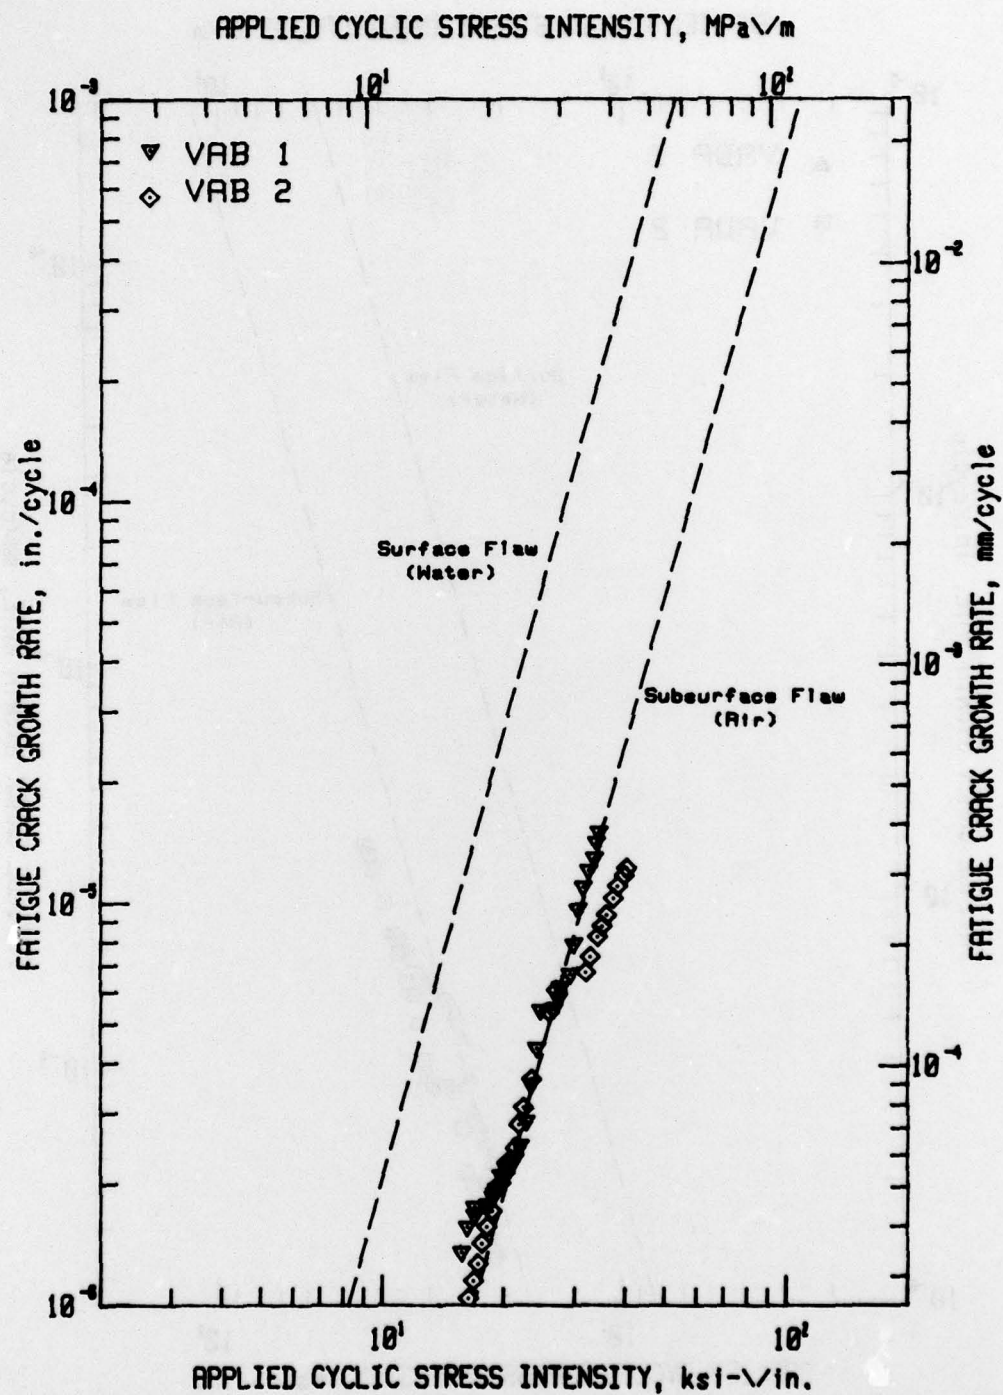
(VAB1) was higher (Fig. 3). The difference in the crack growth behavior in the two sets of specimens was not large. It is interesting to point out however, that a lower starting  $\Delta K$  resulted in a higher growth rate (the starting  $\Delta K$  for VAB1 and VAB2 was  $16.5 \text{ MPa}\sqrt{\text{m}}$  while for VADA1 and VADA2 it was  $22 \text{ MPa}\sqrt{\text{m}}$ ). Since the basic objective of the mechanical tests was to investigate the effect of specimen orientation on the fatigue behavior the effect of starting  $\Delta K$  on FCP will not be critically evaluated in this report.

Fig. 3 Fatigue crack propagation data of A302-B ferritic steel tested in air at room temperature both for the T-L (VAB1) and L-T (VAB2) directions with the lower starting  $\Delta K$  value (16.5 MPa√m).

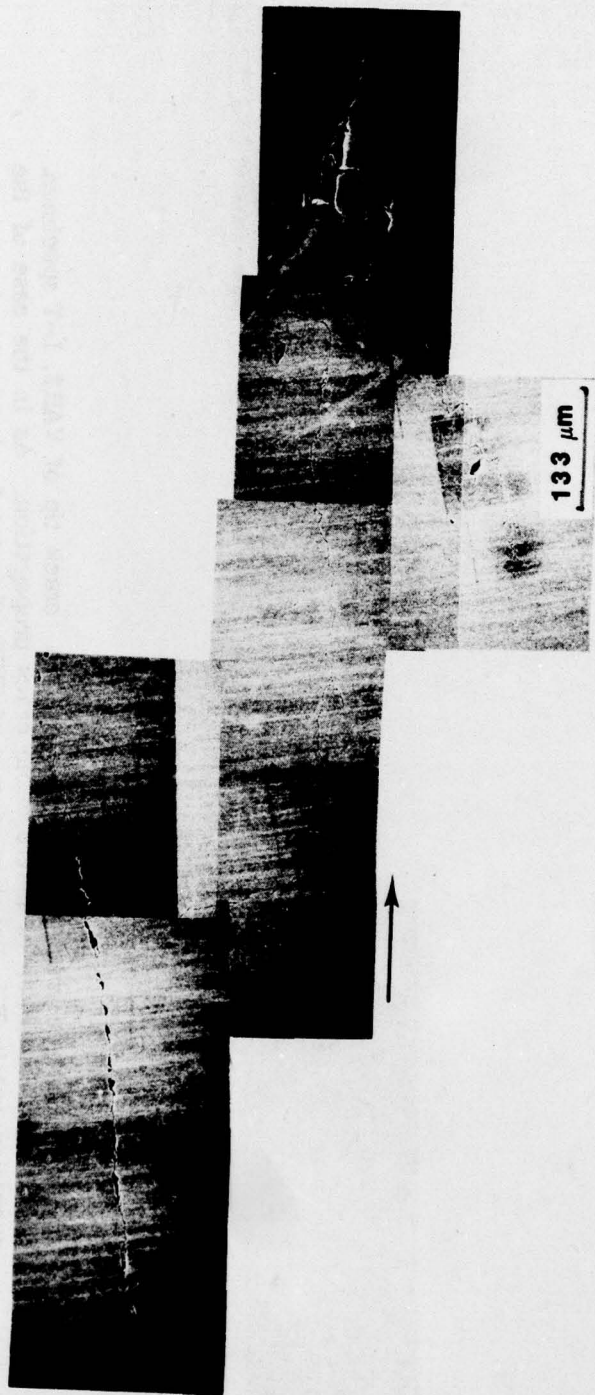
The relationships between the crack path and the microstructure are illustrated by the photomicrographs shown in Figs. 4 and 5. The photomicrographs in Fig. 4 refer to specimen VAB1 (T-L) while the micrographs presented in Fig. 5 refer to specimen VAB2 (L-T). The two crack profiles show that extensive crack branching is present in both specimens. The degree of crack branching, as indicated by the secondary cracks, becomes more pronounced in the high  $\Delta K$  region. In the region of high  $\Delta K$ , where the crack propagation rate is higher, the microcracks associated with crack branching are smaller in size and required a higher magnification to reveal their presence. The reduction in the average size of the microcracks in the high  $\Delta K$  regime did not appear to have affected the crack propagation behavior. Crack branching usually has the effect of slowing the crack propagation rate by distributing the stresses at the crack tip; this did not seem to have been the case in these two specimens.

Fig. 4 Fatigue crack profile close to the crack tip of VAB1, T-L specimen. Arrow indicates direction of macroscopic crack propagation. Series of SEM micrographs show extensive microbranching near crack tip region; some branching runs perpendicular to main crack path.

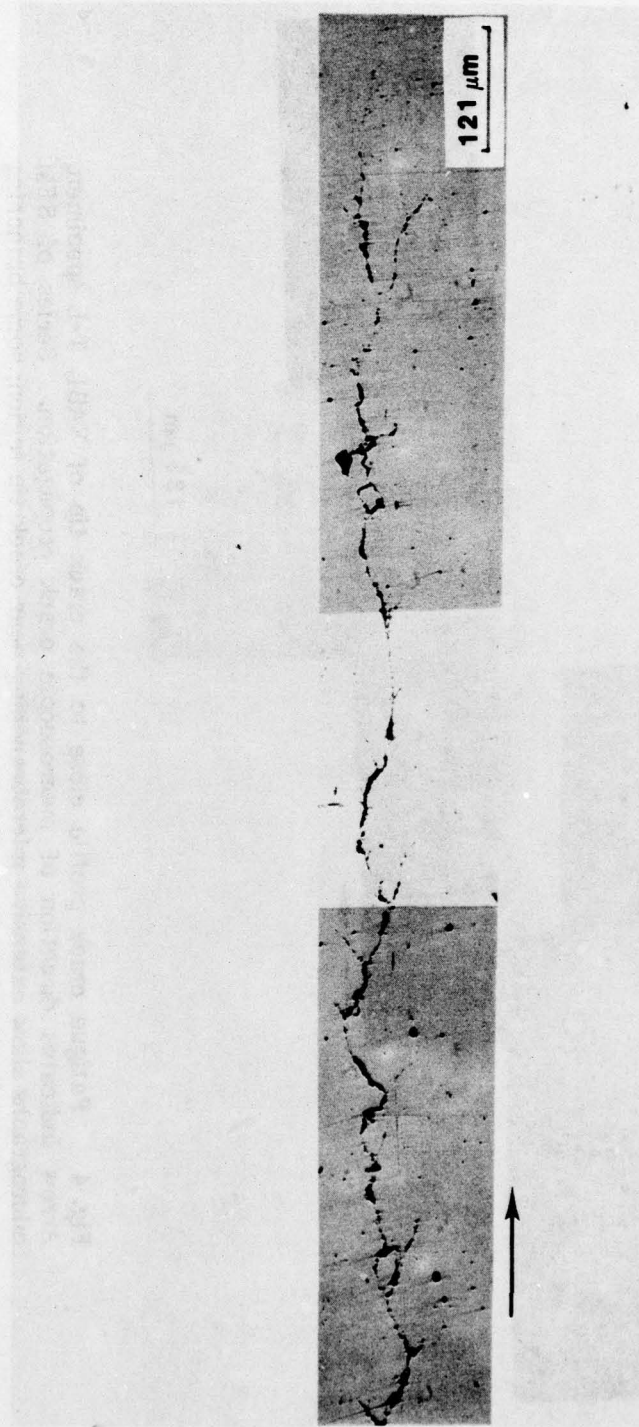
Fig 5 Fatigue crack profile close to the crack tip of VAB2, L-T specimen. Arrow show direction of macroscopic crack propagation. As in the case of the specimen cut in T-L direction, series of SEM micrographs show extensive micro-branching along the main crack path.

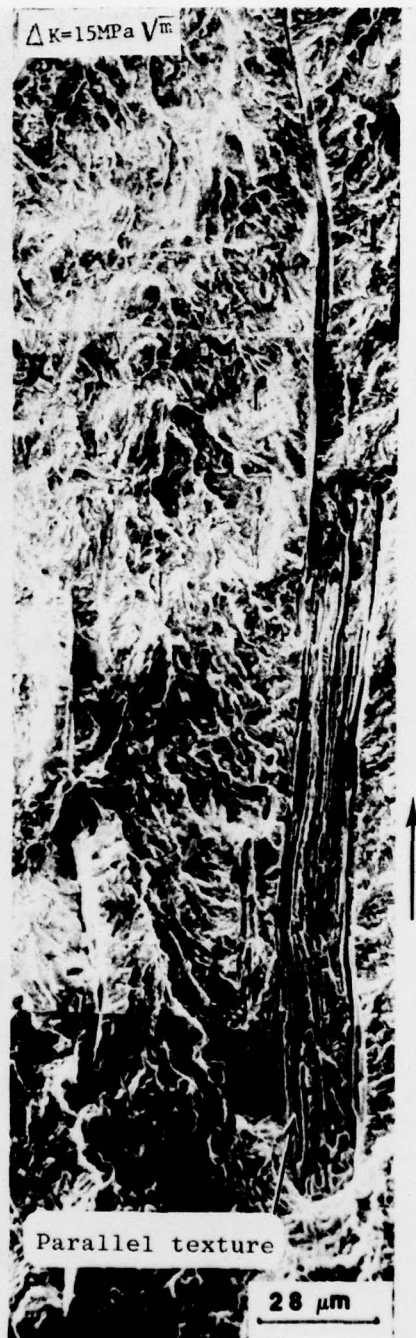
The significant fractographic features observed in the SEM examinations of fracture surfaces are summarized by the micrographs presented in Figs. 6-8. In the T-L specimen (VADA1), a microstructural texture running parallel to the macroscopic crack propagation direction is present (Fig. 6). In the second set of tests the T-L specimen (VAB1) shows an increase in the crack growth rate at  $\Delta K$  values of  $25\text{--}30 \text{ MPa}\sqrt{\text{m}}$  (Fig. 3) that coincides with the appearance of the parallel texture in the fracture surface (Fig. 7). In the L-T specimen (VAB2), whose corresponding crack growth rate was lower, the parallel texture was absent. The failure mode for T-L specimen was transgranular with secondary cracking perpendicular to the macroscopic crack propagation direction (Fig. 8). Similar fractographic features have been observed in other ferritic steels tested under analogous experimental conditions [5,6].

Fig. 6 Fracture surface of A302-B ferritic steel specimen cut along T-L direction (VADAl) tested in air at room temperature with higher starting  $\Delta K$  value. Arrow shows direction of macroscopic crack propagation. SEM micrographs clearly show inclusion bands in the fracture surface that run parallel to the macroscopic crack propagation direction.

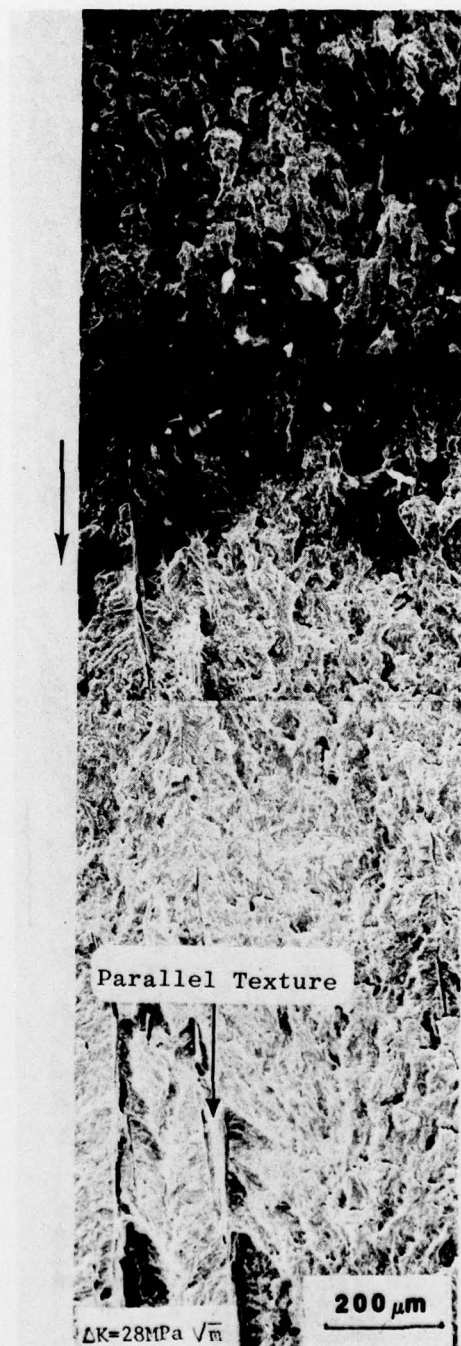
As observed above, the fracture surface of T-L specimen (VAB1) is characterized by a parallel texture when  $\Delta K$  exceeds a minimum value in the range of  $25\text{--}30 \text{ MPa}\sqrt{\text{m}}$ . This texture is thought to arise from inclusion bands that are present in the rolled material. These inclusions became elongated during the rolling procedure. To see if the parallel texture is indeed the result of the inclusion bands, the fracture surface was analyzed with an X-ray microanalyzer that is attached to an AMR 1000 scanning electron microscope. The results of the X-ray microanalysis are summarized in Fig. 9. The analysis confirms that the parallel features were manganese-sulfide inclusion bands.

**Fig. 7** Fracture surface of A302-B ferritic steel specimen cut along T-L direction (VAB1), tested in air at room temperature with the lower starting  $\Delta K$  value. Arrow shows direction of macroscopic crack propagation. Series of SEM micrographs show transition region corresponding to 25-30  $\text{MPa}\sqrt{\text{m}}$   $\Delta K$  value, where inclusion bands begin to appear in fracture surface.

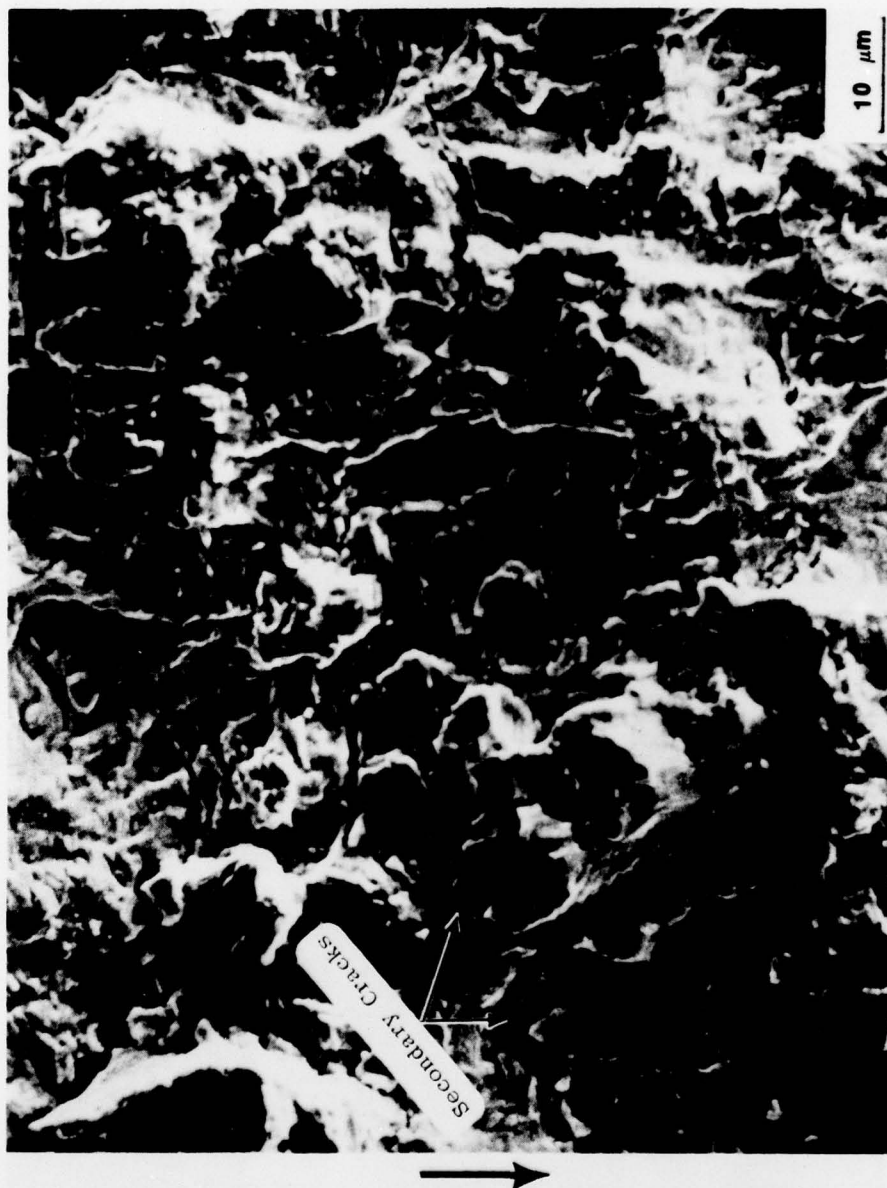
Fig. 8 Fracture surface of A302-B ferritic steel specimen cut along the L-T direction (VADA2), tested in air at room temperature with higher starting K value. Arrow shows direction of macroscopic crack propagation. SEM micrographs illustrate transgranular failure mode with fatigue striations and extensive secondary cracking perpendicular to main crack path. These fractographic features are typical of ferritic steels tested under analogous conditions.

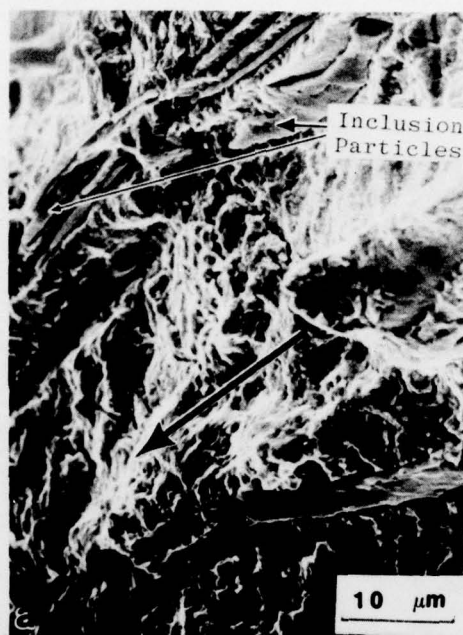
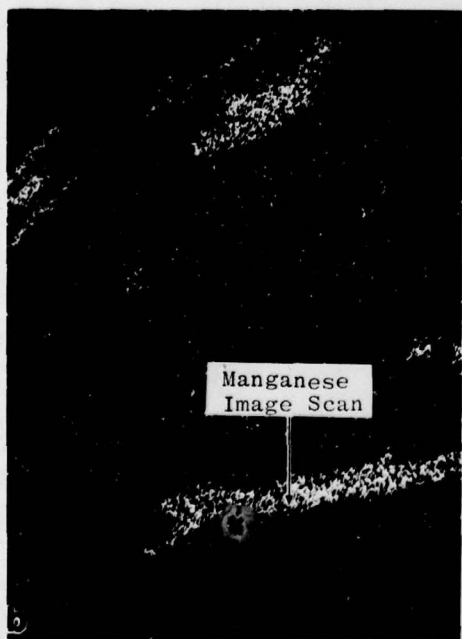
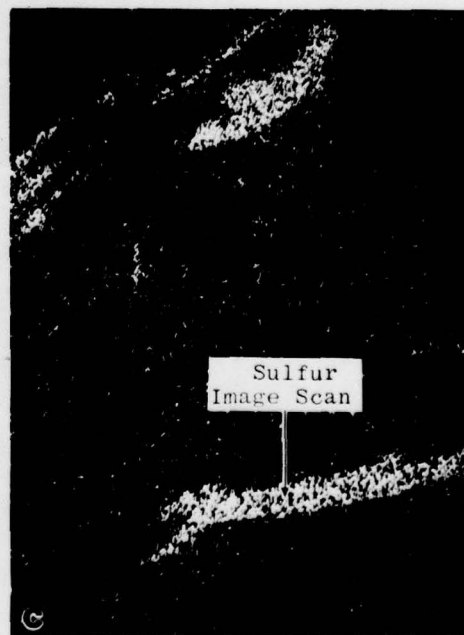
It appears, therefore, that inclusion bands are the primary cause for the increase in the crack growth rate above a minimum  $\Delta K$  value. It is believed that a preferential decohesion process occurs at the inclusion-matrix interface, which become activated above some threshold stress level and resulted in higher crack growth rates. This threshold stress is probably a measure of the bond strength between the inclusion and the material matrix. The inclusion effect is directional,

**Fig. 9** Fracture surface and corresponding energy dispersive X-ray point maps of A302-B ferritic steel specimen cut along T-L direction (VAB1). Arrow shows macroscopic crack propagation direction. SEM micrograph on top of the figure (micrograph a) clearly shows inclusion bands in the fracture surface that run parallel to the macroscopic crack propagation direction. Lower two micrographs are image scans obtained through energy dispersive X-ray microanalysis showing that inclusion bands are manganese (left) and sulfur (right) second-phase particles.

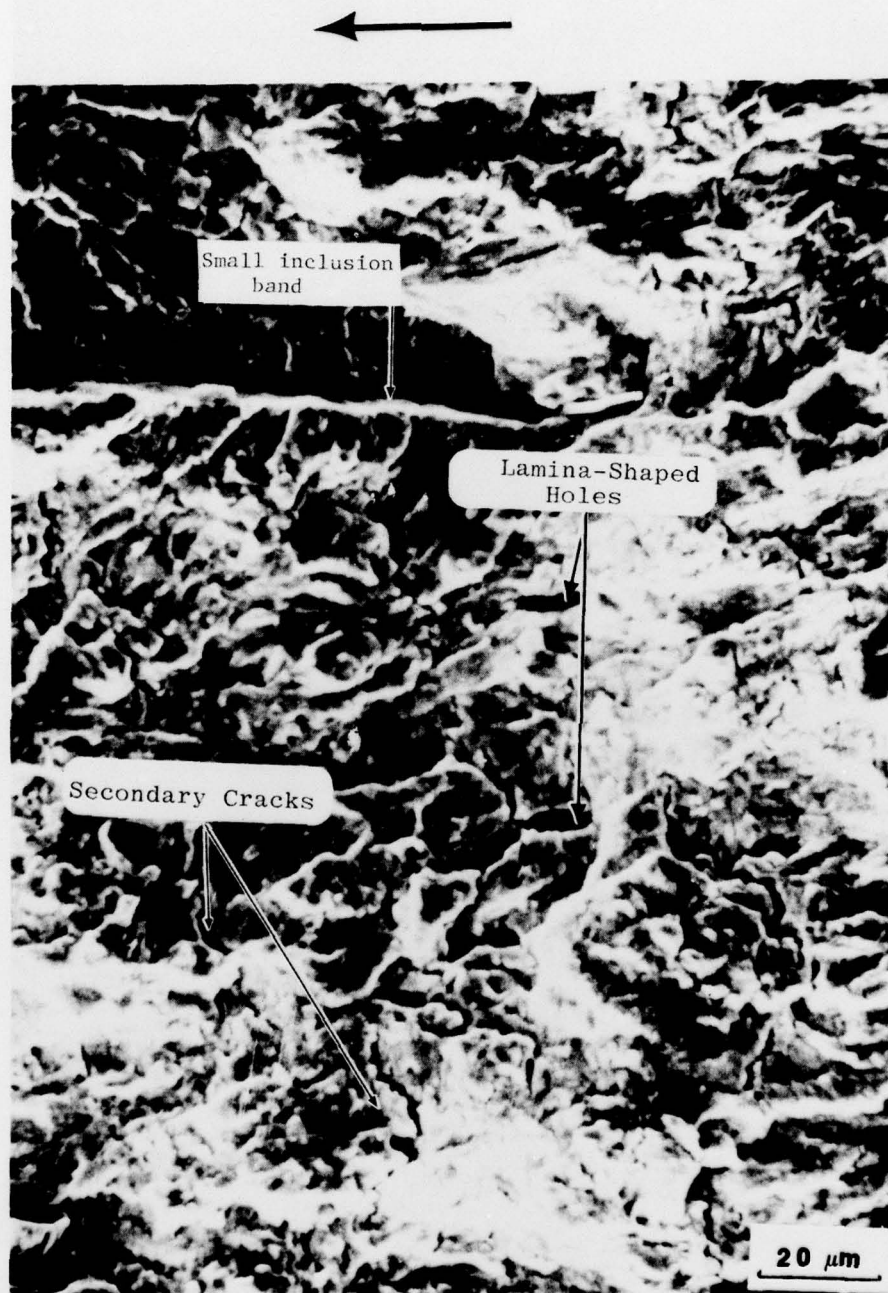
The SEM micrograph shown in Fig. 10 typifies the fractographic features observed in the L-T specimens (VADA2 and VAB2). As illustrated by the micrograph, only a small inclusion band was present though some lamina-shaped holes were seen. These holes are believed to represent the inclusion bands that are oriented perpendicular to the crack plane. Since most of the inclusion bands in the L-T specimens are preferentially oriented perpendicular to the main crack path, the few bands that resided along the crack plane did not seem to have had an affect on crack propagation behavior.

Fig. 10 Fracture surface of A302-B ferritic steel specimen cut along L-T direction (VADA2) tested in air at room temperature. Arrow shows direction of macroscopic crack propagation. SEM micrograph shows small inclusions and lamina-shaped holes present in the fracture surface. The lamina-shaped holes are believed to represent the inclusion bands that are oriented perpendicular to main crack plane.
