MISCELLANEOUS PAPER GL-80-17

TRAFFIC SLOPE TESTS OF MILITARY INVENTORY ITEMS AND THEIR EFFECTIVENESS IN RIVERINE EGRESS TESTS

November 1980
Final Report

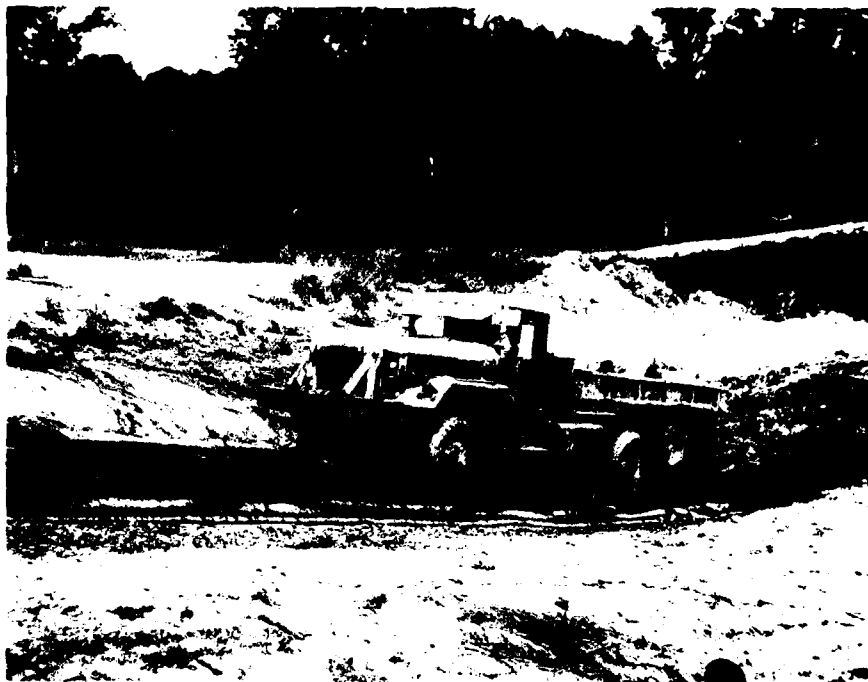
e. M54 truck attempting to negotiate a wet 25 percent membrane-covered slope with a wet clay layer at toe of slope

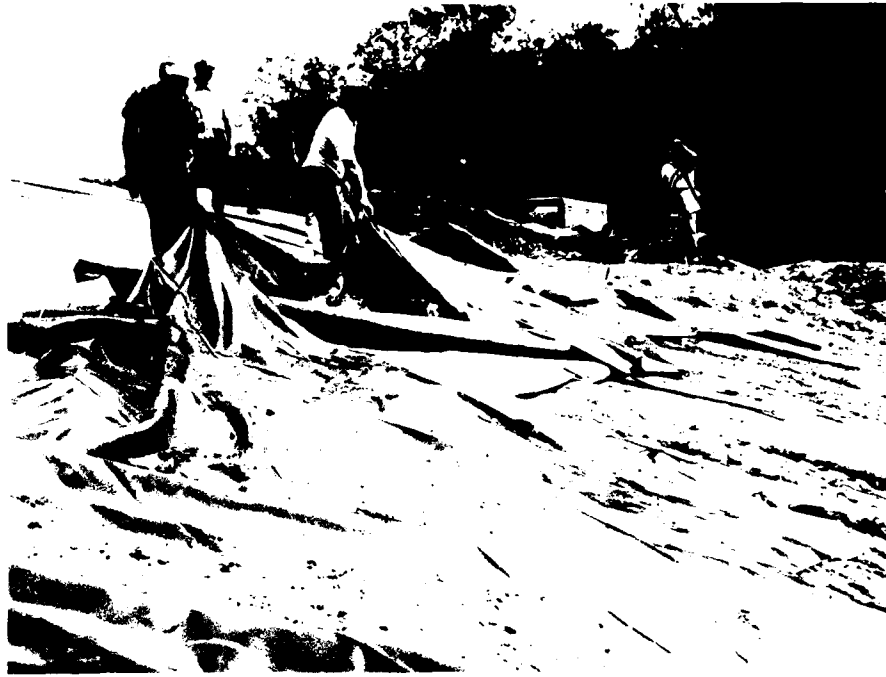
k. Damaged membrane shredded at water's edge by spinning tracks of vehicle

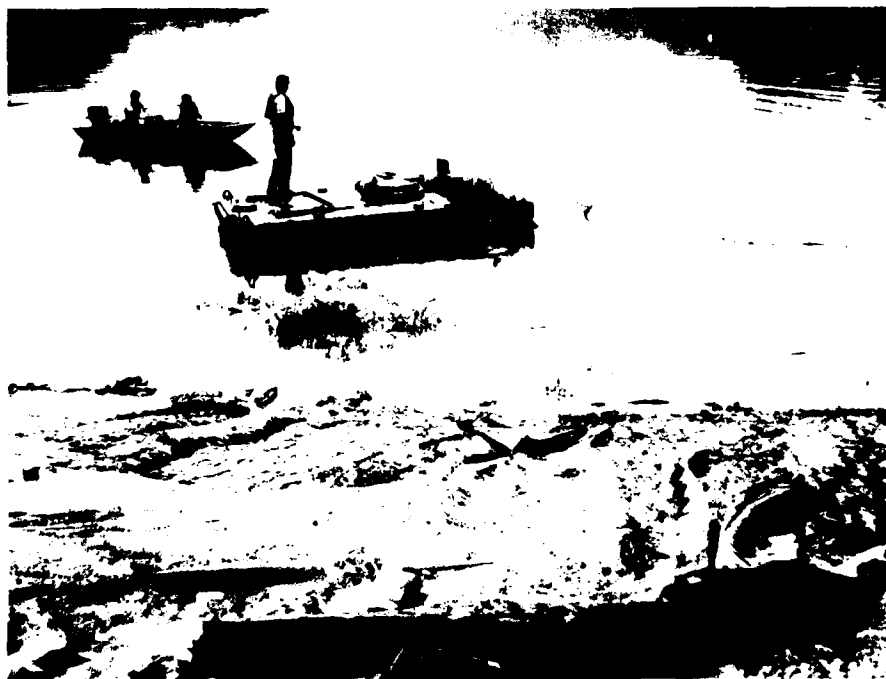
exited the water, the reason for immobilization was readily apparent. Some six to eight wraps of T17 membrane had been pulled around the sprocket between the sprocket and tracks. The rolled membrane thickness had forced the track away from the sprocket, thereby immobilizing the vehicle (Photos 6g-6n). In addition, one of the cables used to anchor the sandbags was entangled in the track. The exact cause of the entanglement, however, could not be determined. After the M113 APC was repaired, several unsuccessful attempts were made to exit the lake up the 25 percent slope (Photos 6o-6r). However, the M113 APC could only exit the lake at the prepared ramp (Photo 6s) where the slope was less than 15 percent.

l. Vehicle immobilized by membrane entangled in track system

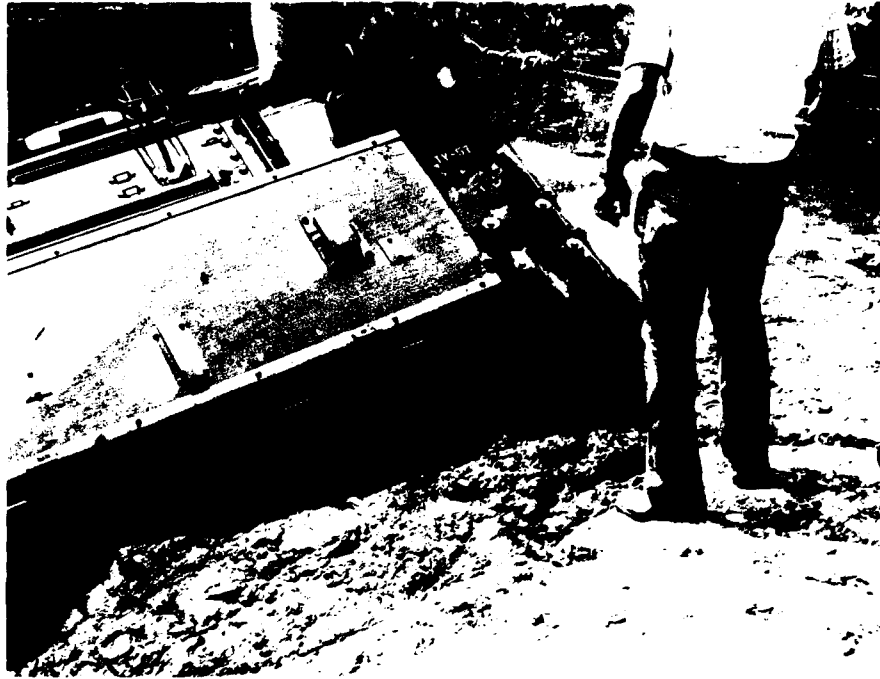
m. Vehicle being pulled from lake, showing damage to left sprocket

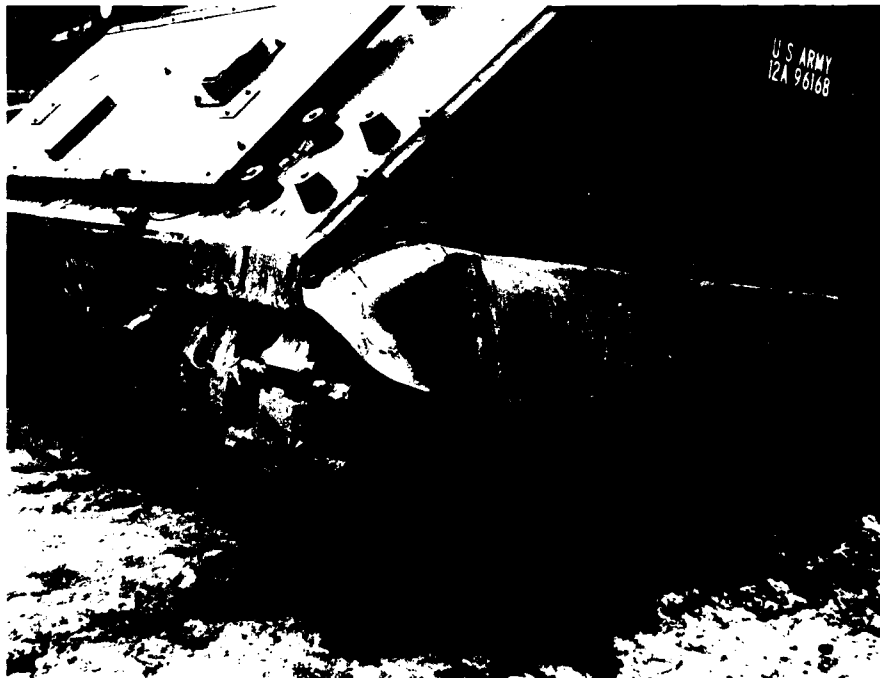
n. Membrane entangled in left sprocket (note steel anchor cable in sprocket, which may have caused initial entanglement)

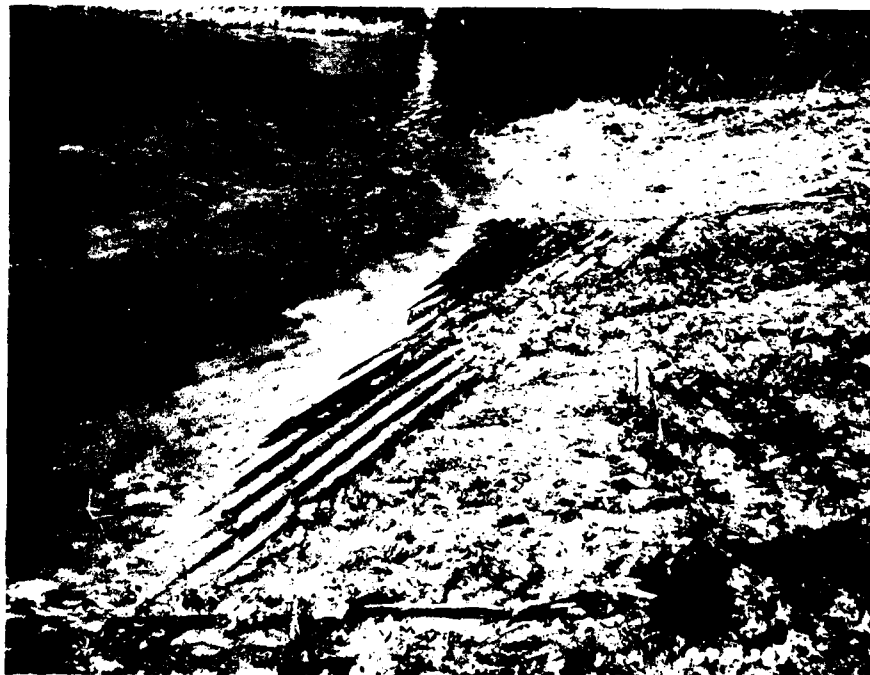
d. Mat sections and anchors pulled toward lake and skewed by tractive elements of the M113 APC

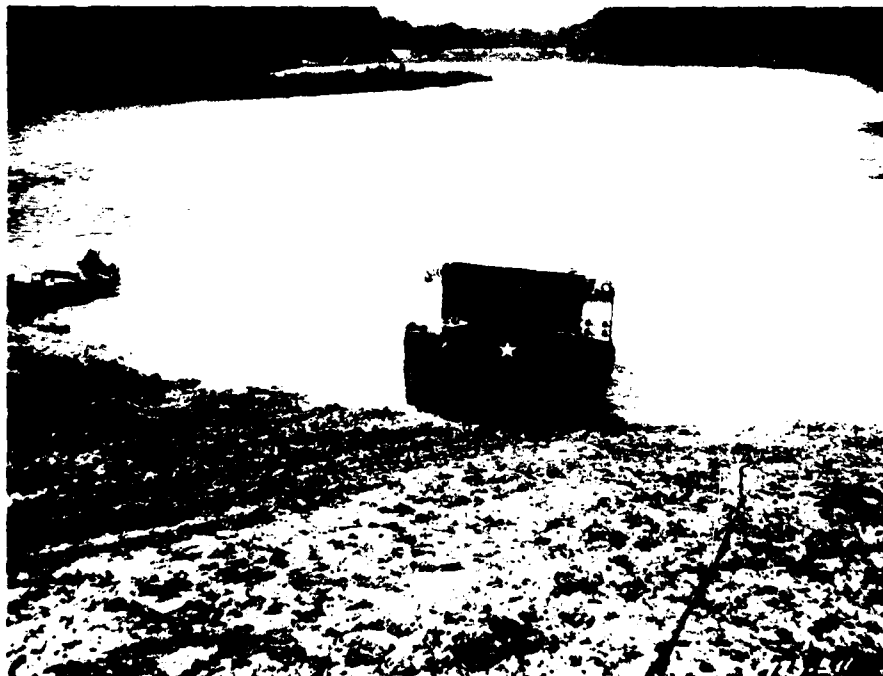
f. M113 APC spinning on mat at water's edge

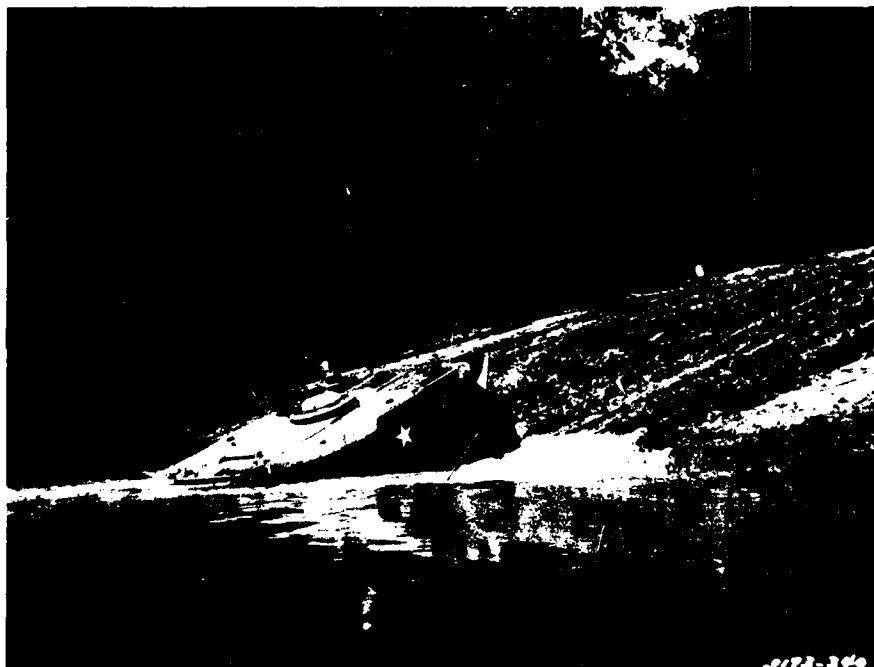
n. Another unsuccessful vehicle test on right-side-up mat

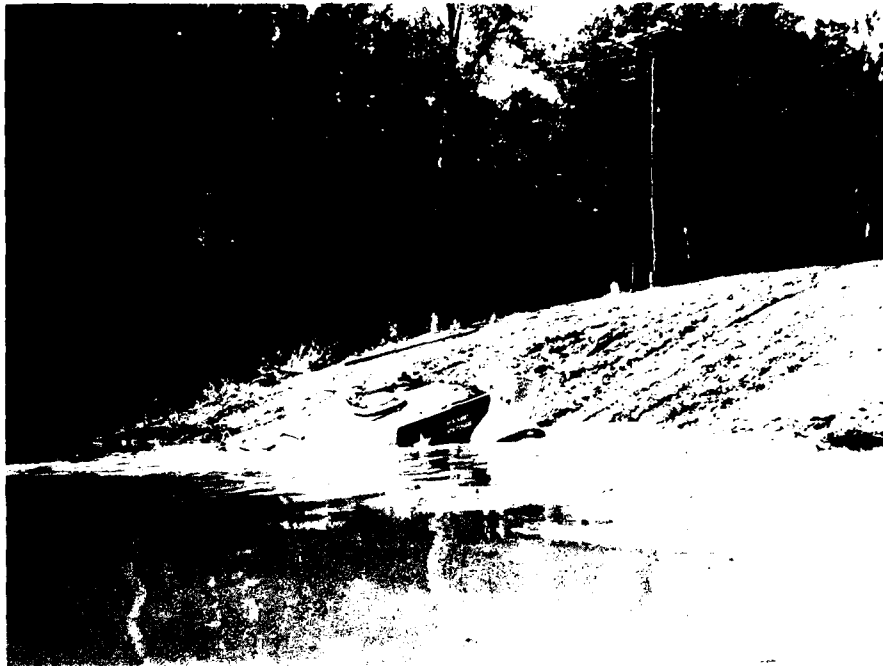
o. Vehicle sliding sideways on right-side-up mat

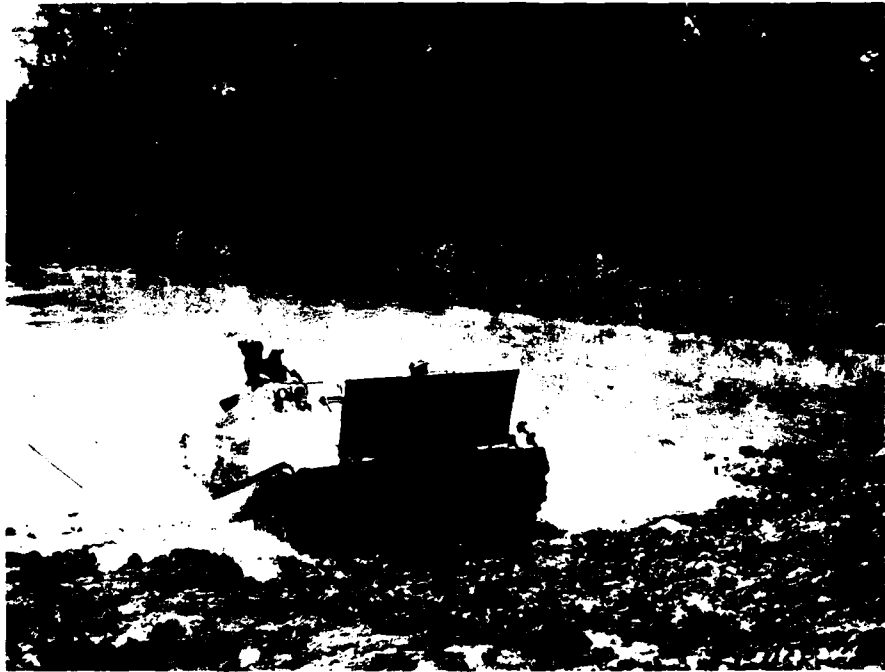
q. Frontal view of vehicle spinning on mat at water's edge
