SECTION 32 PROGRAM  
STREAMBANK EROSION CONTROL  
EVALUATION AND DEMONSTRATION  
WORK UNIT 4-RESEARCH ON SOIL STABILITY AND  
IDENTIFICATION OF CAUSES OF STREAMBANK EROSION

INVESTIGATION OF A GRID FOR  
BANK PROTECTION

November 1979  
Investigation Report 3

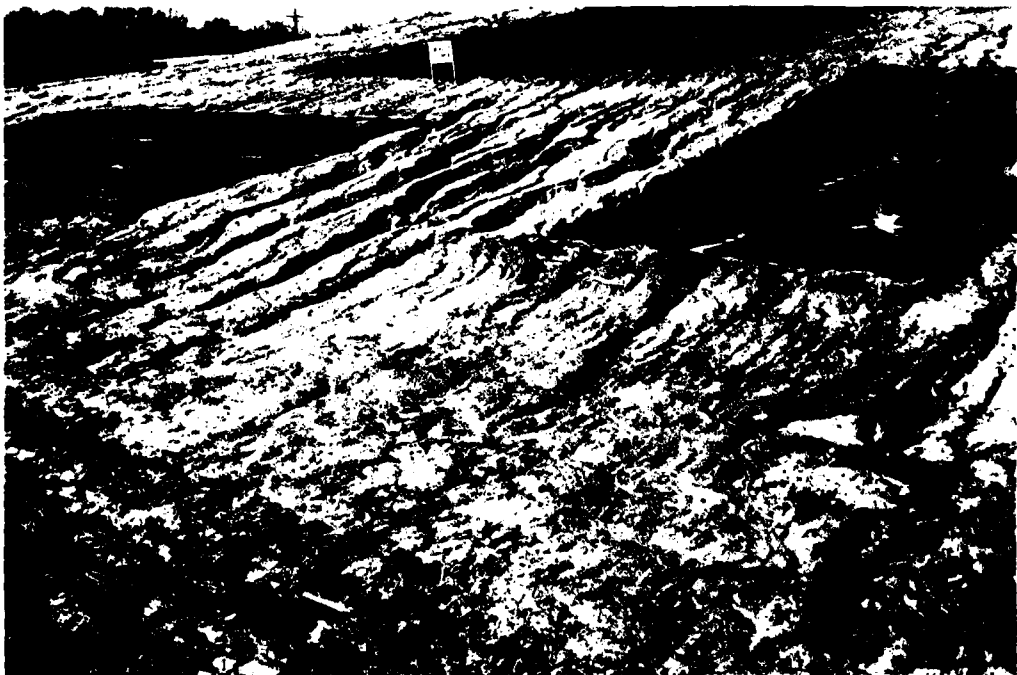
because of the concentrated overland flow of water, a rill 3 to 5 in. (7.62 to 12.70 cm) had formed (Photo 8). The grid section that had a good grass growth started experienced no erosion (Photo 9). The area adjacent to the test section had severe erosion in the unprotected, unseeded area (Photo 10). Observations continued for six months, 1 October - 31 March. One rill protected by rye grass (only) is shown to progress from 3 to 5 in. (7.62 to 12.70 cm) on 5 December (Photo 8) to 8 to 12 in. (20.32 to 30.48 cm) on 12 March (Photo 11). After six months, the area within the grid showed very little or no erosion (Photo 12). Figure 2 presents the amount of monthly precipitation as a bar graph, and Figure 3 shows daily high and low temperatures.

Photo 10. Severe erosion in unprotected, unseeded area adjacent to test area (covered areas below and to the right of the test area will be discussed in a subsequent report(s))
