**A CULTURAL RESOURCES ASSESSMENT  
OF SELECTED MAGNETIC ANOMALIES  
FREEPORT HARBOR, TEXAS  
45-FOOT PROJECT**

**Clell L. Bond**

**Cultural Resources Laboratory  
Texas A&M University  
College Station, Texas**

**November, 1980**

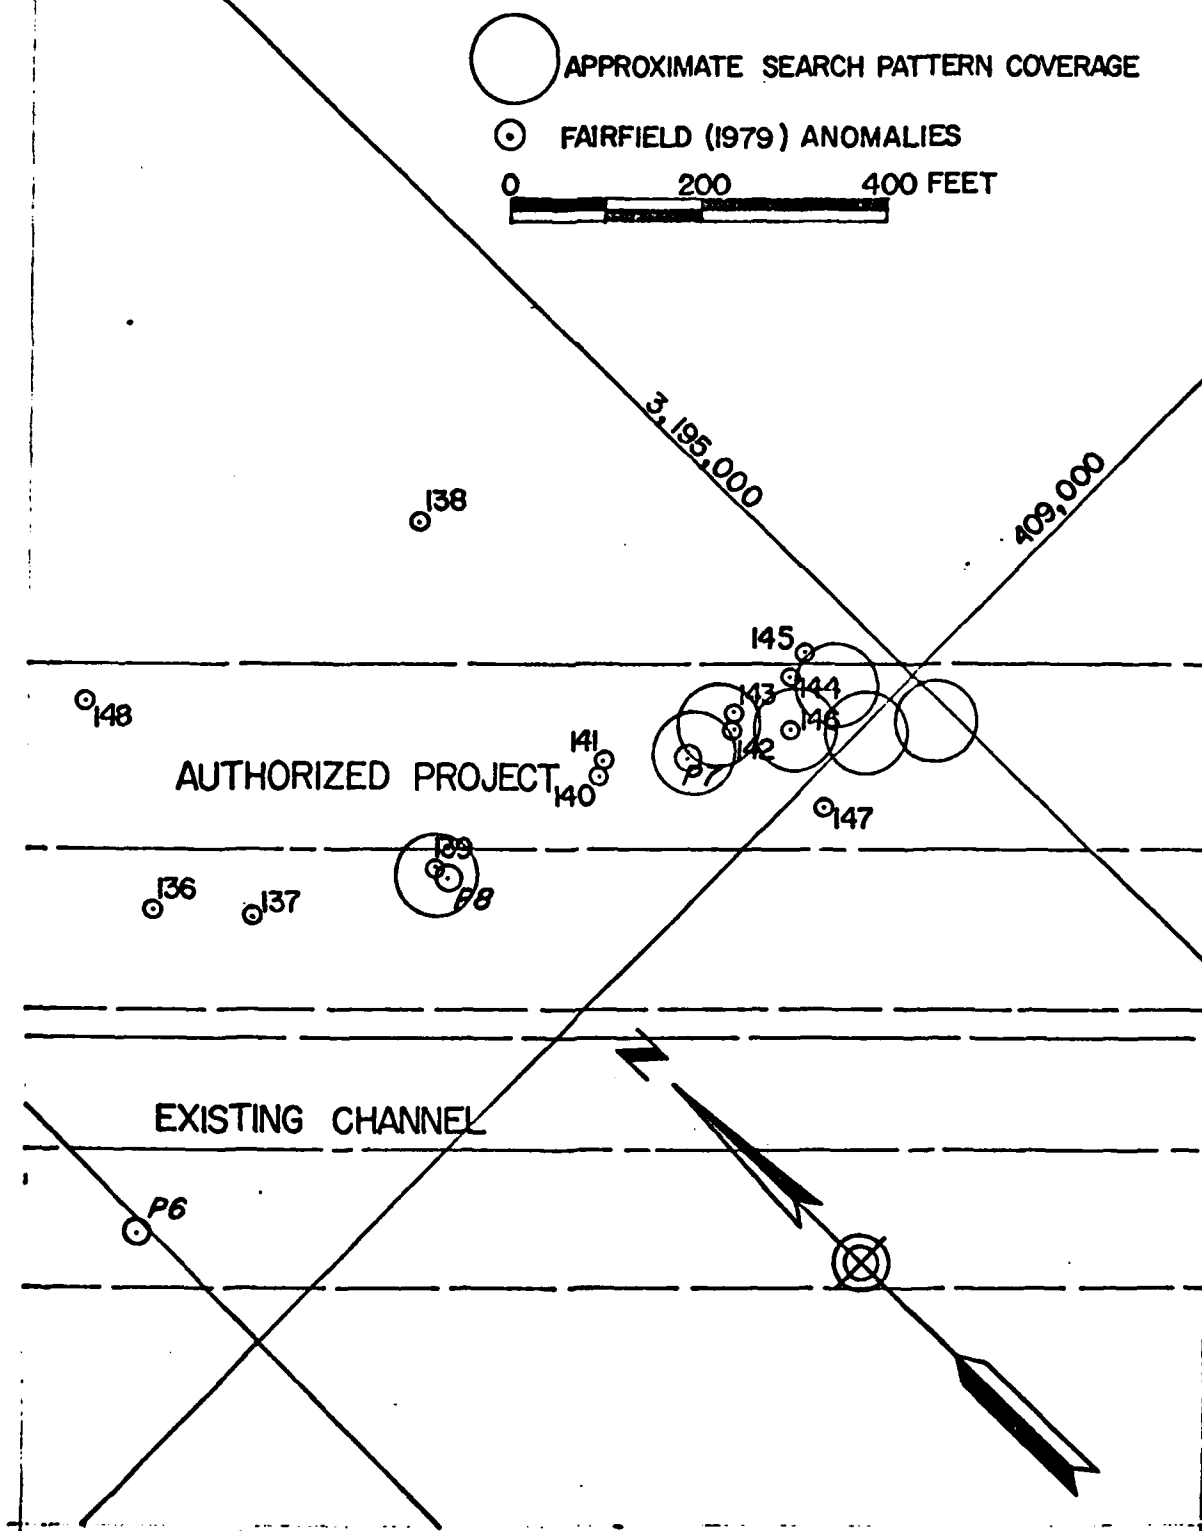
FIGURE 2  
POINT 7 AREA

Point 7 (Figure 2): Dive 3. Positioned approximately 15 m east of Point 7 in approximately 13.5 m of water, the investigating divers found a smooth clay bottom. The clay was noted to be firm but very cohesive under a 10-15 cm thick layer of suspended and/or partially suspended clay particles.

Dive 4. Centered over Point 7, the divers found a smooth undisturbed clay bottom.

Dive 5. Bouyed over anomaly 145, the bottom predominantly consisted of smooth clay although some minimal bottom disturbance seems to have occurred in the eastern portion of the search area.

Dive 6. Located approximately 20 m east of anomaly 145, the search pattern again found a uniform clay bottom with a single groove of 0.5 m wide by 0.5 m deep gouged in the clay. A single waterlogged driftwood fragment of approximately 10 cm in diameter and 20 cm in length was recovered.

Dive 21. Positioned over or very near anomaly 139 in 12.6 m of water, the magnetometer indicated a 12 gamma point source. The divers found a relatively smooth clay bottom but failed to locate any materials which might have caused the 12 gamma magnetometer reading.

Dive 22. This search was centered over an 11 gamma anomaly approximately 25 m southeast of plotted anomaly 146. The divers found a dredge scar in the clay bottom, a modern fire brick fragment reading "...LLSUILLE...AVAGE," a one m length of very rusty welded link chain (approximately five cm link length), two very rusty sheet iron fragments and one small fragment of friable (charred?) wood.

Dive 23. Located 46 m due east of anomaly 146, this dive was to examine a magnetometer-indicated 10-11 gamma anomaly source. No anomaly source was located by the search.

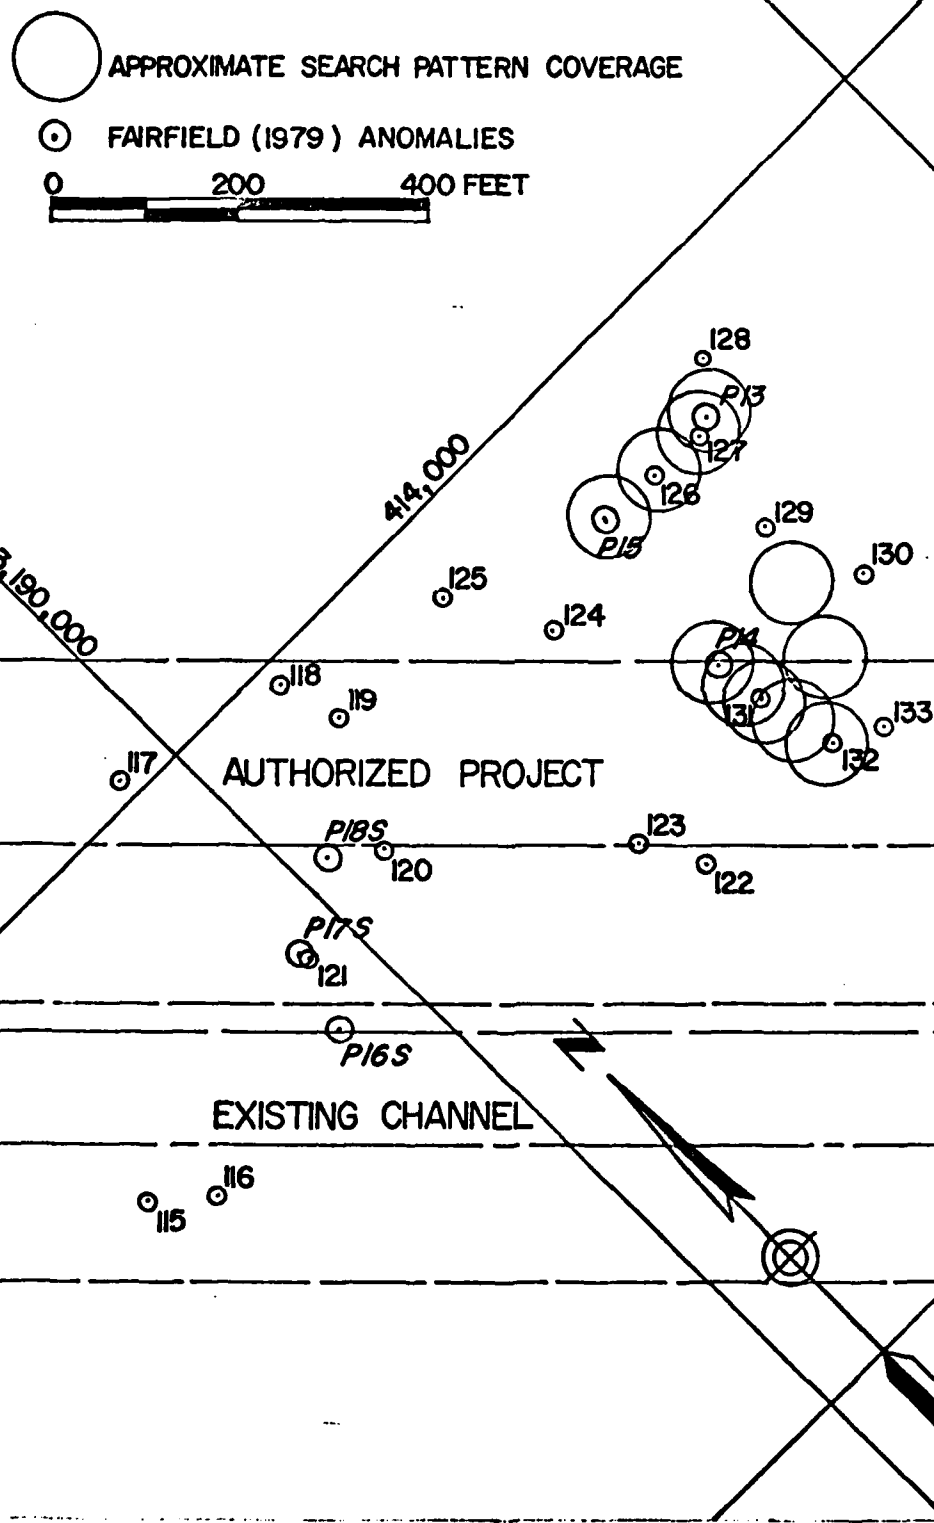
FIGURE 3  
POINT 13, 14 AND 15

Point 13 (Figure 3): Dive 7. Centered over Point 13, the dive was made in 12 m of water and found a relatively smooth clay bottom and a single small waterlogged driftwood fragment.

Dive 8. This search was centered off an anchor set approximately 12 m west of Point 13 near anomaly 127. The divers found a smooth clay bottom and a single somewhat corroded 12 oz beverage container bearing the barely legible label "Miller Lite."

Point 14 (Figure 3): Dive 11. Centered on the buoy set on Point 14, the dive encountered a clay bottom gouged with at least two dredge scars of approximately 1.5 m in width and up to 0.5 m deep.

Dive 12. Dive 12 was made off of a boat anchor set over anomaly 131. The divers found that the clay bottom had been marred by a number of dredge scars. A short length (1-1.5 m) of nylon rope (approximately 3 cm in diameter) was found.

Dive 13. Centered between anomalies 131 and 132, the search found a dredge-damaged bottom consisting predominantly of clay and a light scattering of apparently disturbed oyster shells. A modern waterlogged board of approximately 2 cm X 15 cm X 1 m was recovered in the search.

Dive 14. Dive 14 was made from an anchor located on anomaly 132. The divers reported finding numerous dredge scars in the clay bottom, a few scattered oyster shells and a small thin lens of sand mixed with shell. No artificial materials were located.

Dive 15. Placed roughly 37 m east of Point 14, the divers found only a few shallow dredge trenches in the clay and a thin scattering of oyster shell fragments.

Dive 16. Centered approximately at the midpoint between Point 14 and anomaly 131, this dive rechecked the area examined by dives 11 and 12, again with negative results.

Dive 17. Dive 17 was conducted from an anchor approximately 37 m south-east of Point 14 and overlapped two of the previously checked search patterns. Additional disturbances were noted on the clay bottom; however, no cultural debris was found.

Dive 9. This circle search was conducted off a boat anchor which was set over anomaly 126. A smooth clay bottom was encountered.

Dive 10. This dive was centered off a buoy anchor set at Point 15. The divers found a smooth clay bottom which was cut with a single long, narrow (0.5 m wide and 10.5 m deep) groove. A very corroded aluminum beverage can was recovered.

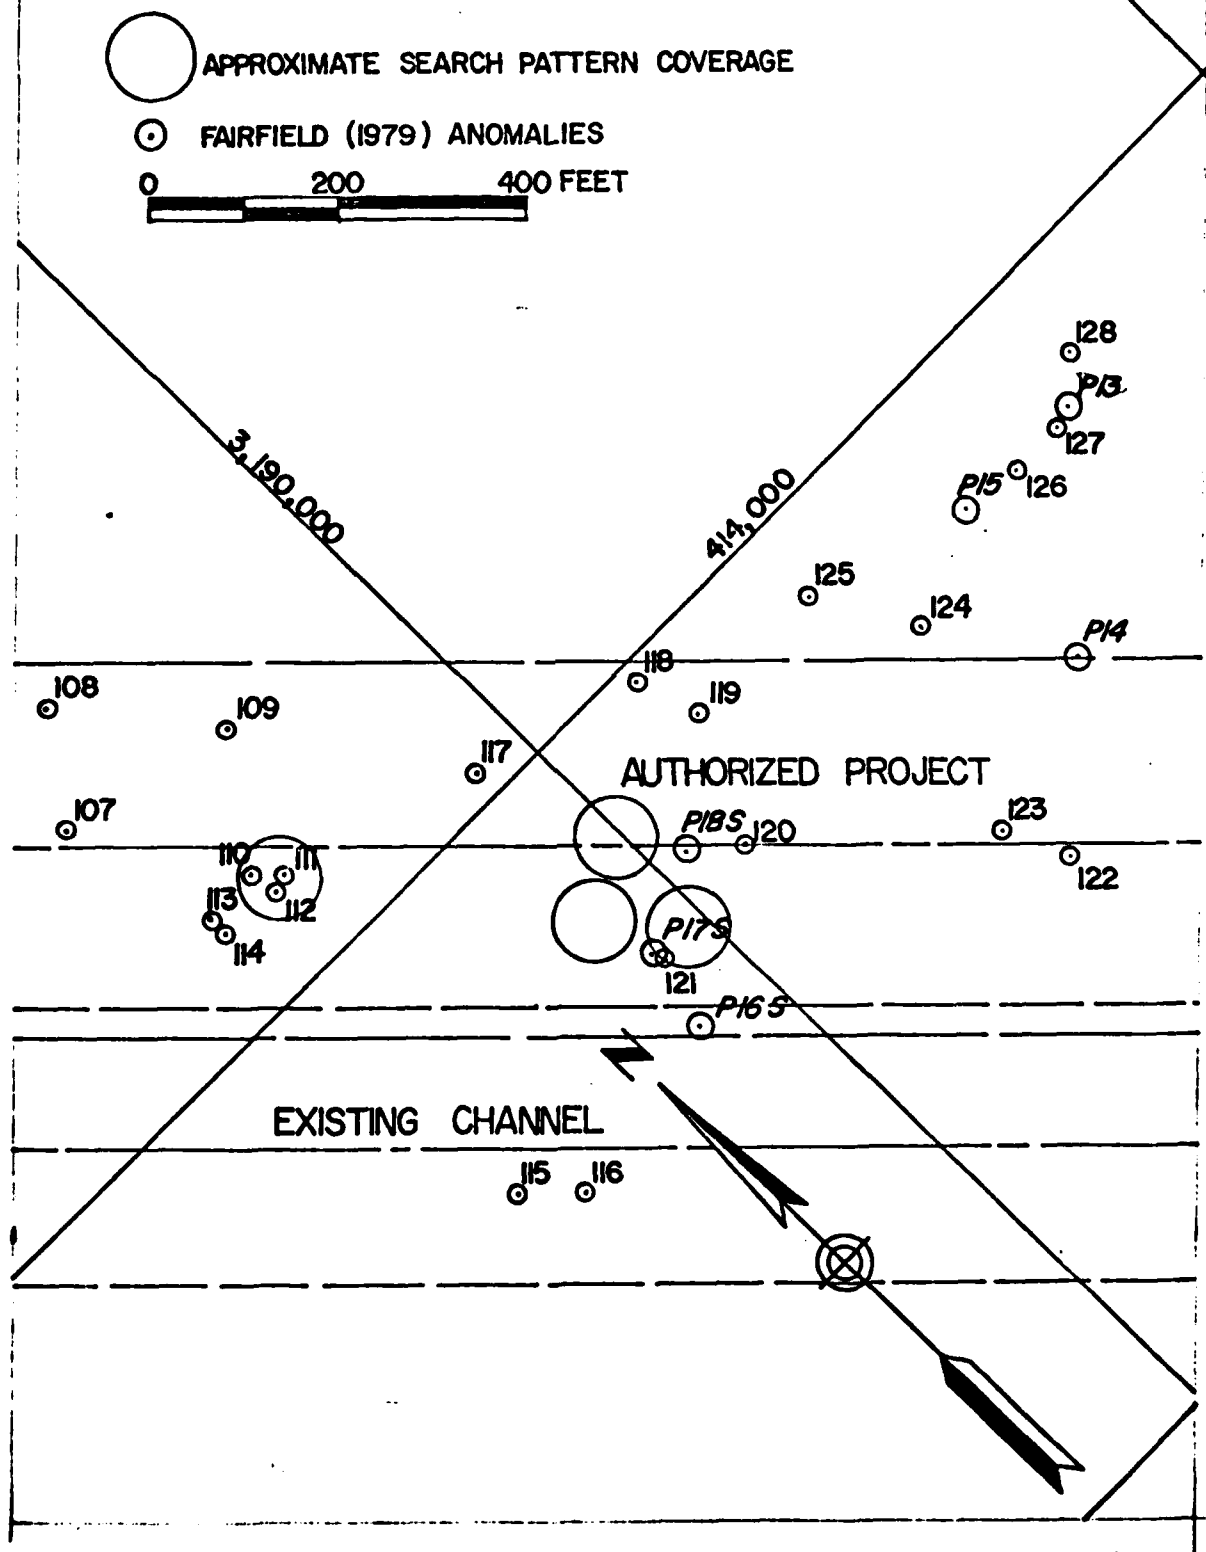
FIGURE 4  
POINT 17 (AND 17 S) AREA

Point 17 (Figure 4): Dive 18. The only dive conducted in the immediate Point 17 area was centered on anomaly 111. The clay bottom was found to be extensively damaged by dredging. Trenches of over one meter in width and up to 1.5 m in depth made the bottom search difficult and hazardous. Except for a few shell fragments, nothing except bottom clay was found in the search.

Dive 24. Approximately 25 m north-northwest of Point 17 S over a 10 gamma magnetometer "hit", the divers found an extensively gouged bottom and a short length of wire rope. The recovered two fragments of wire rope were approximately one m in length, three centimeters in diameter and were badly corroded and encrusted.

Dive 26. Located approximately 37 m northeast of Point 17 S the divers found a dredge disturbance but failed to locate the cause of a 15 gamma magnetometer reading.

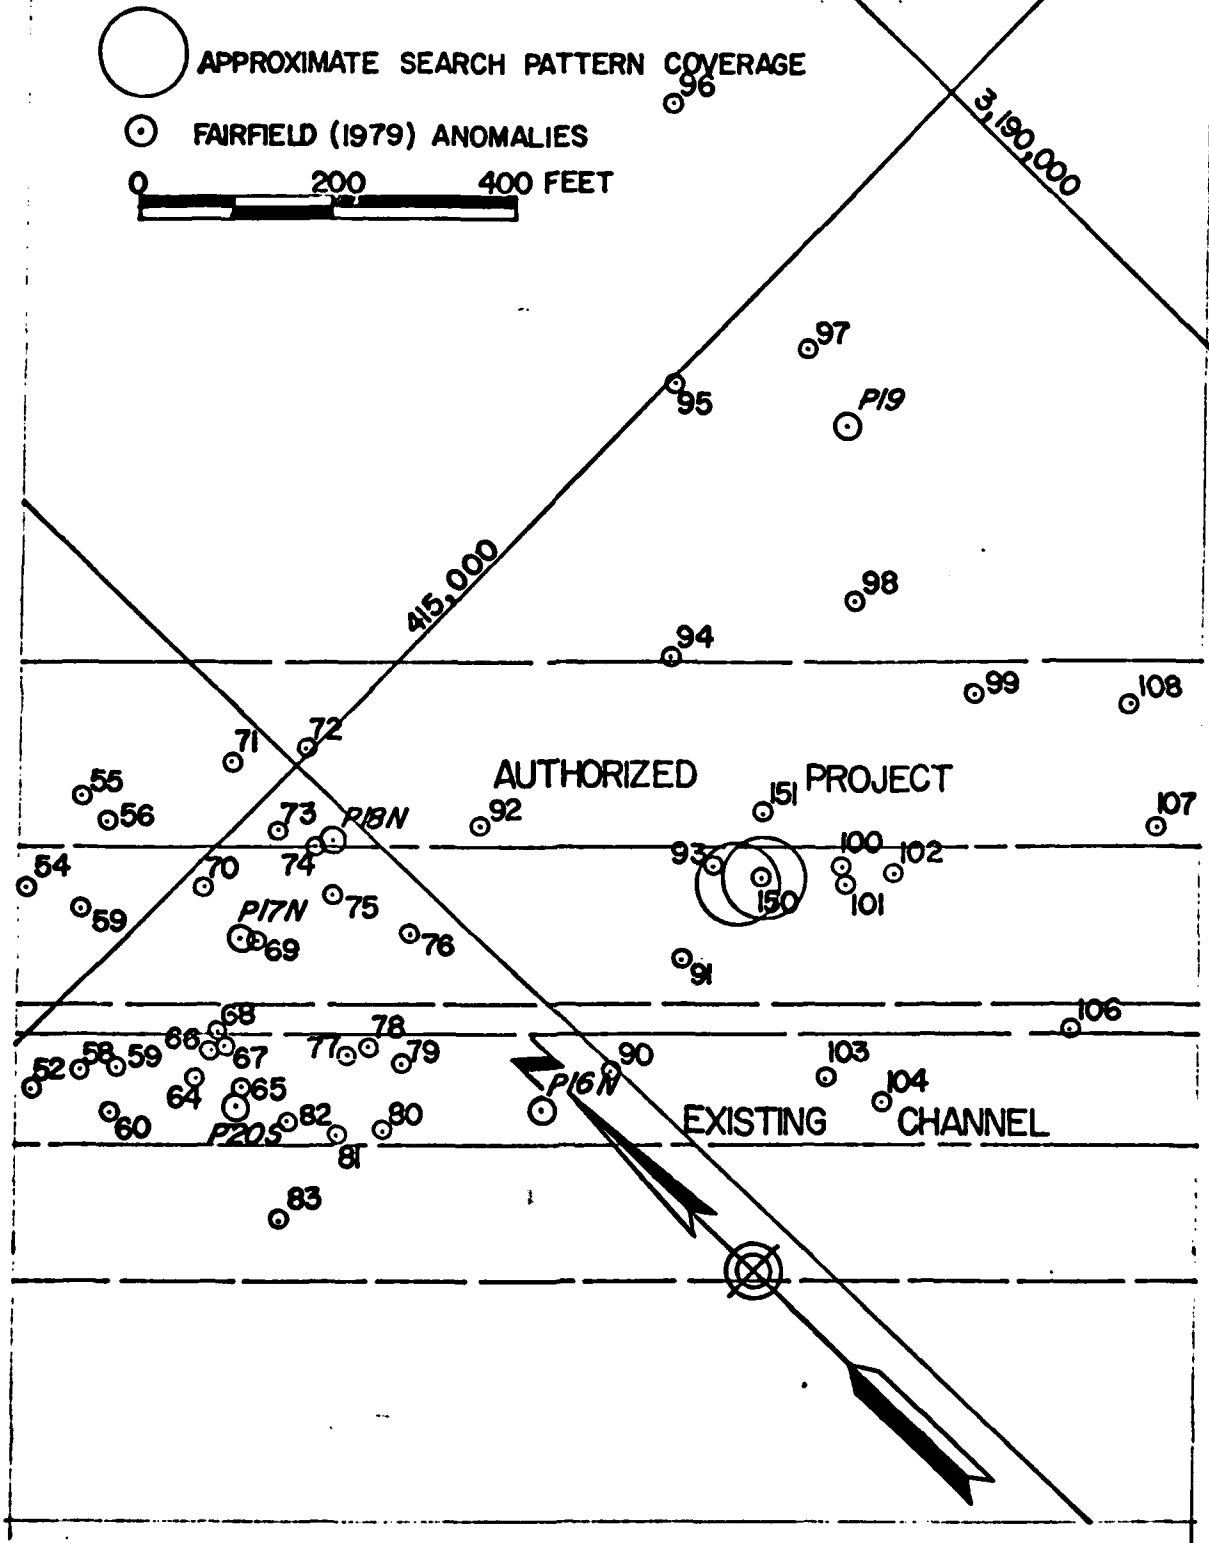
FIGURE 5  
POINT 18 AREA

Point 18 (Figure 5): Dive 19. The dive boat was anchored over anomaly 150 from which the search was centered. The dive team reported that the bottom clays were scarred by more trenches presumed to be dredge scars.

Dive 20. The dive was centered off Corps of Engineers point 18A about nine m northwest of anomaly 150 and overlapping the search area of dive 19.

The dredge disturbed condition of the bottom was reaffirmed. The dive team found a sunken treated piling of approximately 1.5 m in length lying horizontally on the bottom. The divers reported the object had metal fasteners and possessed only a small amount of marine growth.
