DESIGN CONSTRUCTION DEMONSTRATION AND DELIVERY OF AN
AUTOMATED NARROW GAP WELDING SYSTEM(U) CRC AUTOMATIC
WELDING CO HOUSTON TX 31 MAR 83 CRC-NAV-A/W-7
N00600-81-C-E923

Phase 3 Report
3/31/83
-- Page 2 --

PHASE 3 EQUIPMENT CONSTRUCTION

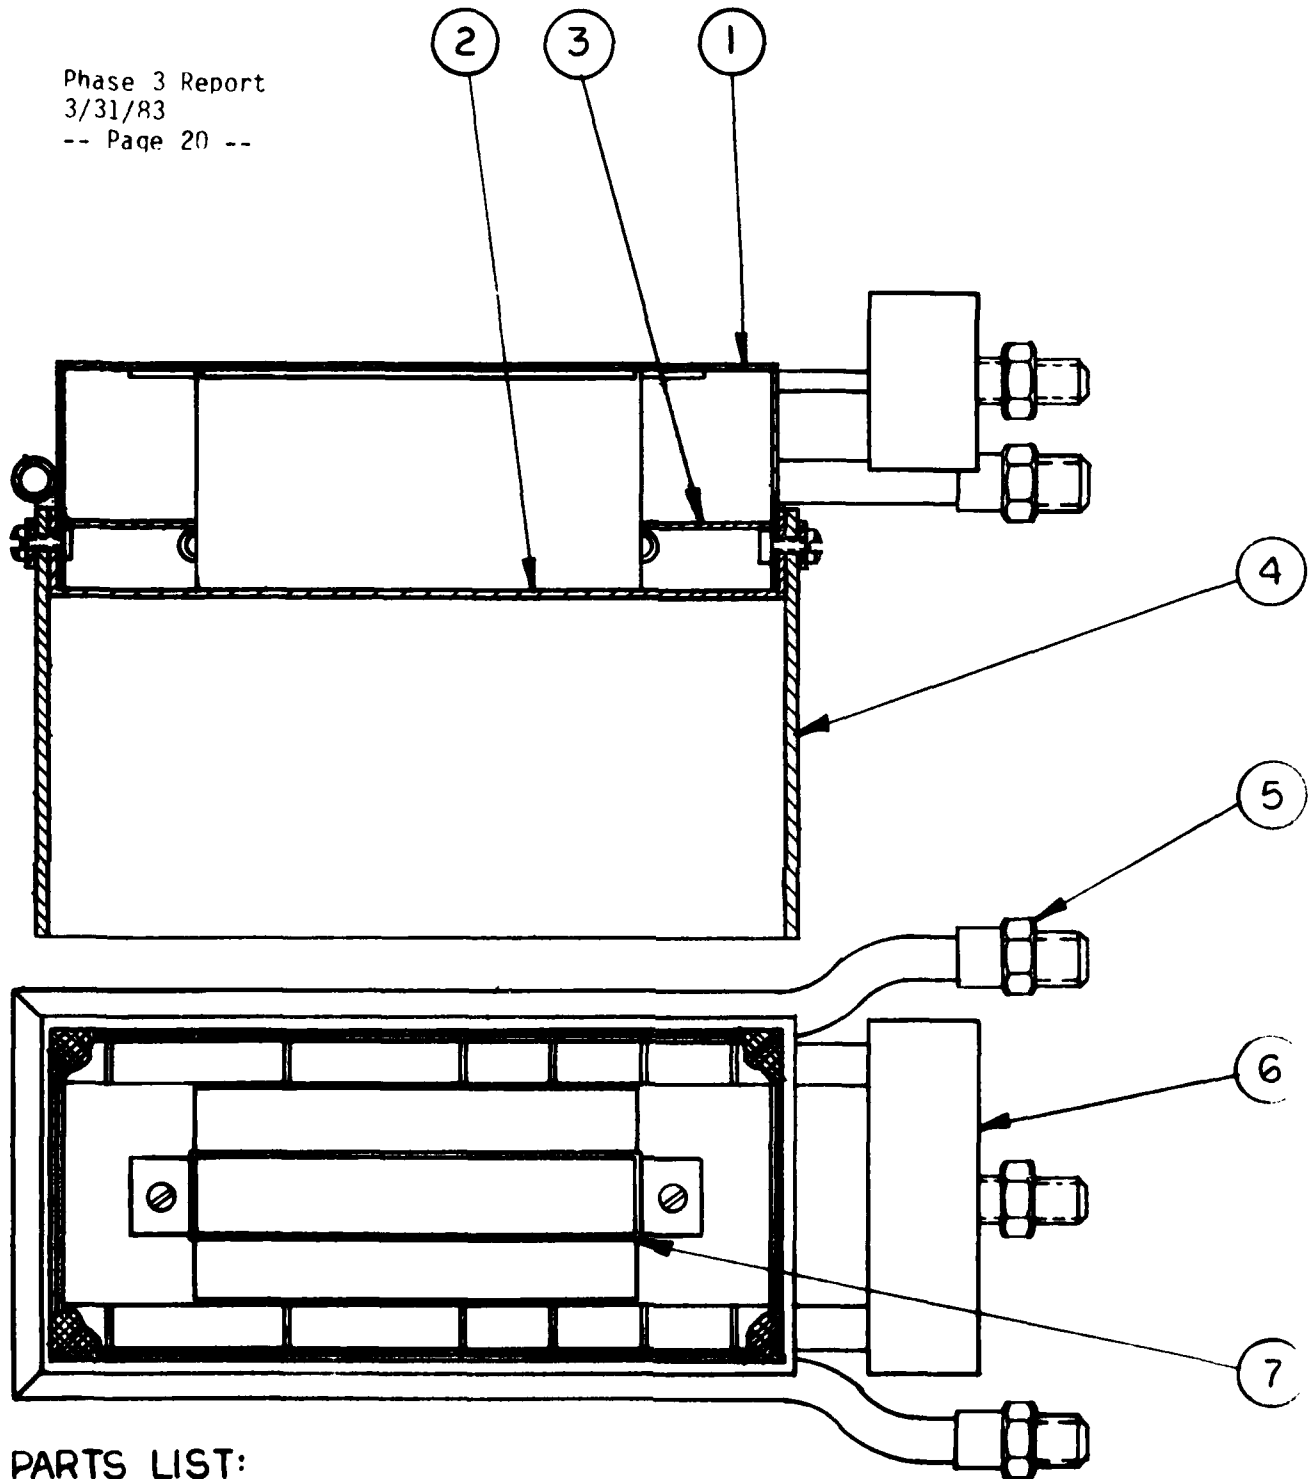
GAS SHIELD ASSY.
FIGURE 4A

Gas Shield Assembly - the design of the gas shield assembly was based on the work summarized in the Second Progress Report, NAV A/W 3, dated June 1, 1982. Initial welding trials with the completed assembly showed inadequate gas shielding in the deeper, narrow-groove joints. With the original design it was necessary to increase gas flows to approximately 350 to 400 cubic feet an hour to sustain proper gas coverage. This intense gas flow rate caused compressive disturbances on the plasma column which induced severe tracking problems. It also caused very fine, sub-surface porosity.

Subsequent testing of the gas shield assembly indicated that the excessively-high flow rates were causing the gas to be distributed into the welding joint with extremely high velocities. The high velocity of the gas flow as it was emitted from the gas shield assembly was causing

turbulence resulting in aspiration of air into the gas shield as well as into the welding joint.

An analytical analysis was made on the gas assembly at various flow rates and it was determined that the gas shield assembly must be reduced in volumetric size. By reducing volumetric size, it was then possible to reduce the flow rates. A subsequent modification of the gas shield assembly reduced its volume by 1/3. This allowed a reduction in the volumetric flow rates to approximately 130 cubic feet per hour. Further welding evaluation indicated that instability still existed in the welding arc plasma column as well as a continual aspiration of air into the welding joint.

Studies of the gas shield assembly revealed that the configuration of the gas tube itself and its placement within the gas shield assembly was extremely important. A gas shield assembly was fabricated that would allow easy removal and replacement of the gas tube. Numerous configurations were evaluated by the use of an external smoke producing source. By the use of the external smoke source, it was possible then to visually monitor the actual flow from the gas shield assembly. As a result of this test, it was determined that the gas tube itself must be located at the outer extremes of the gas shield assembly. It also indicated that the gas tube itself, must have a slotted opening that allows gas to emerge from the remaining exposed surfaces.

To provide a laminar flow from the gas shield assembly, it was necessary to loosely pack coarse steel wool around the gas tube assemblies. The stainless steel wool breaks up the velocity flow from the gas tube assemblies and provides a proper laminar flow from the shield assembly. The steel wool is then retained by a meshed screen.

Figure 4 shows the final gas shield configurations as evaluated on the Narrow Gap welding system. By using the combinational gas shielding assembly, it is now possible to reduce the gas flow rates to a value ranging from 80 cubic feet an hour to 100 cubic feet an hour representing

Another important area of consideration was the transfer of shielding gas from the gas shield assembly to the work piece. To assure proper distribution of the gas over the welding joint, a flexible skirt was fabricated and used to interface the gas shield to the work piece. This skirt was fabricated from Refrasil* which can withstand extremely high temperatures.

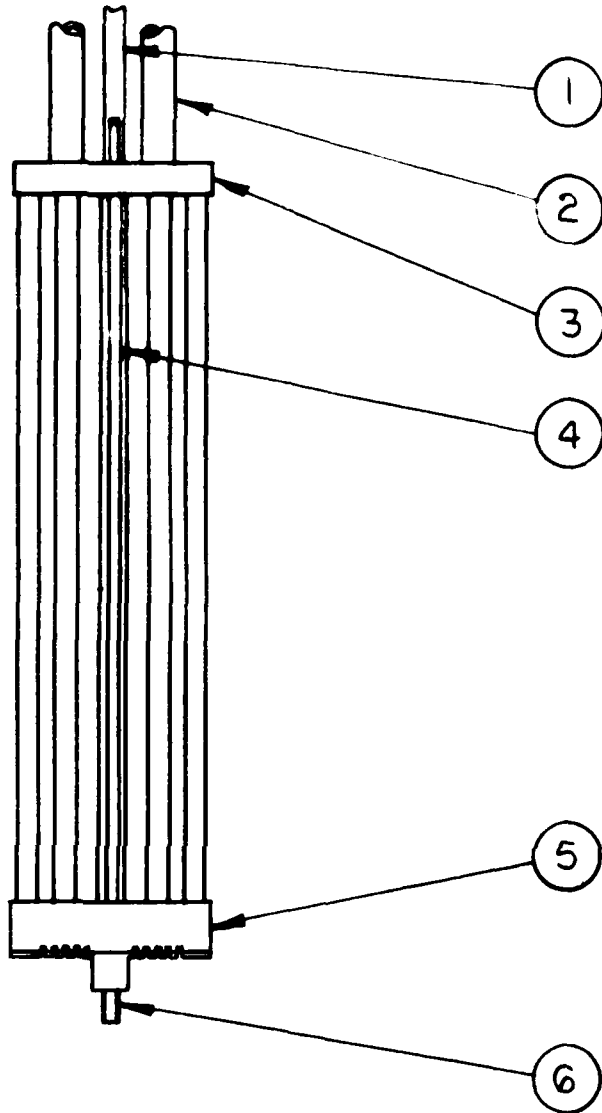
TORCH ASS'Y.
FIGURE 4B

During further investigation into the gas shielding problems, it was also identified that the welding torch may block the gas flow in the narrow

groove joint. To alleviate this problem, a secondary shield was added to the welding torch. At the base of the welding torch, vertical slots were located on either side of the welding tip. Parallel gas tubes then were used to distribute shielding gas on each side of the welding tip. The top portion of the torch assembly was manifolded to provide proper distribution of the gas flow and also provide the water cooling passages required by the torch. At the upper most end of the torch assembly, an additional gas distribution and water distribution block was fabricated. This block provided the separation of water flow to insure a series connection between the welding torch water jacket and the gas shield water jacket. The additional function of this block was to provide a flow division between the gas shield assembly and the gas lenses on the welding torch. The block was fabricated with a controlled orifice size allowing approximately an 8 to 1 division in the gas flow to the gas assemblies with the smaller flow at the contact tip down in the weld joint. This then provided a very gentle flow at the base of the torch surrounding the immediate welding arc. By using this dual shield configuration, it was then possible to provide adequate shielding at the 4-inch joint depth with the narrow groove configuration.
