AMMRC MOBILE ACCELERATOR NEUTRON RADIOGRAPHY SYSTEM  
OPERATIONS AT U.S. ARMY YUMA PROVING GROUND

Interim Technical Report  
Report No. 3-41000/4R-110

15 April 1984

LTV AEROSPACE AND DEFENSE COMPANY  
Vought Missiles and Advanced Programs Division  
P.O. Box 225907  
Dallas, Texas 75265

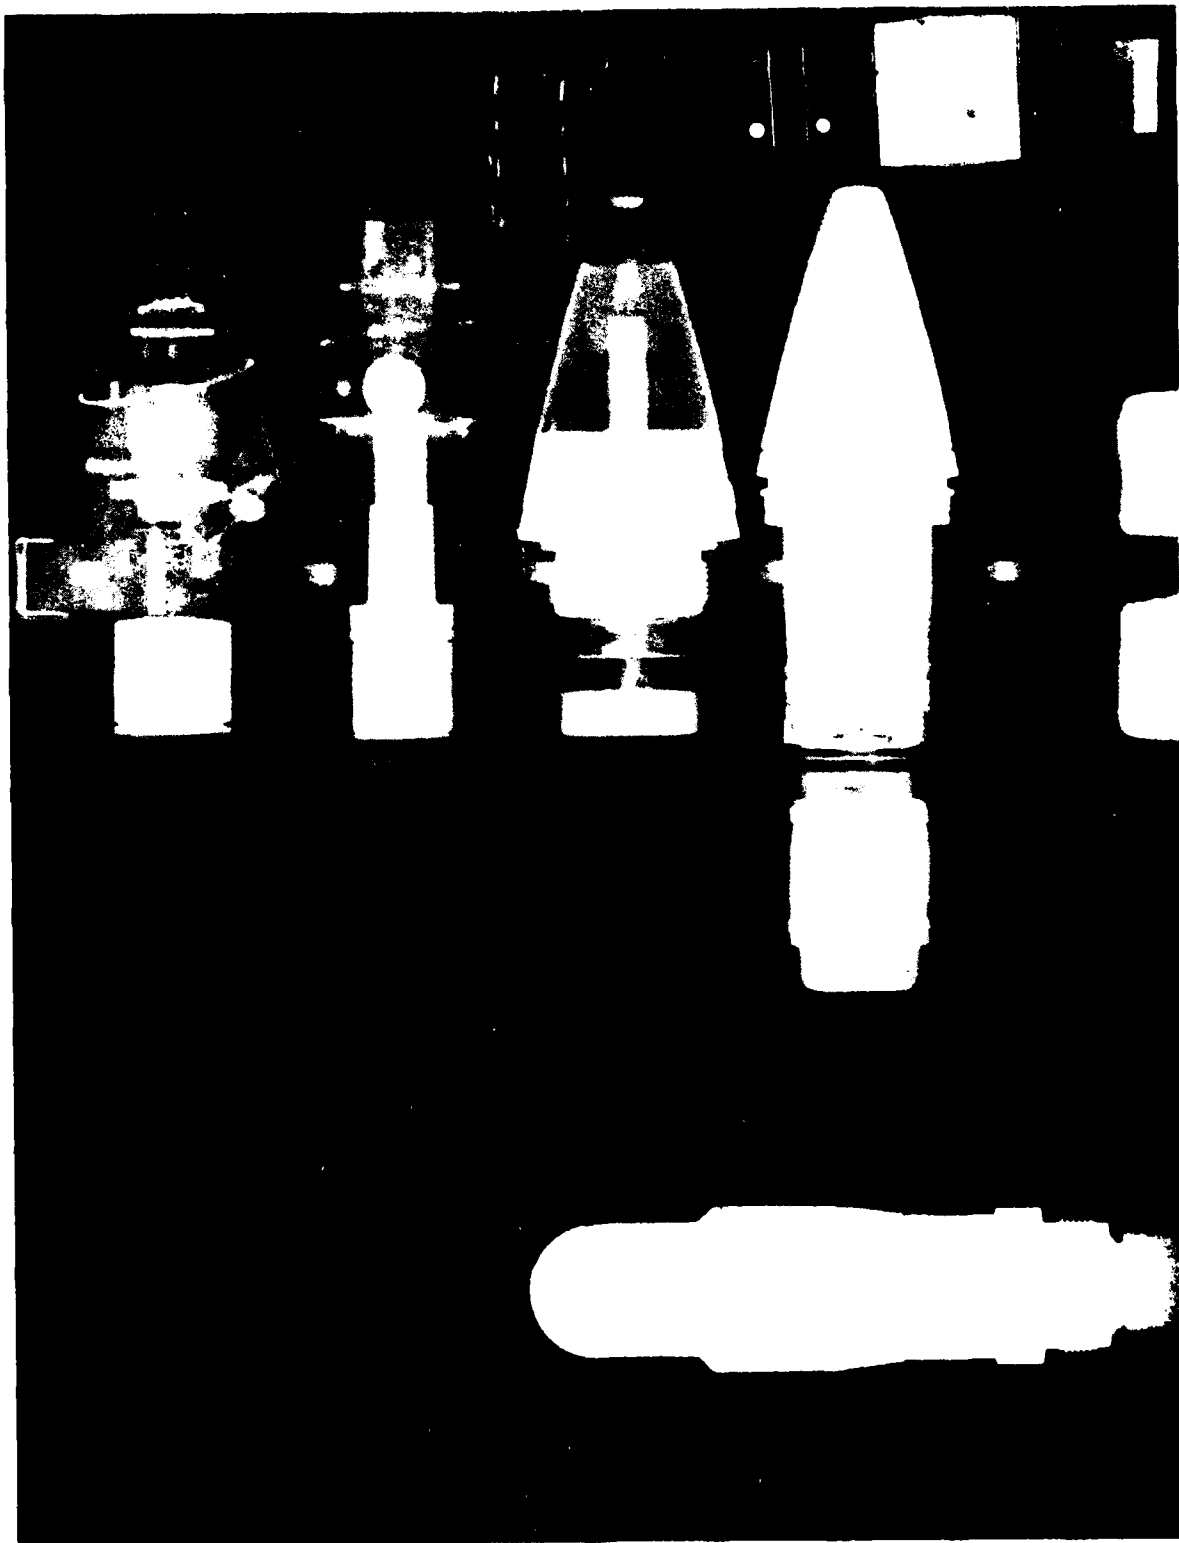
Figure 10N. Neutron Radiograph of M524 Fuze (Top, Right), M567 Fuze (2nd from top on right), M557 Fuze (3rd from top, right), M728 Proximity Fuze (Bottom, right), M432 Rocket Fuze (Bottom, left)

The neutron radiograph (Figure 10N) on the other hand, clearly images, reading from right to left on the M524 fuze (which is the first device beginning at top right in the radiograph), the primer, the M63 detonator, the M2 delay element, the detonator lead charge, the M80 detonator, the booster lead charge and booster assembly. On the M567 fuze (second from top, on right) the metal parts and arming mechanism are not imaged well with neutrons, as would be expected; however, the auxiliary booster assembly, the O-Ring, and booster charge and felt pad are clearly imaged. The M557 fuze, (third from top, on right) had a high attenuation for thermal neutrons throughout the fuze body, and hence details within the body are not imaged. However, the booster charge at the base of the fuze is clearly imaged. The other two devices, the M728 fuze and M432 rocket fuze, do not lend themselves to inspection by thermal neutrons because of the synthetic materials used in the windshield, the plastic material encasing the electronics in the nose cones, and the cadmium plating over most of the metal casing. Exposure parameters used in this neutron radiograph were: Film Kodak SB; converter-Lanex Fine; L/D = 36; Exposure-80 minutes (20 to 30 min. with normal output).

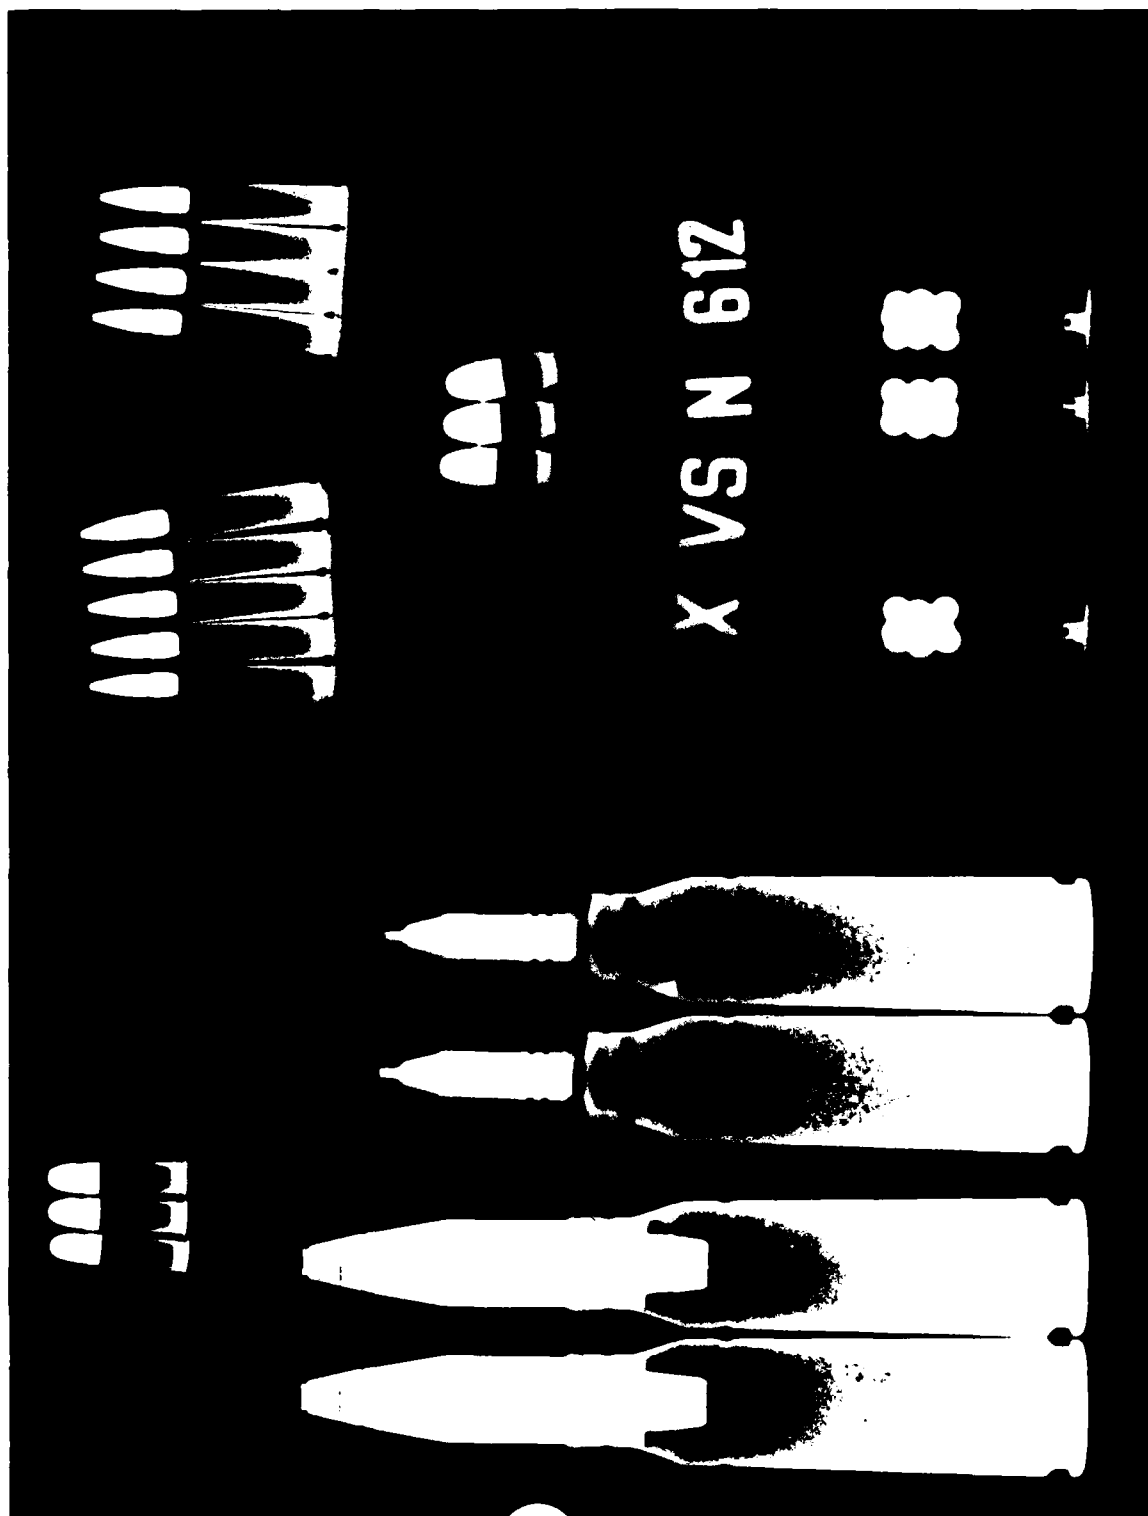
The X-ray images the fuzes in the 30 mm APDS-T projectiles but shows little definition of the case charges, the projectile body charges, and the fuze detonators. In the 25 mm 792 projectiles the X-ray images the projectile body and provides a good image of the case charge except at the lower end of the case, where the firing pin/detonator, which also is not imaged, is located. The X-ray image of the 12-gauge shells show good definition of the cartridge base and minimal detail in the shell area. Similarly, the other small ammunition show little or no definition of the case charges.

Figure 12X. X-Ray Radiograph, Reading from left to right, bottom, 30 mm APDS-T Projectiles (2 ea); 25 mm 792 Projectiles (2 ea), 12-Gauge Shotgun Shells (3 ea); from left to right top, 38 Caliber Specials (3 ea) and 7.62 Tracer Ammunition (5 ea and 4 ea)

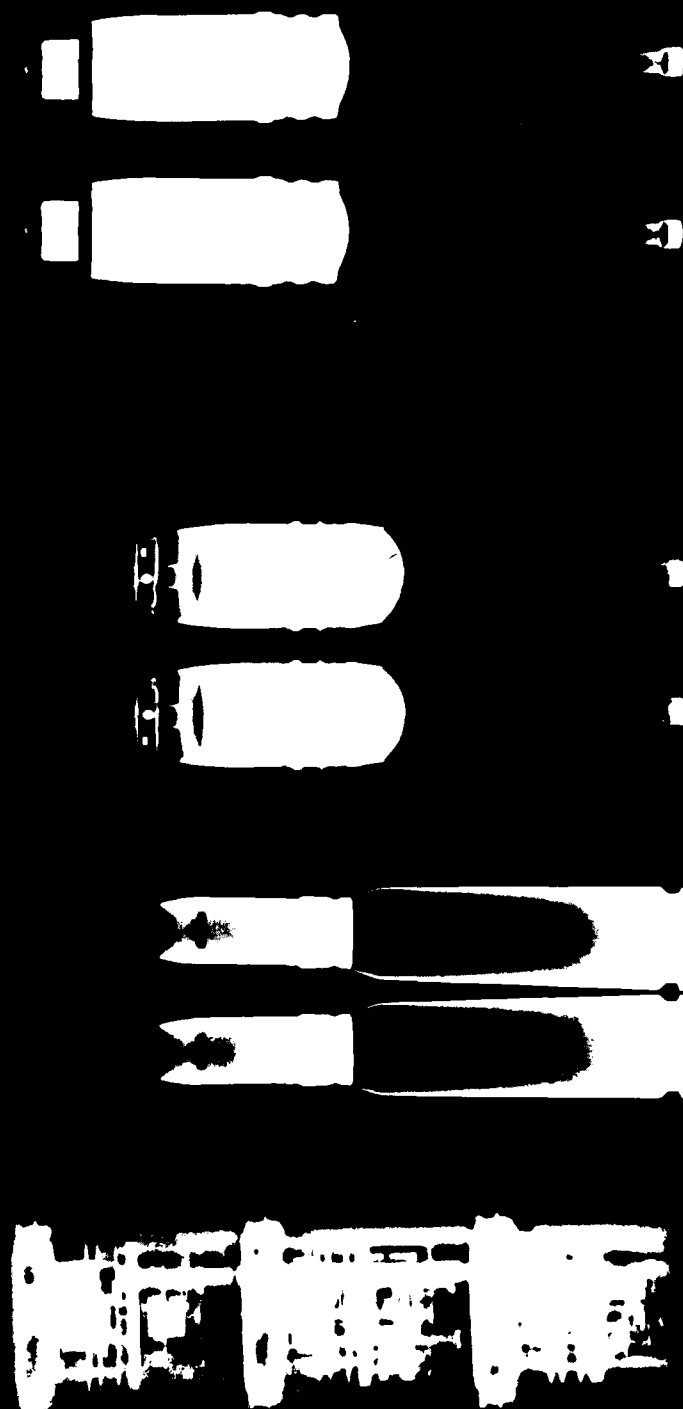
In the three element fuze assembly the X-ray, Figure 13X shows good detail of the metal parts and S&A device but no image of the detonators. The X-ray image of the 20 mm M56A4 HEI projectile shows some detail of both the case charge and the HE body charge. The 30 mm M552 projectile with XM579E2 fuze and 25 mm HEI-T, XM792 w/PD M71435 fuze images show fair definition of the case charge flash element, good body definition and good definition of fuze metal parts but no image of fuze detonators and very little case charge definition. Likewise, the X-ray images show no image of the case charge in the 9 mm projectile shells.

Figure 13X. X-Ray Radiograph, Left to Right, of Three-Element Fuze Assembly, 20 mm M56A4 HEI Projectile (2 ea), 30 mm M552 Projectile with XM579E2 Fuze (2 ea), 25 mm HEI-T XM 792 Projectile with a PDM714E5 Fuze, Top Center: 9 mm Ball Projectile (4 ea)

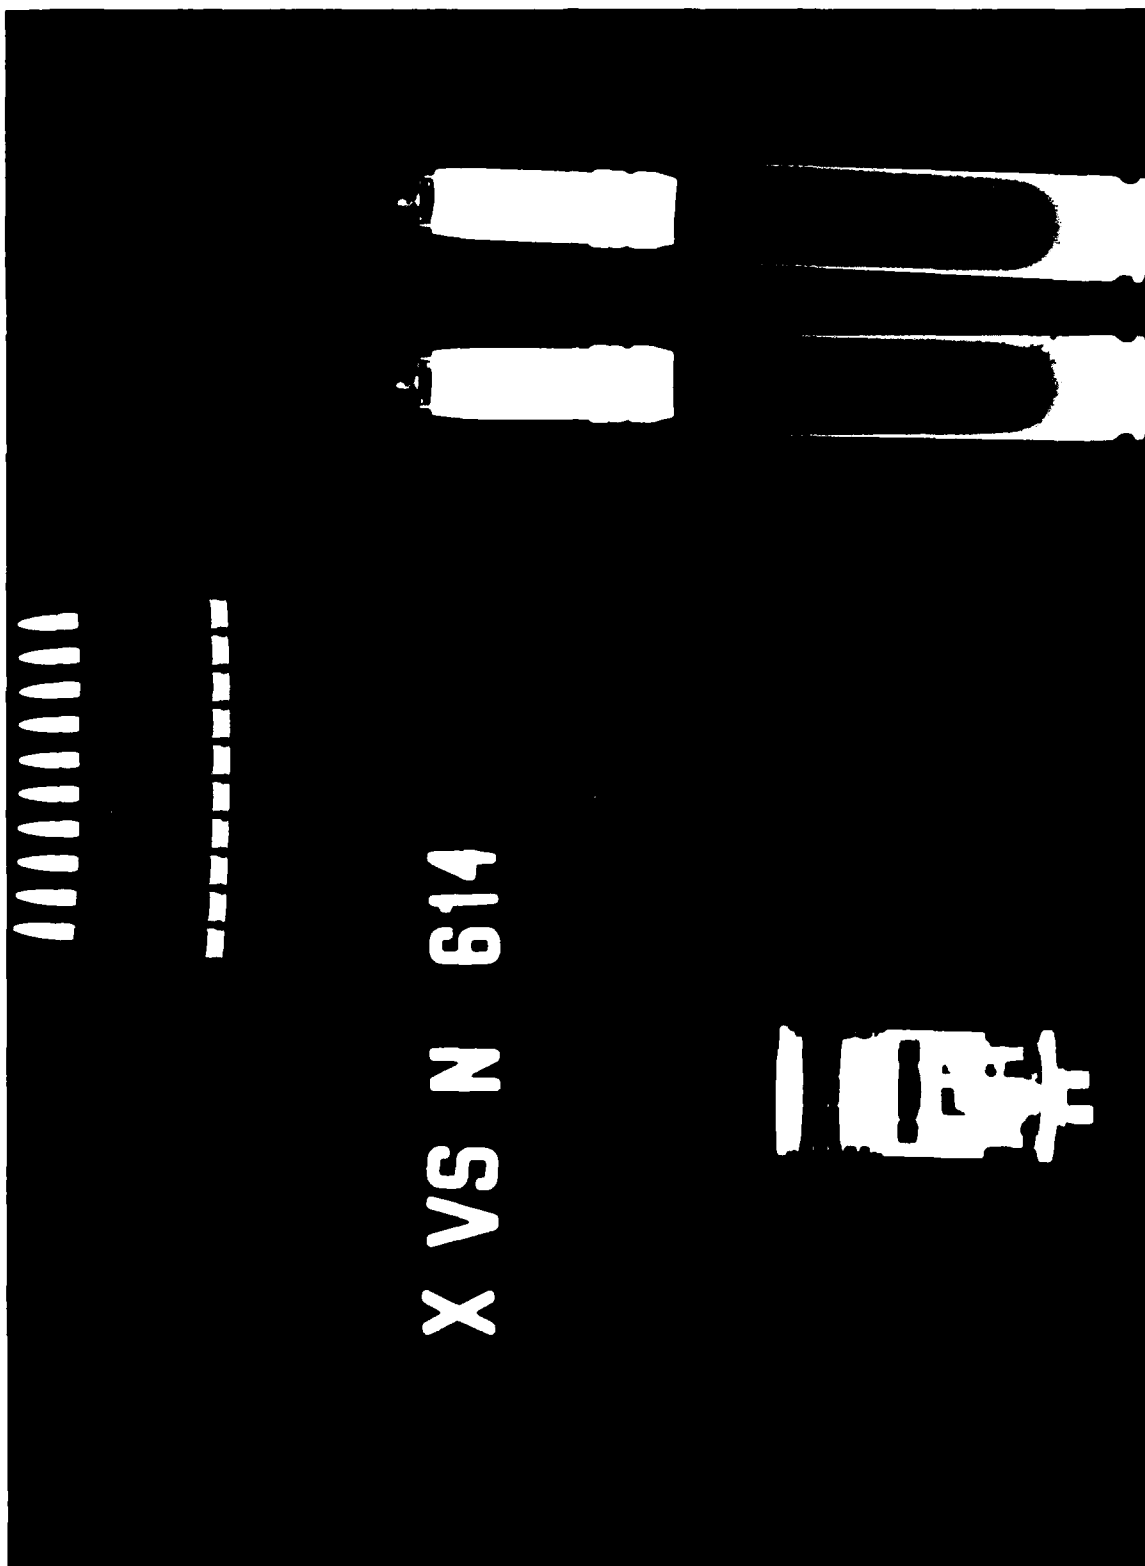
Figure 14X. X-Ray Radiograph of, Left to Right, 2.75 Rocket Fuze, 20 mm XM 599 Projectile (2 ea), and, at top, 7.62 mm Projectile (10 ea)

On the X-ray, Figure 14X, in addition to the usually good definition of the metal parts and S&A device, it is seen that two fuze detonators below the fuze base ring of the 2.75 rocket fuze also are imaged. On the 20 mm XM 599 the X-ray does not image the case detonator. The projectile body and metal fuze parts show the usual good definition, and the usual lack of good definition of the case charge is apparent. The 7.62 projectile image shows only the case and shell projectile body.

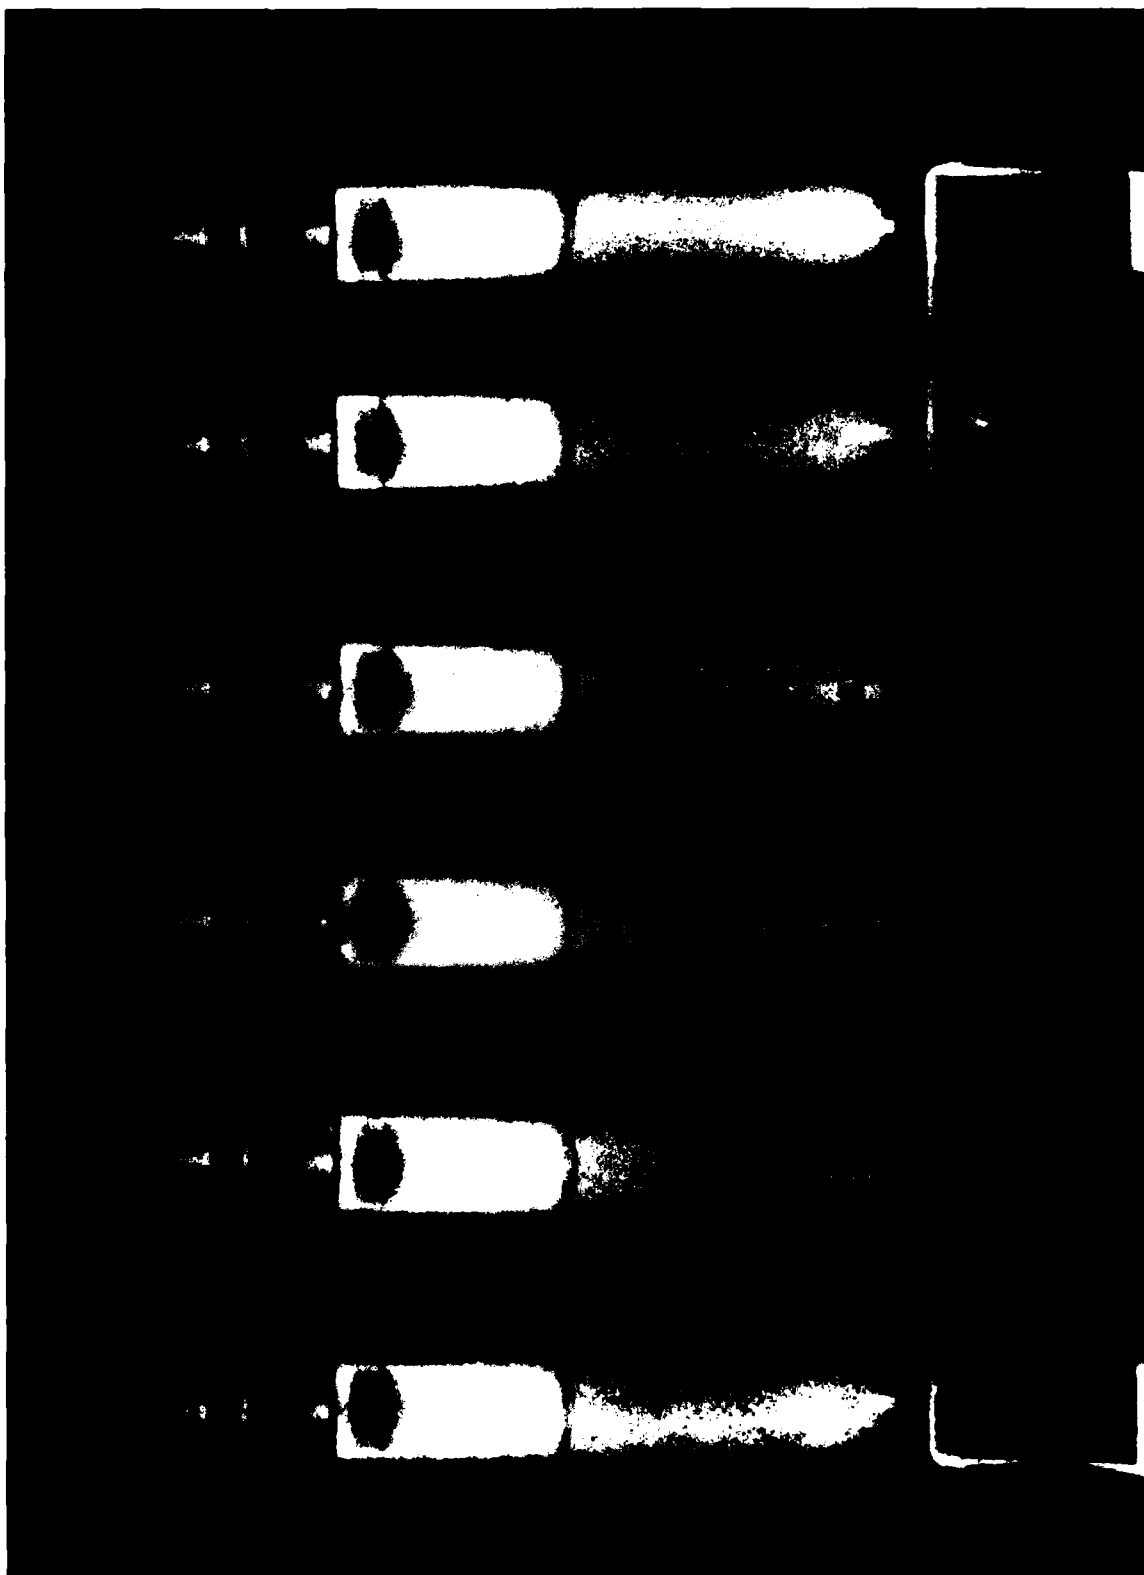
The neutron radiograph presented in Figure 17N images a faulty condition in 30 mm XM789 projectiles which cannot be determined with X-ray inspection. Inside the flash tubes of the projectiles (bottom end) can be seen the independent flash elements. The positions of the elements along the projectile axes are seen to be random. This random positioning can result in an unacceptable "hang-fire" functioning. X-rays do not image the internal portions of the flash tube and hence, as mentioned above, cannot be used to detect this unsafe condition.

Figure 17N. Neutron Radiograph of 30 mm XM 789 Projectiles Showing Unacceptably Random Positions of the Flash Elements Along Projectile Axes (at Bottom End of Projectiles)
