AFWAL-TR-84-4186

FRACTOGRAPHY OF MIXED MODE I - II FAILURE IN GRAPHITE/EPOXY  
AND GRAPHITE/THERMOPLASTIC UNIDIRECTIONAL COMPOSITES

Steven L. Donaldson  
Mechanics & Surface Interactions Br  
Nonmetallic Materials Division

June 1985

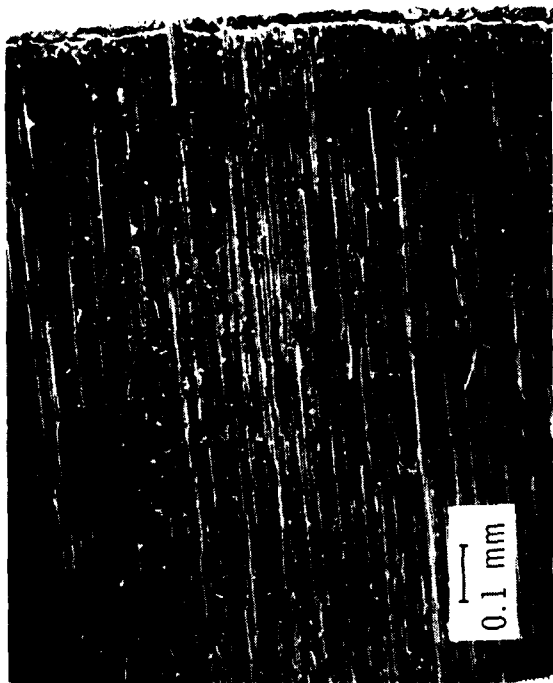
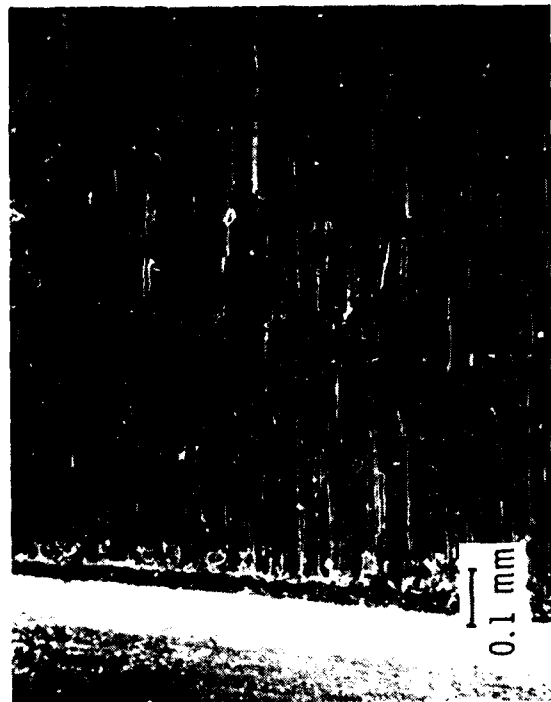
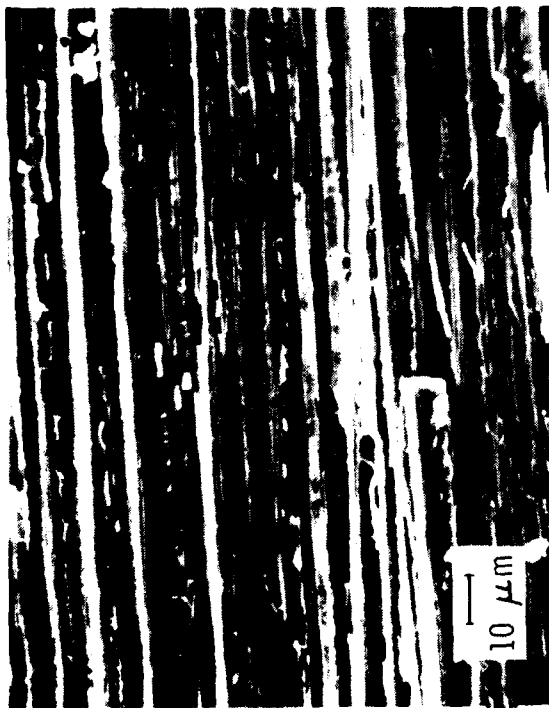
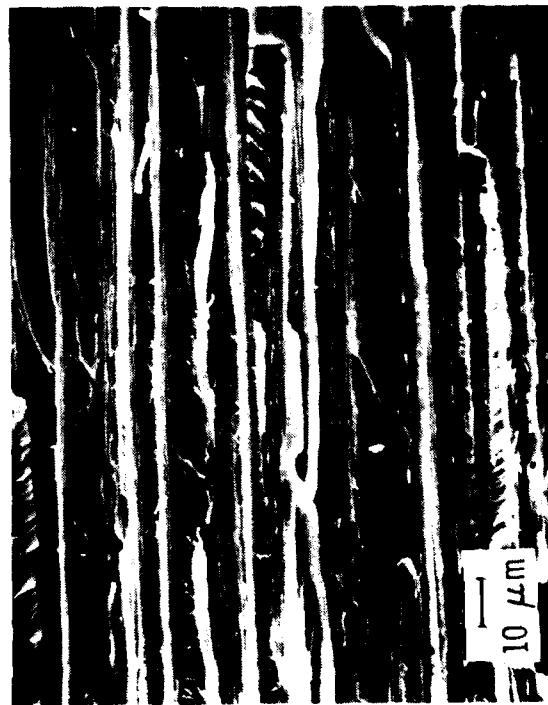
Figure 8.  $\beta = 90$  deg,  $K_T$  Only. T300/1034c

Figure 8,  $\beta = 90^\circ$ ,  $K_I$  only.

The 800X views show the matrix has failed in a smooth cleavage fashion. Very many long matrix wedges are visible. These result from the resin areas between fibers. (See Figure 7).

Note the clean fiber breaks. Some matrix lacerations, or hackles as they are sometimes called, are seen in the grooves of the missing fibers. These are likely due to local shearing along the side walls of the fiber as it was pulled away.

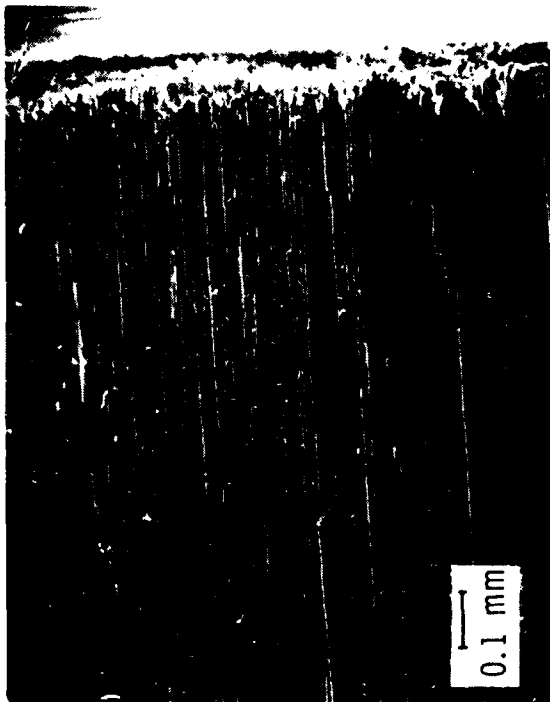
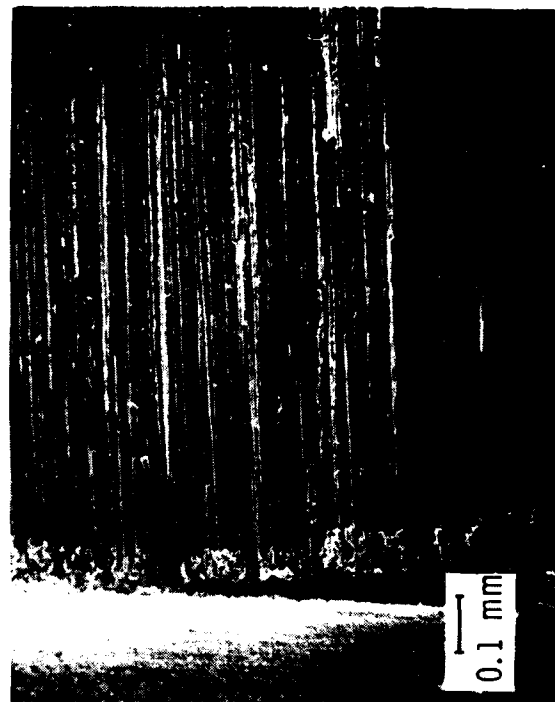
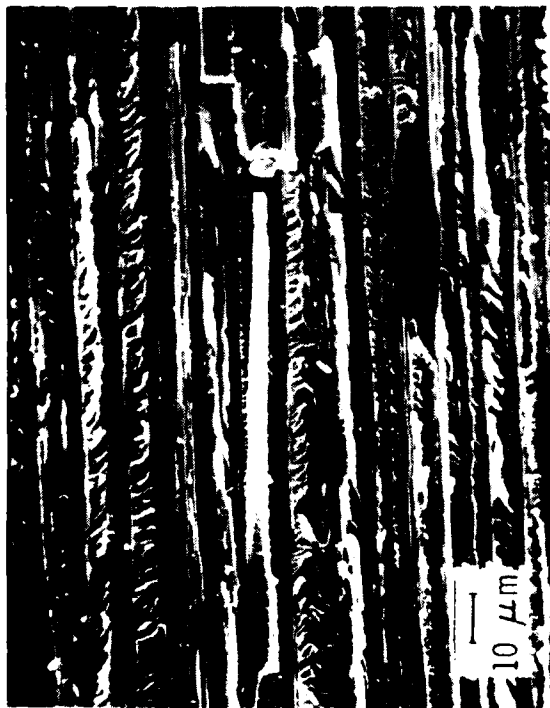
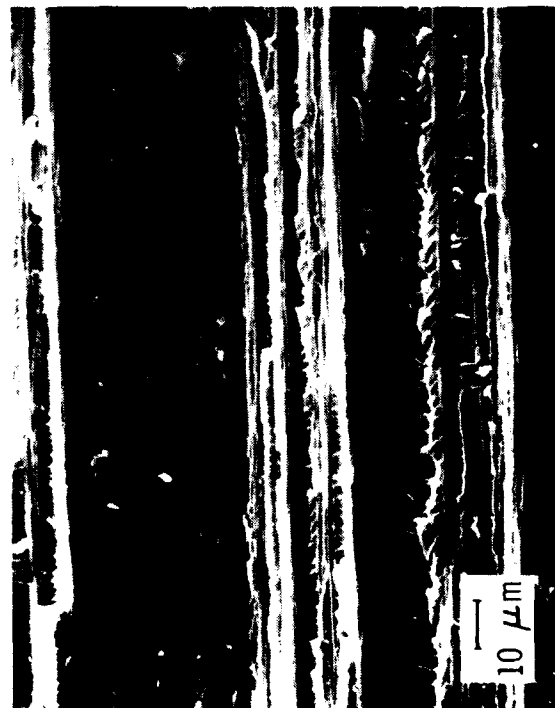
Figure 9.  $\beta = 45$  deg,  $K_1/K_{II} = 1.0$ , 7300/1034c

Figure 9,  $\beta = 45^\circ$ ,  $K_I/K_{II} = 1.0$ .

The 100X magnification shows a roughly equivalent number of fiber breaks in each direction on each surface. The first 800X photo (9c) shows a large number of fairly small hackles, evenly spaced and lying nearly flat. Matrix wedges are still visible. There were some bands with no hackles, as shown in Figure 9(d). Note the hackles form in the resin areas between fibers, as depicted in Figure 7. The fibers bordering the hackles may still be in place, 9(d), or missing, 9(c).

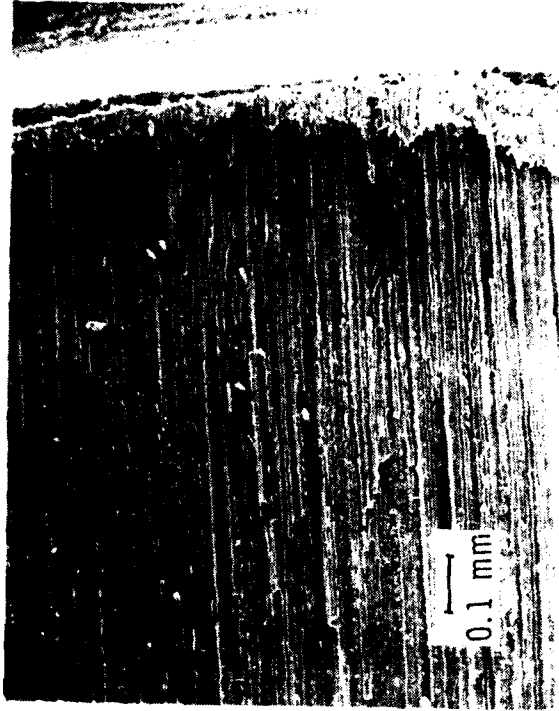
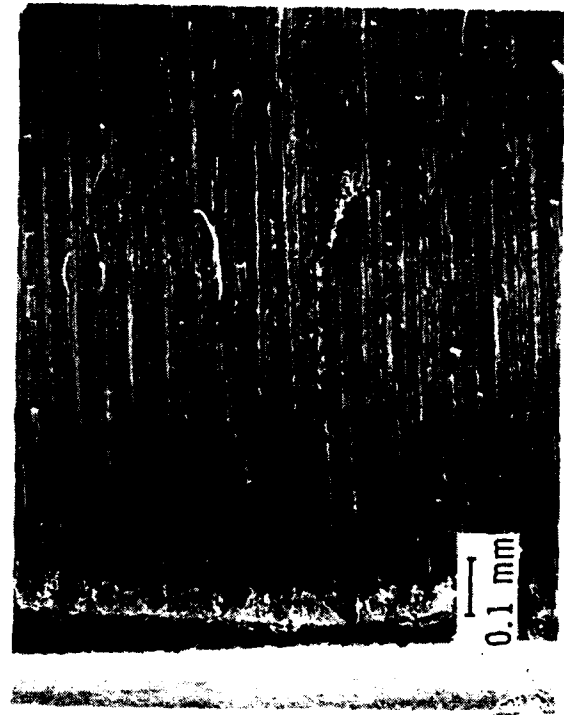
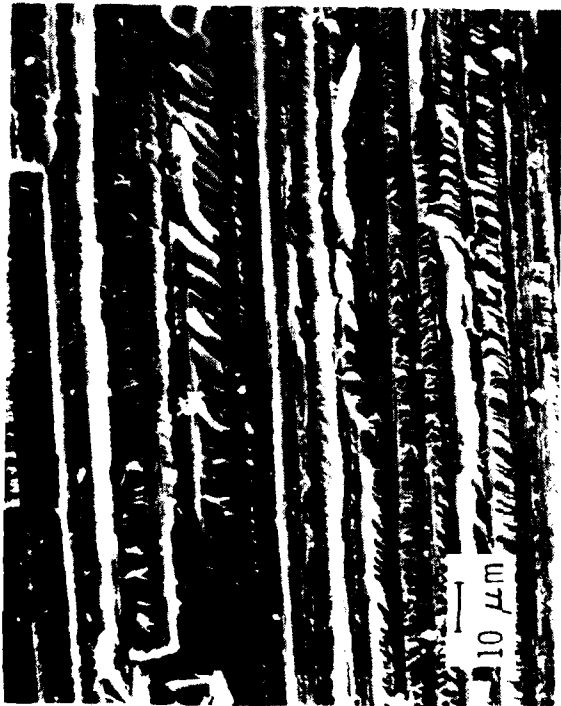
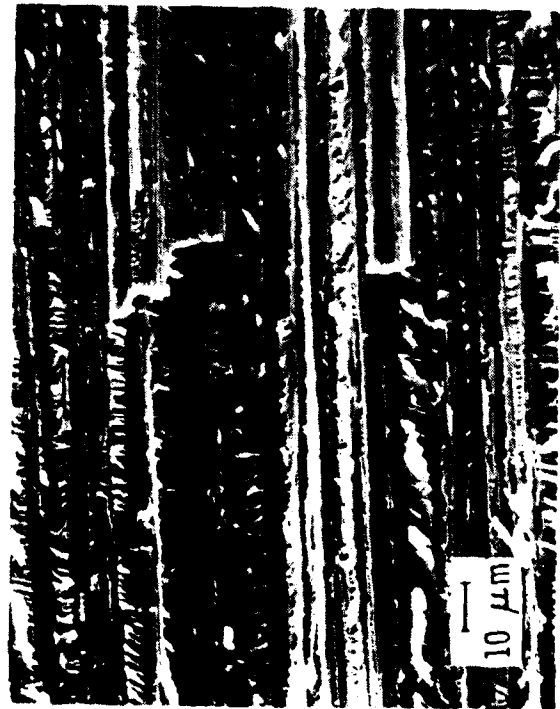
Figure 10.  $\beta$ -phase,  $\theta = 20^\circ$ ,  $F_1/F_{111} = 0.58$ , T300/1034c

Figure 10,  $\beta = 30^\circ$ ,  $K_I/K_{II} = 0.58$ .

The 100X photos show there are still many broken fibers in both directions, although there are more pointing to the left. Figure 6 shows that fibers on both surfaces experience a force to the left due to the global shear force. If the fibers break more easily in tension than compression, one would indeed expect more broken fibers pointing left. The 800X views show the hackles have become more raised than in the  $45^\circ$  specimen, as expected in the discussion earlier. Also visible are large hackles, formed in an area with more space between fibers.

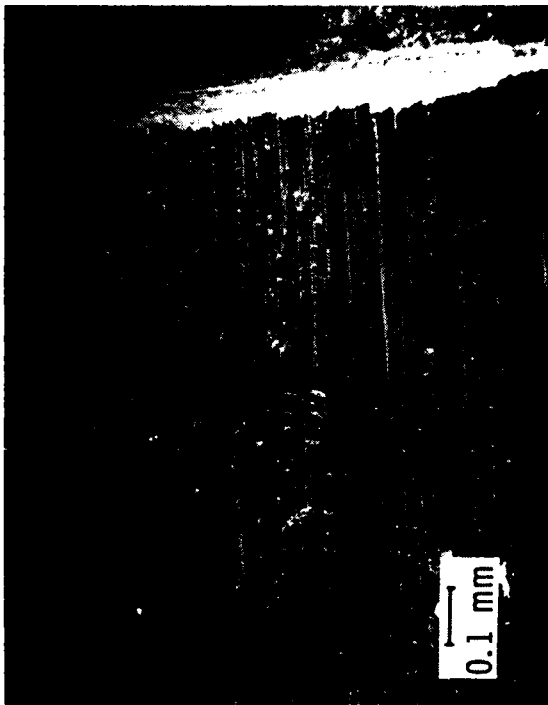
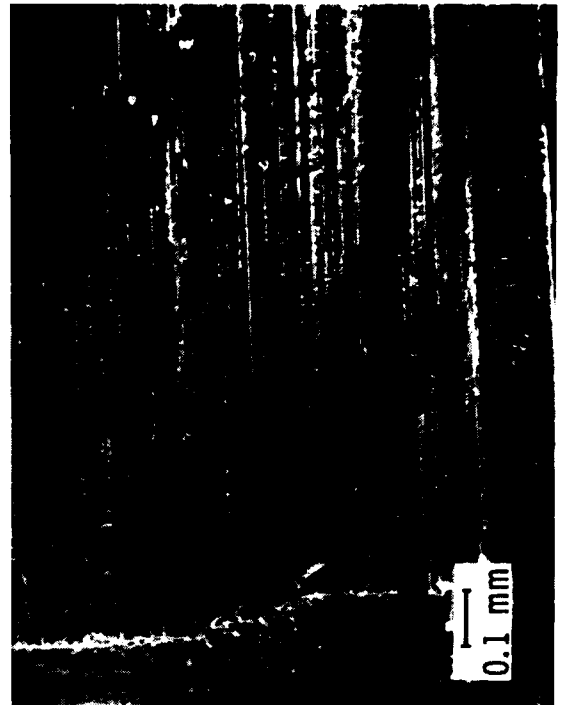
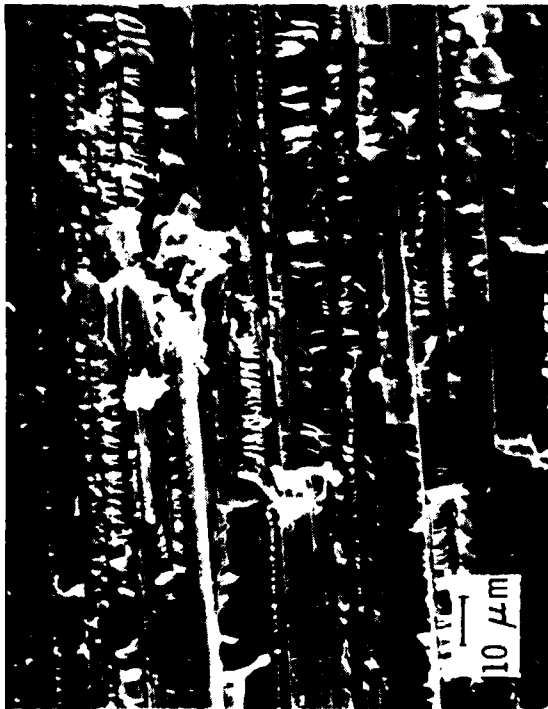
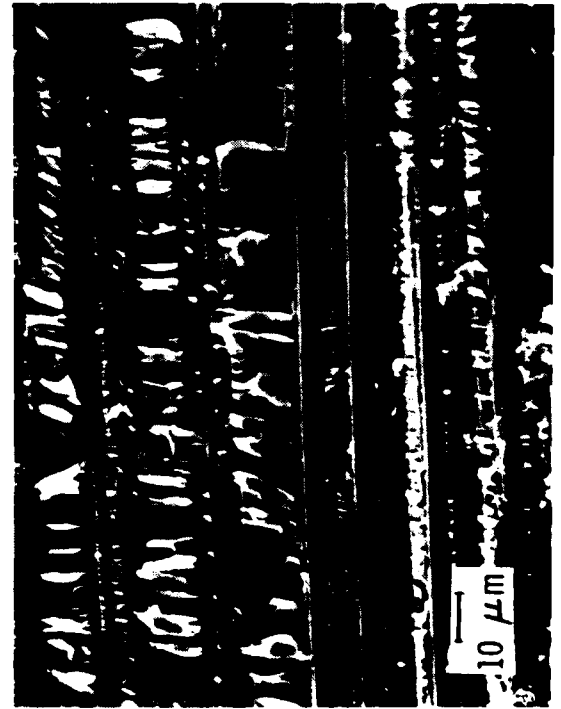
Figure 11.  $\beta = 15 \text{ deg}$ ,  $K_I/K_{II} = 0.27$ , 1300/1035.

Figure 11,  $\beta = 15^\circ$ ,  $K_I/K_{II} = 0.27$ .

By now, nearly all of the fiber breaks point left, as shown in the 100X photos. The 800X shows the hackles are nearly vertical - more than expected from the stress analysis. Their spacing has become very irregular. The fiber breaks clearly show the effects of shear direction. Broken fibers pointing to the left have failed in tension. Broken fibers

pointing to the right show a compression mushrooming type of failure. An increase in resin debris, as reported by Hahn and Johannesson [11] is apparent.

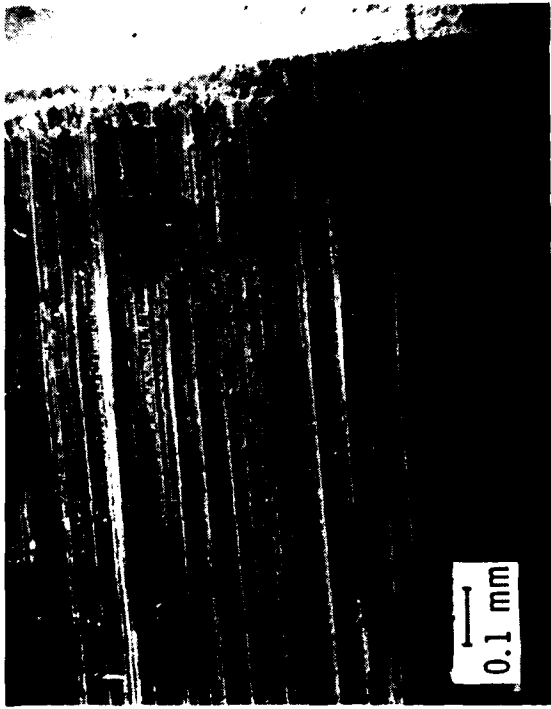
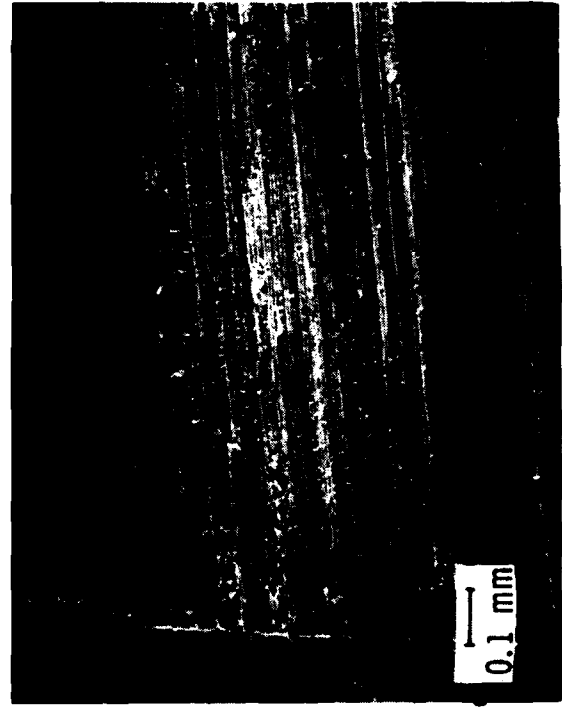
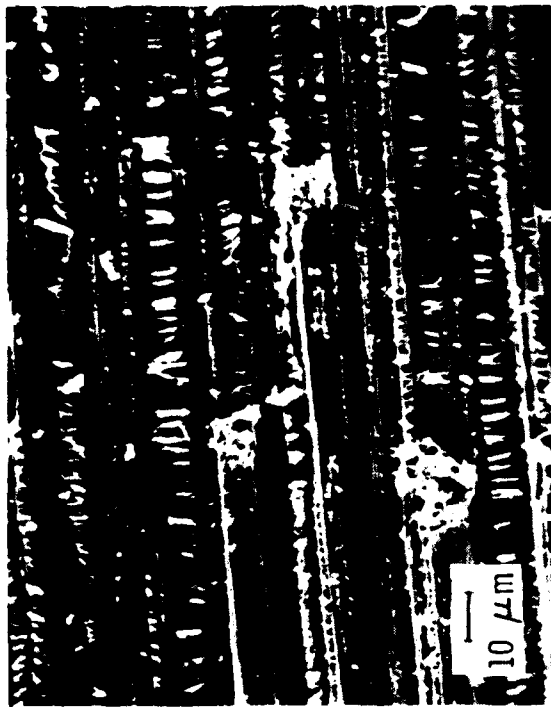
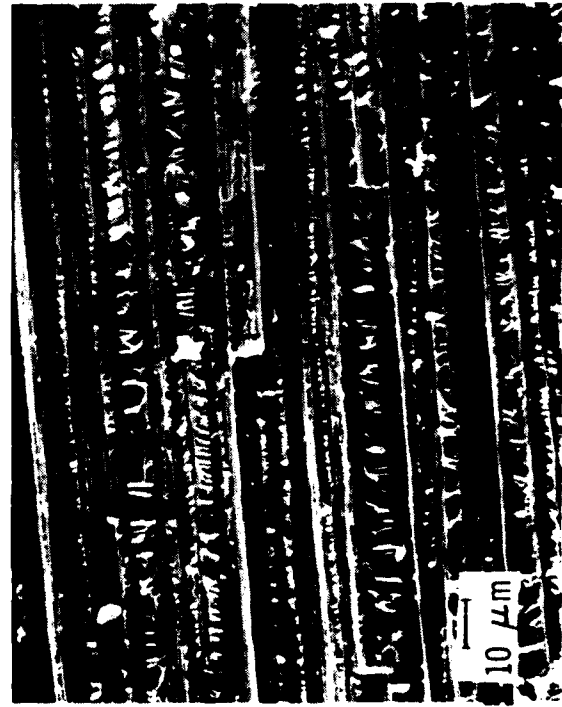
Figure 12.  $\beta = 10 \text{ deg}$ ,  $K_I/K_{II} = 0.18$ . T300/1034c

Figure 12,  $\beta = 10^\circ$ ,  $K_I/K_{II} = 0.18$ .

Fibers broken in tension, 12(d), and compression, 12(c), clearly show shear direction. The hackle spacing is more irregular.

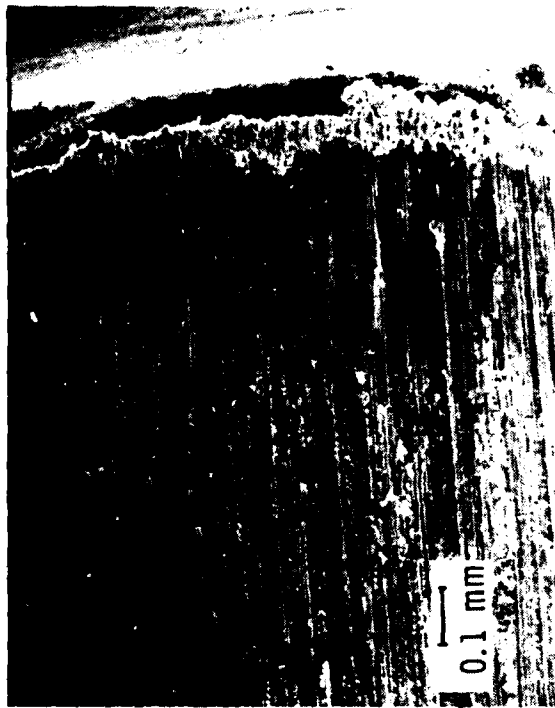
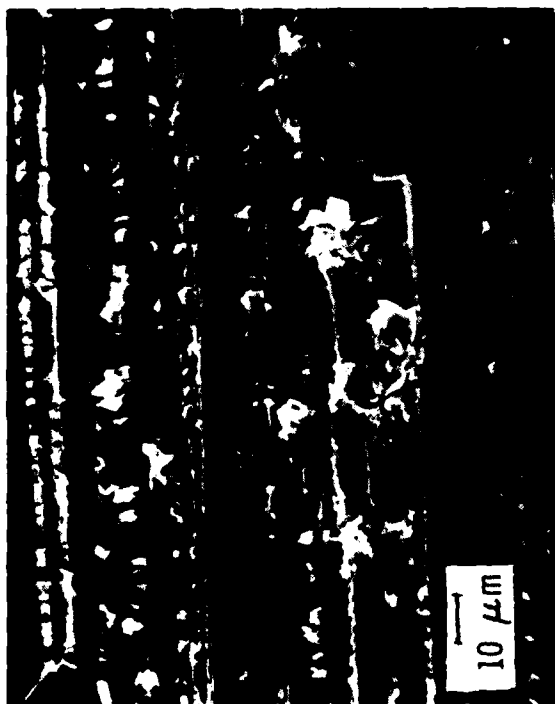
Figure 13. Rail Shear,  $K_{II}$  Only. T300/1034c

Figure 13, Rail Shear,  $K_{II}$  only.

The fiber breaks continue their failure pattern. Some have even segmented and are wedged with resin debris, 13(d). The matrix hackles have become very block-like (they are referred to by Purslow [7] as cusps), and exist only in the deep crevices between fibers. Their spacing is very intermittent. Exposed fiber surfaces are stripped clean.

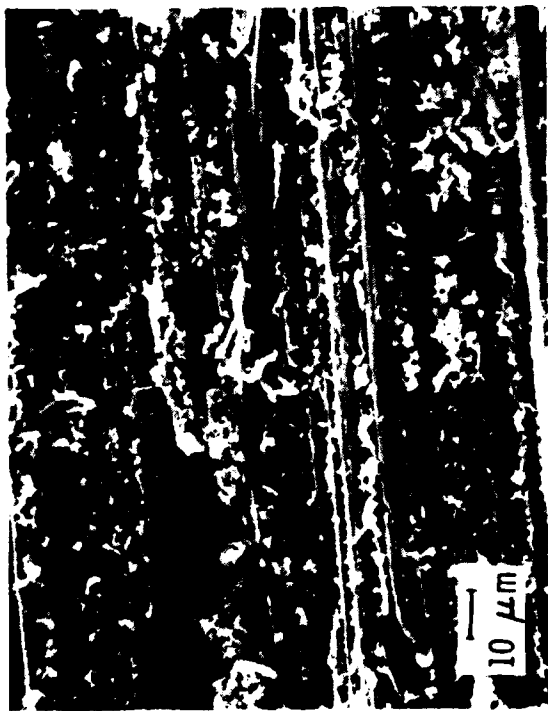
Figure 14. Beta = 15 deg Compression,  $K_I/K_{II} = -0.27$  T300/1034c

Figure 14,  $\beta = 15^\circ$  compression,  $K_I/K_{II} = -0.27$ .

In these photos, the shear direction is opposite to that shown in Figure 6. Note the large amount of resin debris remaining on the surface. Some areas, 14(c), show segmented fibers. The surface has a general ground down appearance, as expected due to friction between the upper and lower surfaces during fracture.

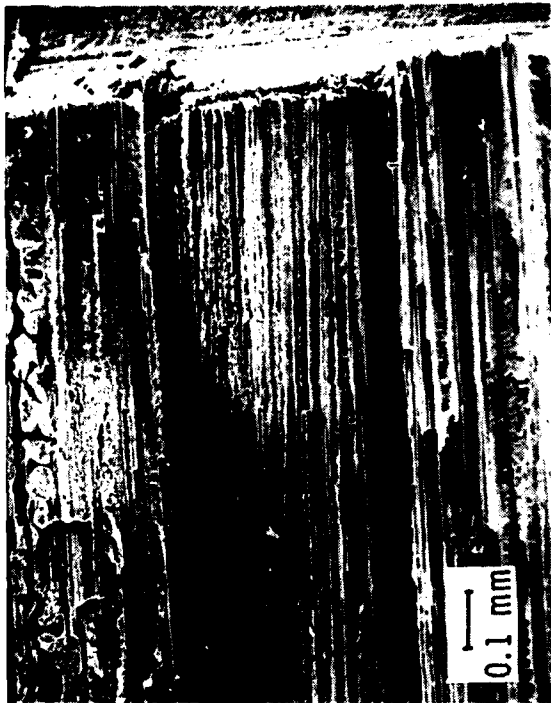
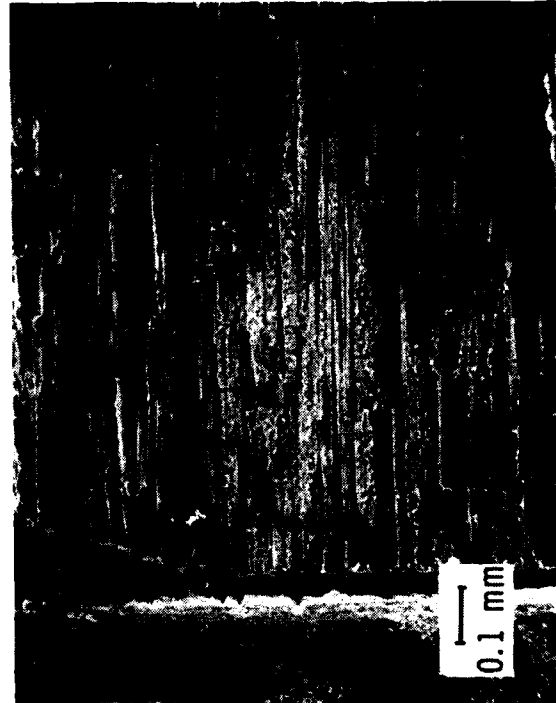
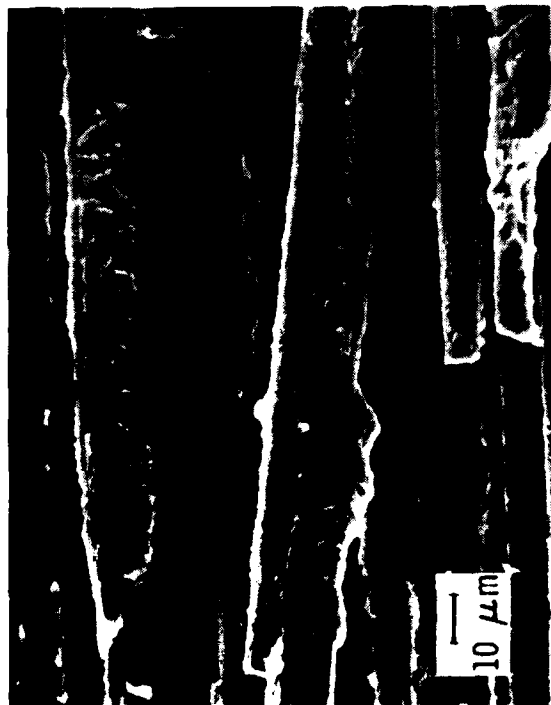
Figure 15. Beta = 90 deg.  $K_T$  Only. APC-1

Figure 15,  $\beta = 90^\circ$ ,  $K_I$  only.

Even at 100X it is obvious that much more energy went into the fracture than into the equivalent epoxy specimen. The surface is very uneven, and some groups of fibers have been pulled up. Higher magnification shows large amounts of resin adhered to the fibers.

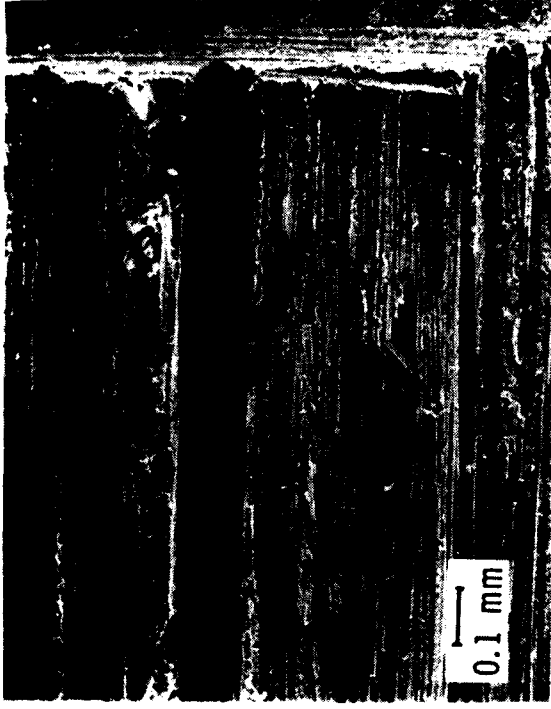
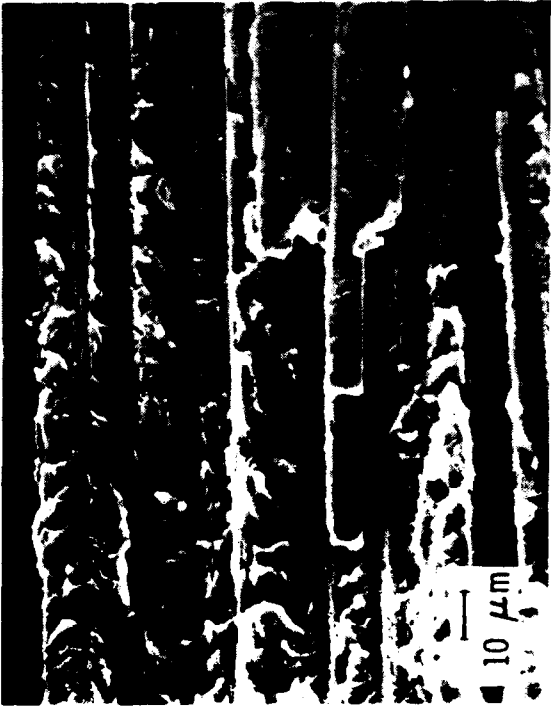
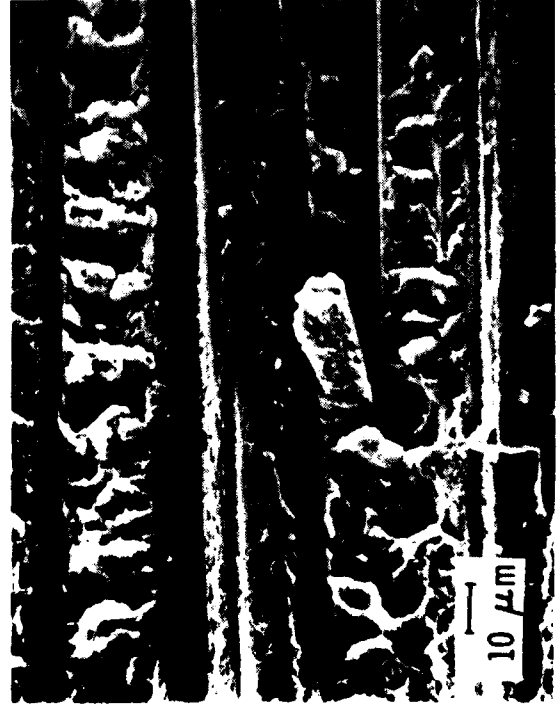
Figure 16. Beta = 45 Co.,  $K_I/K_{II} = 1.0$ . APC-1

Figure 16,  $\beta = 45^\circ$ ,  $K_I/K_{II} = 1.0$ .

The 100X photos show that most broken fibers point to the left on both surfaces. The 800X shots show rough, thick hackles. Figure 16(c) shows tensile, and 16(d), compressive evidence to show shear direction in the graphite/PEEK. This direction agrees with the hackle orientation.

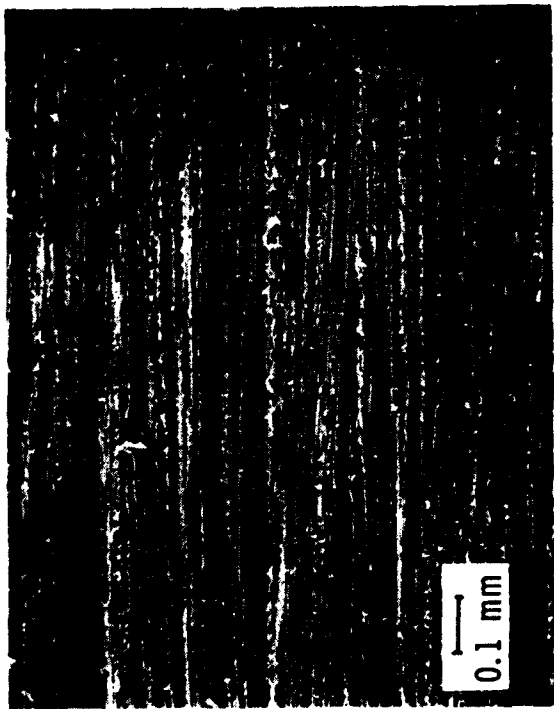
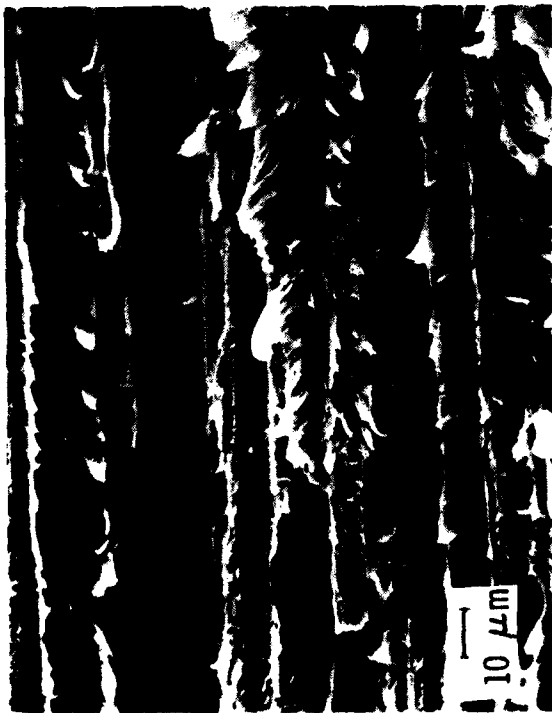
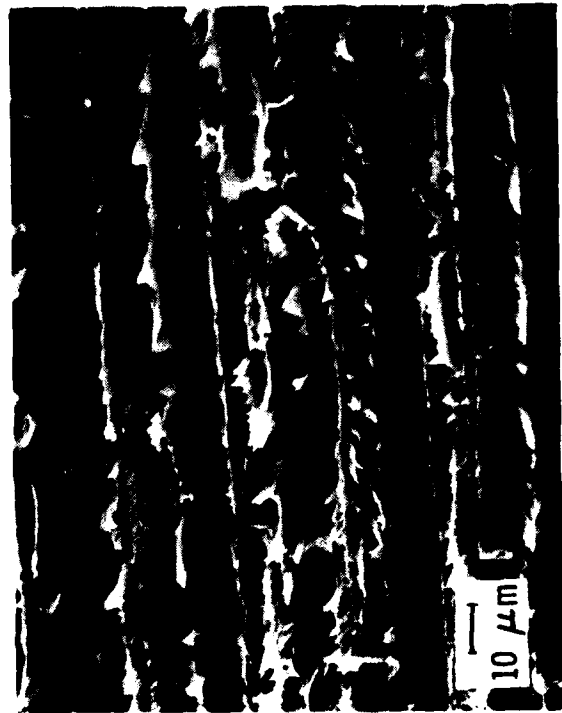
Figure 17.  $\beta = 15 \text{ deg}$ ,  $K_I/K_{II} = 0.27$ . APC-1

Figure 17,  $\beta = 15^\circ$ ,  $K_I/K_{II} = 0.27$ .

A series of pointed spike formations are present in the region of the crack tip. Note they point in the direction of the applied shear stress. These spikes appear as though formed by crazing [12]: As the opposing fracture surfaces displaced under opening and shear forces, the spikes necked down in a ductile manner until they broke off at the mid-section.

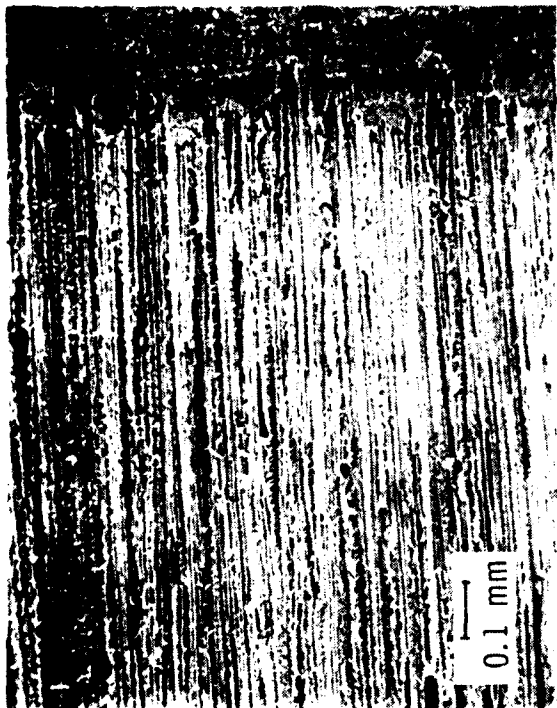
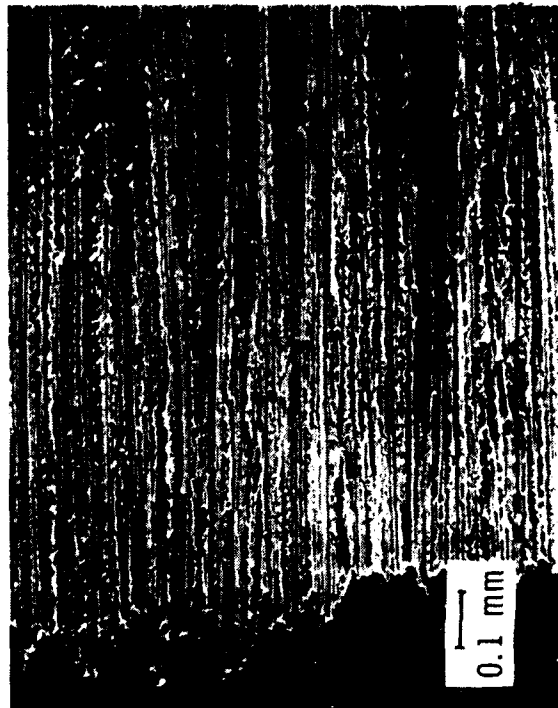
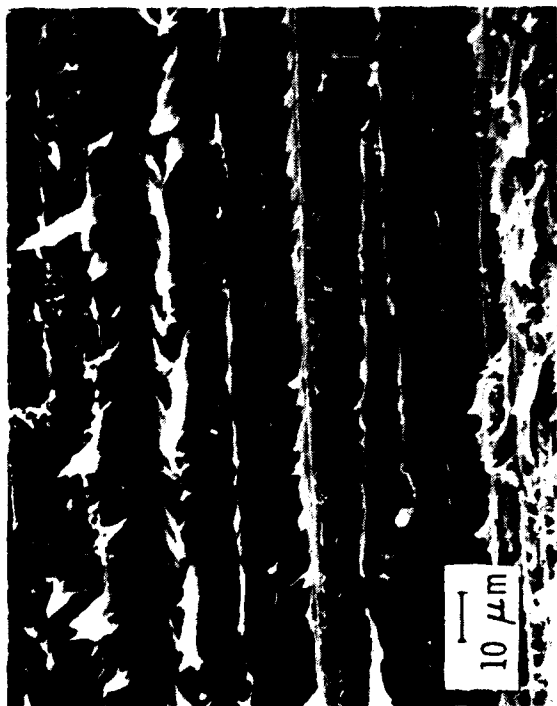
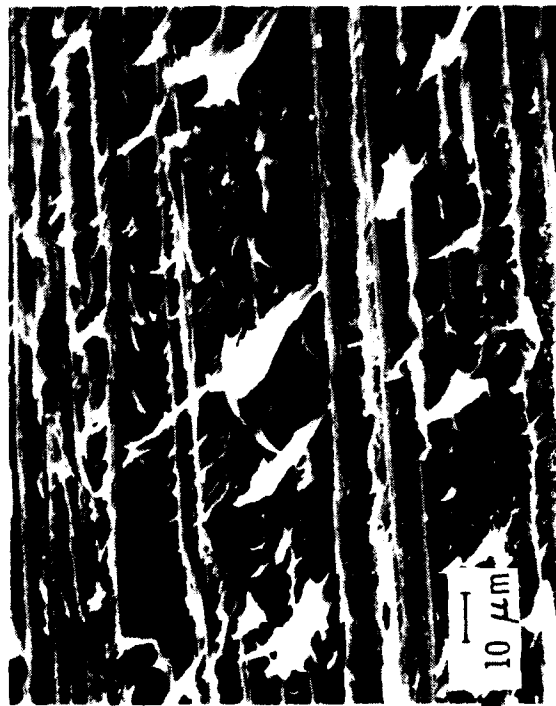
Figure 18.  $\beta = 10 \text{ deg}$ ,  $K_{11}/E_{11} = 0.18$ . APC-1

Figure 18,  $\beta = 10^\circ$ ,  $K_I/K_{II} = 0.18$ .

The spike formations are still prevalent. Figure 18(c) shows tensile and compressive fiber failures. Figure 18(d) shows a rare feature found

on the surface: sheaths from around the fibers pulled-up almost cobra-like.

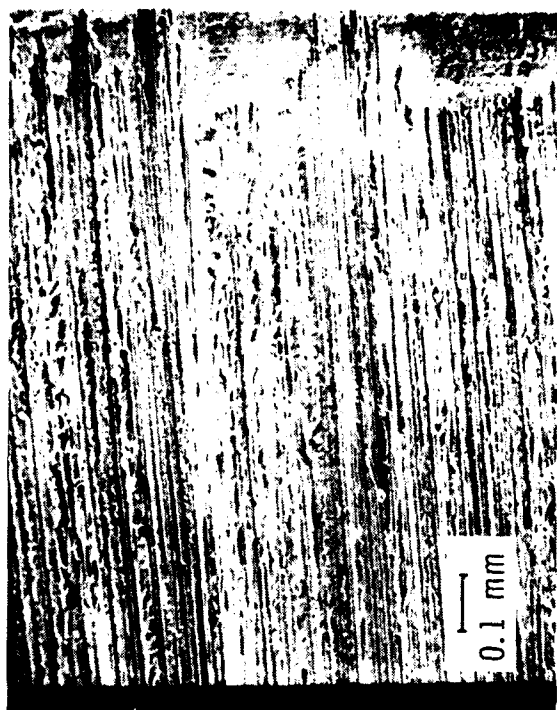
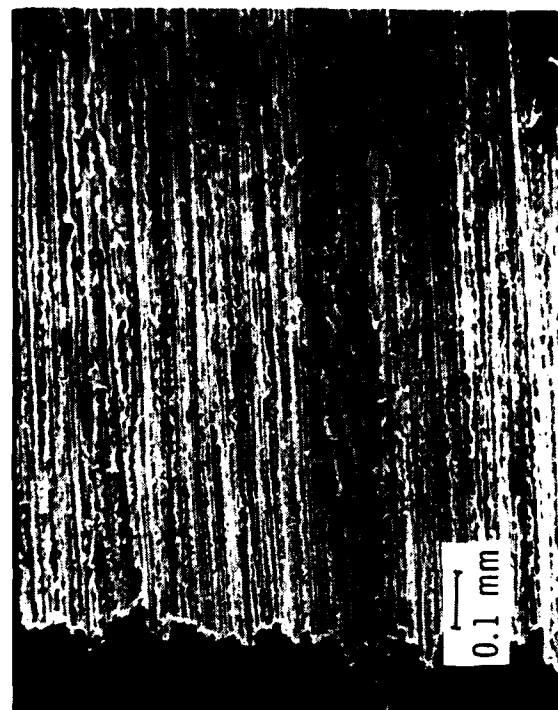
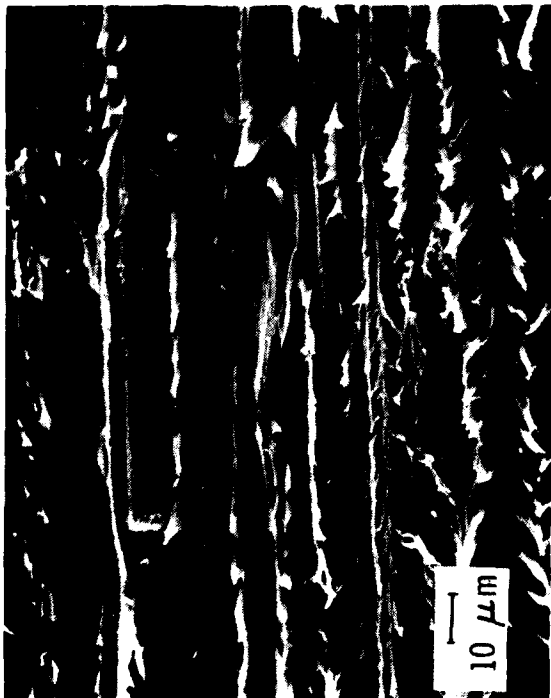
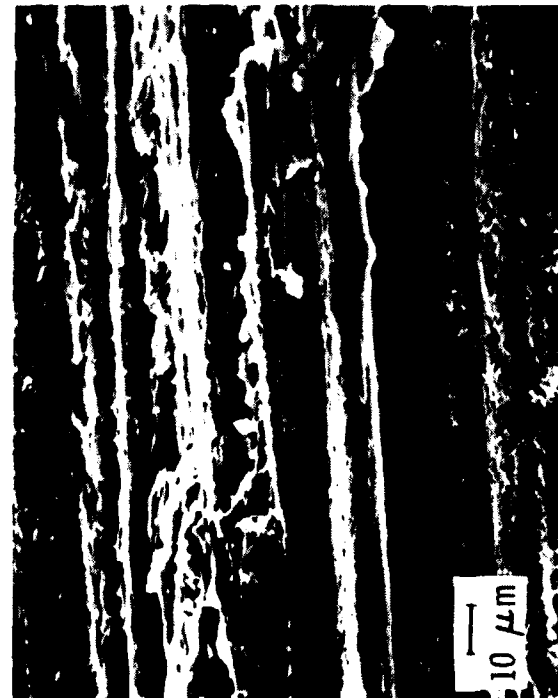
Figure 19. Rail Shear,  $K_{II}$  Only. APC-1

Figure 19, Rail Shear,  $K_{II}$  only.

The spikes in Figure 19(c) are well developed and leaning strongly in the shear direction. Tensile and compressive fiber breaks can be seen in this photograph. There are also smooth bands on the fracture surface, shown in Figure 19(d) at 800X. Compressive fiber failures can be seen in this photo.

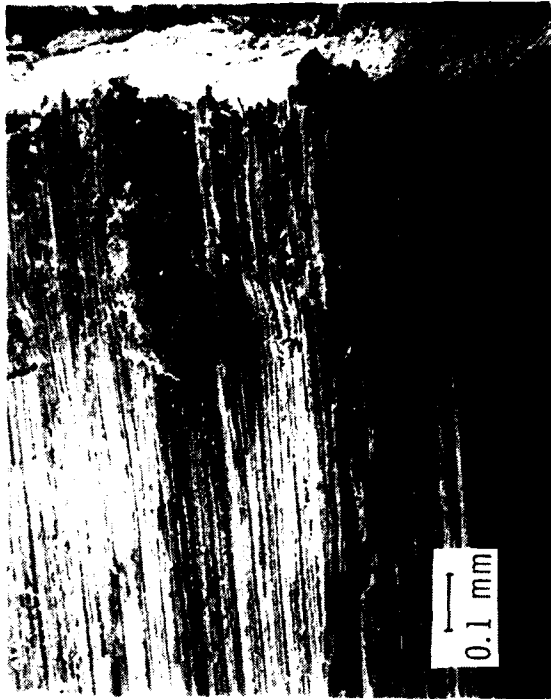
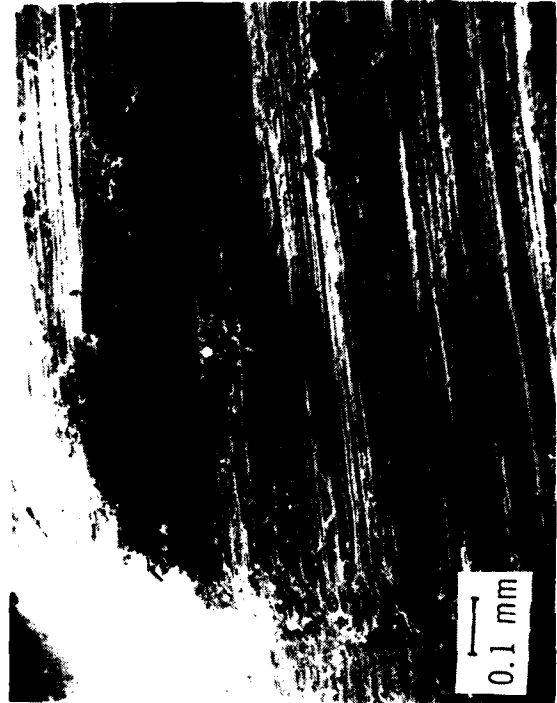
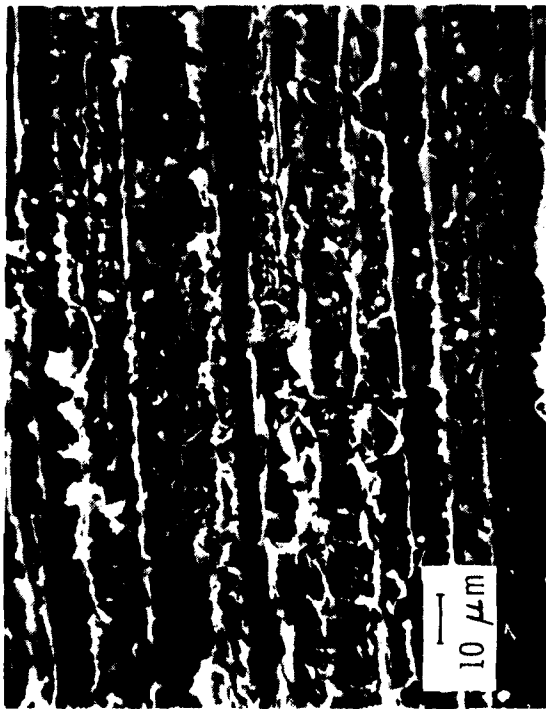
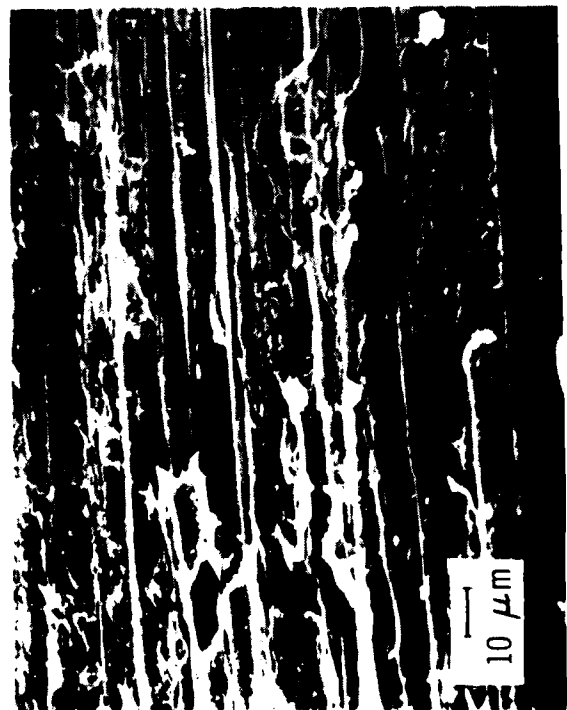
Figure 20.  $\beta_{\text{eff}} = 15$  deg. Compression,  $K_{\text{I}}/K_{\text{II}} = -0.27$ . APC-1

Figure 20,  $\beta = 15^\circ$  compression,  $K_I/K_{II} = -0.27$ .

The surface at 100X shows the specimen buckling that occurred in compression. The surface had several zones. One type, as shown in Figure 20(c), was mottled and had much debris. The second type was smoother and darker, 20(d).
