# FIELD EVALUATION OF THE WATER WEDGE FOR CUTTING PORTLAND CEMENT CONCRETE PAVEMENTS FOR REPAIR AND RESTORATION OF PAVED SURFACES (REREPS)

David M. Coleman

Waterways Experiment Station, Corps of Engineers  
PO Box 631, Vicksburg, Mississippi 39180-0631

January 1986  
Final Report

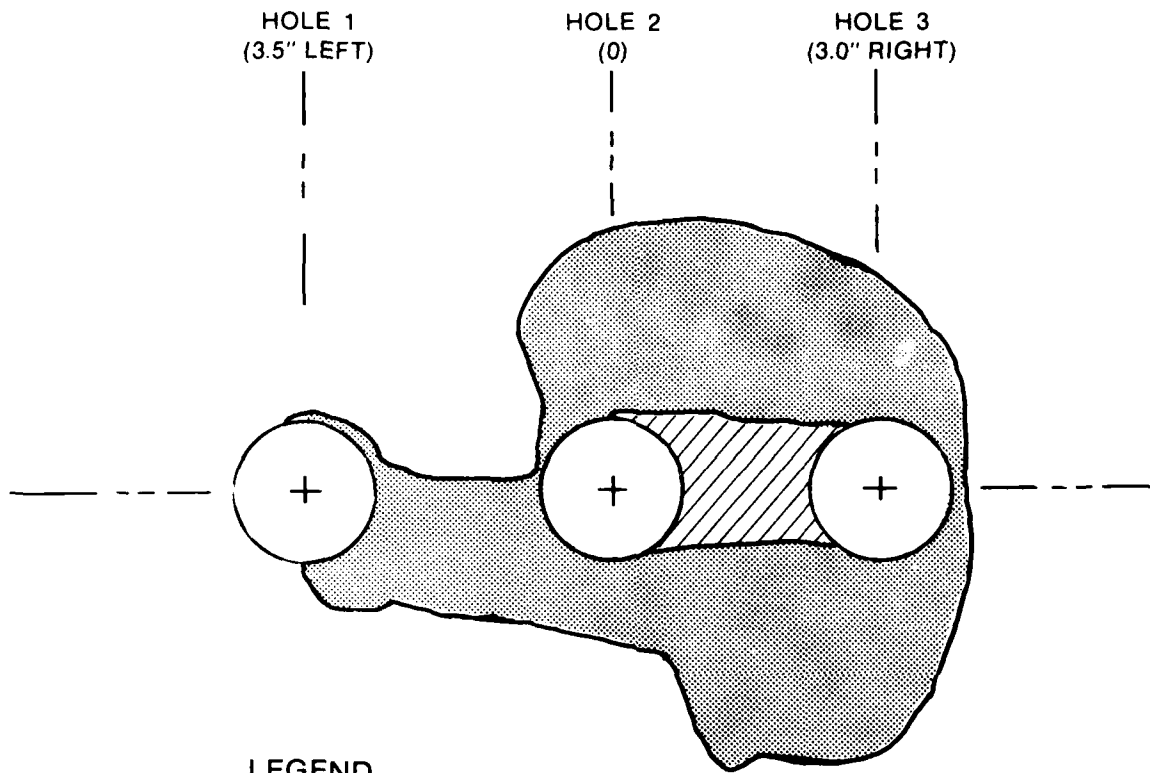
12. No cracks were generated in Tests 1 and 2; therefore, it was decided to change the approach. In Test 1A, three holes were drilled in the pavement spaced 3 in. apart as shown in Photo 7. The device was discharged in the center hole. The first 100 percent charge shot resulted in only spalling around the top of the holes as shown in Figure 1 and Photo 8. No cracking was observed on the pavement surface or the interior walls of the holes. After the second shot of a 100 percent charge in the center hole, some additional spalling was observed between holes 2 and 3 as shown in Figure 2 and Photo 9. Two hairline cracks were observed inside the center hole at the locations shown by the arrows in Figure 2. These cracks began approximately 1 in. below the pavement surface and extended downward into the pavement. The third shot of a 100 percent charge in the center hole resulted in little additional spalling and no observable change in the width of the cracks. Once again the device was wedged in the hole; however, it was easily removed by jacking it out as shown in Photo 10. Figure 3 shows the extent of spalling at this time.

Figure 1. Spall depths after test 1A, shot 1

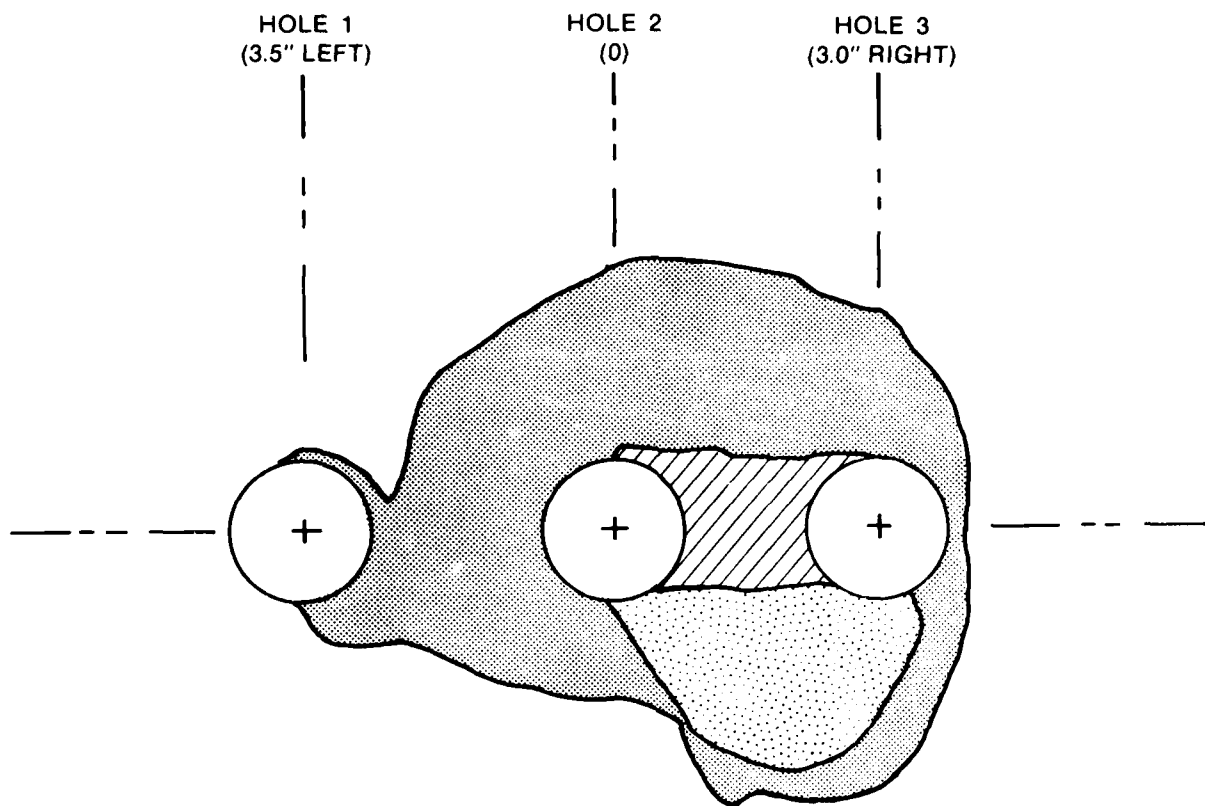
Figure 2. Spall depths after test 1A, shot 2

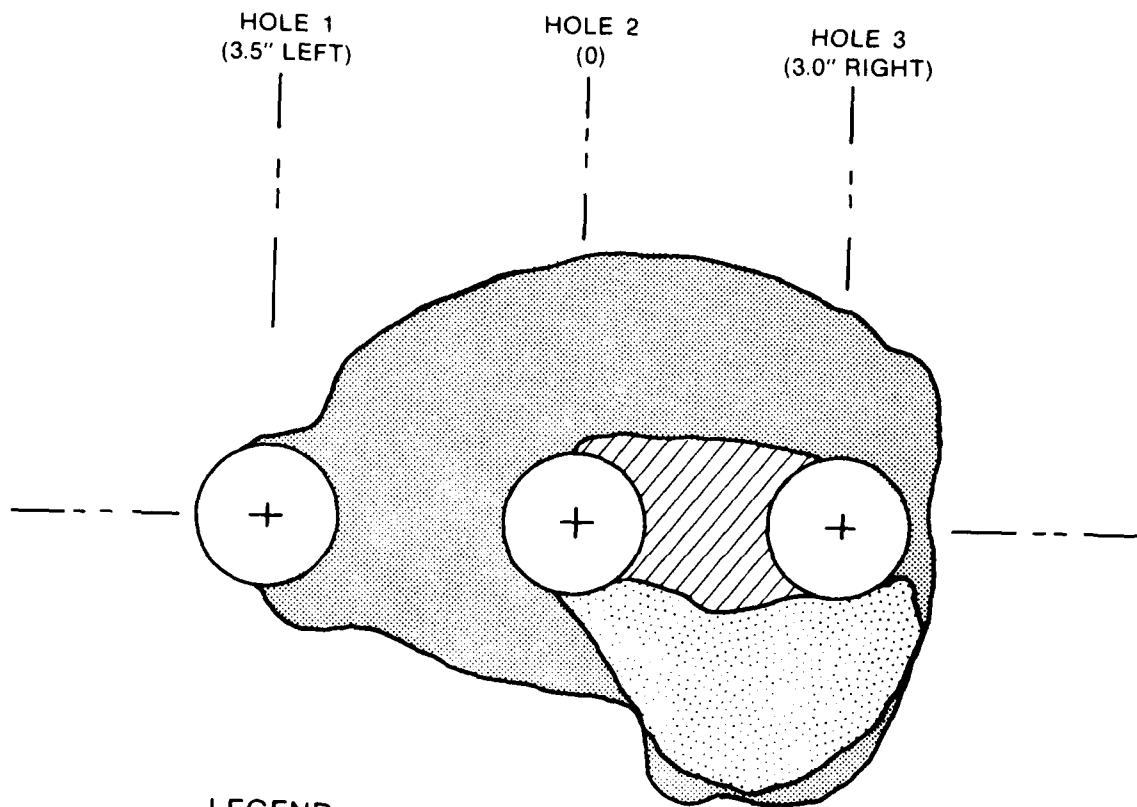
Figure 3. Extent of spalling after test 1A, shot 3

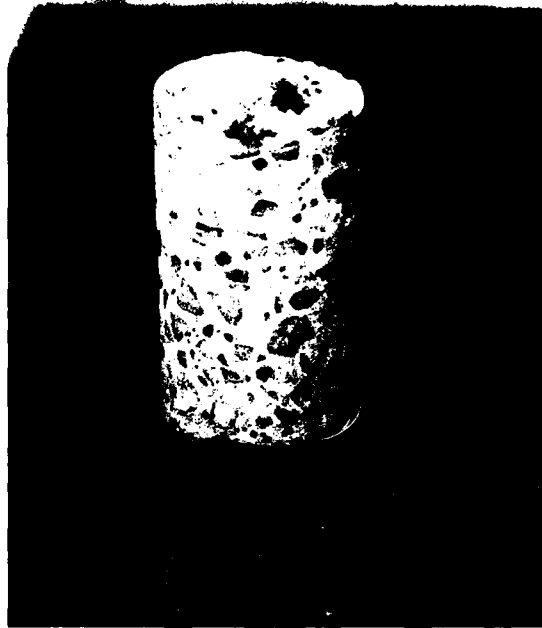
taken from Test Area 1A. This core included holes 2 and 3. The core was cracked completely through as seen in Photos 11 and 12; however, the crack was not large enough to break the core into two pieces when it was removed from the core barrel.

Photo 11. Core taken from test 1A  
(west side between holes 1 and 2)

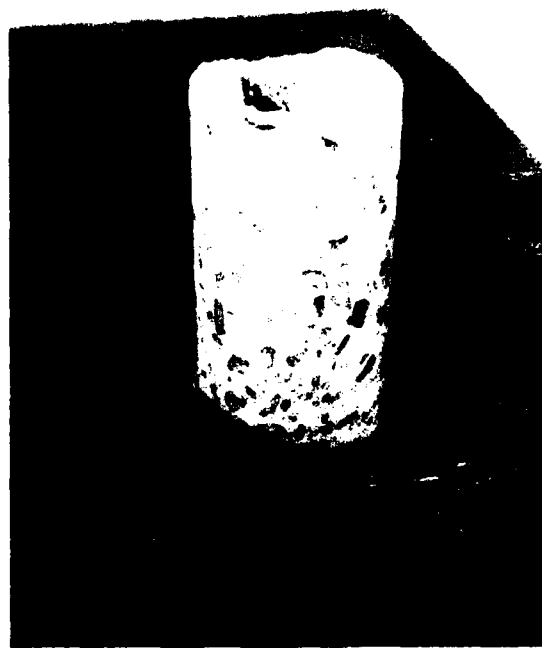
Photo 12. Core taken from test 1A  
(east side between holes 2 and 3)

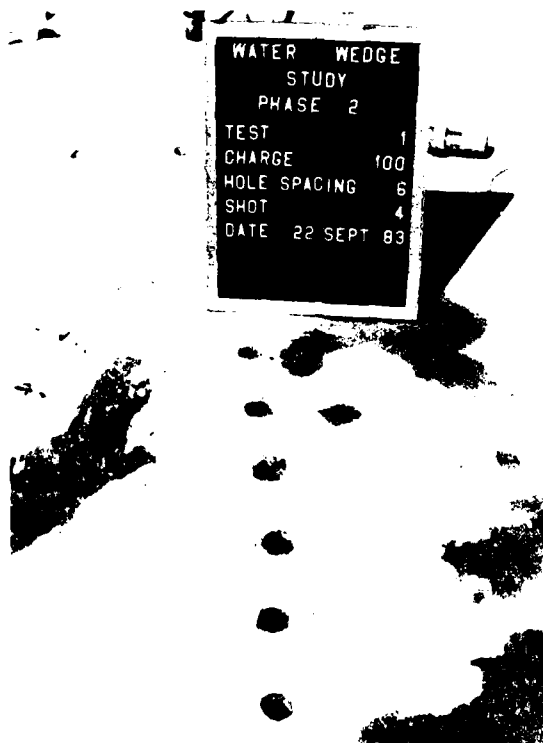
Photo 15. Extent of cracking after test 1, shot 4

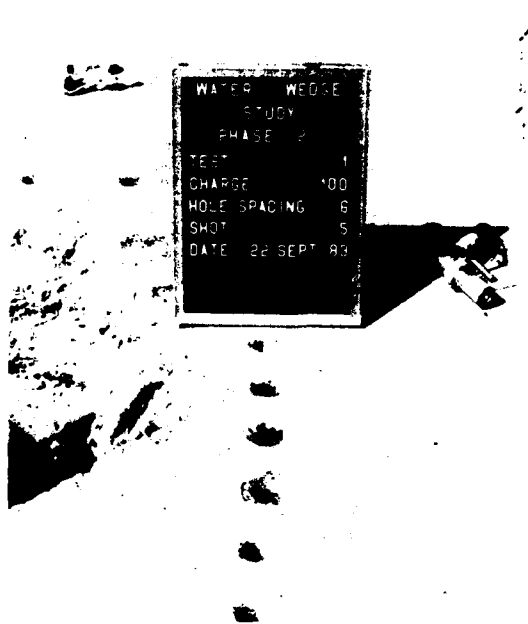
Photo 16. Extent of cracking and spalling after test 1, shot 5

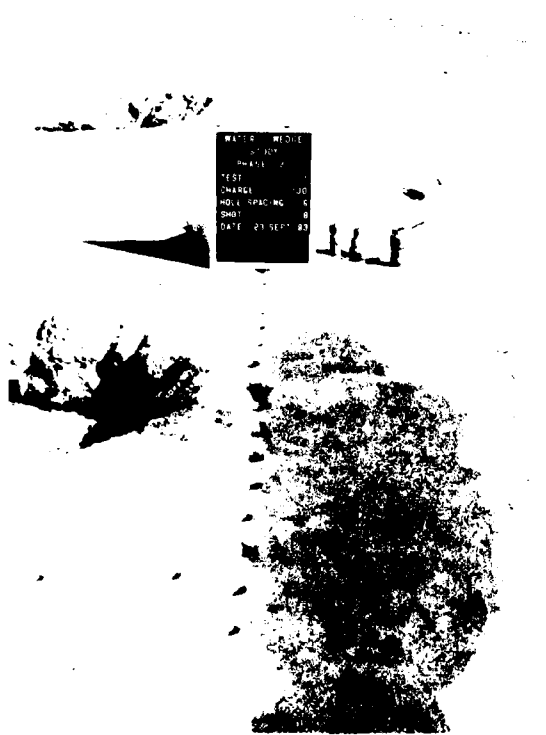
around the top of the hole. The crack extends from hole 1L to hole 1R along previously existing cracks with new hairline cracks formed from hole 1R to hole 4R. Photo 17 shows the extent of cracking and spalling existing at this time. In Shot 7 the device was discharged in hole 0 again resulting in spalling that completely removed the top 3/8 in. of concrete between holes 0 and 1L. The existing cracks between hole 0 and hole 1R widened to approximately 1/16 in. on the surface. The existing crack between holes 1R and 2R appears slightly wider. New hairline cracks are formed from hole 4R to approximately 3 in. past hole 6R and from holes 4L to 8L. Photo 18 shows the extent of cracking at this time. The fourth shot (Shot 8) in hole 0 resulted in no apparent increase in spalling. The crack between hole 0 and hole 1R is slightly wider. New hairline cracks were formed between holes 5R and 6R, 2R and 3R, 3R and 4R, and 4L and 5L. The extent of cracking and spalling present at the end of Test 1 is shown in Photo 19.

Photo 19. Cracking and spalling after test 1, shot 8

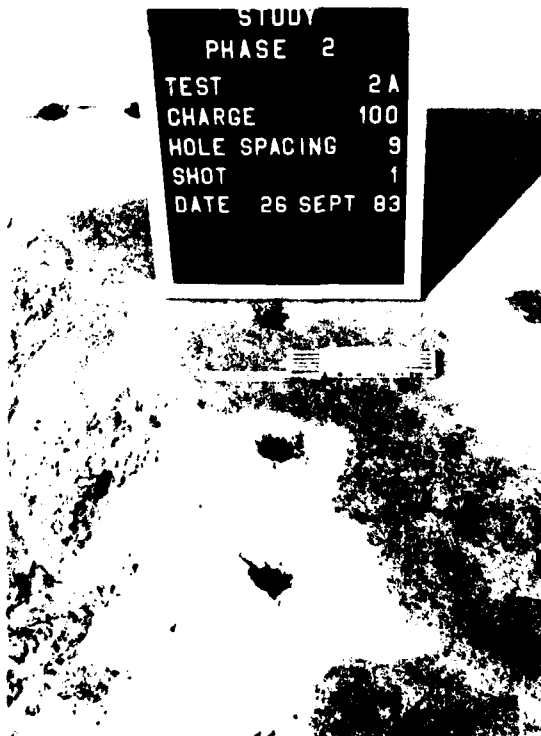
18. Test 2 was repeated with the devices in holes spaced 9 in. apart in holes 6 in. from the crater edge. The devices were fired simultaneously resulting in spalling around the top of both holes along with hairline cracks between the holes. Photo 21 shows the results of Test 2A. A core taken from between the holes indicates vertical hairline cracks extending through the core; however, these cracks did not come completely through as no cracking was observed on the bottom of the core.

Photo 21. Cracking and spalling resulting from test 2A

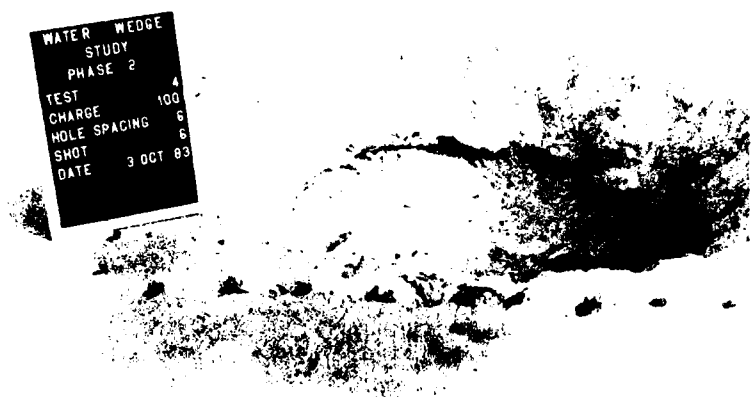
Photo 28. Extent of cracking and spalling after shot 6, test 4

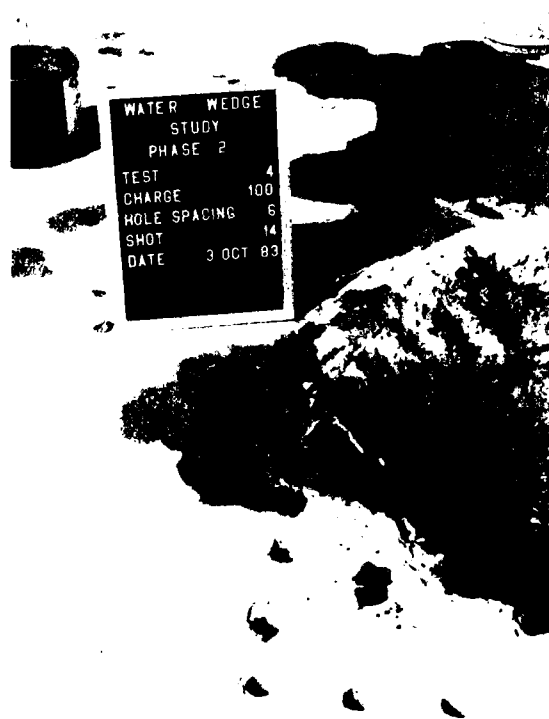
Photo 29. Extent of cracking and spalling after shot 15, test 4
