## FAILURE ANALYSIS OF COMPOSITE STRUCTURE MATERIALS

Brian Smith  
Ray Grove  
Thomas Munns  
Boeing Military Aircraft Company  
P.O. Box 3707 M/S 73-43  
Seattle, WA 98124

May 1986  
Interim Report for 18 July 1984 to 1 October 1985

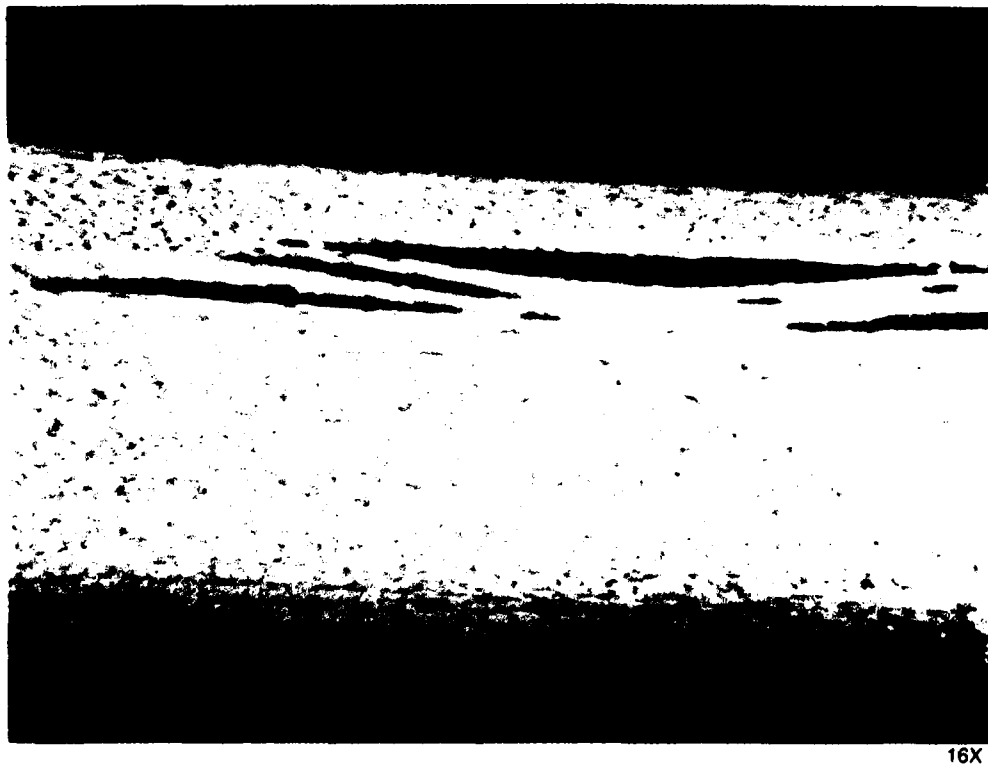
This specimen was rejected and cross-sectioned at location A-A (Figure 3.2.1-4) for evaluation of defect condition. The specimen baseline output symbol is 1. For this program, specimens having areas greater than 322 cm<sup>2</sup> (0.05 inch<sup>2</sup>), and exhibiting ultrasonic attenuation indications three levels higher than specimen baseline were rejected. One numerical level change is equal to a six dB change in sound transmittance.

**Figure 6-8.** Cross section A-A (Figure 6-7) of TTU Identified Defect, Showing Localized Voids in Laminate

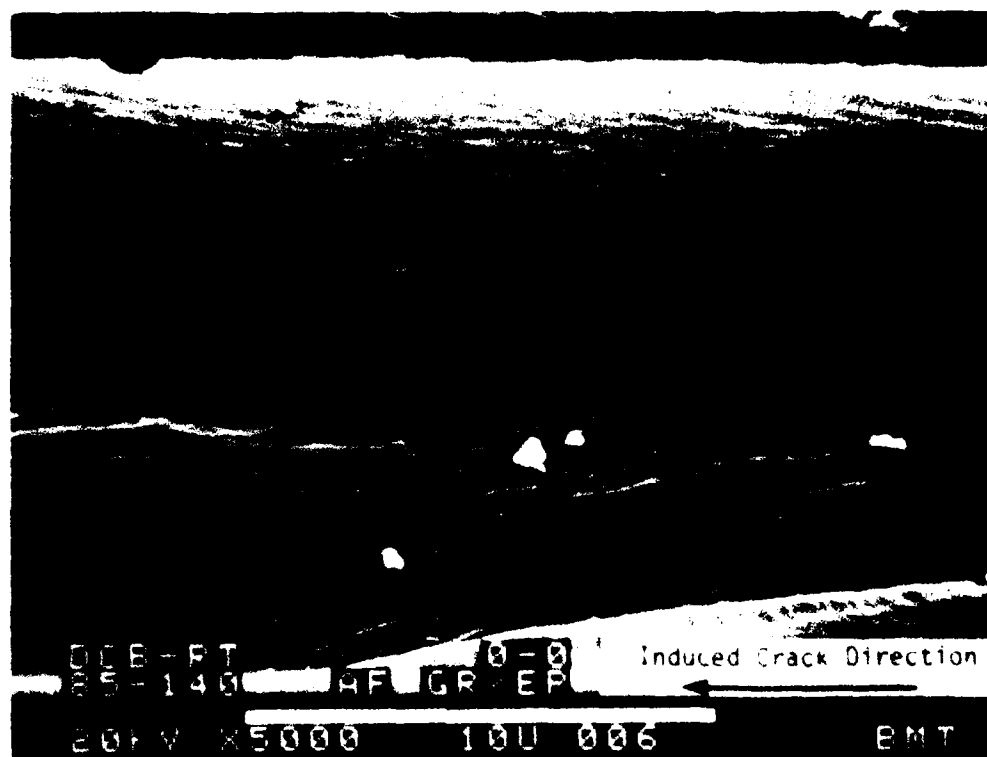
**Figure 7-3. Photomicrograph Illustrating Adhesive Areas of Fiber/Matrix (F) Separation and Textured Microflow (T)**

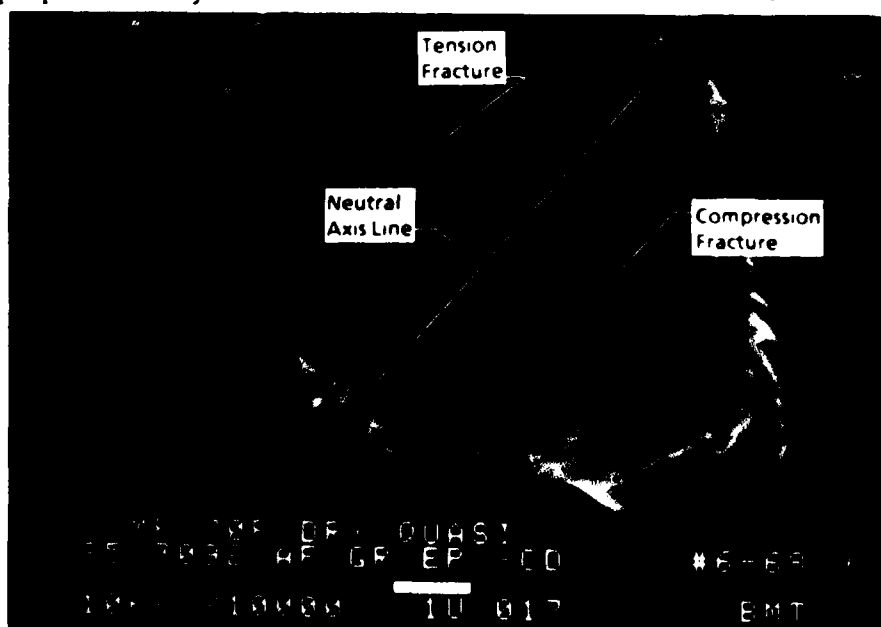
**7.53. Typical Fiber End Fracture; Representative of Fiber Flexure Fracture**
