Corrosion Phenomena During Overcharge
in Polymer Electrolyte Cells

M.Z.A. Munshi
R. Gopaliengar
B.B. Owens

Department of Chemical Engineering and Material Science
Corrosion Research Center
University of Minnesota
221 Church St. SE
Minneapolis, MN 55455
USA

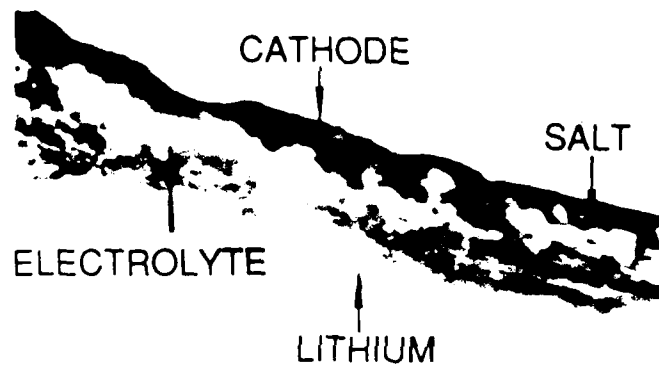
Figure 4. Cross-sectional view of cell #1

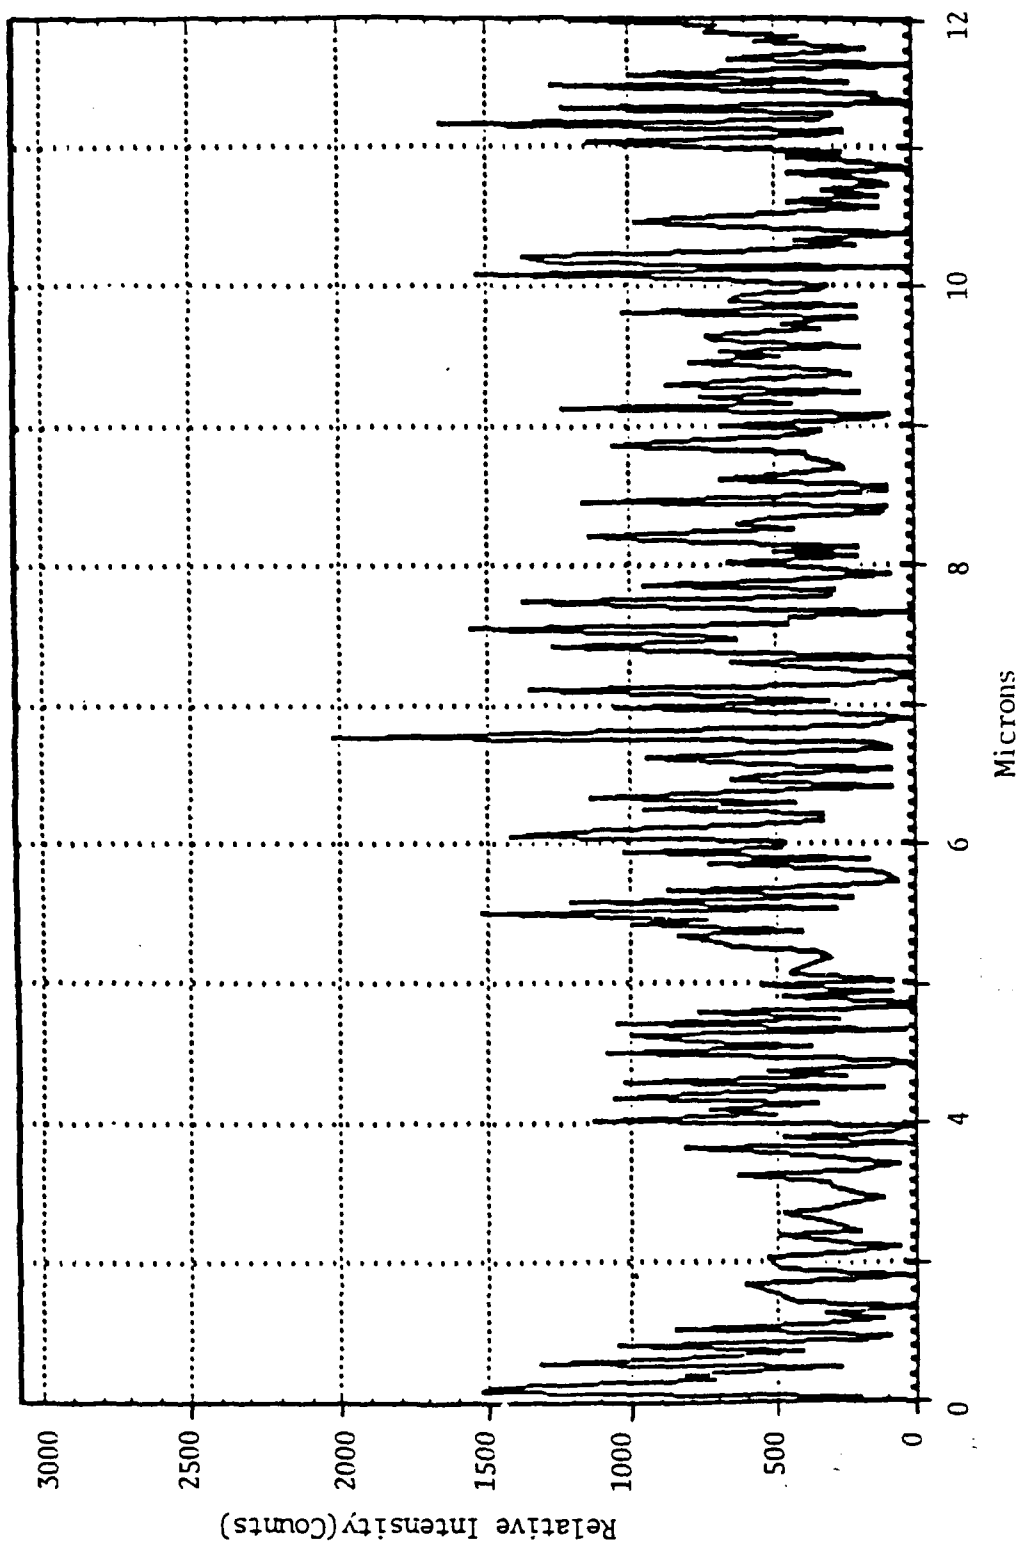
Auger microprobe analysis was made on the electrolyte cross-section for vanadium. Figure 8 shows such a scan indicating vanadium to be present virtually throughout the electrolyte.

Figure 8. Auger microprobe line scan across the electrolyte cross-section for vanadium.

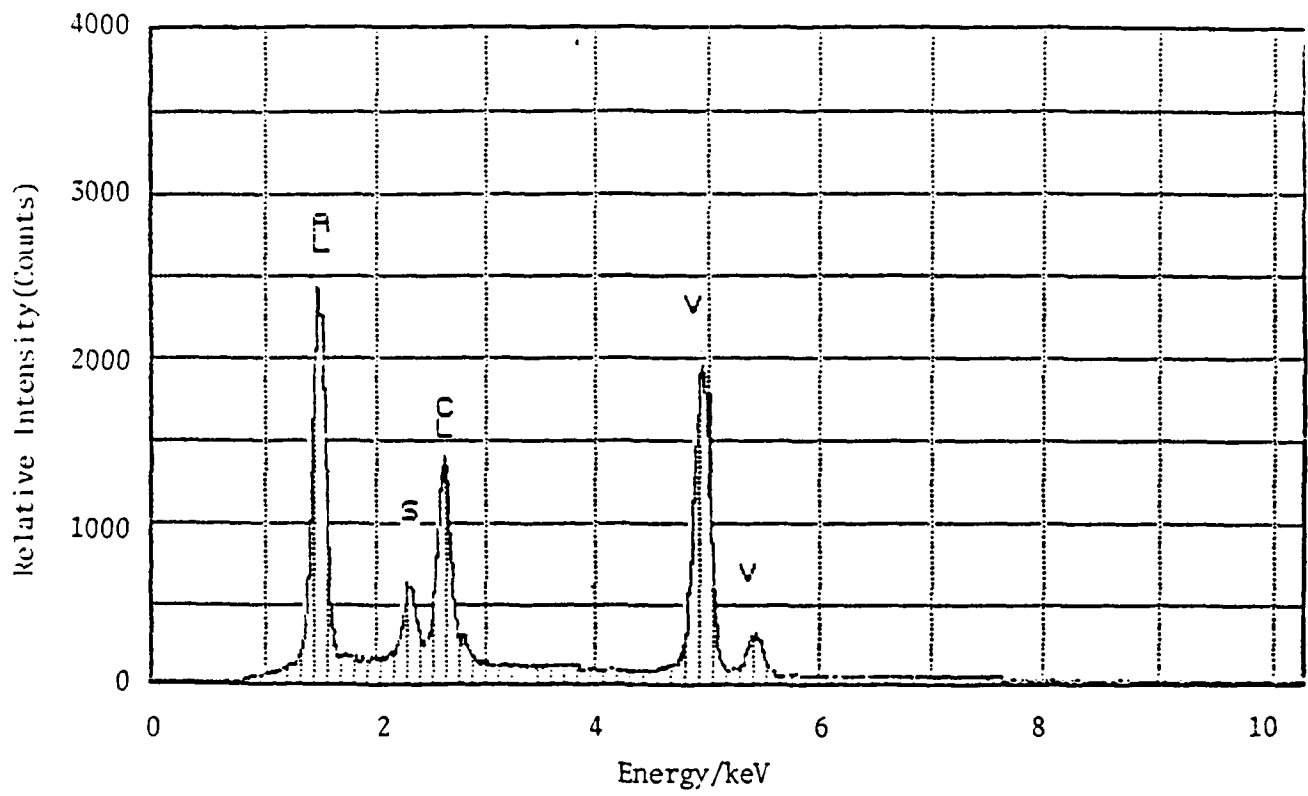
analysis of this surface indicated the presence of Al, Cl, S and V (Figure 12). A Cl x-ray map of this surface revealed that the Cl was situated in localized areas (Figure 13). More remarkable was that the Al was also only present in these same localized clusters (Figure 14). It is well known that Al has a strong affinity for Cl, but the presence of both elements in the same region may just be coincidental.

Figure 12. EDAX analysis of the lithium surface (cell # 4).

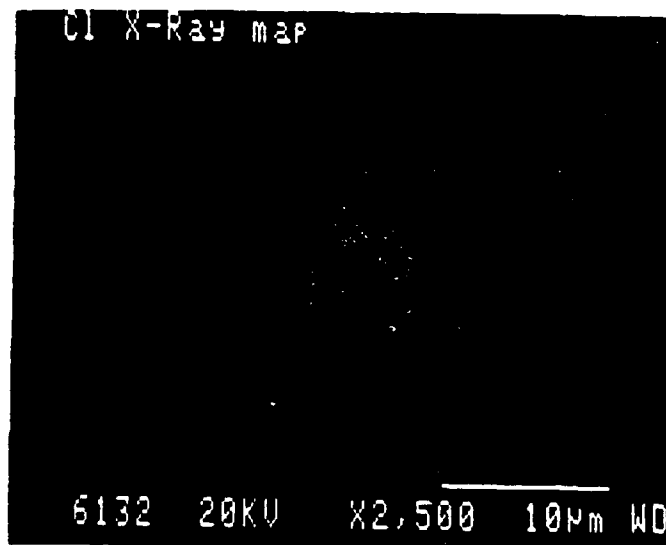
Figure 13. X - ray mapping of Cl on the lithium surface (cell #4).

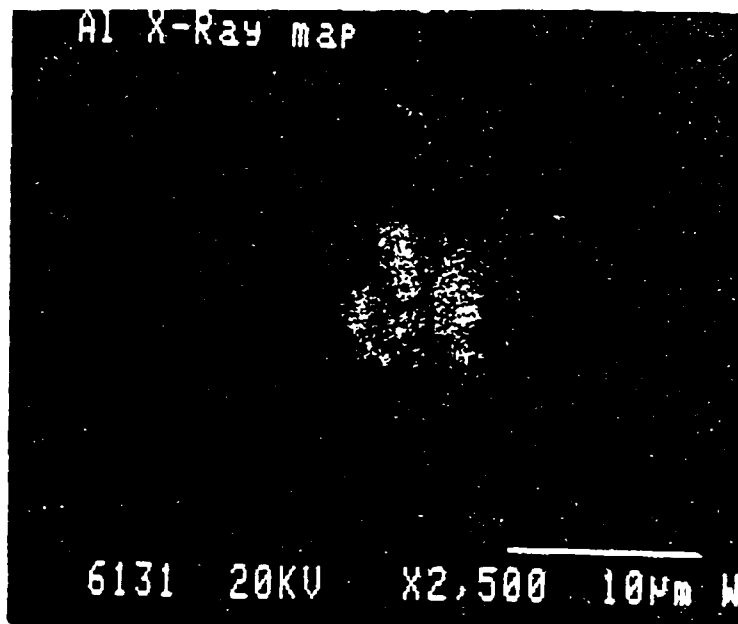
The microscopic evidence provided from this cell clearly suggest that at the potential of about +4V, the reactions occurring in the cell during overcharge are mainly based on corrosion from the cathode. In addition to the V_6O_{13} migration, the Al backing for the cathode is corroding and migrating to the Li surface. This is supported not only from physical observation of the Al, but also from evidence provided by elemental Al analysis. The results also support the conclusion that at this potential neither the electrolyte nor the cathode undergo degradation. This explains the constancy in the potential-time curves during overcharge whereby a simple steady-state corrosion of the Al and vanadium oxide take place.

Figure 14. X - ray mapping of Al on the lithium surface (cell #4).
