| 4. PERFORMING ORGANIZATION REPORT NUMBER(S)<br><b>ONR Technical Report 19</b> | | | 5. MONITORING ORGANIZATION REPORT NUMBER(S) | |
| 11. TITLE (Include Security Classification)<br><b>Corrosion Phenomena During Overcharge in Polymer Electrolyte Cells</b> | | | | |

Corrosion Phenomena During Overcharge  
in Polymer Electrolyte Cells

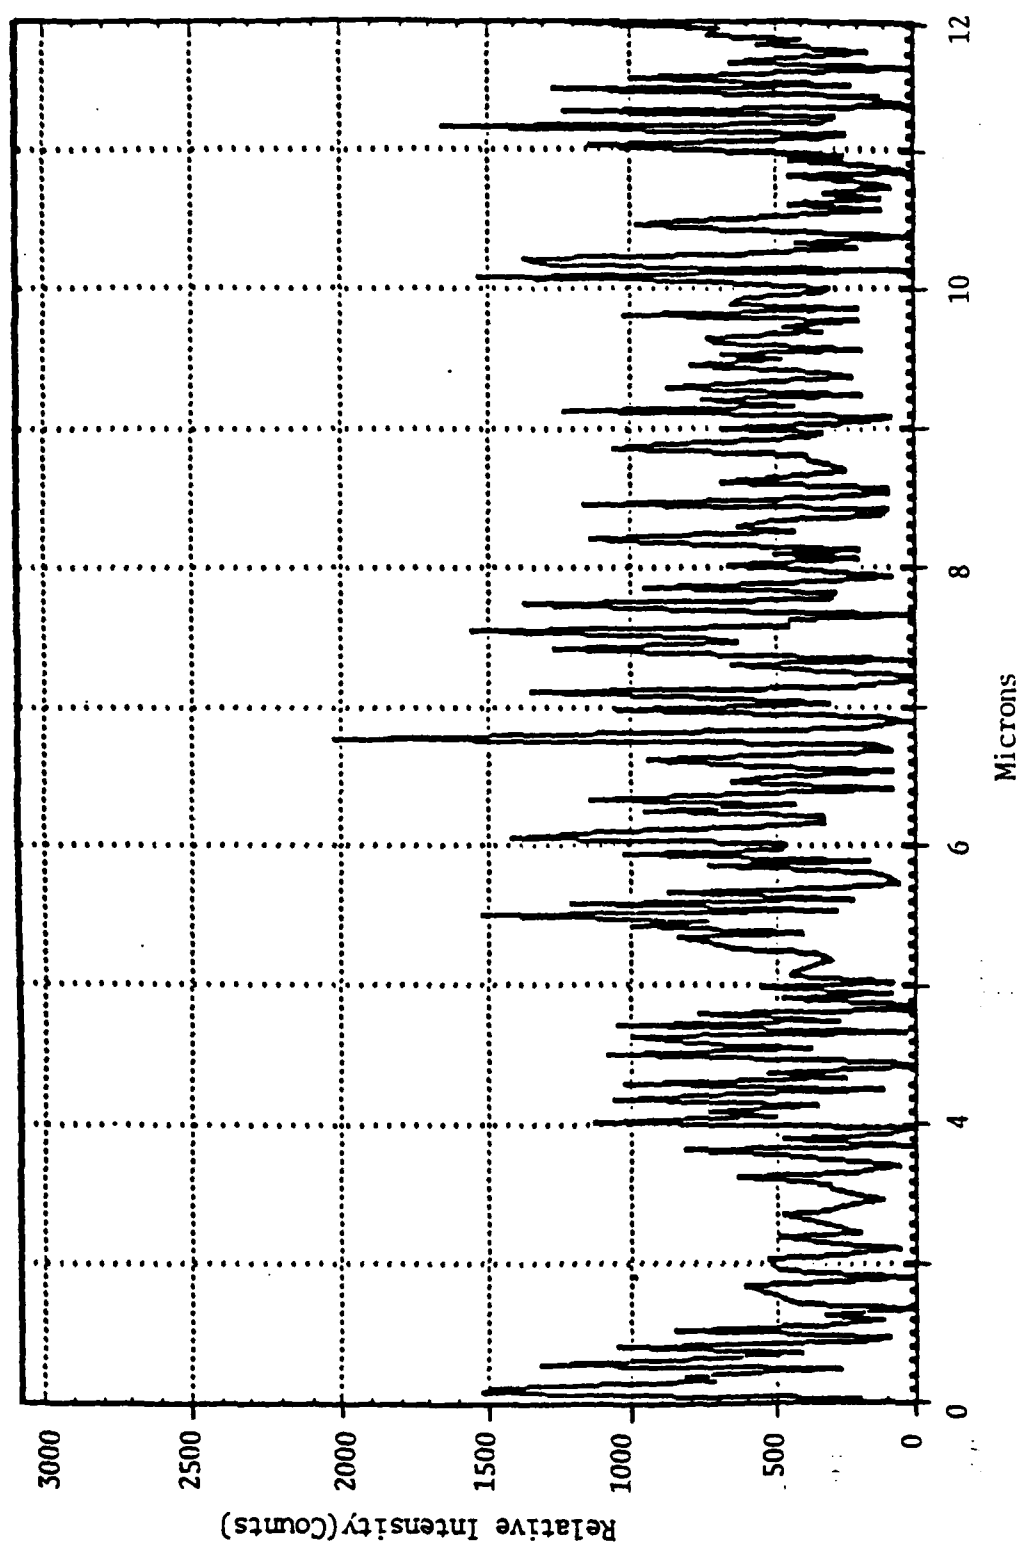
Auger microprobe analysis was made on the electrolyte cross-section for vanadium. Figure 8 shows such a scan indicating vanadium to be present virtually throughout the electrolyte.

Figure 8. Auger microprobe line scan across the electrolyte cross-section for vanadium.

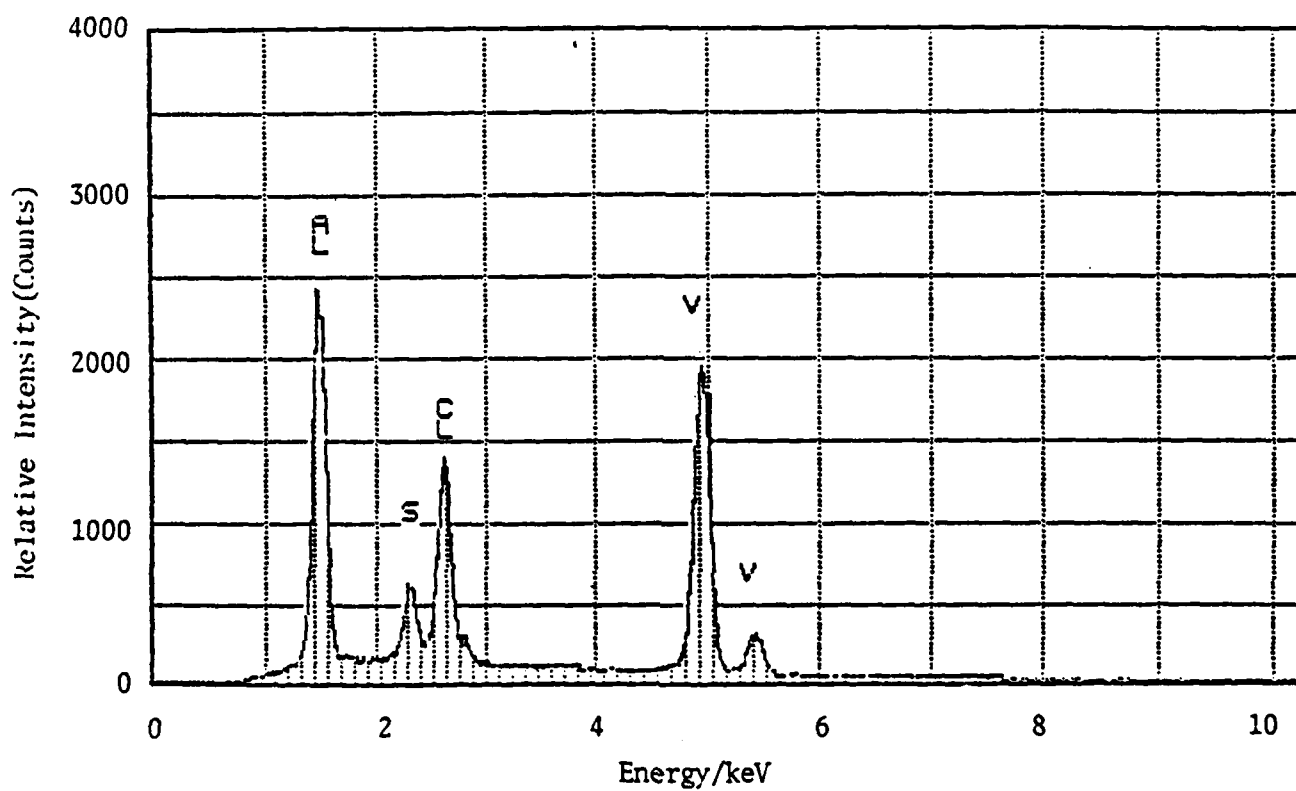
analysis of this surface indicated the presence of Al, Cl, S and V (Figure 12). A Cl x-ray map of this surface revealed that the Cl was situated in localized areas (Figure 13). More remarkable was that the Al was also only present in these same localized clusters (Figure 14). It is well known that Al has a strong affinity for Cl, but the presence of both elements in the same region may just be coincidental.

Figure 12. EDAX analysis of the lithium surface (cell # 4).

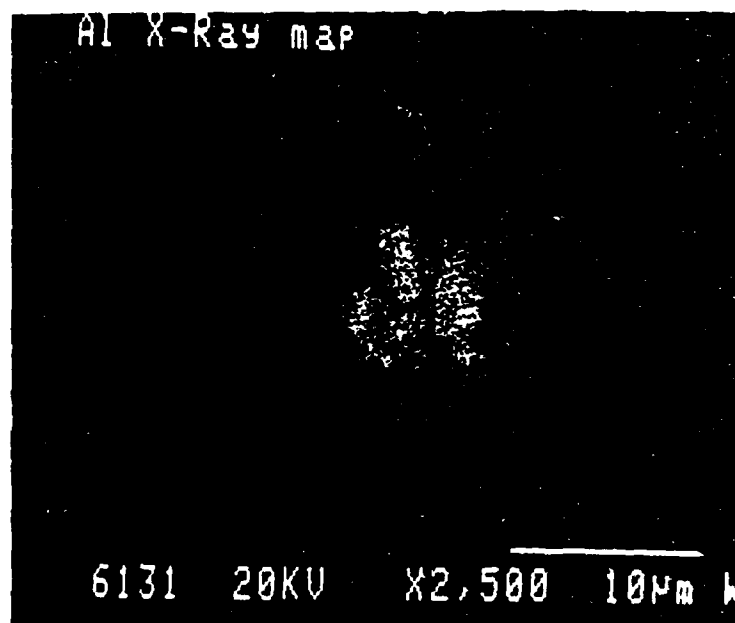
The microscopic evidence provided from this cell clearly suggest that at the potential of about +4V, the reactions occurring in the cell during overcharge are mainly based on corrosion from the cathode. In addition to the  $V_6O_{13}$  migration, the Al backing for the cathode is corroding and migrating to the Li surface. This is supported not only from physical observation of the Al, but also from evidence provided by elemental Al analysis. The results also support the conclusion that at this potential neither the electrolyte nor the cathode undergo degradation. This explains the constancy in the potential-time curves during overcharge whereby a simple steady-state corrosion of the Al and vanadium oxide take place.

Figure 14. X - ray mapping of Al on the lithium surface (cell #4).
