US Army Corps  
of Engineers  
Construction Engineering  
Research Laboratory

USA-CERL TECHNICAL REPORT N-88/21  
August 1988

# An Economic Assessment of Renovating Temporary Wood Frame Buildings

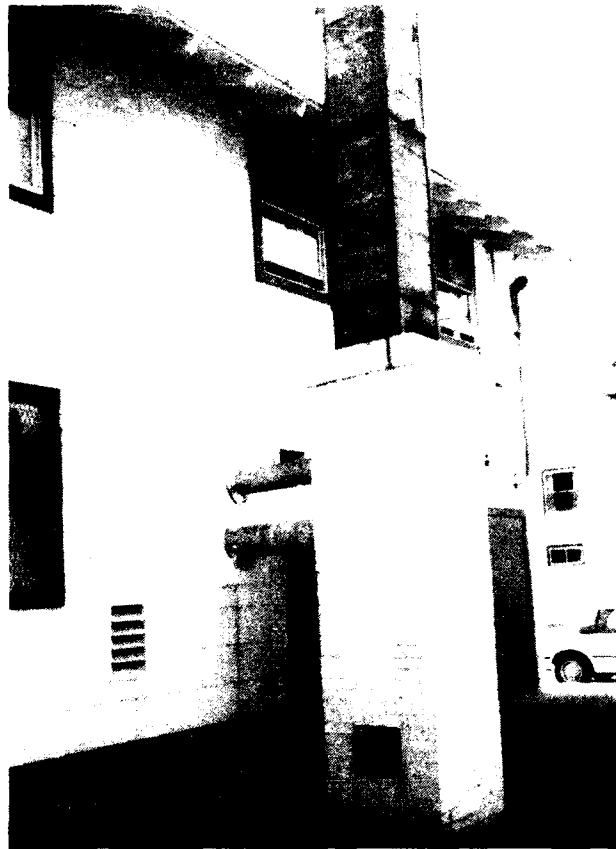
**Figure 3. Free-standing chimney of a barracks at Fort Lewis.**

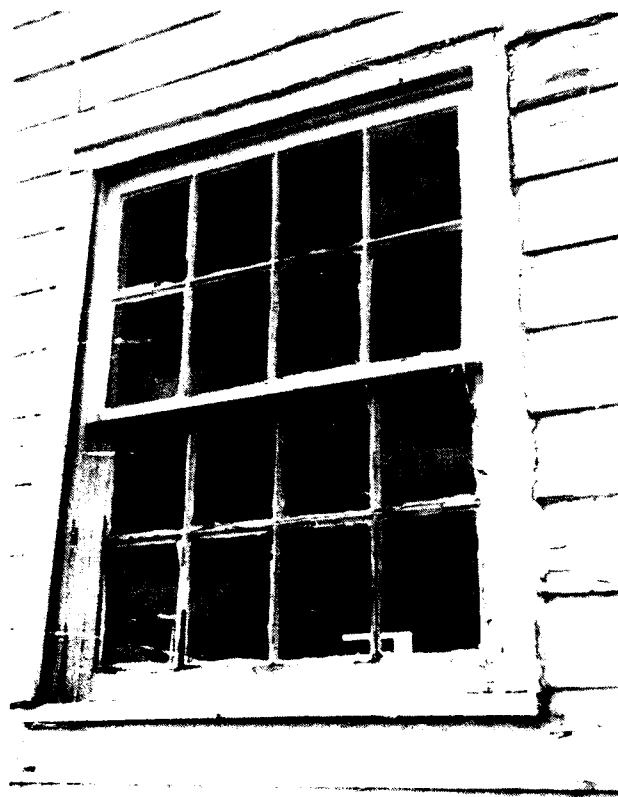
Exterior windows were frequently in poor condition (Figure 11). In 14 buildings (half of the sample) windows were clearly inadequate. Exterior doors were in much better condition. In only four structures were they judged to be poor. In general they were rated average to good.

Figure 11. A window in poor condition.

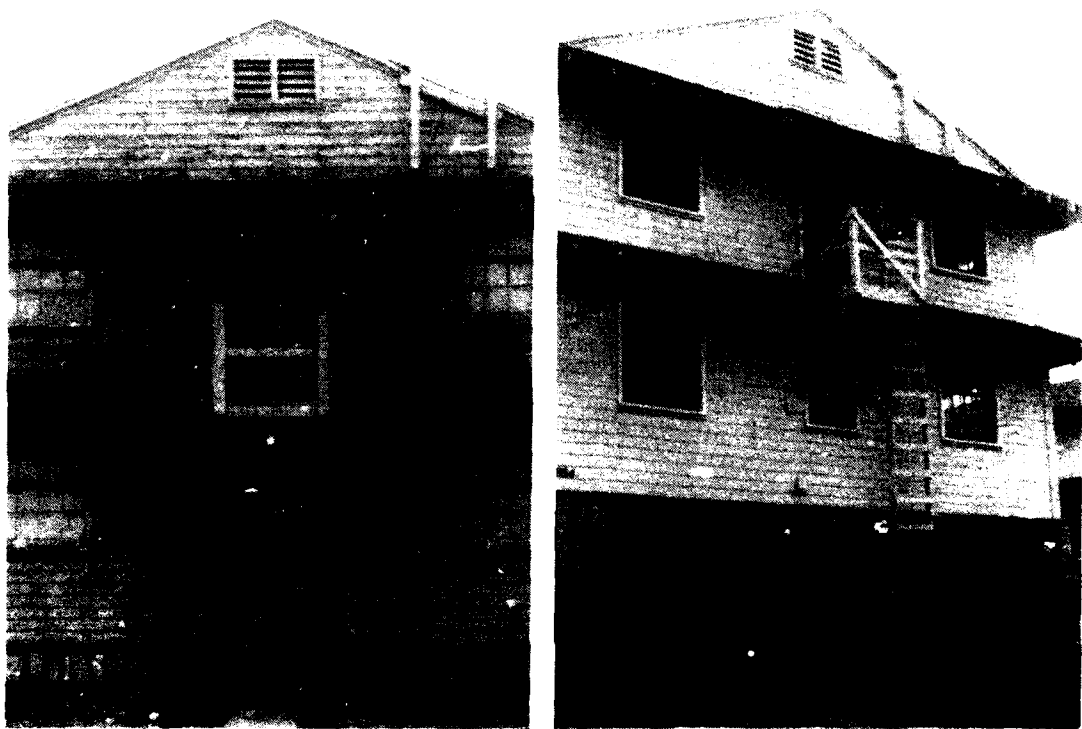
A third observation concerns fire safety. In cases where the duct system was not replaced, smoke in the corridor may prevent users from safely reaching the fire escape at the end of the corridor. Also, the wooden ladder fire escapes are often in need of repair or replacement (Figure 13). In judging the fire safety of wood buildings in general, however, it should be noted that building contents are at least as important a source of fire hazard as the structure itself.<sup>7</sup>

Figure 13. Fire escapes.
