STAPLETON INTERNATIONAL  
AIRPORT

\*  
GROUND WATER  
MONITORING

\*  
SOUTHERN TIER OF  
ROCKY MOUNTAIN ARSENAL

February 1987

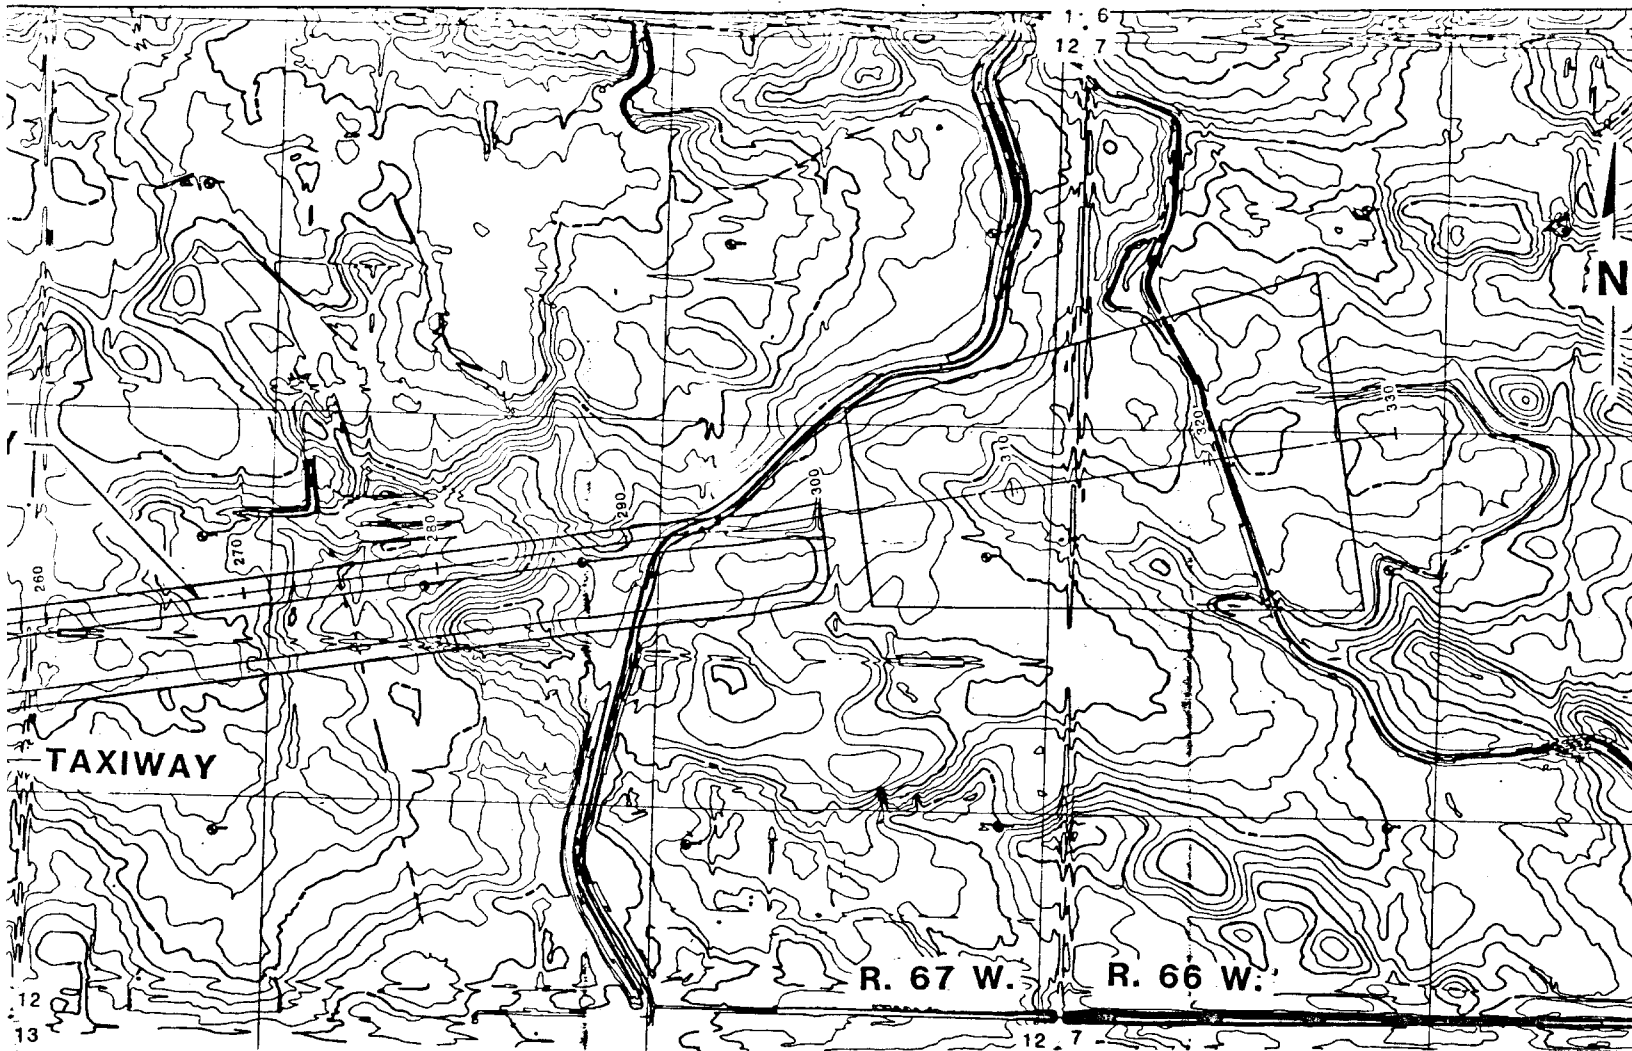
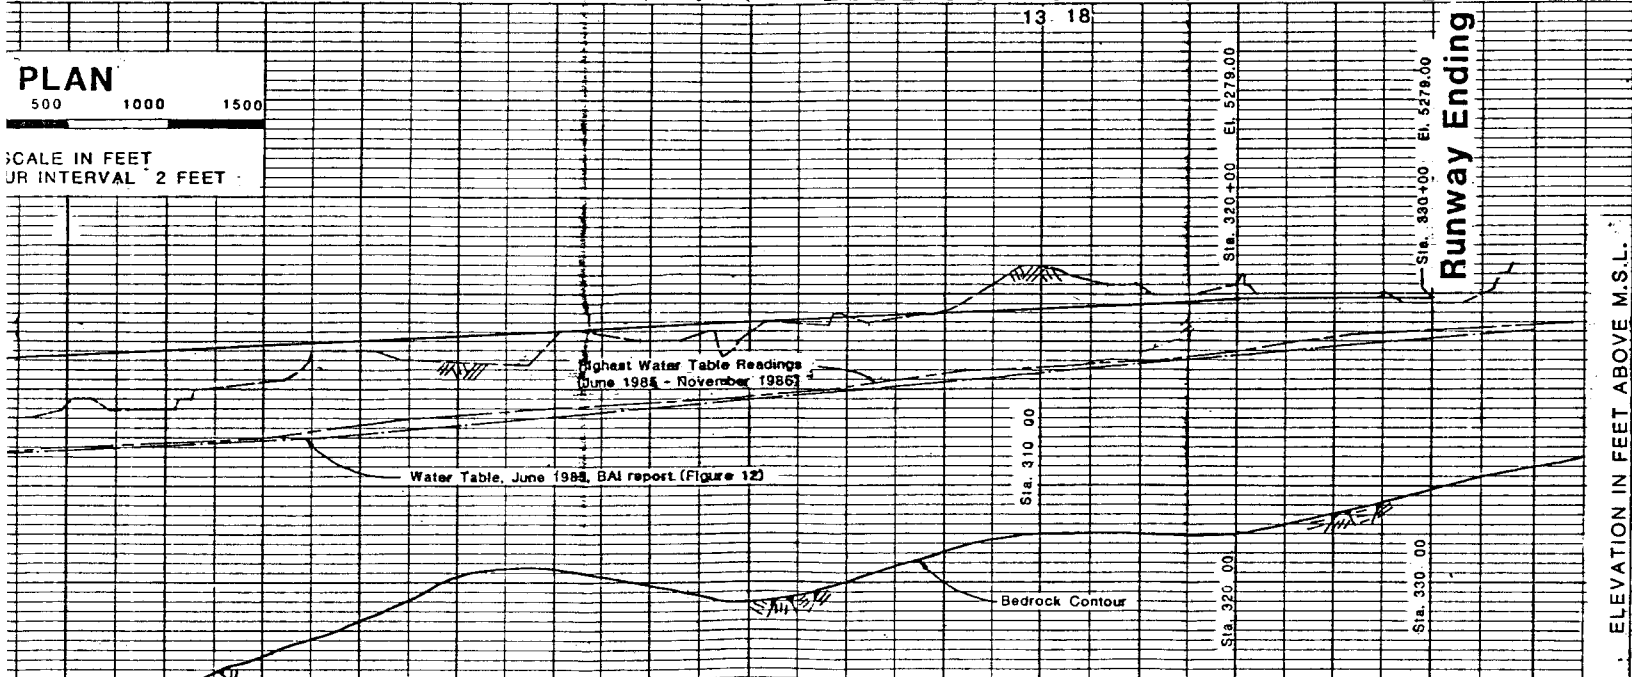
**GROUNDWATER/BEDROCK PROFILE  
EAST-WEST RUNWAY 9.5° CANT**

The results of the investigations are presented in profile in Figure 3 showing the initial configuration of the alluvial ground water table and bedrock beneath the selected runway alignment (9.5° Cant). This data provides the basis for the conclusions and recommendations. Figure 3 also shows the approximate location of the selected runway alignment.

(1) The water table for the East-West Runway configuration, 9.5° Cant, does not present an immediate problem from the standpoint of having to dewater for the normal runway construction. Areas of the proposed runway alignment in which the water table is nearest to the surface are in areas where the fill for the runway will be most extensive. The construction and/or operation of structures under the runway may be affected by ground water depending on where the structures are located.

(2) It is recommended that when the field investigations for the design of the selected runway proceed, that observation holes be established only for Station 217+00 through Station 234+00 and Station 245+00 through Station 265+00. Once the water table has stabilized in the test holes, one or two readings should be sufficient to verify the water table location for construction purposes.
