DOT/FAA/AR-95/81

# Corrosion of Aluminum Alloys in the Presence of Fire-Retardant Aircraft Interior Materials

October 1995

Final Report

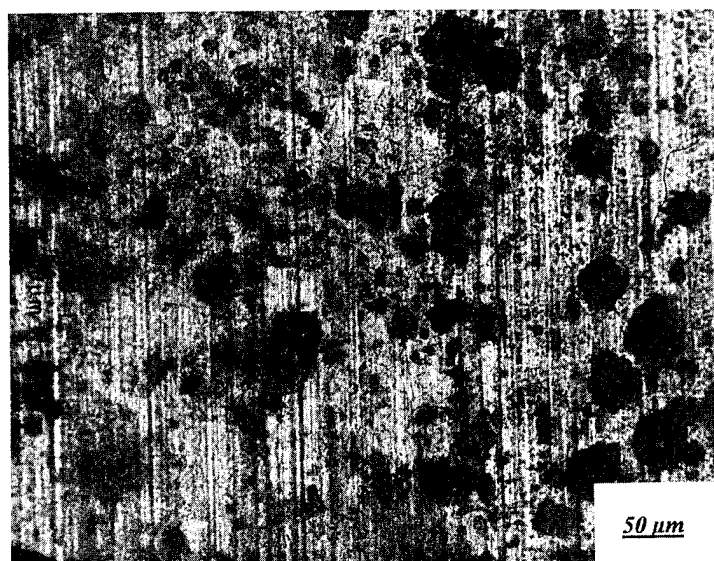
FIGURE 4. MICROGRAPH OF AL 7075-T6 WITH ULTRASUEDE, 100°F, 90% RH, 21 DAYS (SEVERE CORROSION, 100 POINTS)

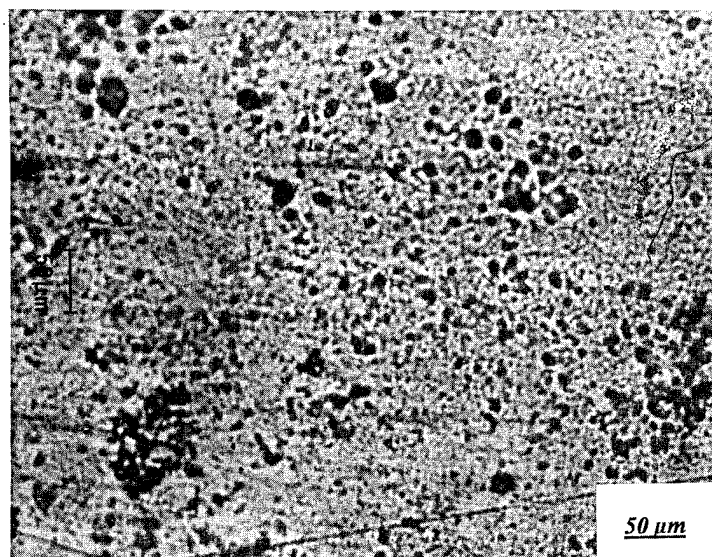
FIGURE 5. MICROGRAPH OF AL 2024-T3 WITH GLENLIVIT, 100°F, 90% RH, 14 DAYS  
(MODERATE CORROSION, 50 POINTS)

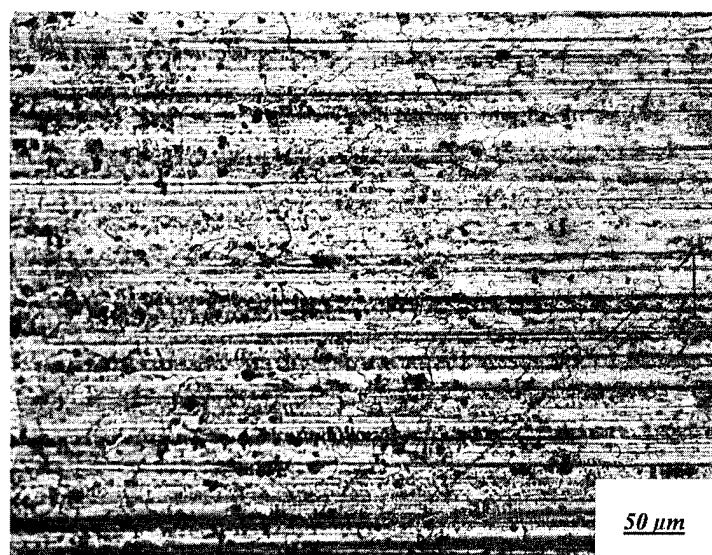
FIGURE 6. MICROGRAPH OF AL 7075-T6 WITH HIGHLAND WOOL, 70°F, 50% RH,  
7 DAYS (MINIMAL CORROSION, 5 POINTS)

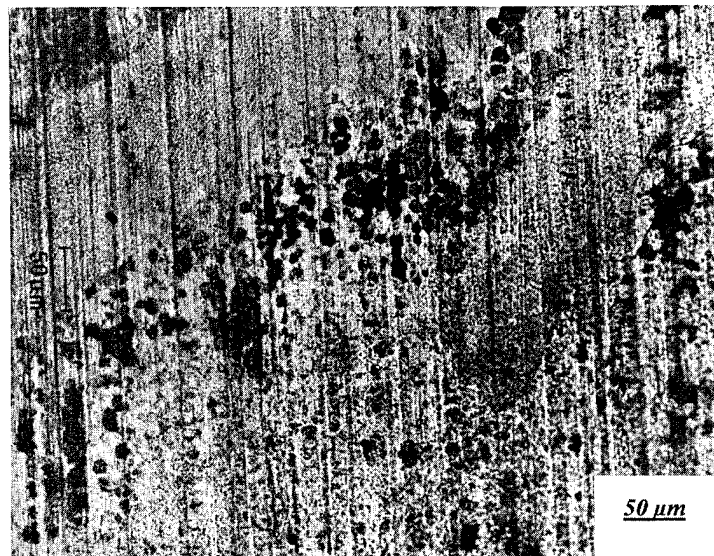
FIGURE 7. AL 2024-T3 WITH ULTRASUEDE, 100°F, 90% RH, 21 DAYS  
(50 POINTS)

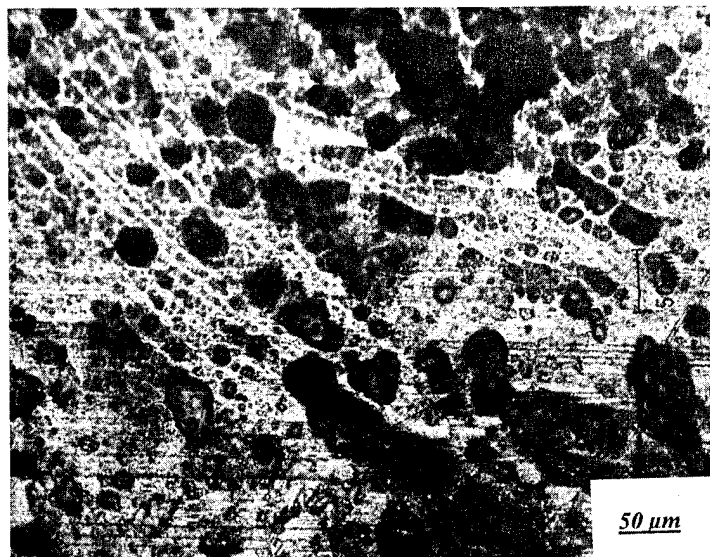
FIGURE 8. AL 2024-T3 WITH ULTRASUEDE, 130°F, 90% RH, 14 DAYS  
(80 POINTS)

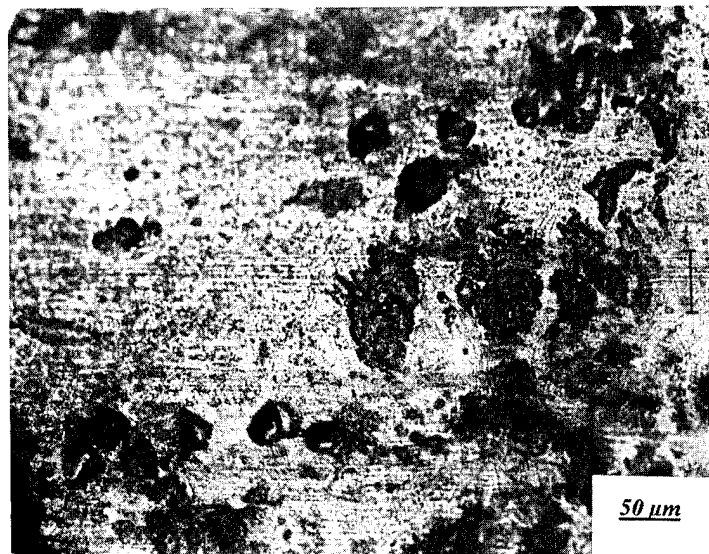
FIGURE 9. AL 7075-T6 WITH ULTRASUEDE, 70°F, 50% RH, 21 DAYS  
(40 POINTS)

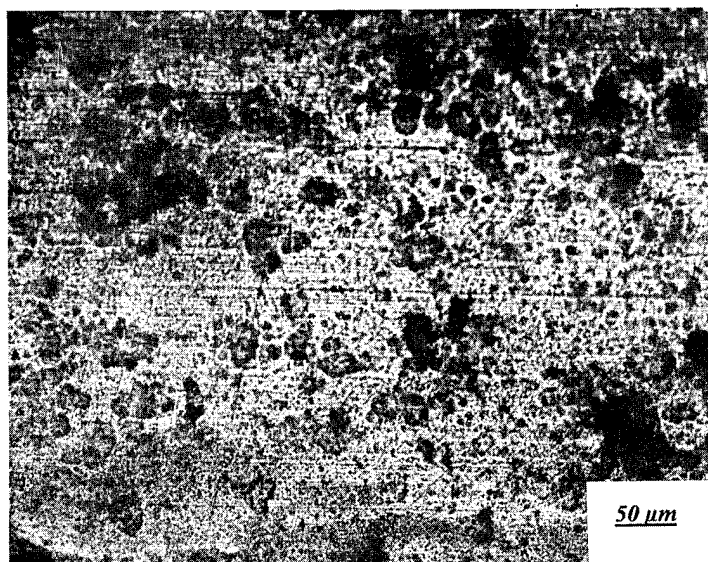
FIGURE 10. AL 7075-T6 ALCLAD WITH ULTRASUEDE, 130°F, 90% RH, 21 DAYS  
(40 POINTS)

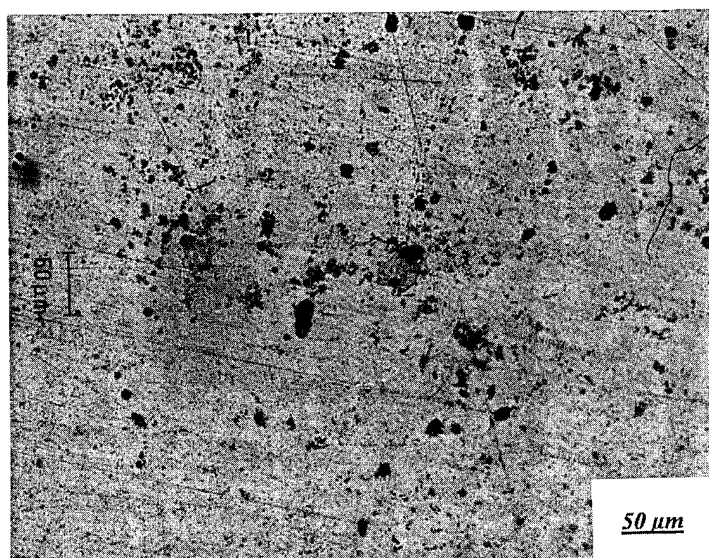
FIGURE 11. AL 2024-T3 WITH GLENLIVIT, 100°F, 90% RH, 21 DAYS  
(65 POINTS)

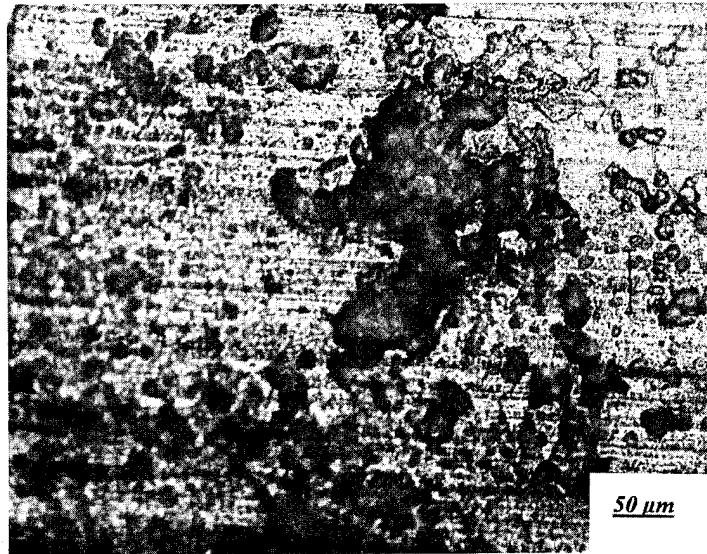
FIGURE 12. AL 2024-T3 ALCLAD WITH GLENLIVIT, 130°F, 50% RH, 14 DAYS  
(80 POINTS)

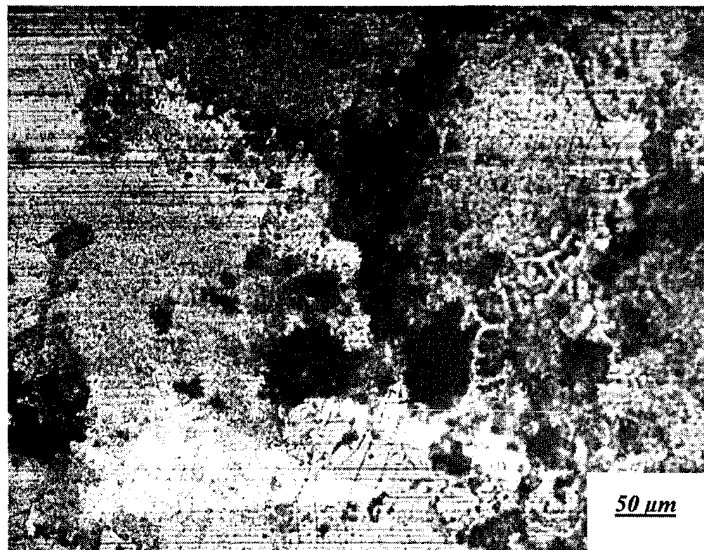
FIGURE 13. AL 7075-T6 ALCLAD WITH GLENLIVIT, 130°F, 50% RH, 21 DAYS  
(55 POINTS)

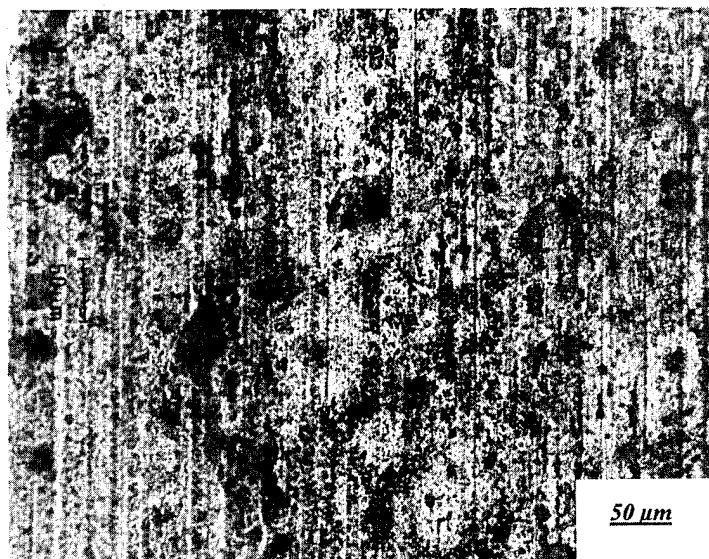
FIGURE 14. AL 2024-T3 WITH GLENLIVIT, 130°F, 90% RH, 21 DAYS  
(85 POINTS)

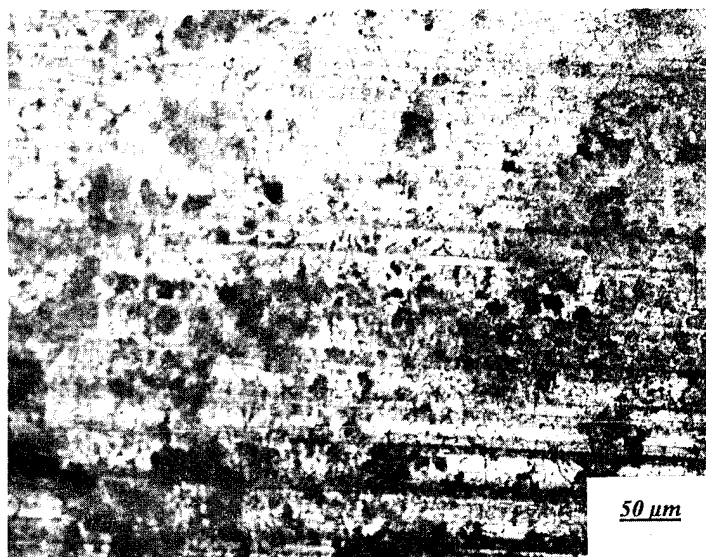
FIGURE 15. AL 2024-T3 WITH HIGHLAND WOOL, 70°F, 90% RH, 7 DAYS  
(40 POINTS)

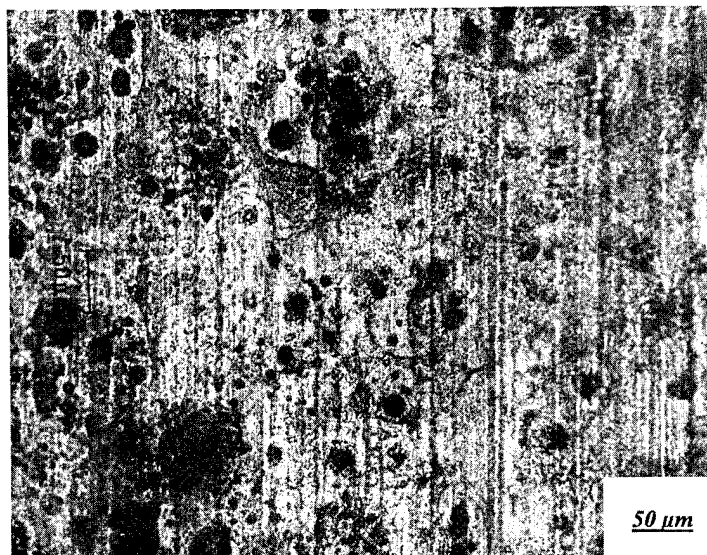
FIGURE 16. AL 7075-T6 WITH HIGHLAND WOOL, 130°F, 50% RH, 7 DAYS  
(45 POINTS)
