Fire Spread and Plastics Pipes

CI/SIB 1976 (59) 1n6 (K)	CP 38/77

Fire spread and plastics pipes

M Curtis

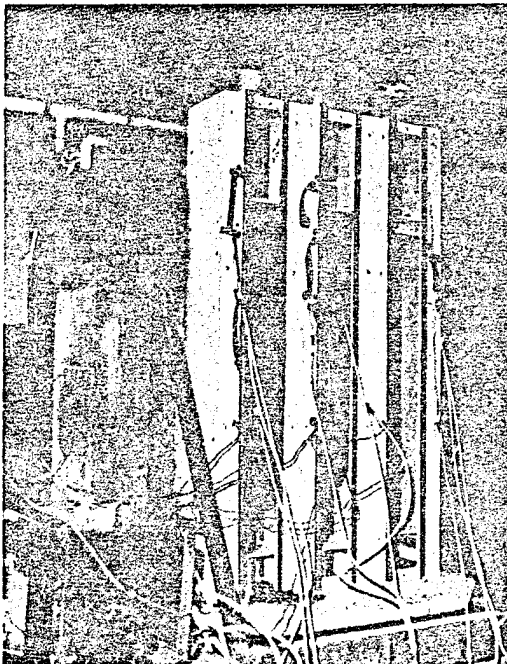
Figure 10 Cabinet viewed from unexposed side after test 2a (reinforced glass window removed)

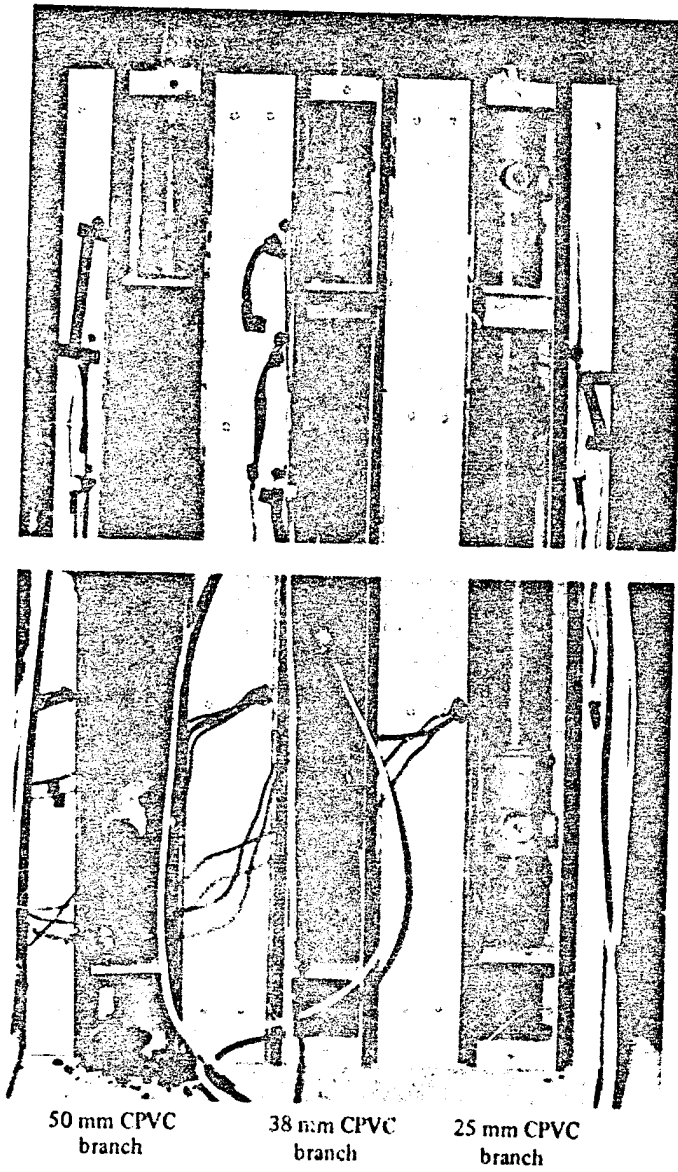
Tests 2a, 2b, 2c and 2d each consisted basically of a 50 mm, a 38 mm and a 25 mm waste pipe passing through a wall and connecting to a 100 mm stack. Damage occurred more quickly within the lower compartments penetrated by the larger pipes. This is clearly shown in Figures 16 and 17. It should be noted that the conditions shown in these figures are after 120 minutes and 100 minutes exposure respectively.

Figure 16 After test 2a. Showing variation of damage due to size of CPVC horizontal branch pipe. Duration of test: 115 min

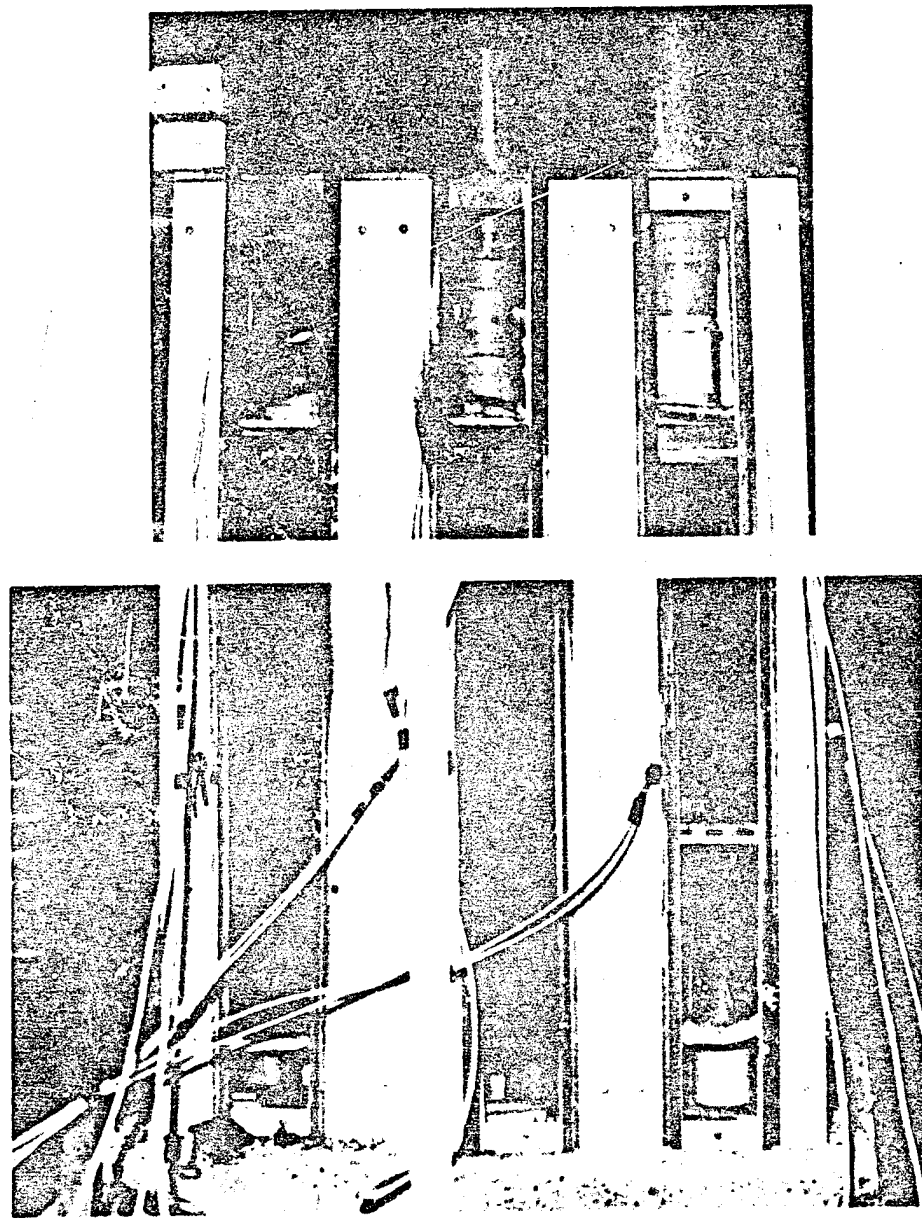
Comparison of Tests 2b and 2c suggest that the type of branch pipe material used influences the conditions within the lower compartment for an initial period but after longer periods of exposure the thickness of the exposed wall and the pipe diameter are the significant factors. The other tests although not giving a direct comparison did not contradict this statement.

The thickness of the wall exposed to the heating conditions was shown to have a considerable effect on the conditions within the lower compartment. Tests 2c and 2d provide a direct comparison. (Figures 17 and 18.)

Figure 17 After test 2b (75 min). Variation due to pipe size (50 mm on right, 25 mm on left) and protection given by floor stop to stack higher up clearly shown

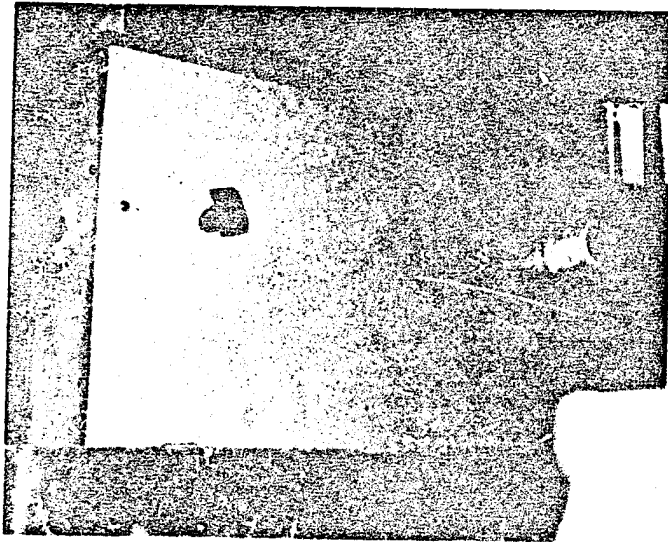
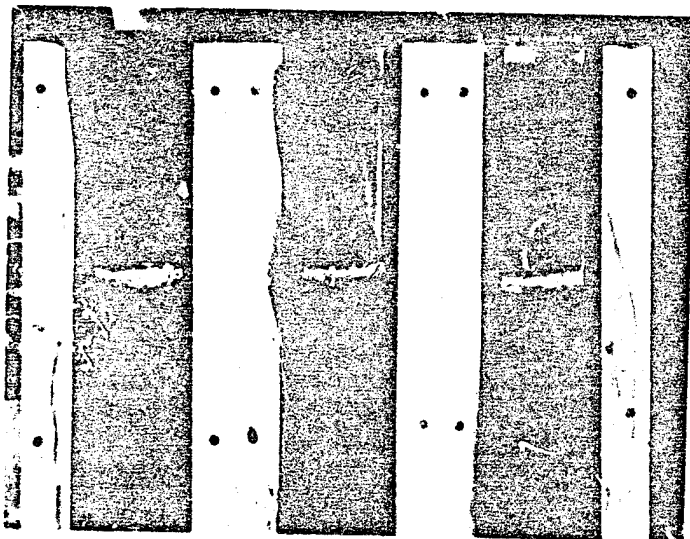
peratures appear to be related to lower compartment temperatures, 100°C being reached in the upper when the lower reached about 300°C. Above these temperatures distortion of the stack in the upper compartment occurred (arrangement 2d/1h – Figure 15).

Figure 18 Test 2d. Upper compartment after test (65 min). Considerable distortion inside compartment (some occurring after end of test - Figure 18b). Integrity between upper and lower compartment believed to be intact at end of test. Integrity of branch (sealed) pipes intact - Figure 18a

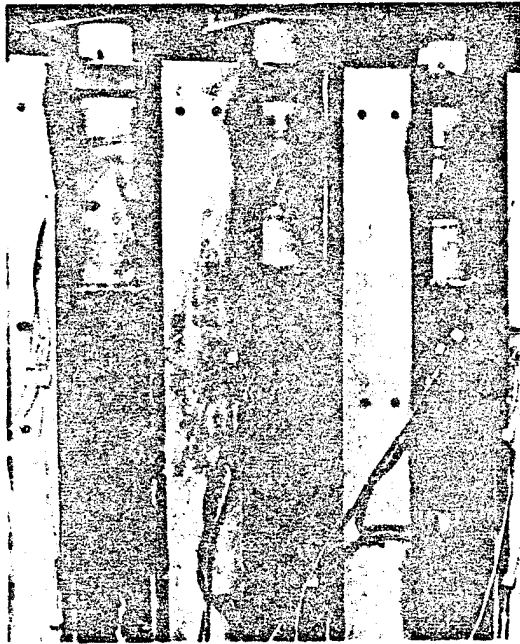
Figure 19 After test 2c. Upper compartment stacks in lower compartment completely destroyed. Stacks in upper compartment protected by floor stud (much of the distortion shown occurred well after cessation of test)

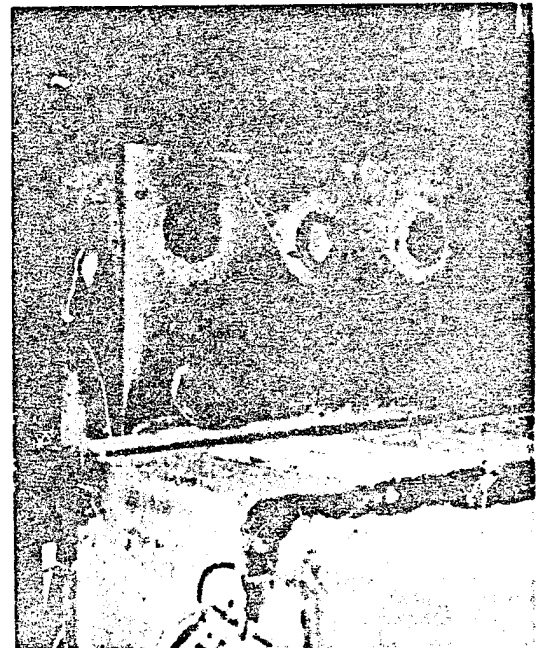
Arrangement 2f/rh was virtually the same as 2f/1h but for the exclusion of the upper fire stop. Burning in both arrangements commenced before 60 minutes. In arrangement 2f/rh, without a fire stop, the complete stack was destroyed and integrity lost from the upper compartment at 49 minutes. In the fire-stopped arrangement integrity through the fire-stop and also from the upper compartment was still intact at the end of the test (85 minutes). Figure 21.

Figure 21 After test 2f. Loss of integrity from upper compartment

Fire stops within the protected shaft are not normally required by the Regulations. The early tests in Part 2 suggested that with combustible pipes, fire stops should be provided in order to minimise spread of smoke through the building, to localise damage to the drainage system and to prevent collapse of large sections of pipework into areas in close proximity to the fire. Figures 16, 17, 18 and 19 all show the protection given to pipework higher up by the floor stop. Because of the obvious necessity for a floor stop, only one arrangement was tested without a fire stop – (2f/right hand.) The complete stack in this example collapsed at about 29 minutes. Figure 20 shows test 2f at about 40 minutes with the left hand stack intact at the upper level. Failure occurred in test 2f/rh at 49 minutes

when integrity was lost, (for the only time in the test series, from the upper compartment (Figure 21)). This loss of integrity seems to have occurred not solely due to the temperature in the upper compartment but also to the disturbance caused by the collapse of the stack.

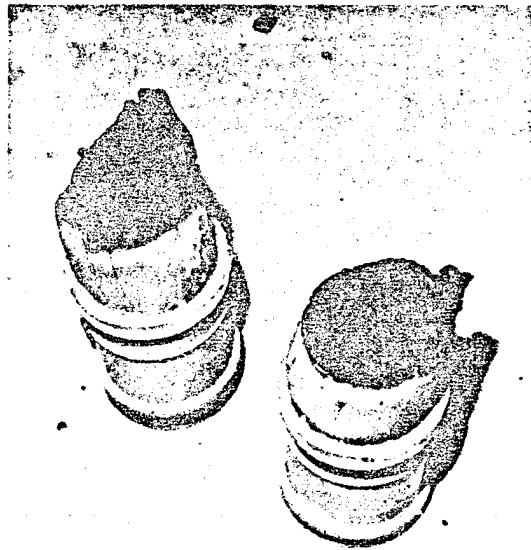
Part 1 has shown chlorinated PVC to be the best material under the type of fire test conditions investigated in that part. PVC and chlorinated PVC pipes given reasonable support (partly by the thickness of the wall) remain in position, decompose and carbonise leaving a rigid, brittle carbonaceous residue. This effect considerably assists the performance of the larger (and thicker) 100 mm pipe. Partly for this reason PVC was the only larger plastics pipe examined in Part 2. It is stressed that the comments made here and the conclusions drawn later on the use of 100 mm pipes apply only to PVC. It is believed that no other plastics material currently readily available as drainage pipework would perform as well. The carbonising effect of PVC is clearly shown on Figure 22 which shows the remains of the 100 mm PVC pipes through the 100 mm back wall of test 2f/left hand and right hand. The carboniferous

Figure 22 Horizontal branch pipes – test 2f showing rigid carbonised residue

residue will break down on prolonged exposure but will retard the penetration of fire through pipe and wall combinations.

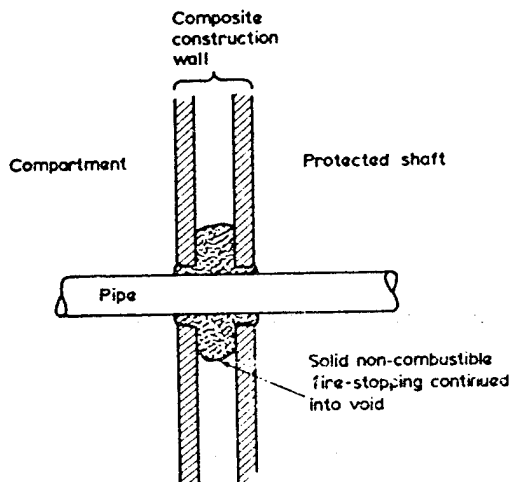
Figure 23 Suggested fire-stopping in walls of sandwich construction

Again, this effect was not examined. It is possible that a sandwich wall construction with a void in the centre would give a different performance from the homogeneous constructions examined. Comparable performance would probably be achieved if a non-combustible sleeving were used or if care were taken to ensure that solid, non-combustible fire stopping was continued into the void (see Figure 23).
