SAND 80-0808
UNLIMITED DISTRIBUTION

PROTECTIVE COATINGS AND SEALANTS FOR
SOLAR APPLICATIONS

K. B. WISCHMANN
M. H. GONZALES

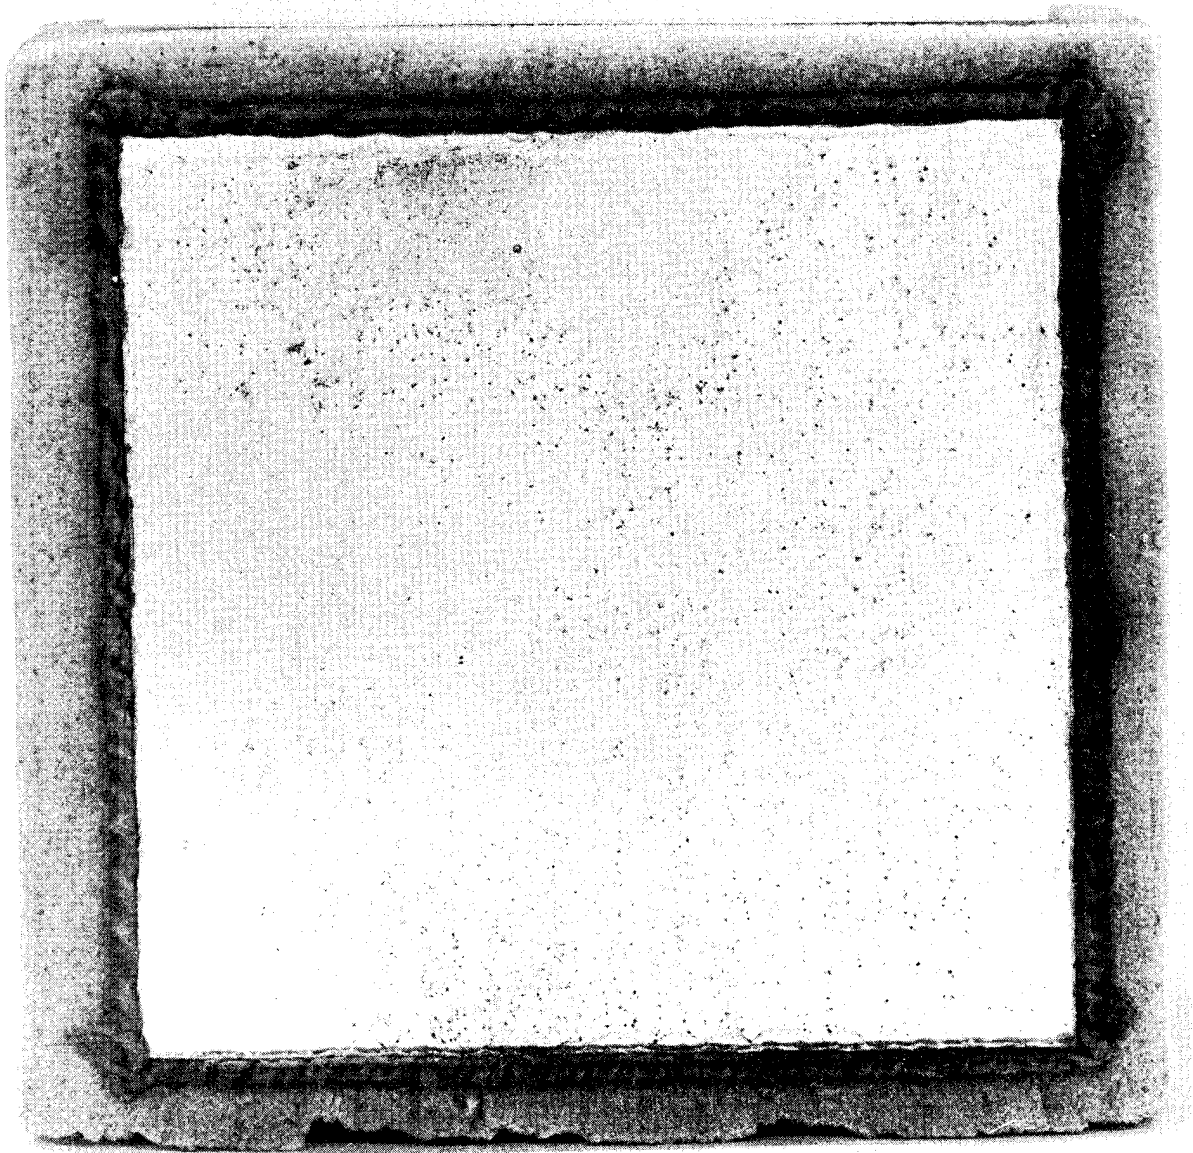
FIGURE 1

POLYSTYRENE FOAM

ADHESIVE : 3M's EC- 3549

EDGE SEAL : DOW CORNING 790 SEALANT

TIME AGED : 12 mos

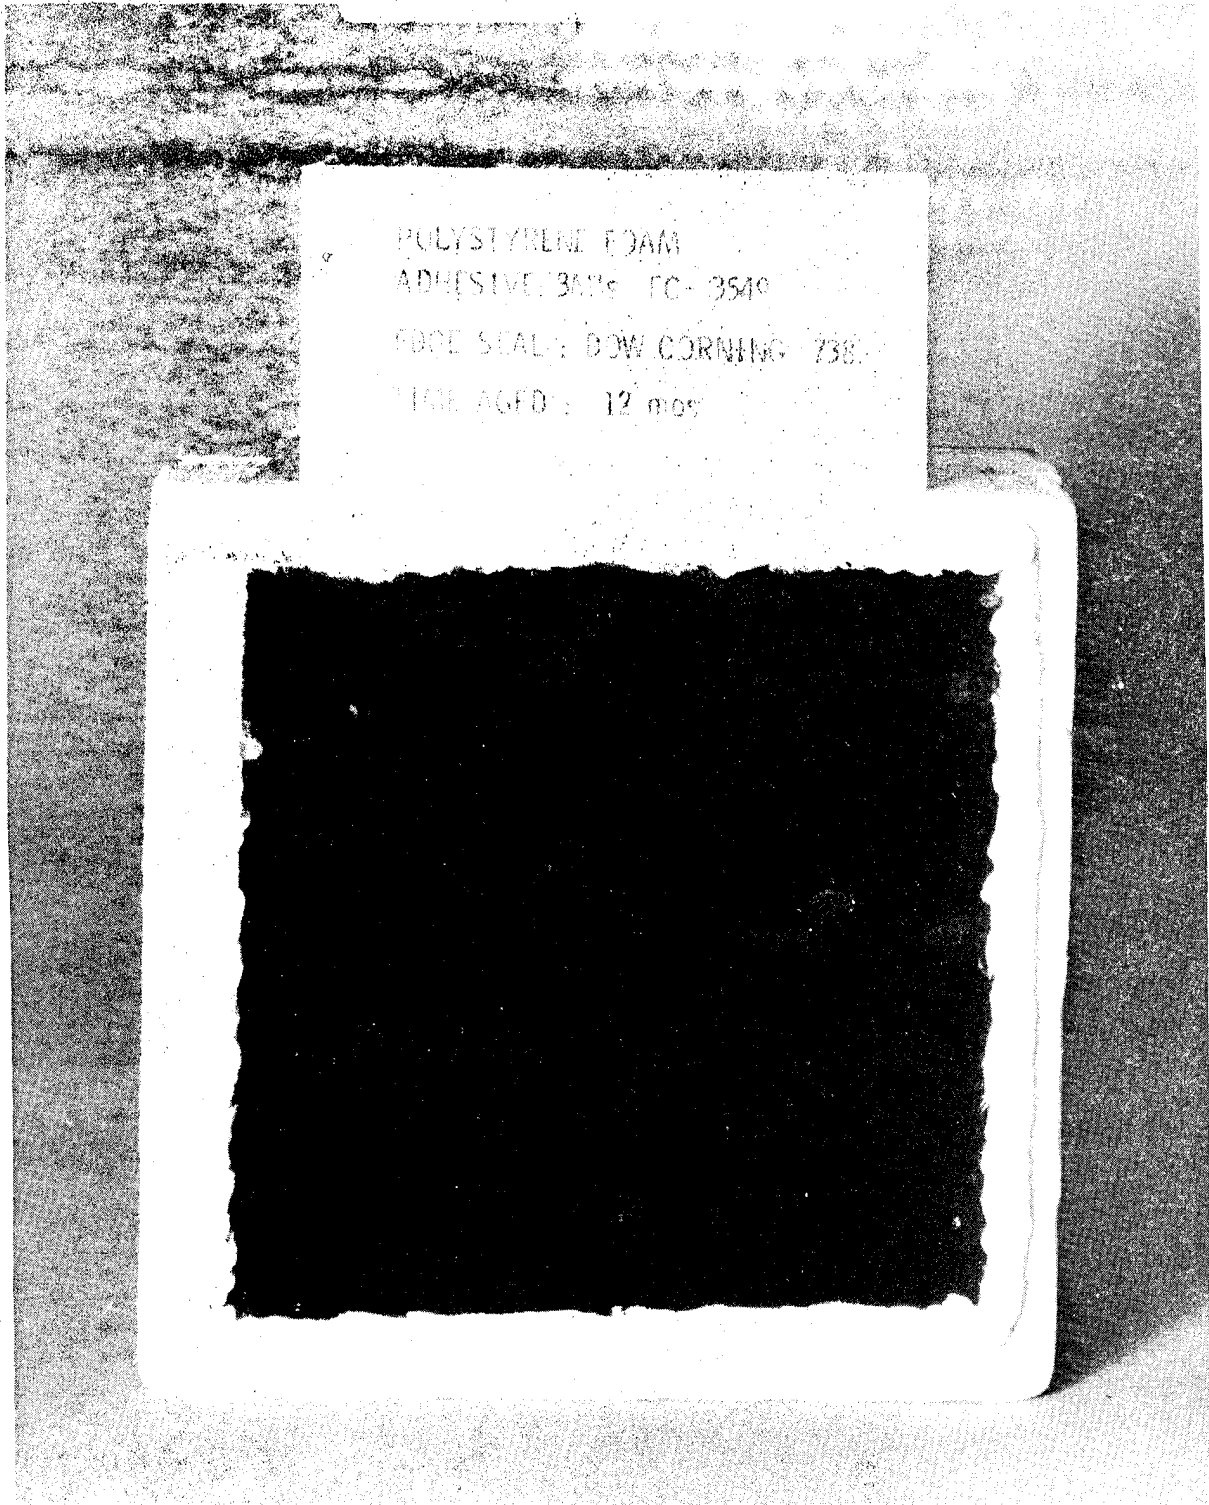
FIGURE 2

POLYSTYRENE FOAM
ADHESIVE: 3M's FC-3519
EDGE SEAL: DOW CORNING 738
TIME AGED: 12 mos

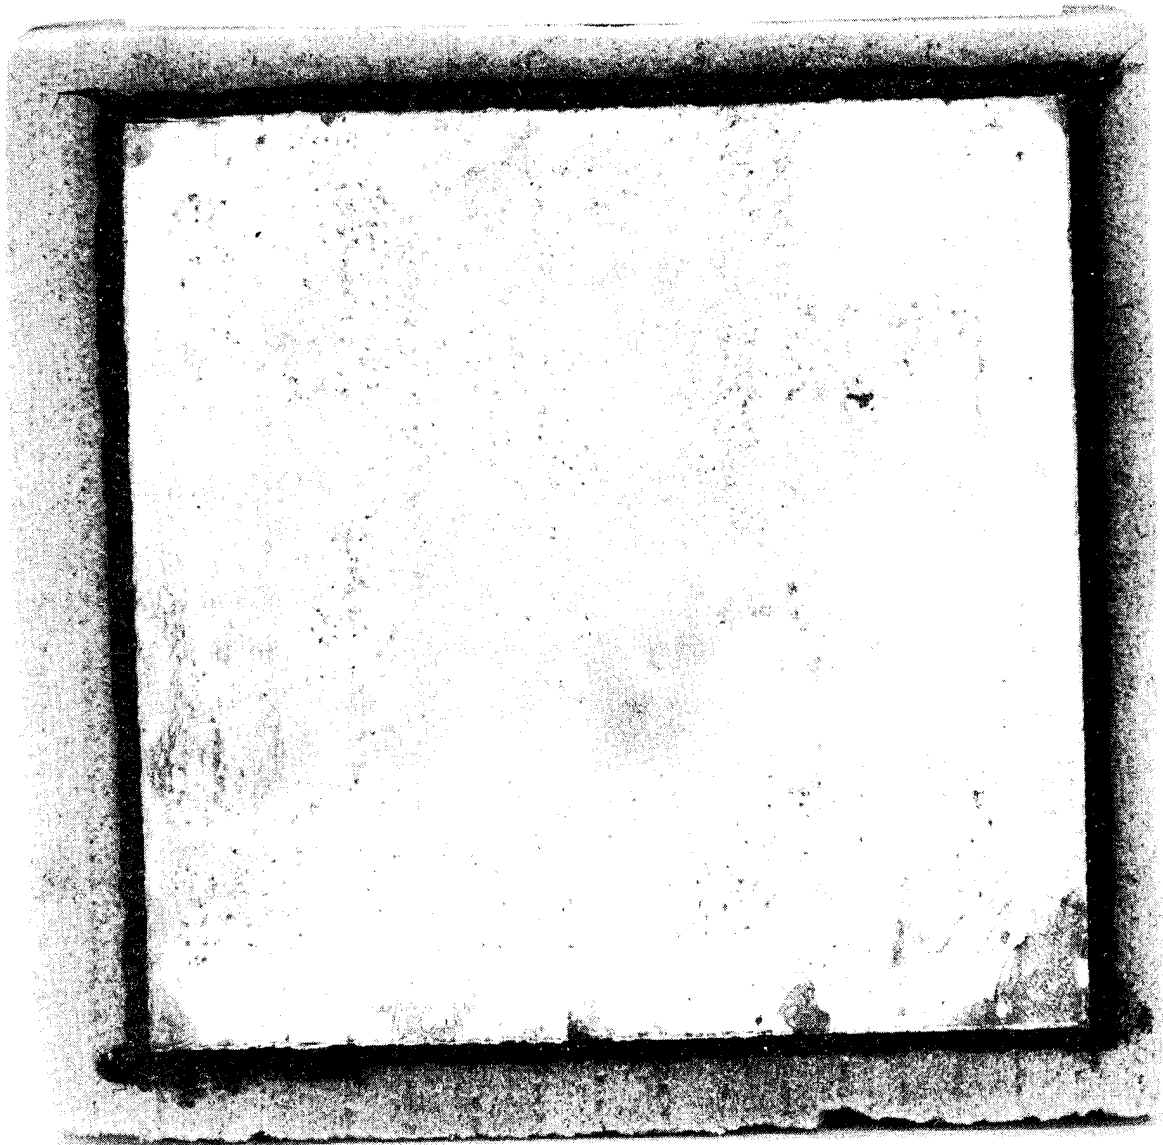
FIGURE 3

POLYSTYRENE FOAM

ADHESIVE : 3M's EC- 3549

EDGE SEAL : GE 1200 CONSTRUCTION SEALANT

TIME AGED : 12 mos.

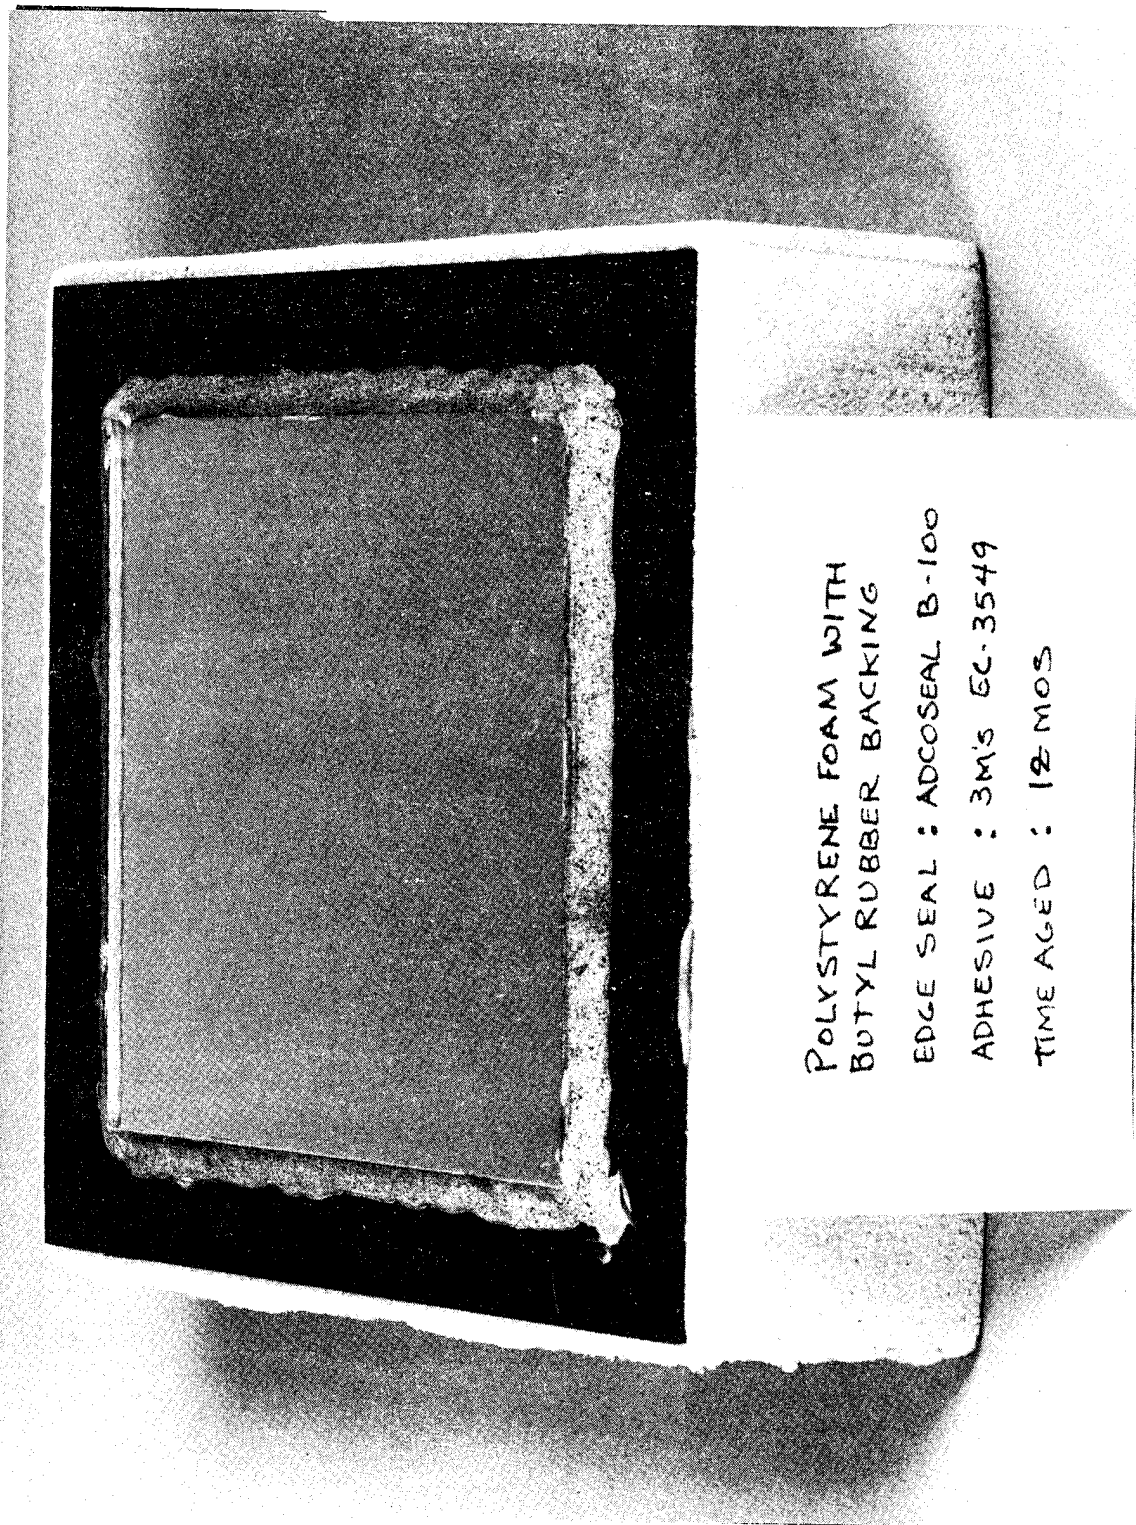
FIGURE 4

One of the better heliostat sealants was found to be a butyl rubber, Adco seal B-100 (see Table 2 and Figure 4). This module incorporated a design modification; a 1/16" butyl rubber pad bonded between the mirror and the polystyrene foam substrate. The module looked extremely good after 12 months accelerated aging. A sealant of this type must be used with some degree of caution because butyl rubbers are not normally as thermally stable or UV resistant as silicones.

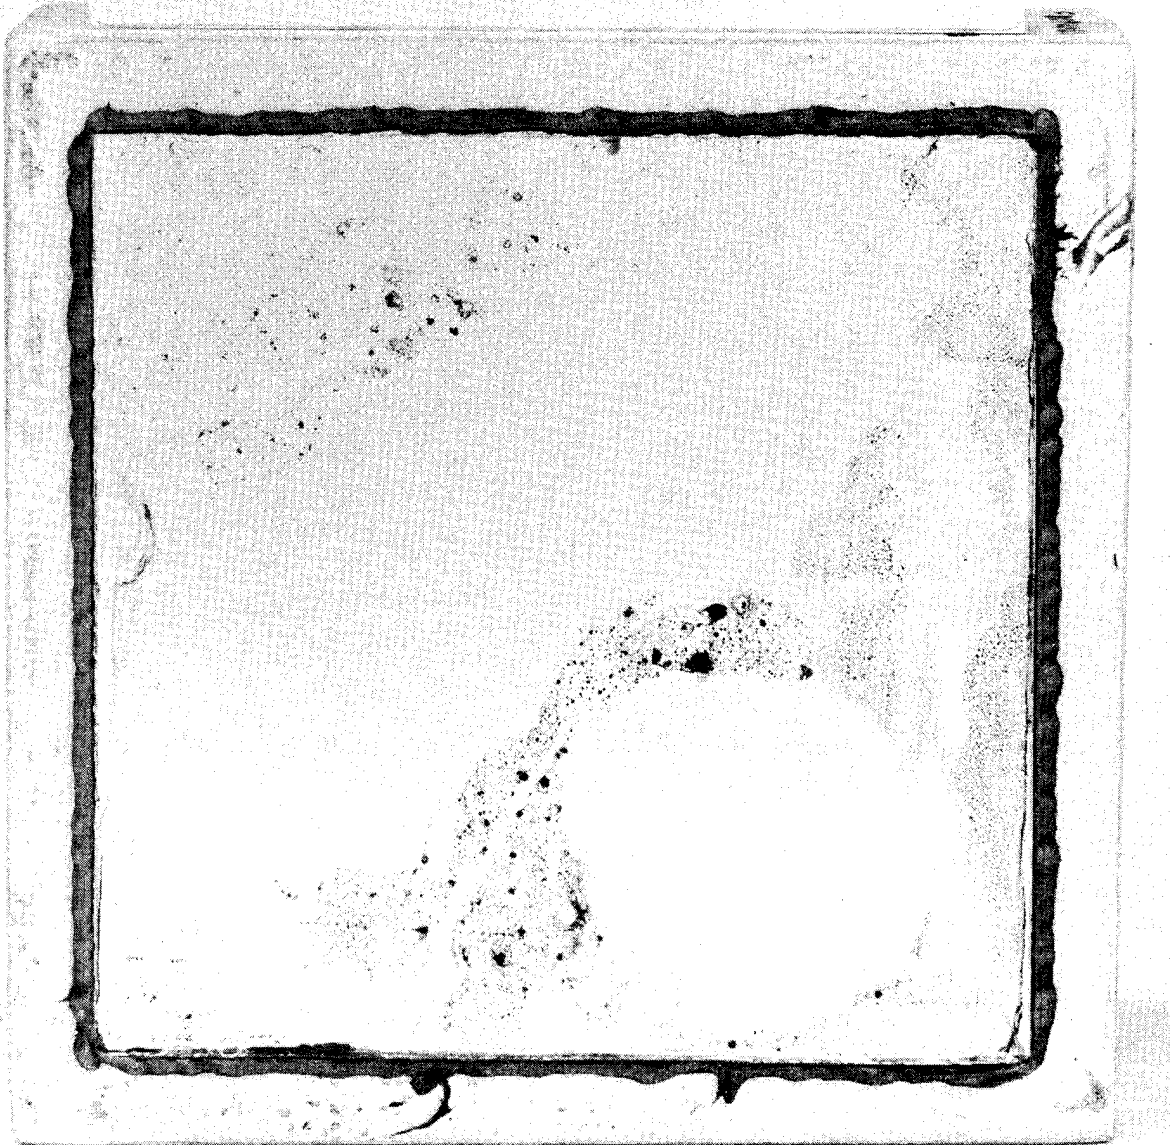
FIBERGLASS FACE
PAPER HONEYCOMB BODY
ADHESIVE : 3M's EC-3549
EDGE SEAL : DOW CORNING 790 SEALANT
TIME AGED : 12 mos.

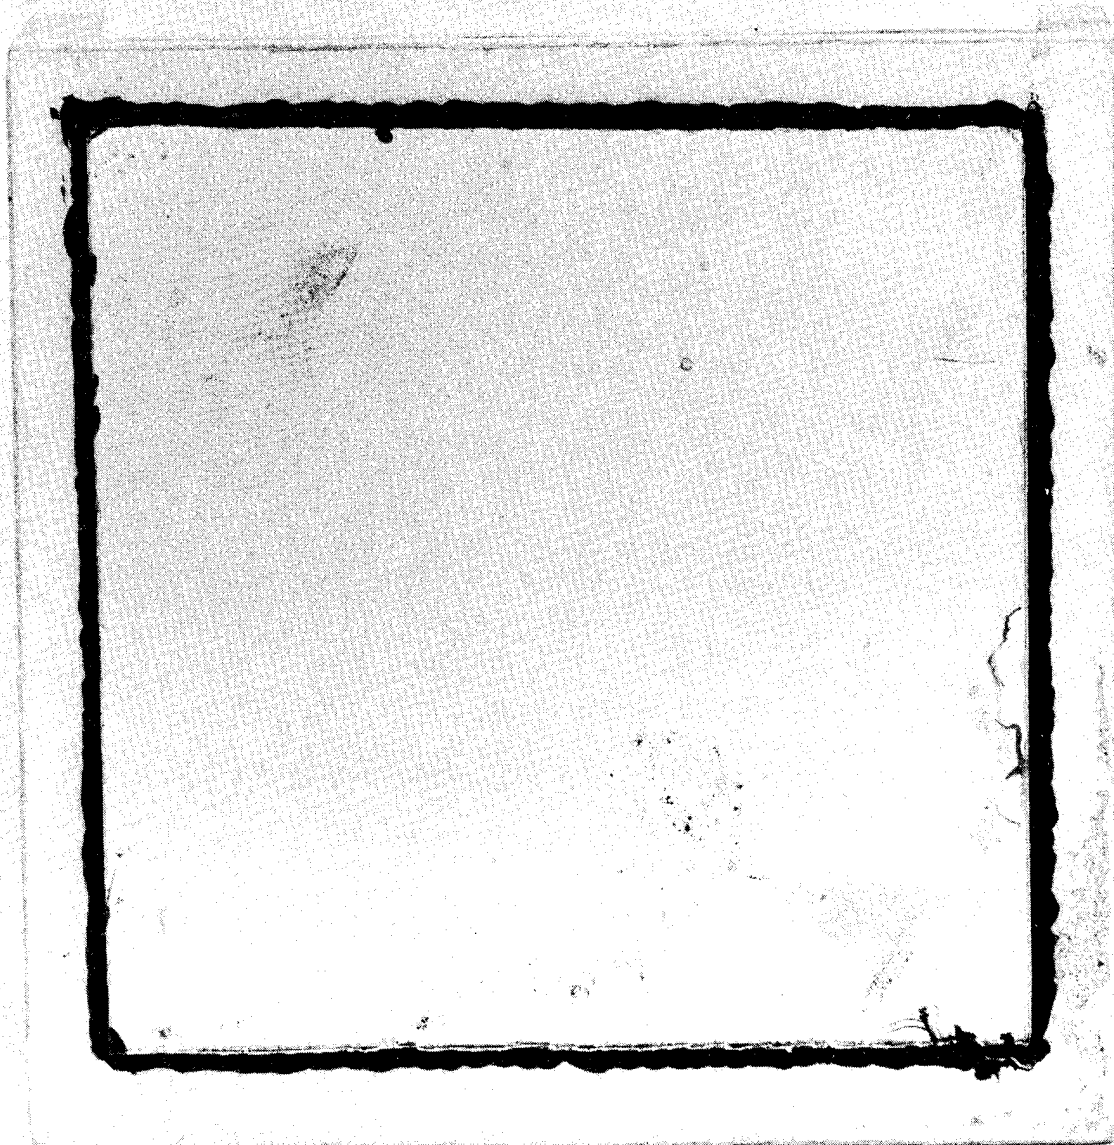
FIGURE 7

FIBERGLASS FACE
PAPER HONEYCOMB BODY
ADHESIVE : 3M's EC-3549
EDGE SEAL : GE 1200 CONSTRUCTION SEALANT
TIME AGED : 12 mos.

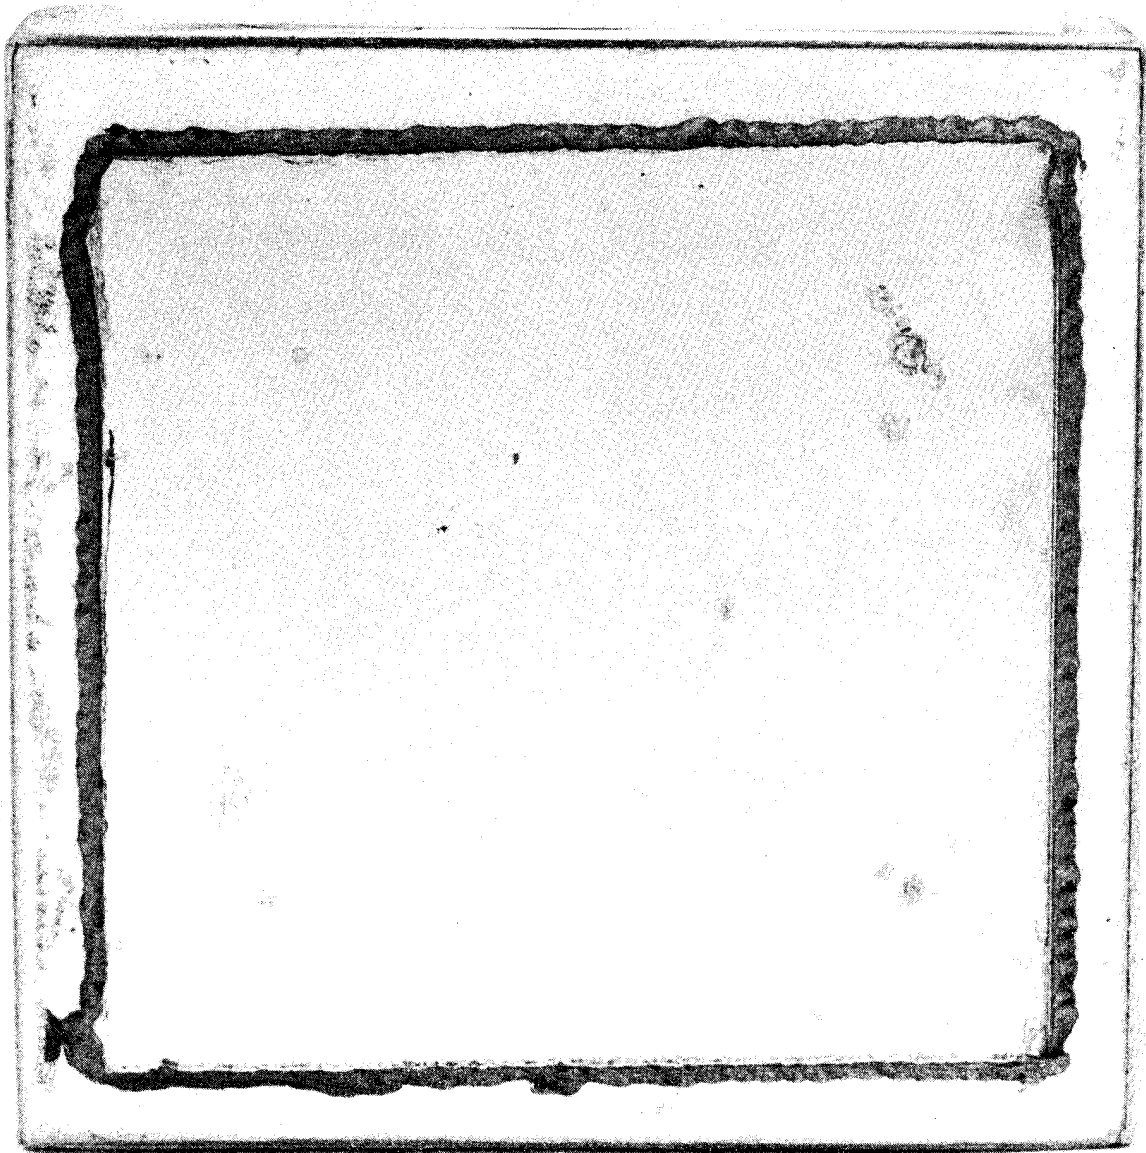
FIGURE 8

MELAMINE FACE
PAPER HONEYCOMB BODY

ADHESIVE : 3M's EC- 3549
EDGE SEAL : DOW CORNING 790 SEALANT
TIME AGED : 12 mos.

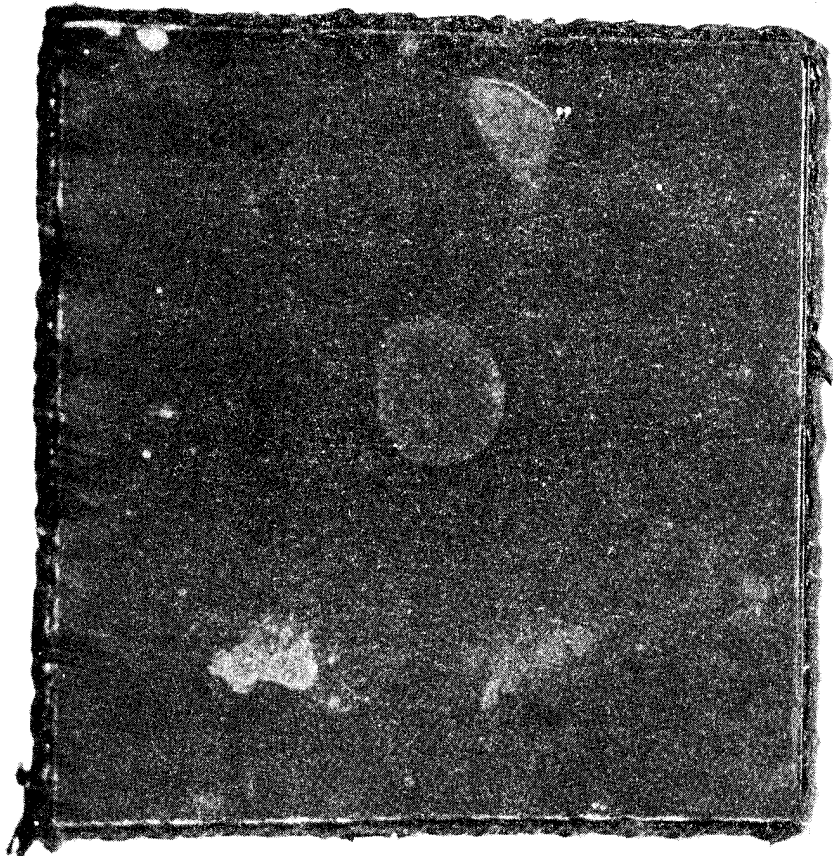
FIGURE 10

MELAMINE FACE
PAPER HONEYCOMB BODY

ADHESIVE : 3M's EC- 3549
EDGE SEAL : GE 1200 CONSTRUCTION SEALANT
TIME AGED : 12 mos.

MELAMINE
PAPER
HONEYCOMB
BODY

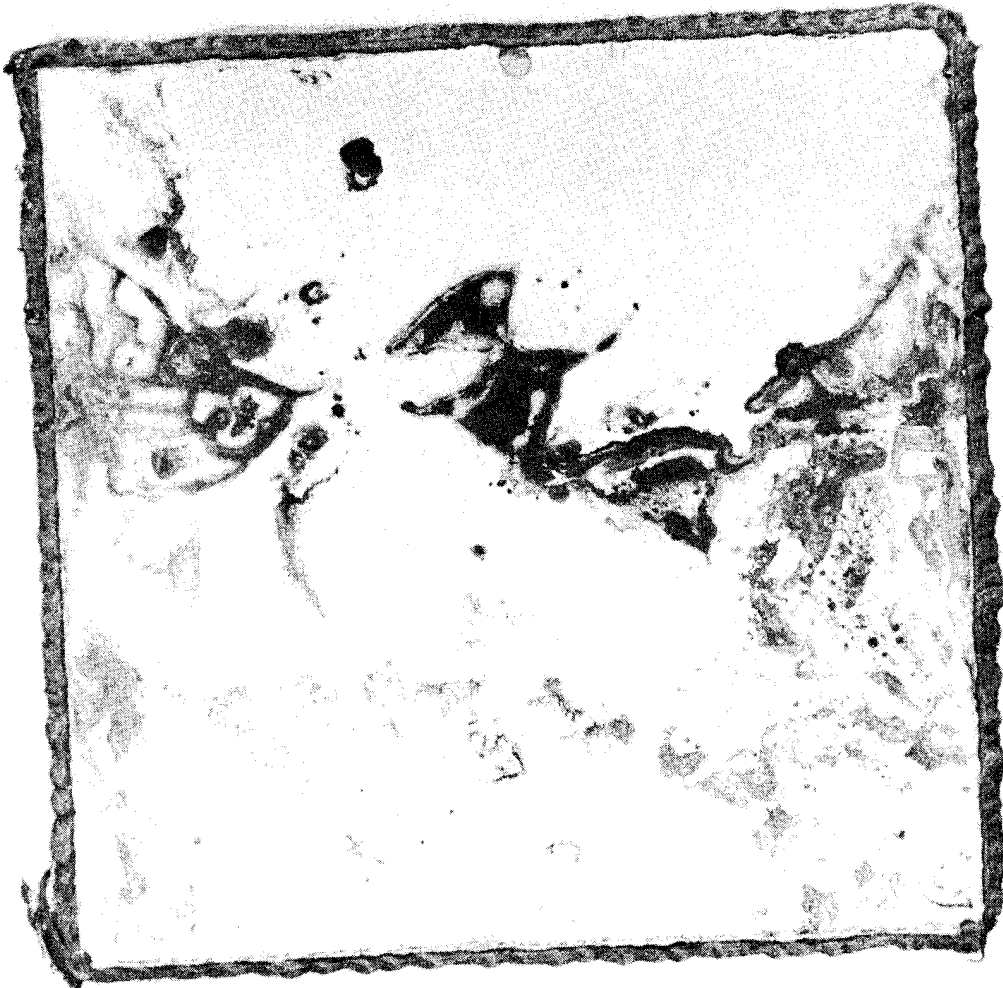
FIGURE 13

FIBERGLASS FACE
SINE WAVE FIBERGLASS BODY

ADHESIVE : 3M's EC- 3549
EDGE SEAL : DOW CORNING 790 SEALANT
TIME AGED : 12 mos.

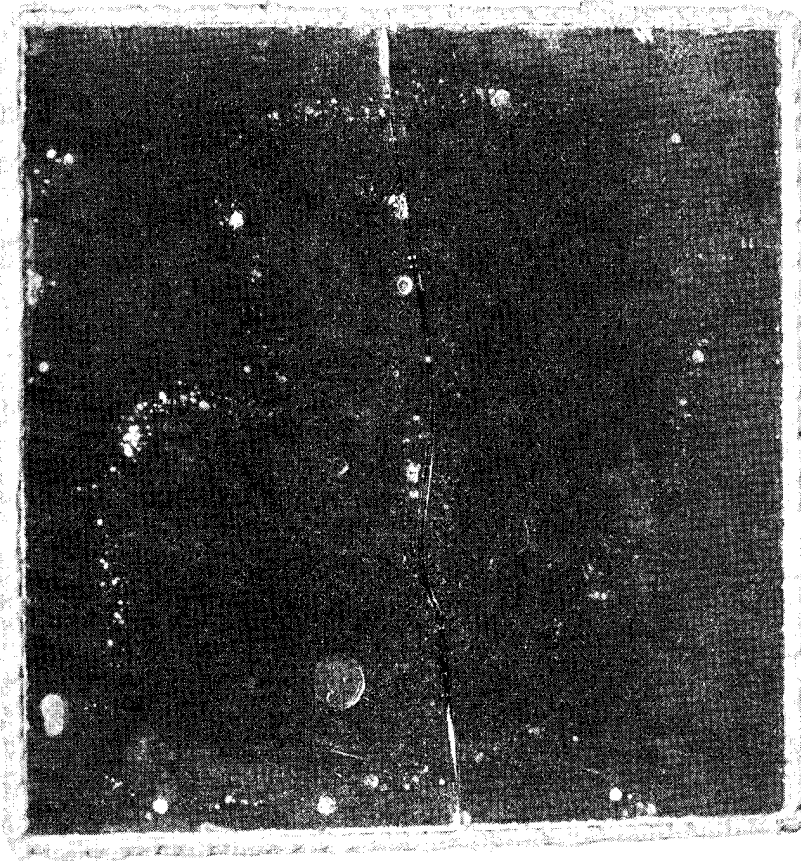
FIGURE 15

MELAMINE FACE
SINE WAVE FIBERGLASS BODY

ADHESIVE : 3M's EC- 3549
EDGE SEAL : DOW CORNING 790 SEALANT
TIME AGED : 12 mos.

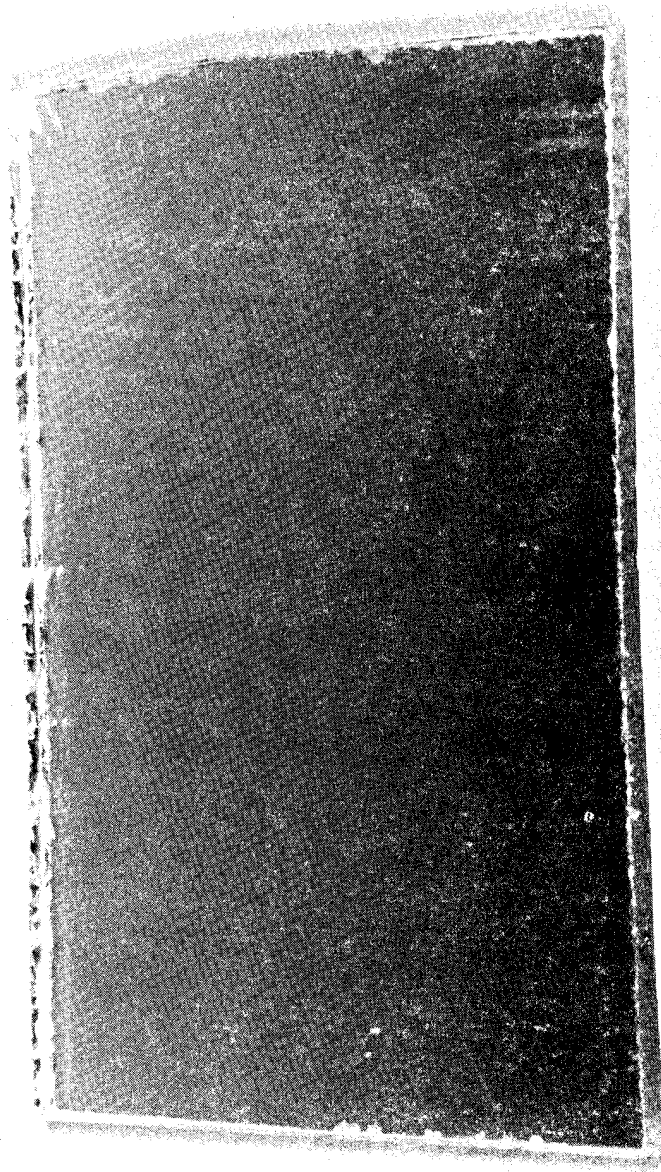
FIGURE 17

Observe the two control samples that were included in the aging study (see Table 3 and Figures 15-16). The Gardner mirror without any protection showed only a slight amount of pitting after 12 months. Survival of this mirror with a minimal amount of damage was attributed to its ability to "breathe". Moisture was not trapped as postulated in the

PLAIN MIRROR

NO EDGE SEAL

NO BACKING

TIME AGED: 14 MOS

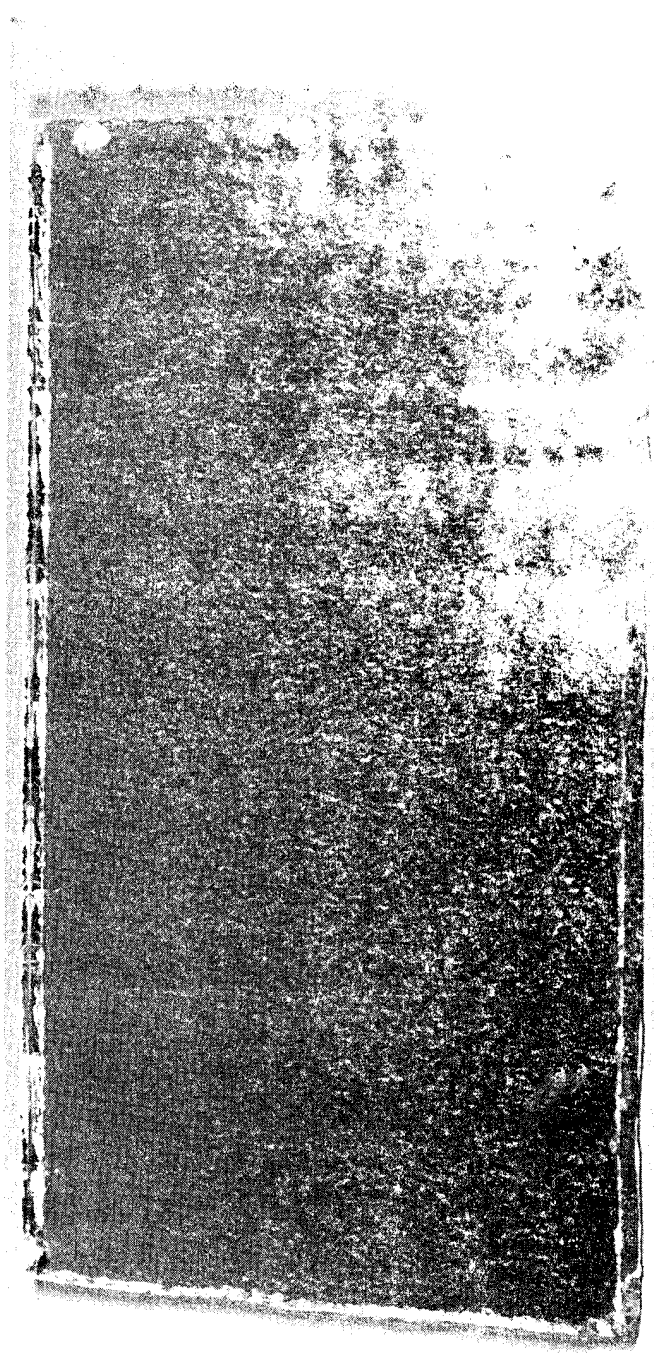
other composite heliostat designs. The control which was coated with the adhesive, EC-3549, showed evidence of deterioration (spotting, shadows) after 6 months. This corrosion suggests incompatibility between the adhesive and silver. The EC-3549 is a polyurethane adhesive cured with an amine. According to a literature source (8), the basicity of an amine in the presence of moisture can result in silver deterioration. Therefore, we could not really evaluate the effectiveness of the respective edge seals because material incompatibilities, nebulous bonding and heliostat designs appeared to have a greater bias on the results than edge seal selection.

PLAIN MIRROR

NO EDGE SEAL

ADHESIVE : 3M'S EC-3549

TIME AGED : 14 MOS
