NASA Contractor Report 3816

Advanced Composite Vertical Fin for L-1011 Aircraft

*Design, Manufacture, and Test
(Executive Summary)*

A. C. Jackson
*Lockheed-California Company
Burbank, California*

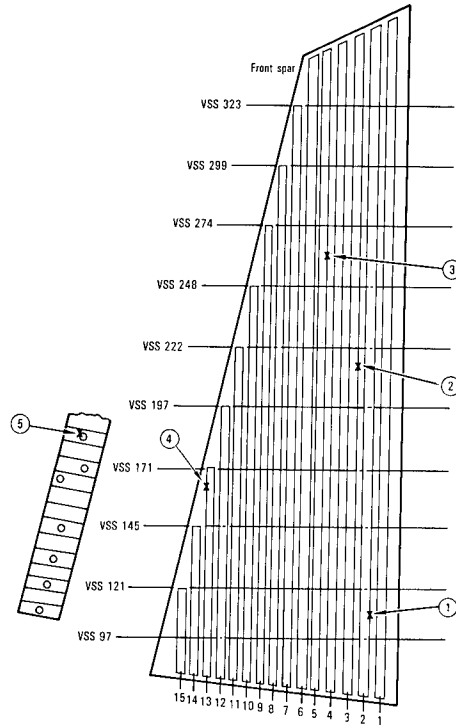
Figure 34. - Impact damage locations.

Impact No. 2 was in the 14-ply skin area. Four impacts were required to obtain visible damage. The first impact was at 13.33 ft-lb. Some damage was evident ultrasonically. A second impact at 8.64 ft-lb showed no evidence of change ultrasonically. A third impact, now back at 13.33 ft-lb, gave no visible damage but increased the damage area determined ultrasonically. A fourth impact was made, but at an energy level of 18.95 ft-lb. Visible penetration through the thickness occurred.

Impact No. 3 was in the 10-ply skin area. This area was impacted at 13.33 ft-lb also. One impact caused visible surface damage.

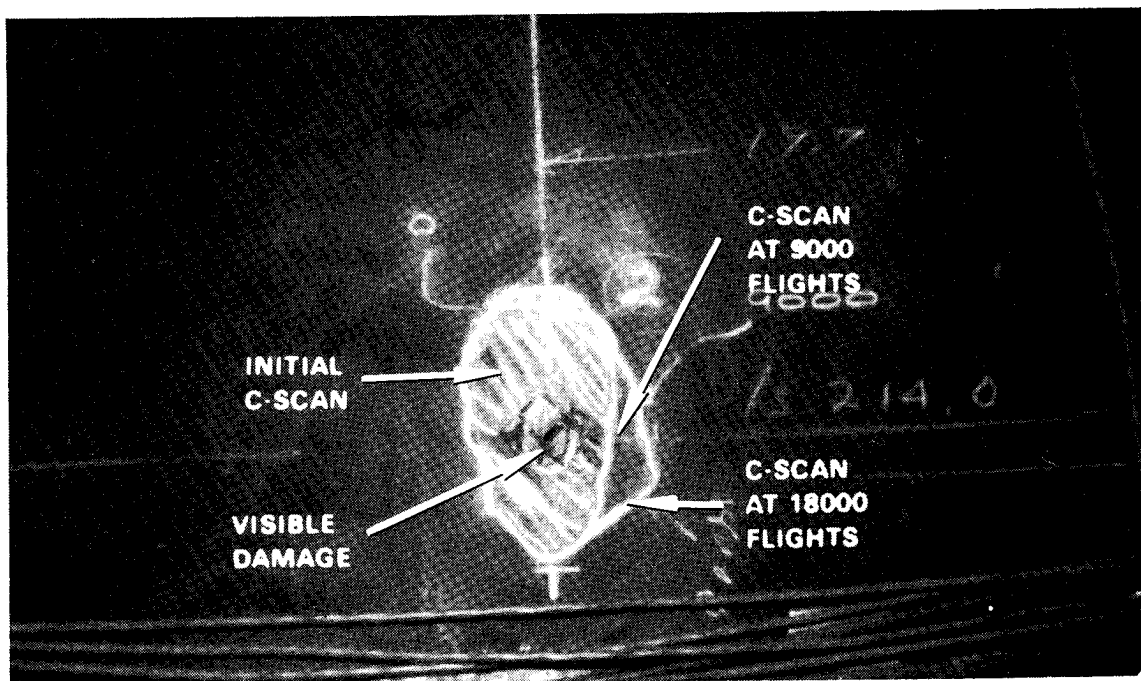
Figure 35. - Impact No. 2 damage growth.

At the completion of each one-quarter lifetime (9000 flights) of fatigue loading the impacted areas were inspected ultrasonically and damage growth, if any, marked on the part. The damage and growth for impact No. 2 shown in figure 35 is typical of that which occurred at all five locations. Most growth occurred during the first half lifetime of fatigue cycling and could only be determined ultrasonically.

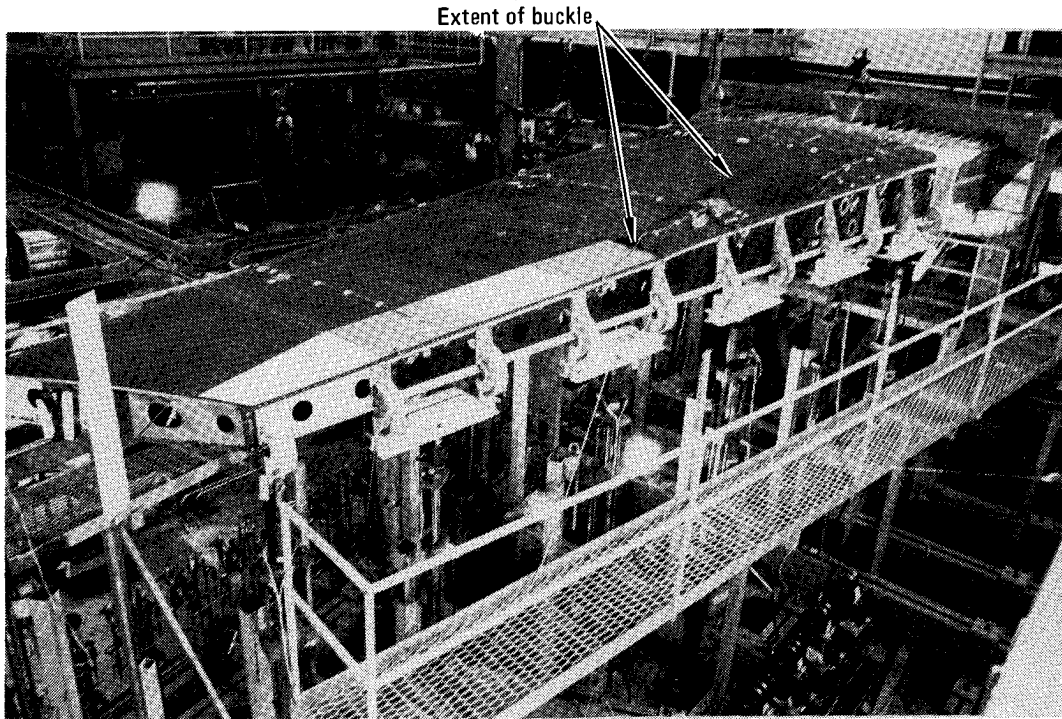
Figure 38. - Fin box at the moment of failure.

The initial failure was caused by high interlaminar stresses induced by shear buckling of the trapezoidal skin panel between VSS 222 and VSS 248 and between the front spar and stiffener No. 10. The high speed film showed that the skin buckled up just above VSS 222 and the buckle then propagated outboard and inboard as the skin and stiffener separated. Shear buckling was measured by a pair of back-to-back shear rosettes in the bay below VSS 222. The strain gage plots shown in figure 39 indicate that shear buckling initiated at about

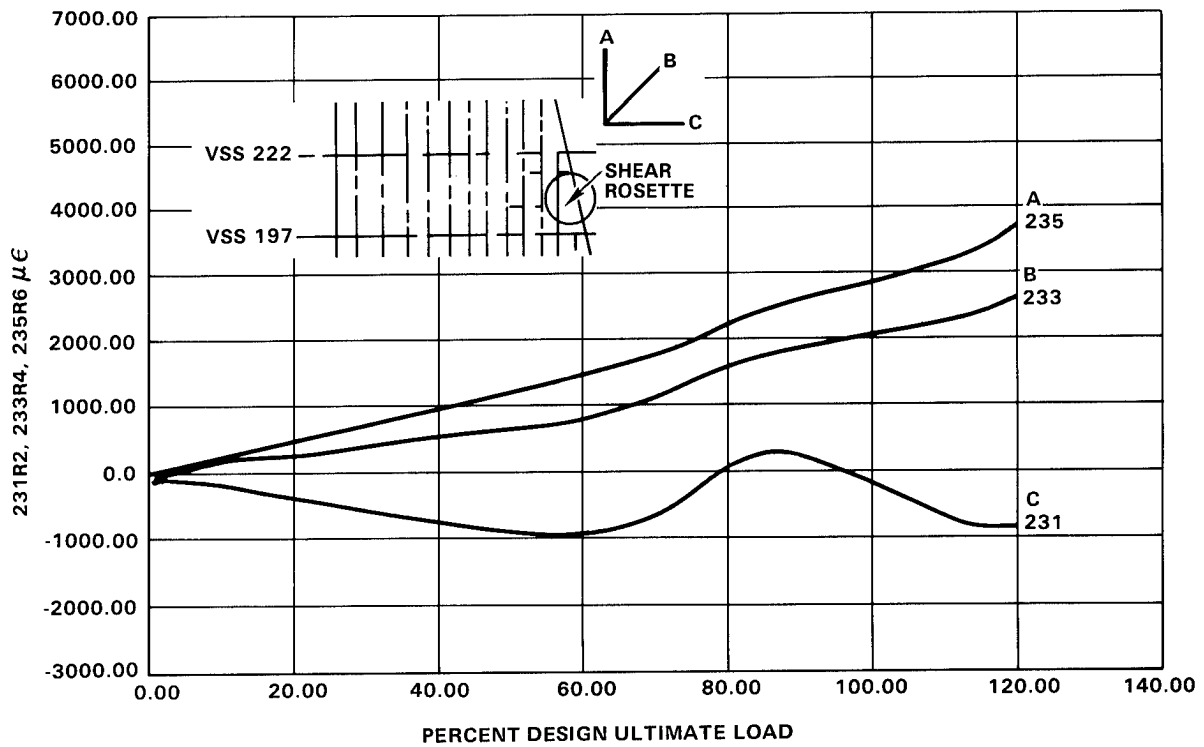
Figure 39. - Shear rosette strain gage plots on tension cover in bay below the failure bay.

design limit load. The Poisson-induced lateral compression strain combined with the shear caused the initial buckling and proved to be more severe than the axial compression and shear on the other cover which did not buckle until 80 percent DUL.
