Final
Report

March 1972

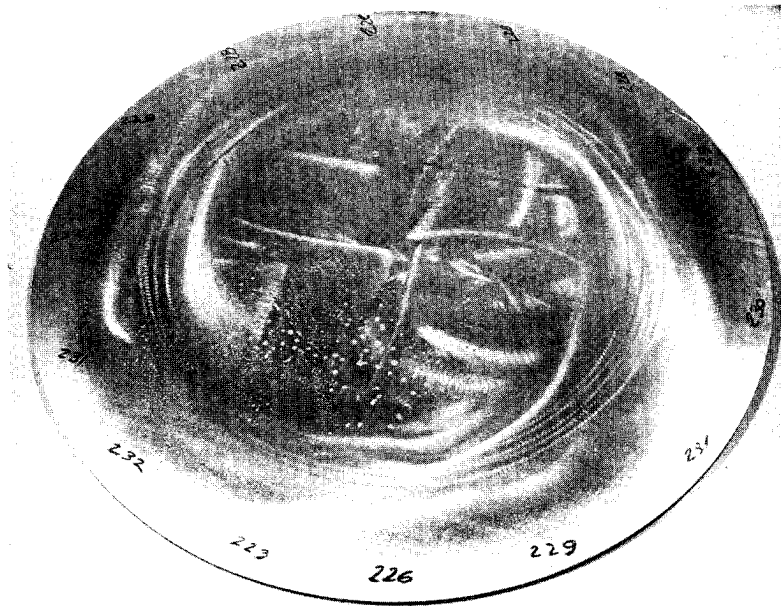
Figure 3 Explosive-Forming Titanium Blank Showing Rolled-In Defects and Surface Pitting Remaining After Attempts to Grind the Surface under a Coolant

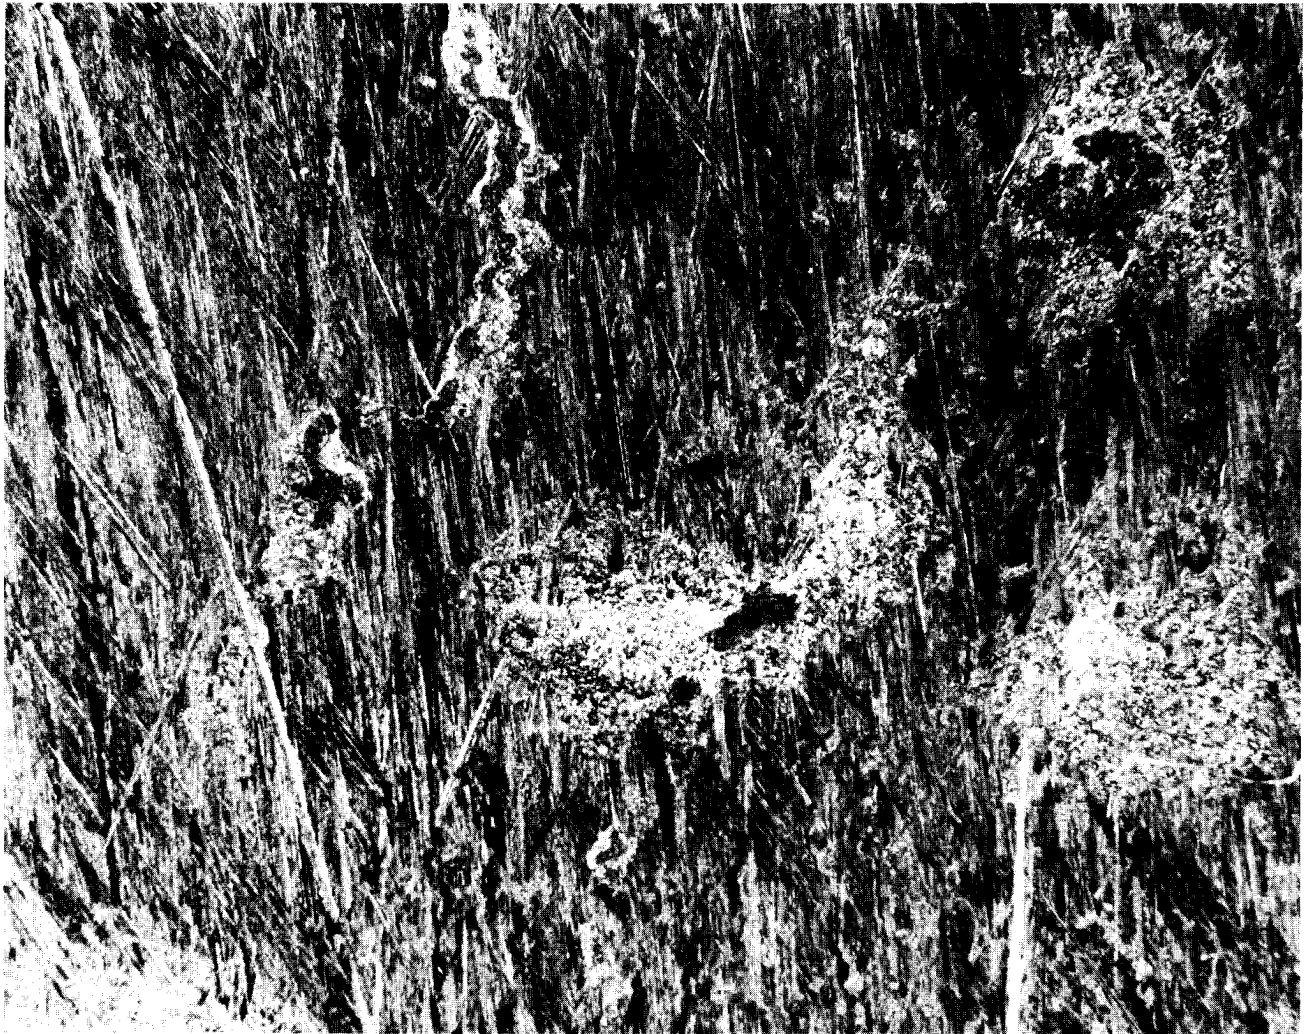
Figure 4 Macrophotograph (Approximately 10X) of Rolled-In Surface Defects in Titanium Plate Shown in Figure 3

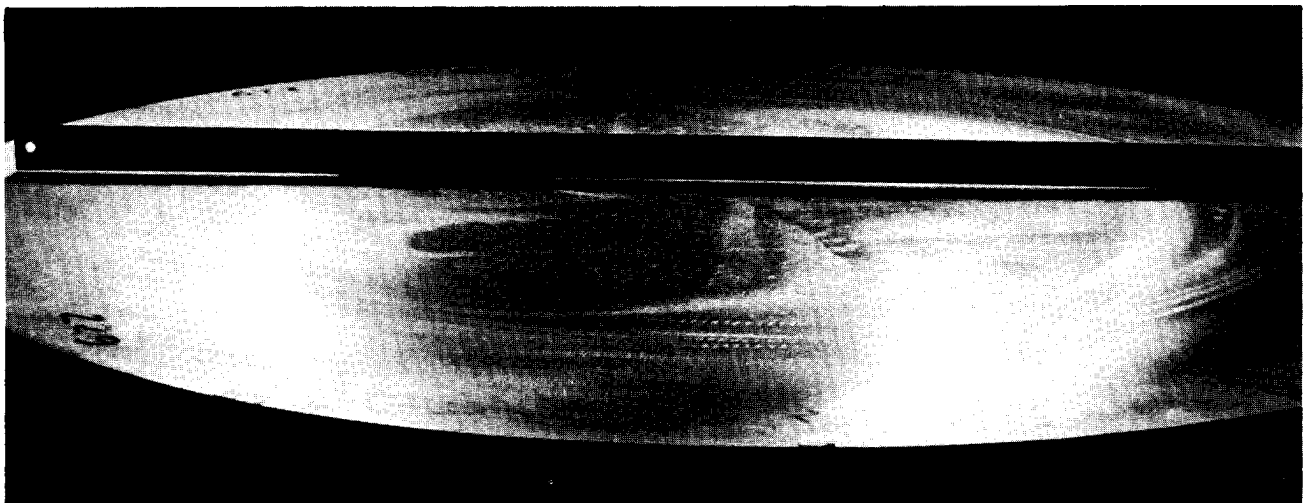
Figure 5 Explosive-Forming Blank (Same as Fig. 3 and 4) Illustrating Deviation From Flatness

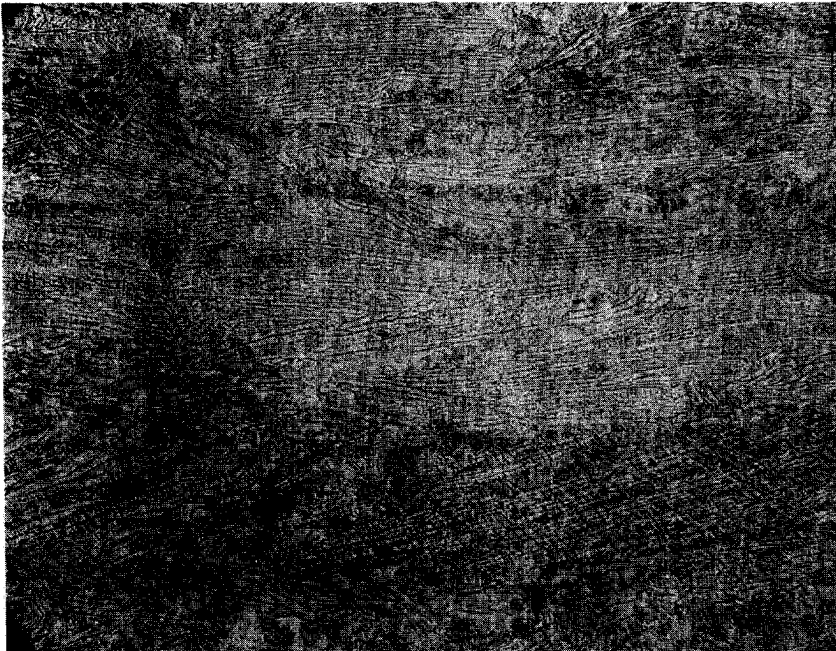
Figure 7 Photomicrograph of Cross Section at 100X from Failure Area of Dome C-2 Showing Hot Roll Texture

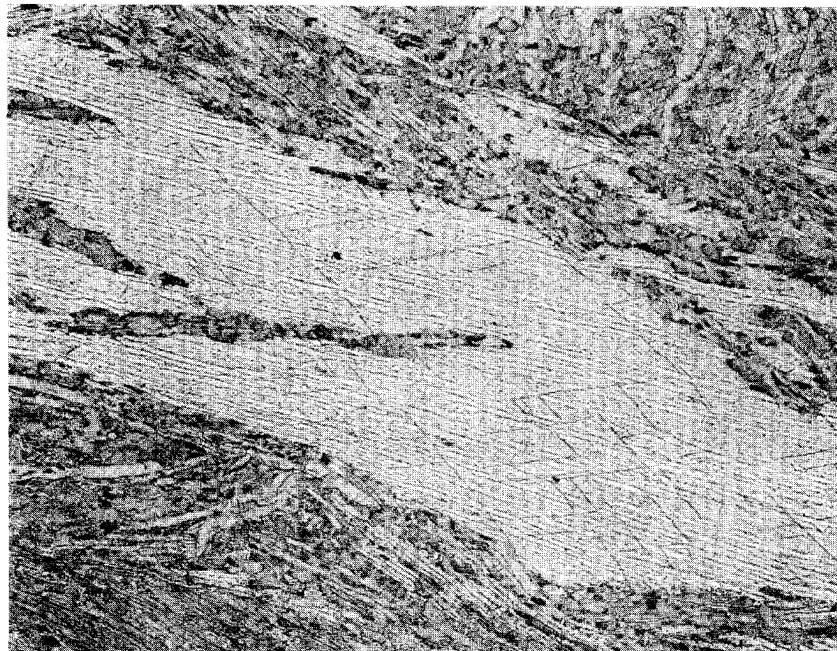
Figure 9 Photomicrograph of Cross Section at 100X from Failure Area of Dome D-3 Showing Crosshatch Cracking

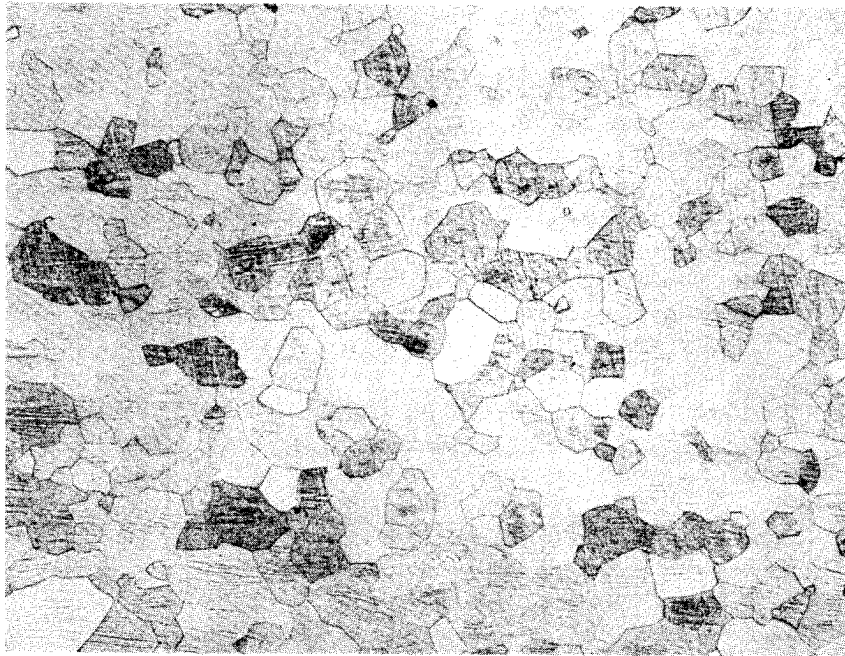
Figure 10 Photomicrograph of Properly Annealed
Ti-5Al-2.5Sn (ELI)

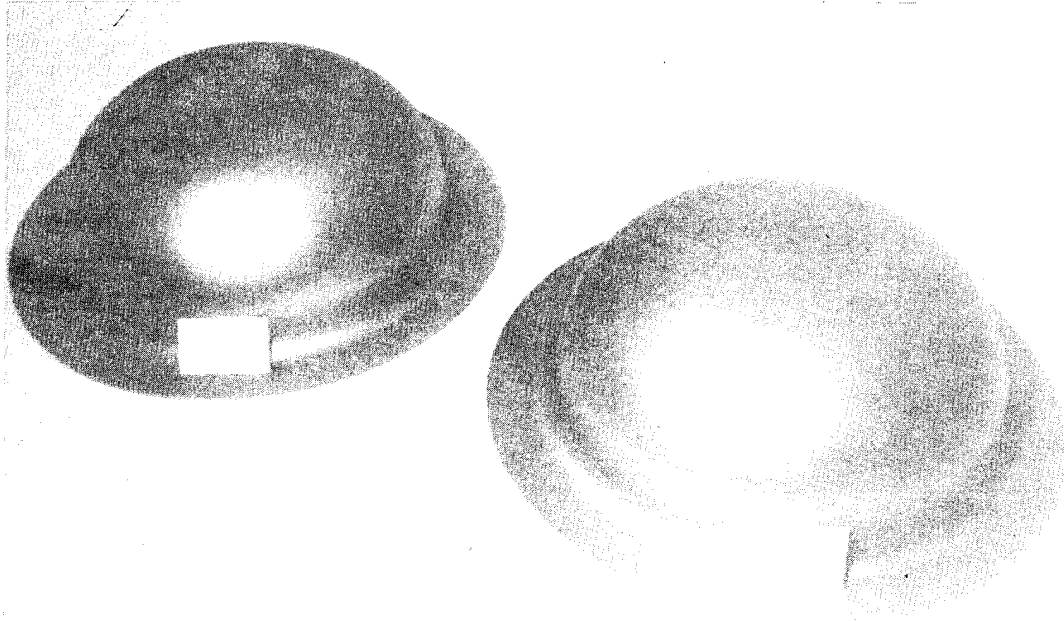
Figure 12 Fully Formed Domes Coated with Turco Pretreat Prior to Annealing in Air Furnace

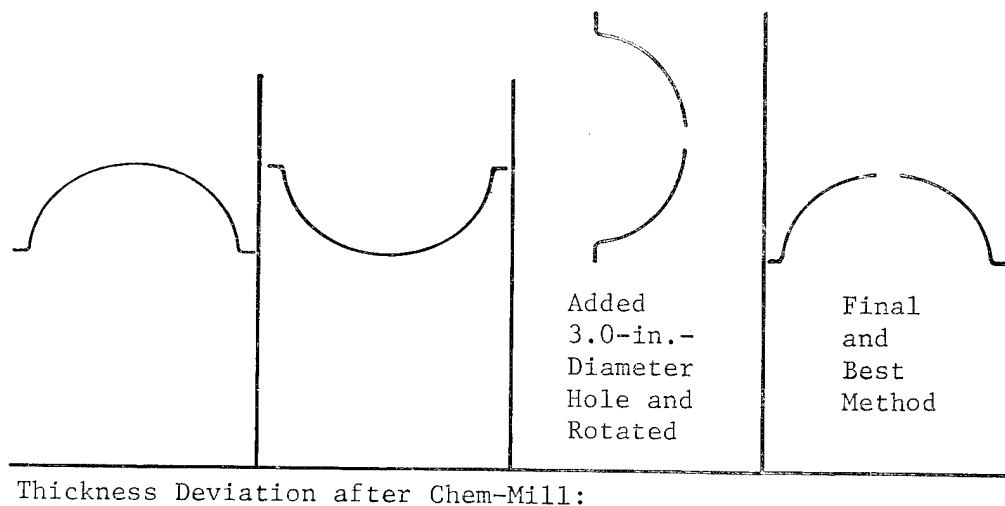
Thickness Deviation after Chem-Mill:

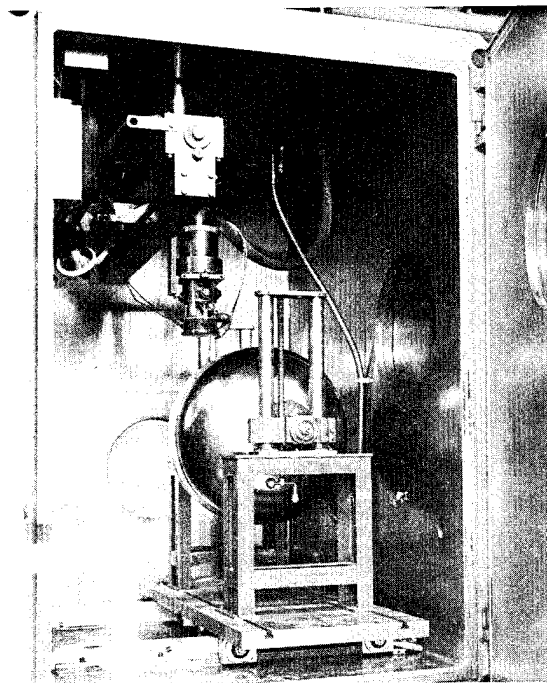
Figure 30 Interior of Electron Beam Vacuum Chamber Showing Titanium Tank Mounted on Rotating Fixture Prior to Welding Dome-to-Barrel Joint (Stationary Weld Head Has Been Adjusted for Proper Elevation and Joint Alignment)

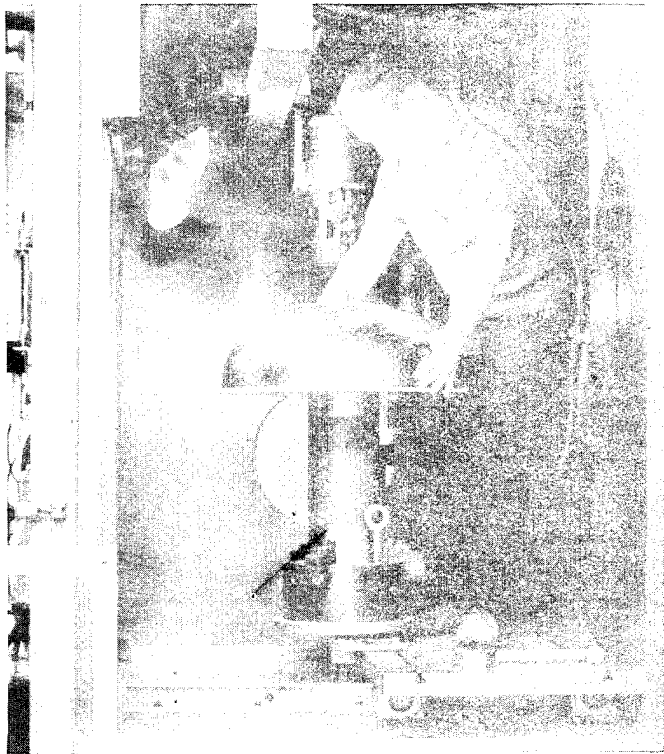
Figure 32 Electron Beam Weld Technician
in Weld Chamber Assembling
Dome and End Fitting on Fixture
for Welding

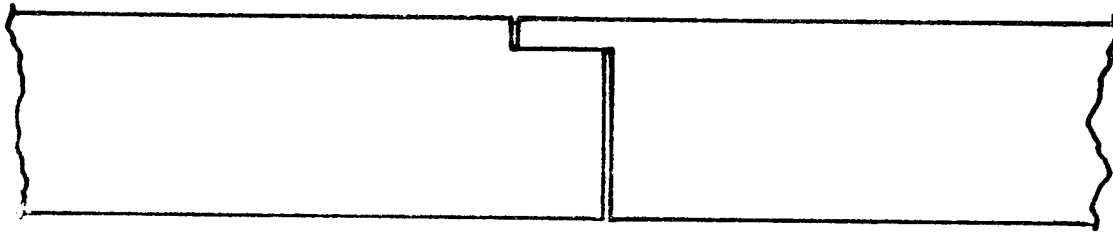
After S/N 1 failed during the hydrostatic sizing operation, a failure analysis uncovered lack of fusion in the girth joint. As a result S/N 2, which had been completed, was returned for rework. Rework consisted of removing both interlocking step joints at the girth. Although a new barrel was used for reassembling the tank liner, some volume was lost due to elimination of the old weld area on both domes. The barrel and domes were prepared for final welding by machining a straight butt joint and tack-welding the barrel and dome together.

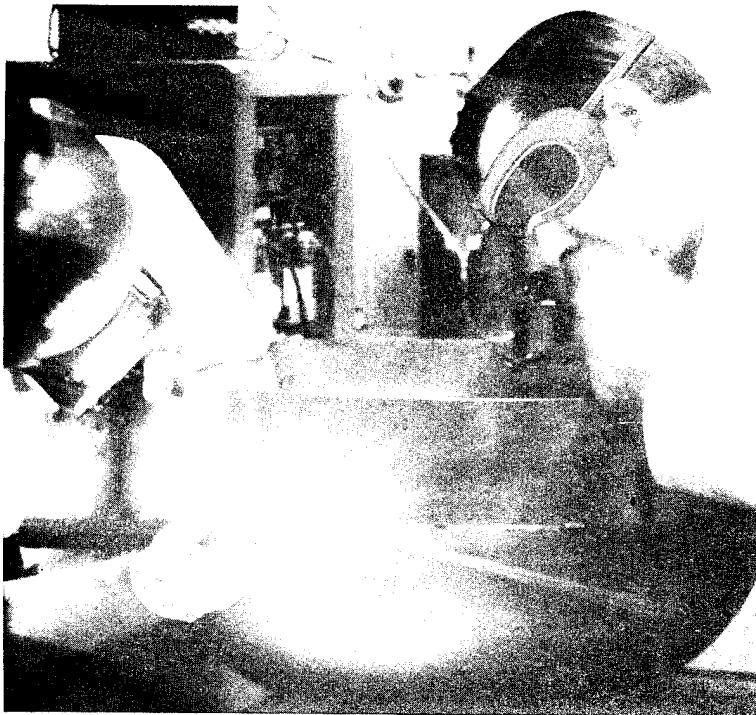
Figure 34 TIG Surface-Tack Weld of Barrel-to-Dome
Prior to Performing Electron Beam Weld

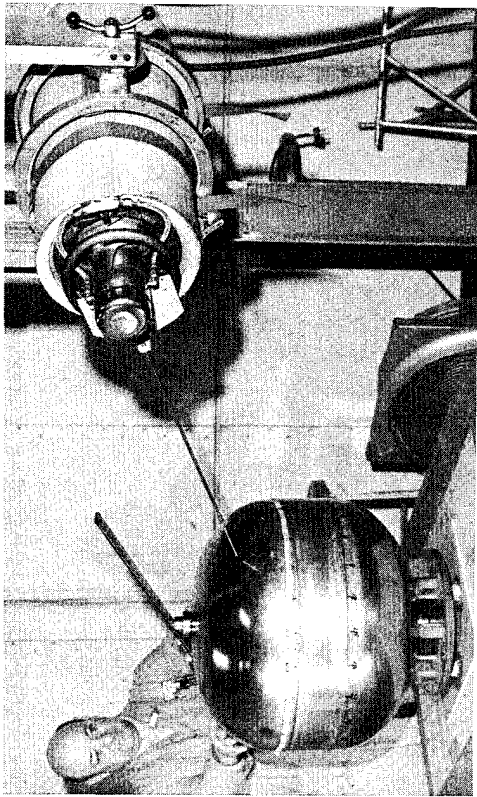
Figure 37 X-ray Technician Aligning X-ray Machine for Shooting Double-Wall X-ray on Section of Dome-to-Barrel Weldment

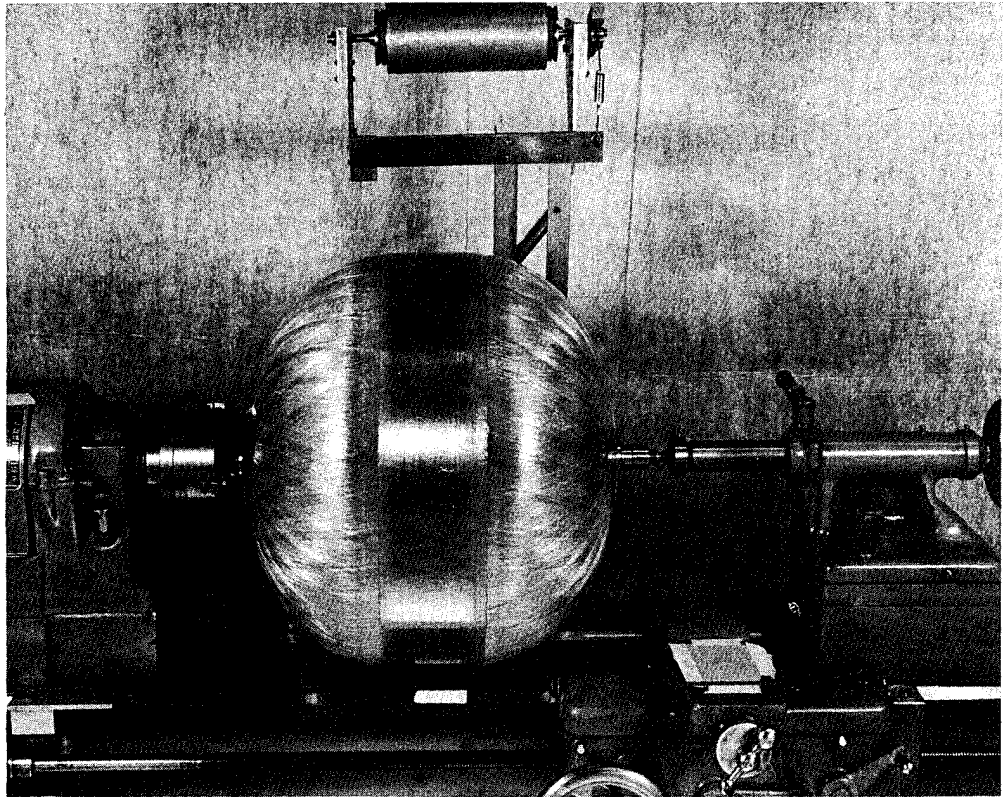
Figure 39 Fiberglass-Overwrapped Tank on Lathe Prior to Adding Hoop Wraps on Cylindrical Section of Tank

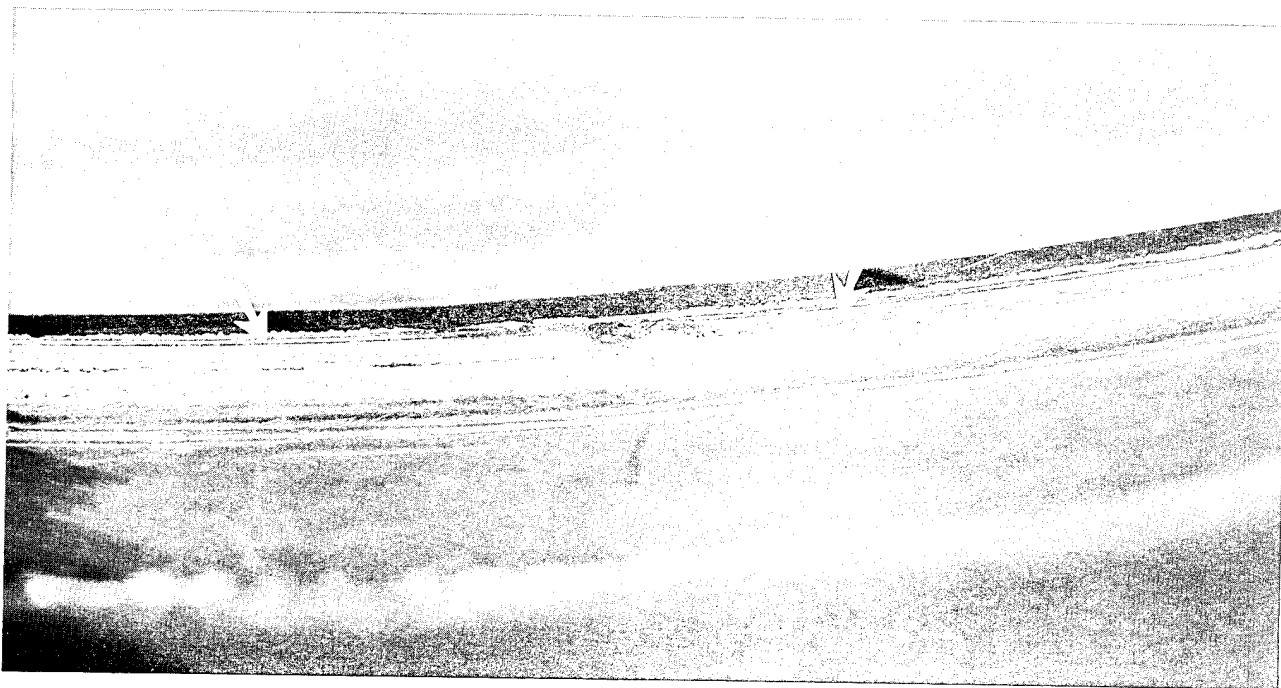
Figure 57 Origin of Failure at Girth Joint; Machining Marks Indicate Lack of Fusion (Typical of S/N 1 and S/N 2)

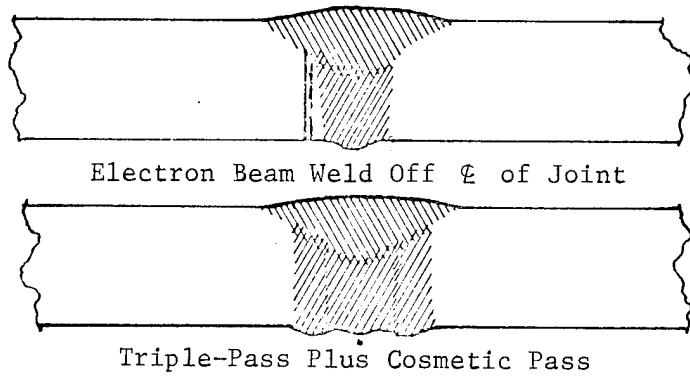
Figure 58 Defective Single Pass Electron Beam Weld and Proper Triple-Pass Weld

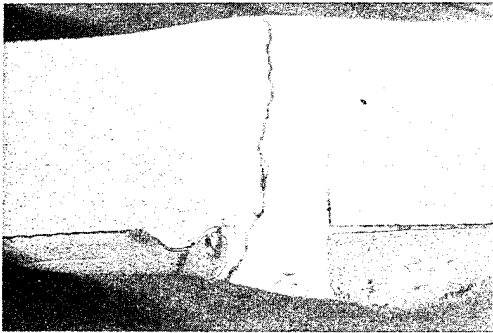
Figure 59 S/N 3 Failure in Girth Joint due to Weld Contamination

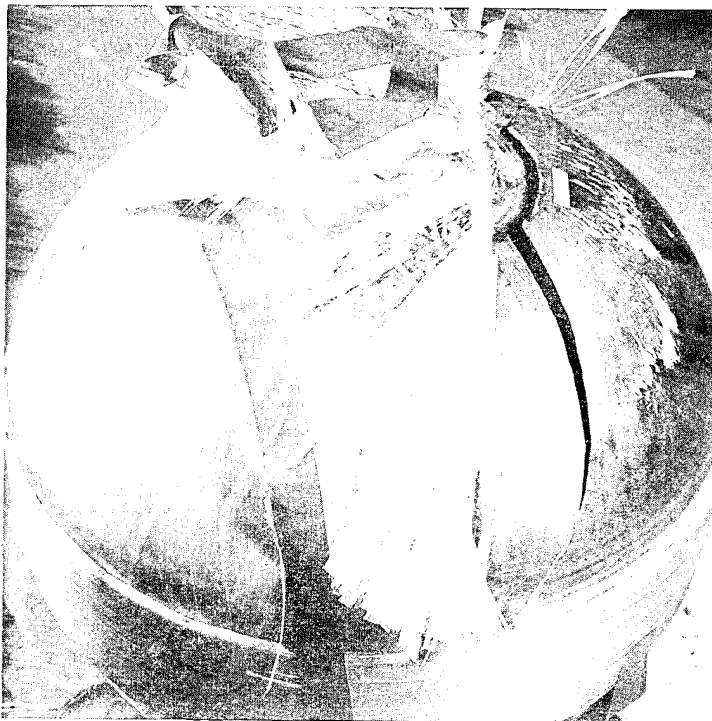
Figure 60 Photograph of S/N 4 Tank Showing Fracture After Removal of Fiberglass

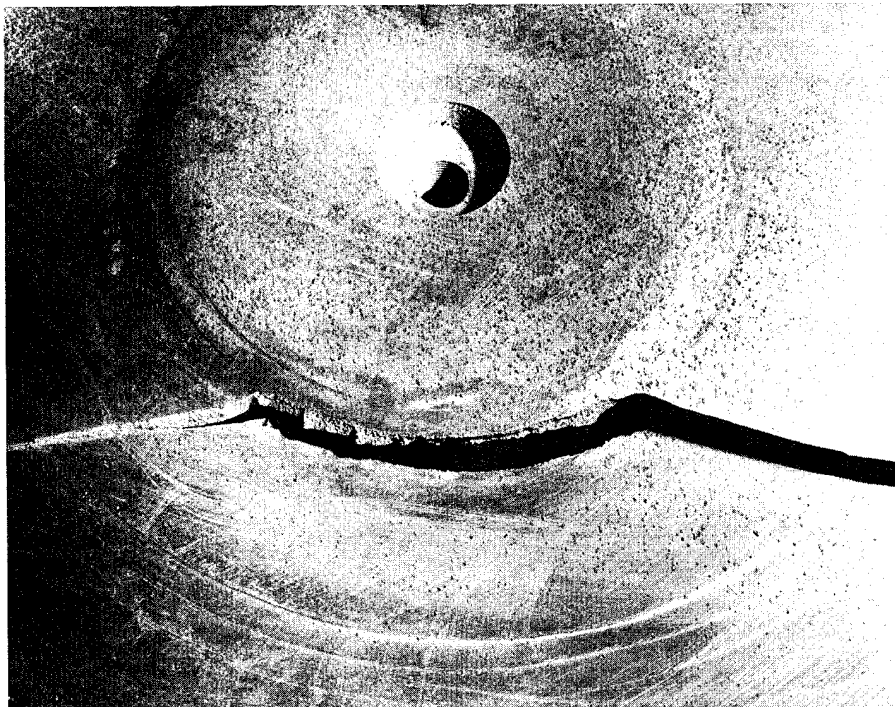
Figure 62 Photograph of S/N 4 Fracture from Inside the Tank

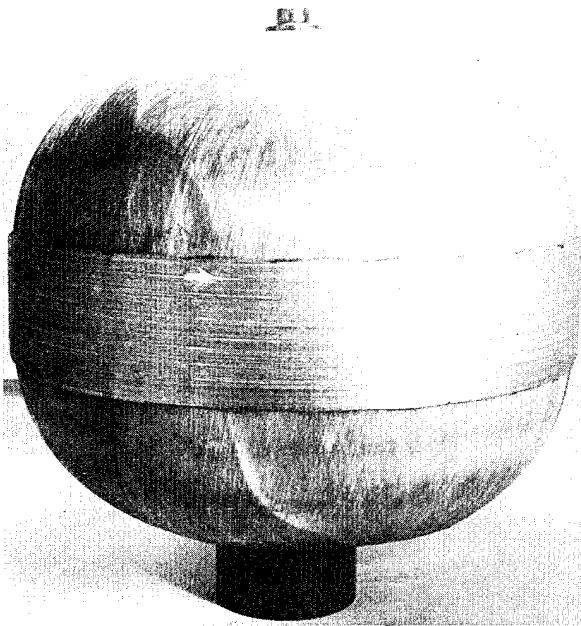
Figure 64 Photograph of S/N 5 Showing the As-Failed Configuration; Arrow Indicates Approximate Origin of Fracture

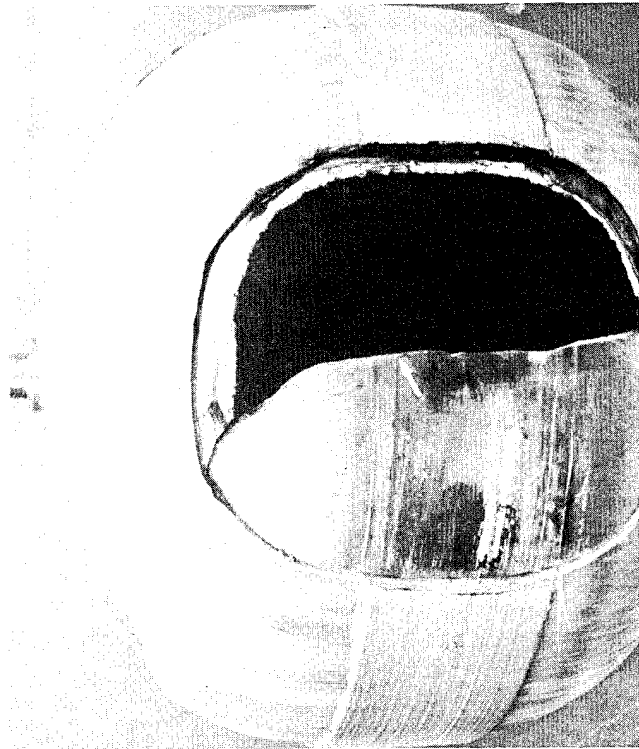
Figure 65 Photograph of S/N 5 Showing Exposed Fracture Surface; Arrow Indicates Failure Origin

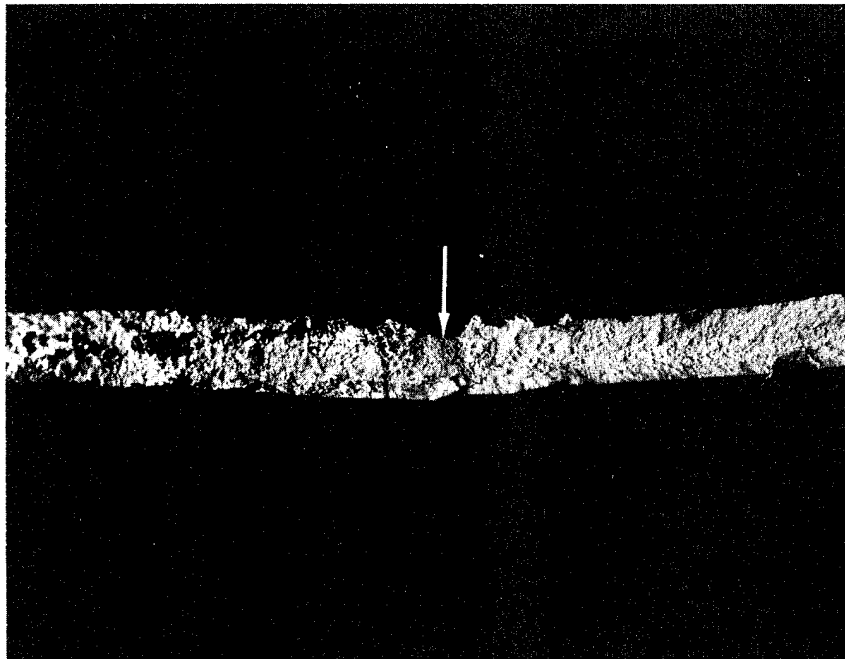
Figure 66 Photomicrograph of Fracture Surface on S/N 5; Arrow Shows Origin of Failure

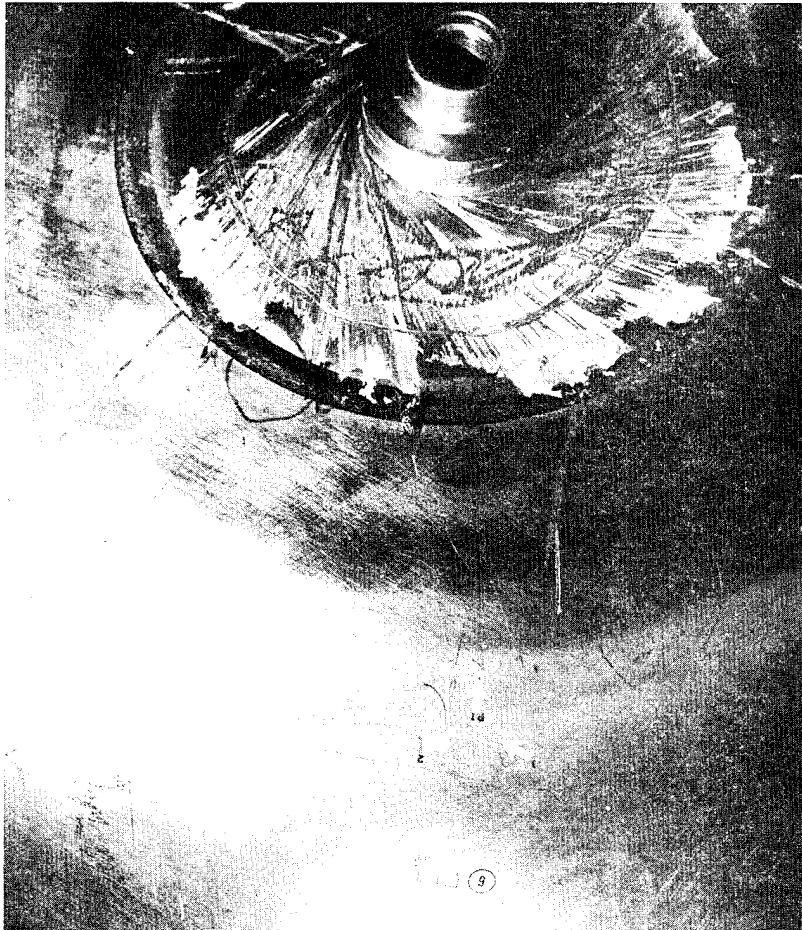
Figure 68 Photograph of S/N 6 Showing
Leak Area

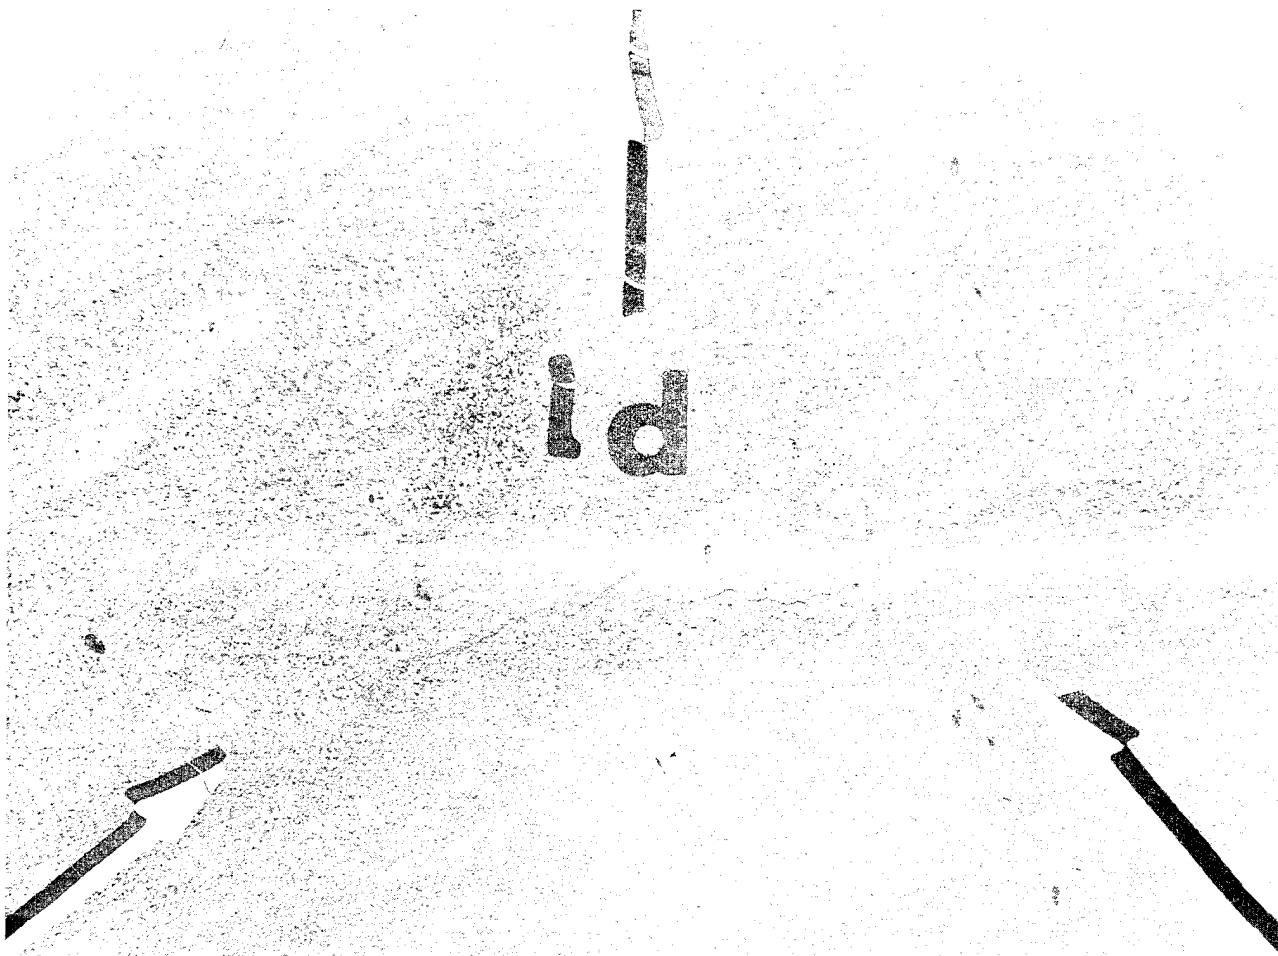
Figure 69 Photomicrograph Showing Fracture of S/N 6 Located on the Exterior of the Dome at Station 59

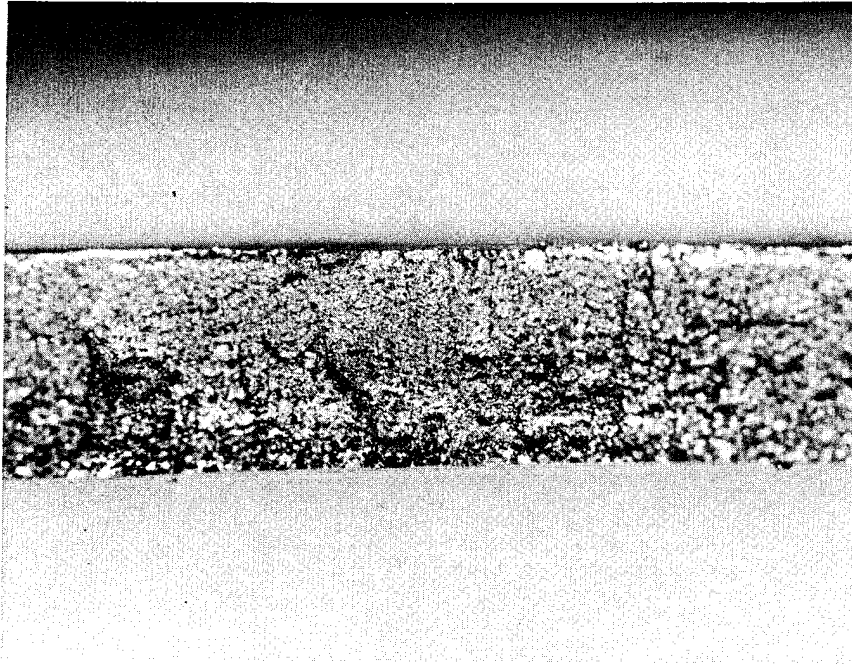
Figure 70 Cross Section of Failure Area on S/N 6
Looking at End of Crack Shown on Figure 67

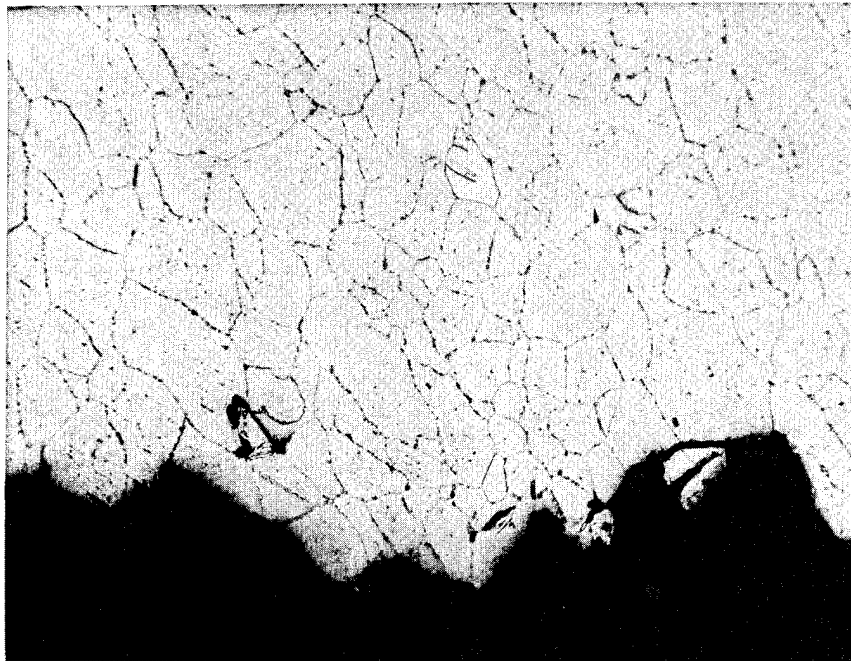
Figure 71 Section of S/N 6 Failure Looking at Edge
of Fracture That Follows Grain Boundaries
(Magnification, 250X)

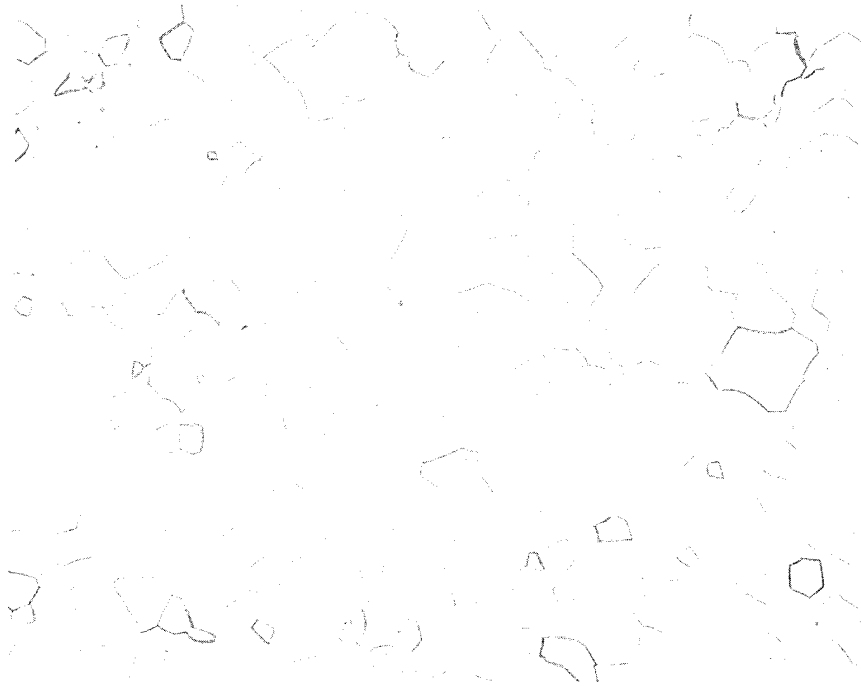
Figure 72 Photomicrograph of Normal "Clean" Microstructure (100X)

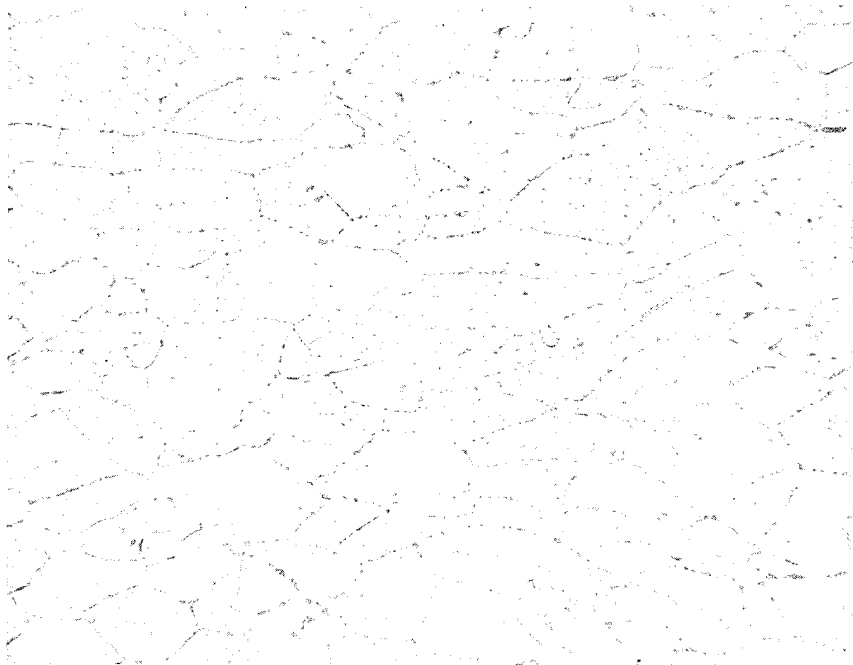
Figure 73 Photomicrograph of the Microstructure Through the Leak Area of S/N 6 (Note the "Dirty" Microstructure and Grain Boundary Precipitant, 250X)

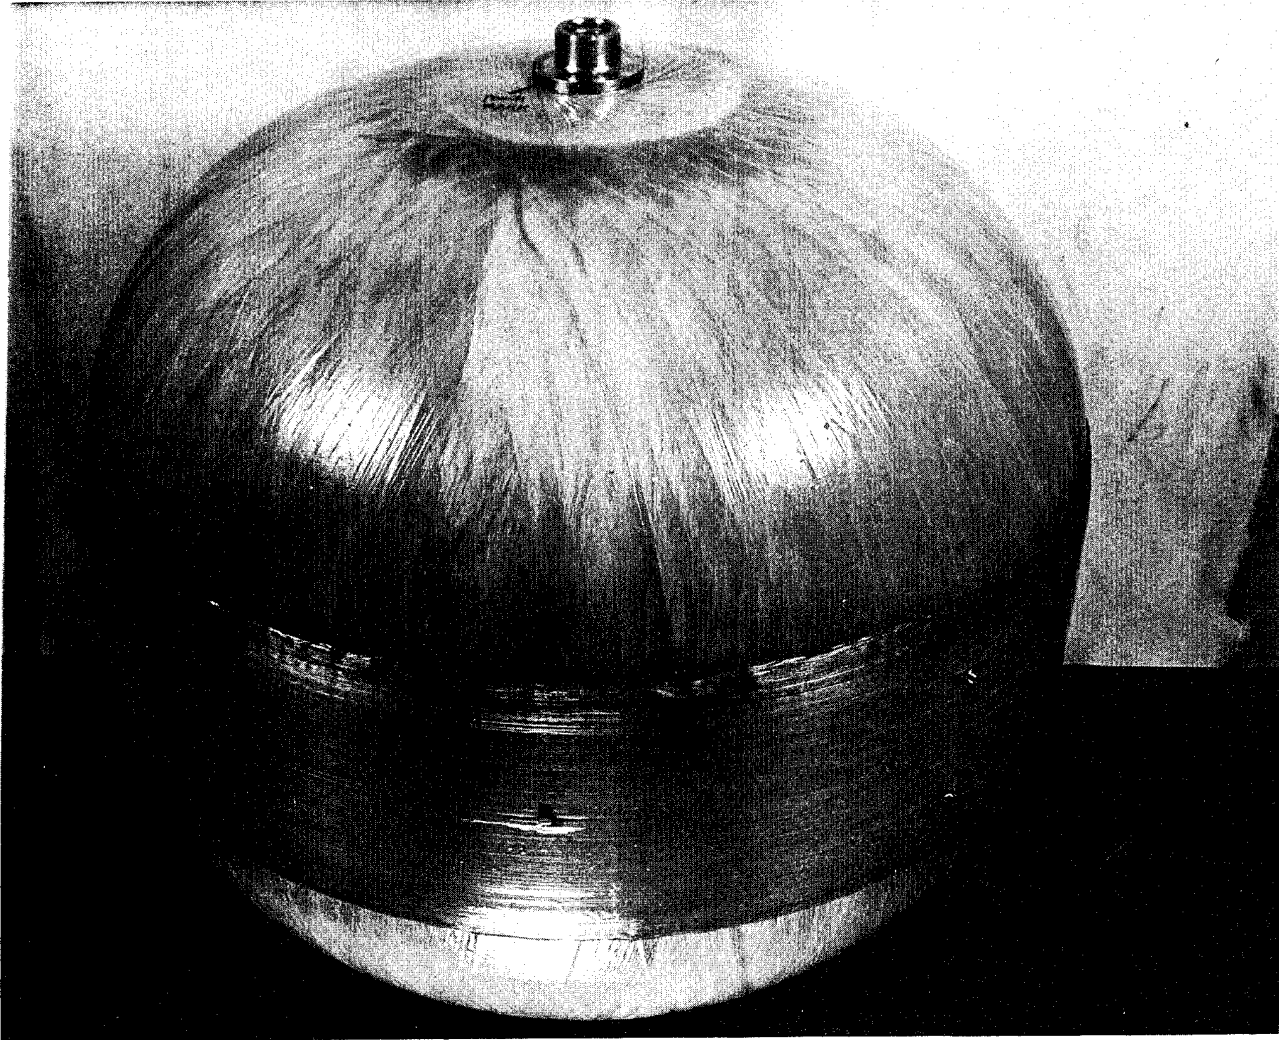
Figure 74 S/N 7 after Failing at 5062 psi (Note the Lack of Fragmentation or Shattering of Overwrap Material)

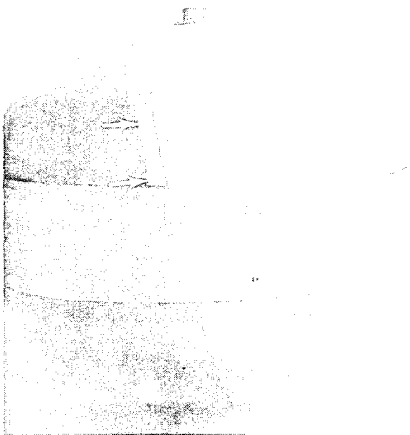
Figure 75 Photograph of Tank S/N 8 Showing the As-Failed Configuration (Arrows Indicate Subsurface Fracture)

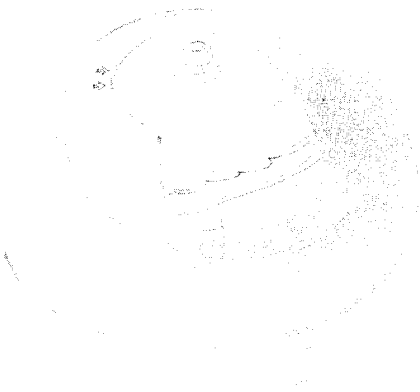
Figure 76 Photograph of Tank S/N 8 Showing Exposed Fracture Surface (Arrows Indicate Approximate Origin of Failure)

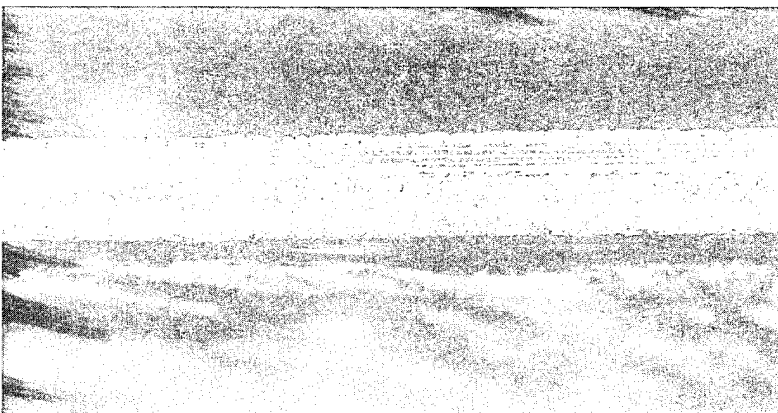
Figure 77 Photomicrograph of S/N 8 Fracture Surface Showing Lack of Fusion at Dome-to-Fitting Joint

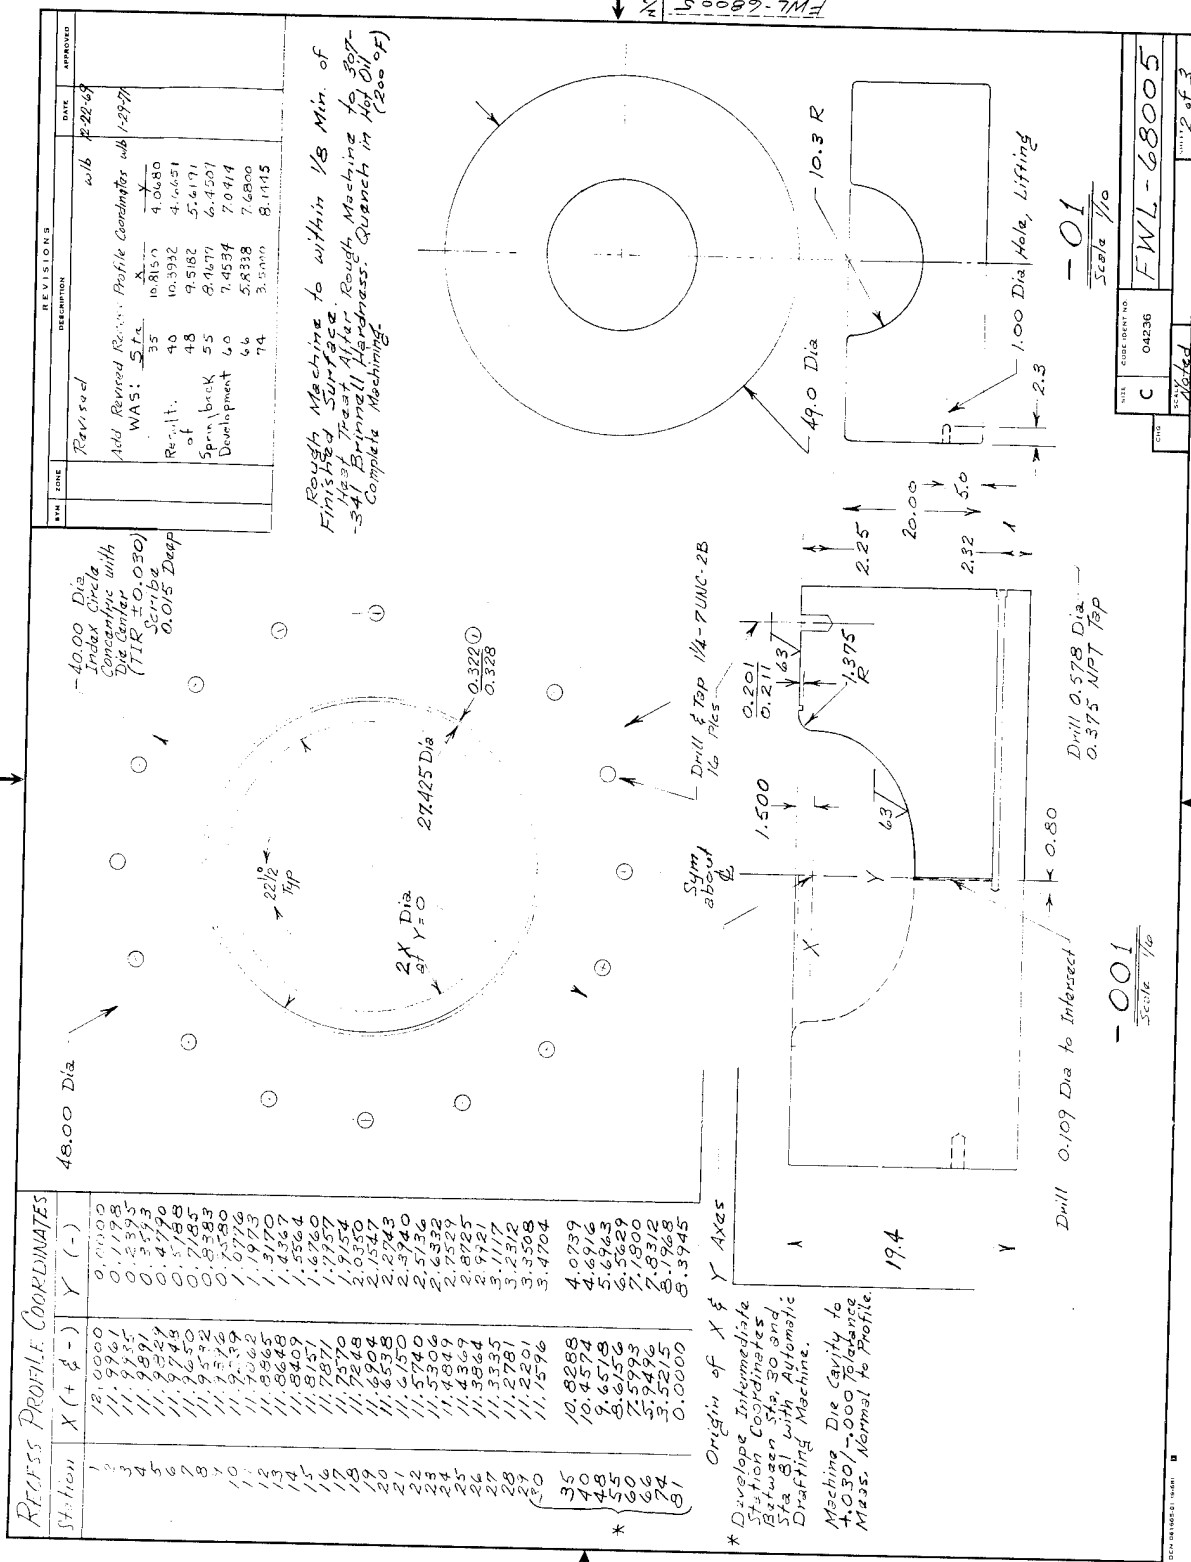
Engineering Drawings of Tank Liner
and Overwrap

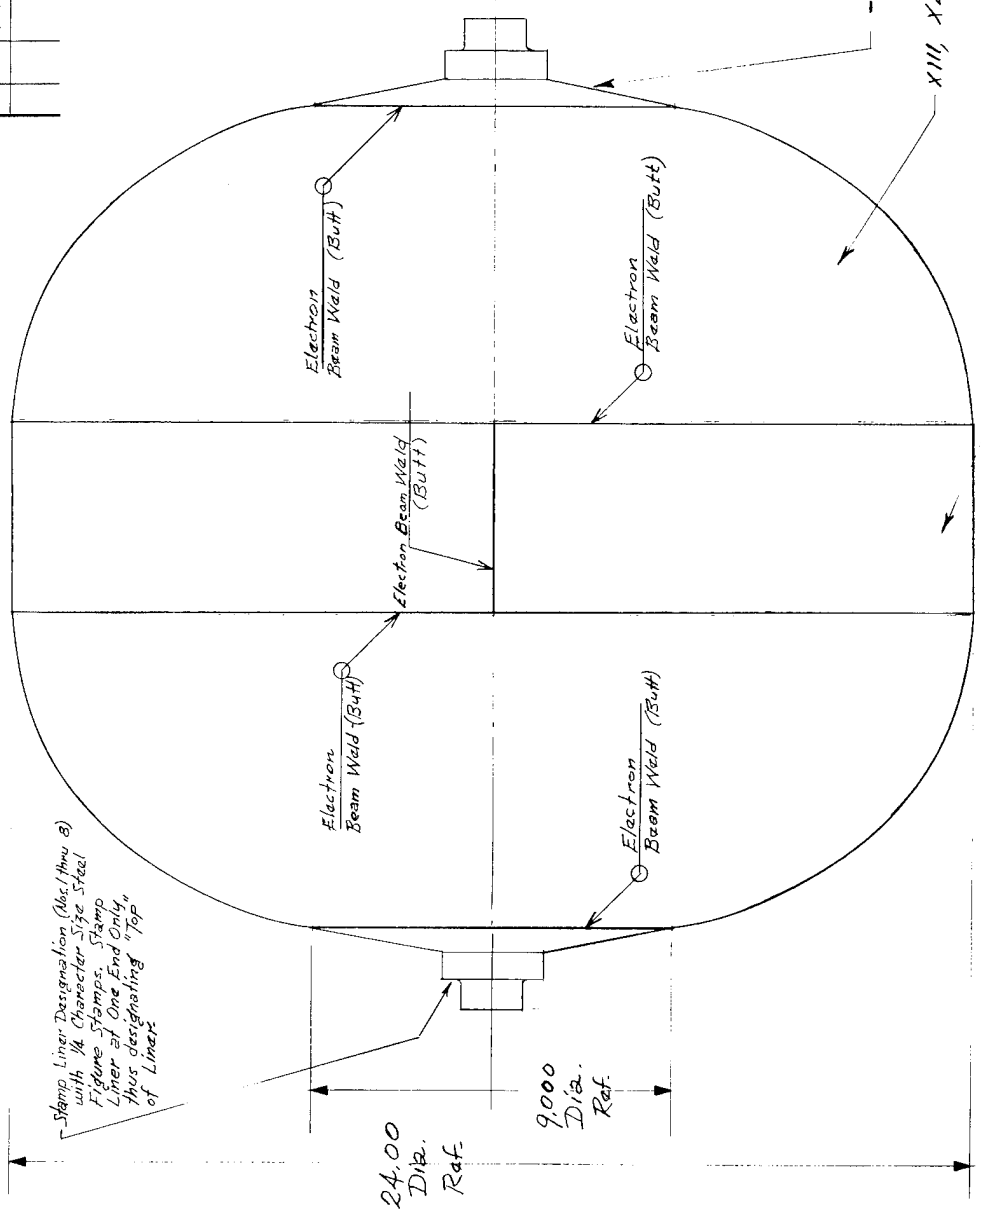
Stamp Liner Designation (As shown a)
 with the Character Size Steel
 Figure Stamps. Stamp
 Liner at One End Only,
 thus designating "TOP"
 of Liner.
