Final
Report

March 1972

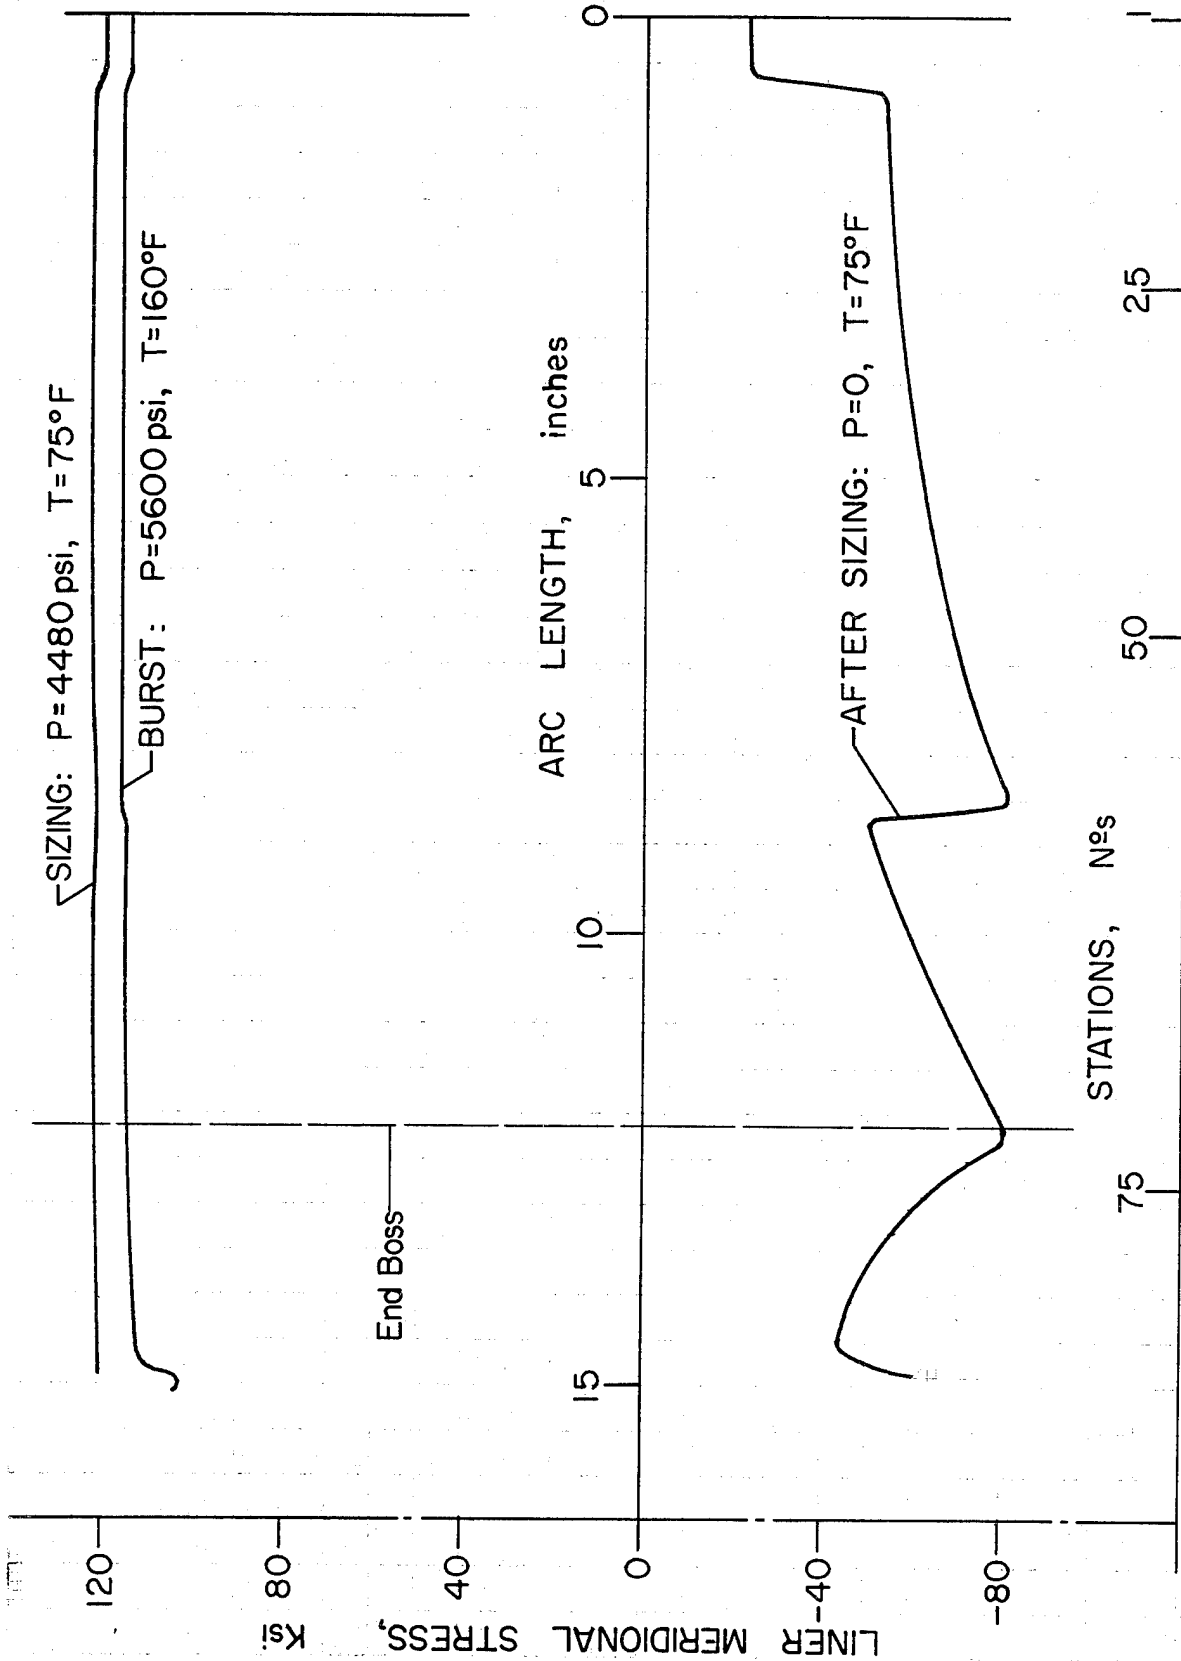
SCHEME 2-STEP, .156-.120

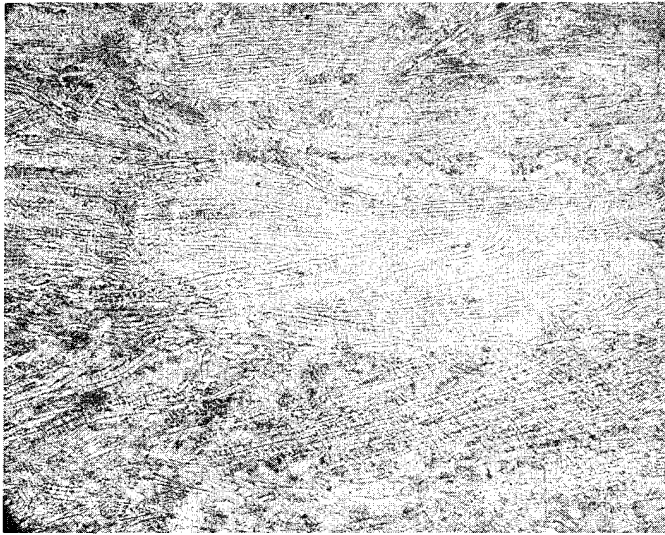
Figure 1 Photomicrograph of Cross Section at 100X from Failure Area of Dome C-2 Showing Hot-Roll Texture

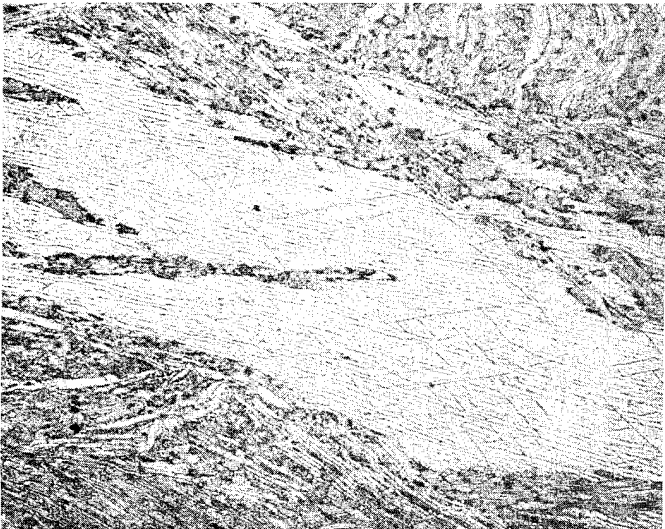
Figure 2 Photomicrograph of Cross Section at 100X from Failure Area of Dome D-3 Showing Crosshatch Cracking

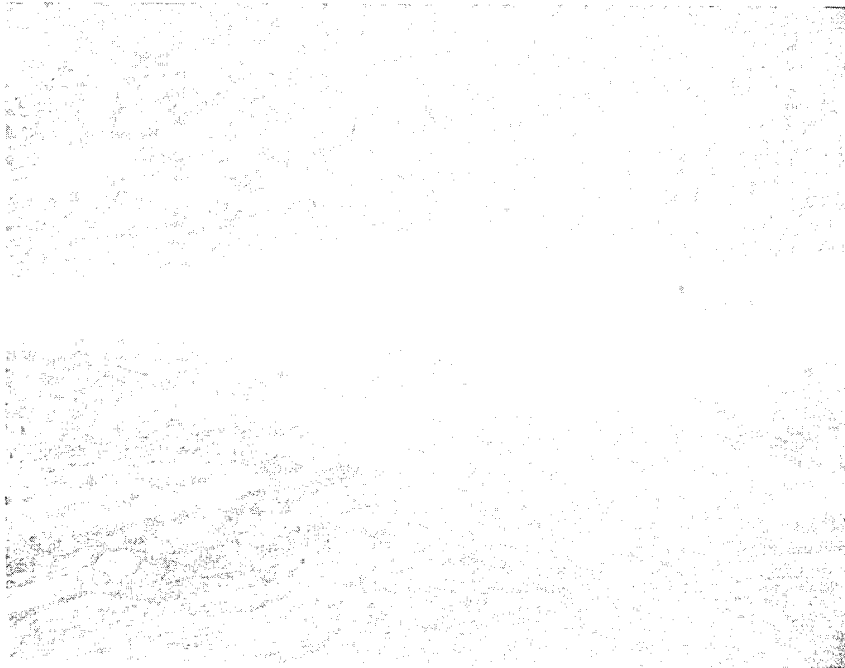
Figure 3 Photomicrograph of Longitudinal Cross Section at 100X of As-Received "C" Plate

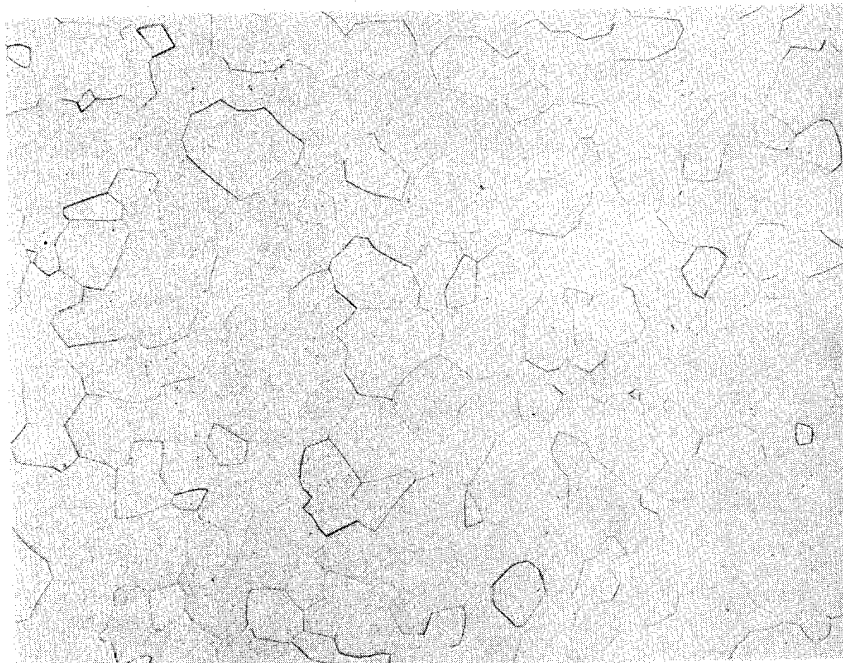
Figure 17 Photomicrograph of Longitudinal Cross Section at 100X of C Plate Annealed 24 hours at 1660°F

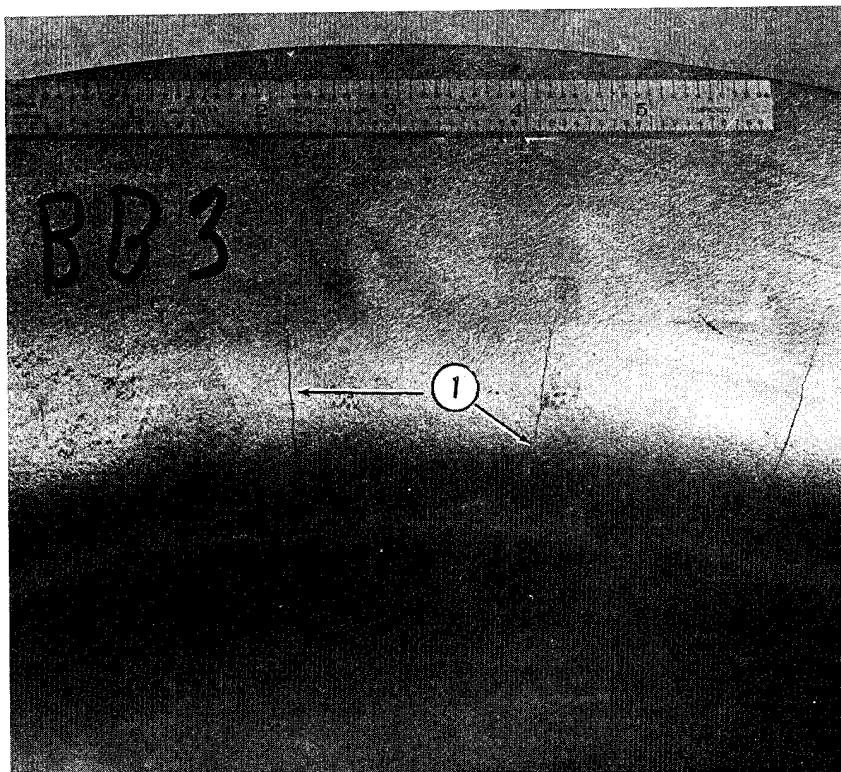
Figure 1 Cracks in the Flange Radius of Dome BB3

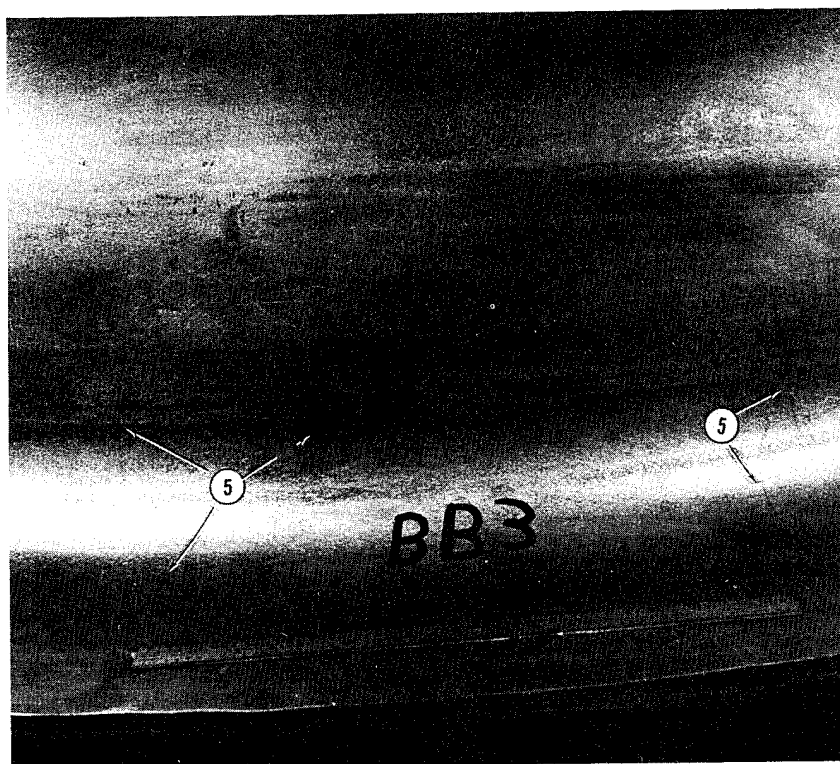
Figure 2 Cracks in the Flange and above the Flange of Dome BB3

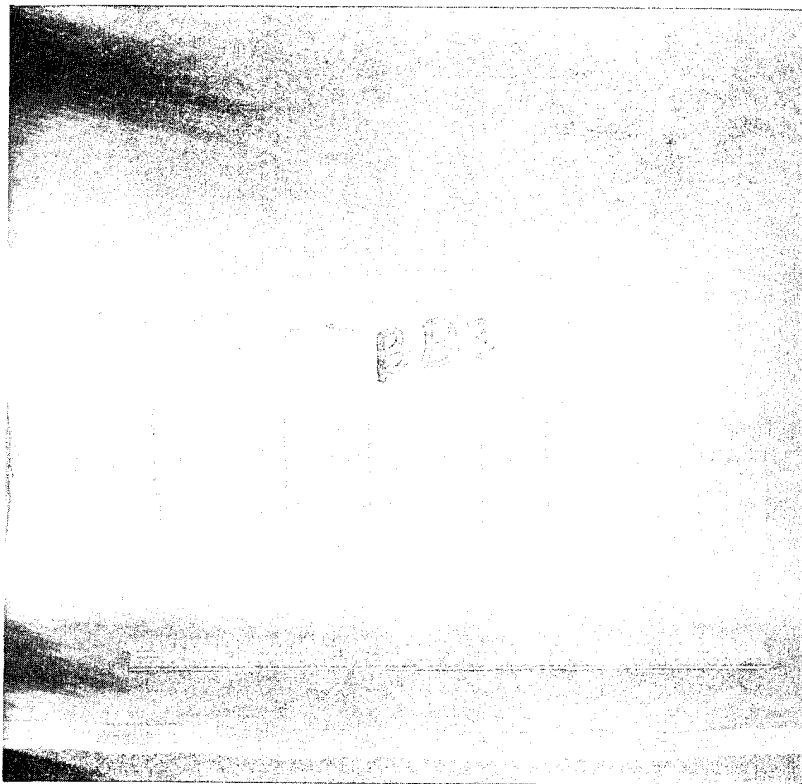
Figure 3 Cracks above the Flange of Dome BB3

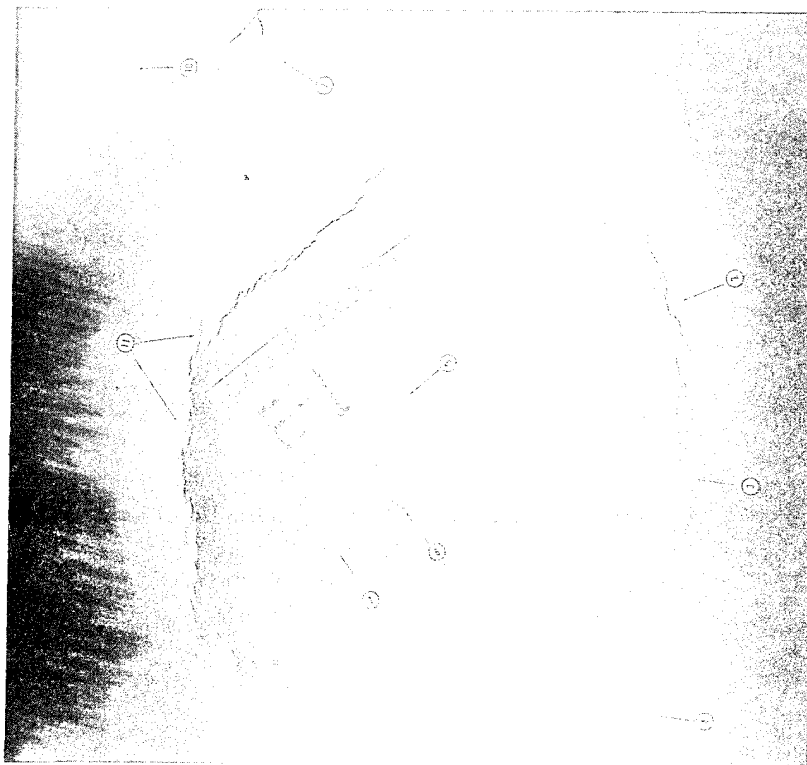
Figure 4 Cracks on the Inside Surface Near the Apex of Dome E1

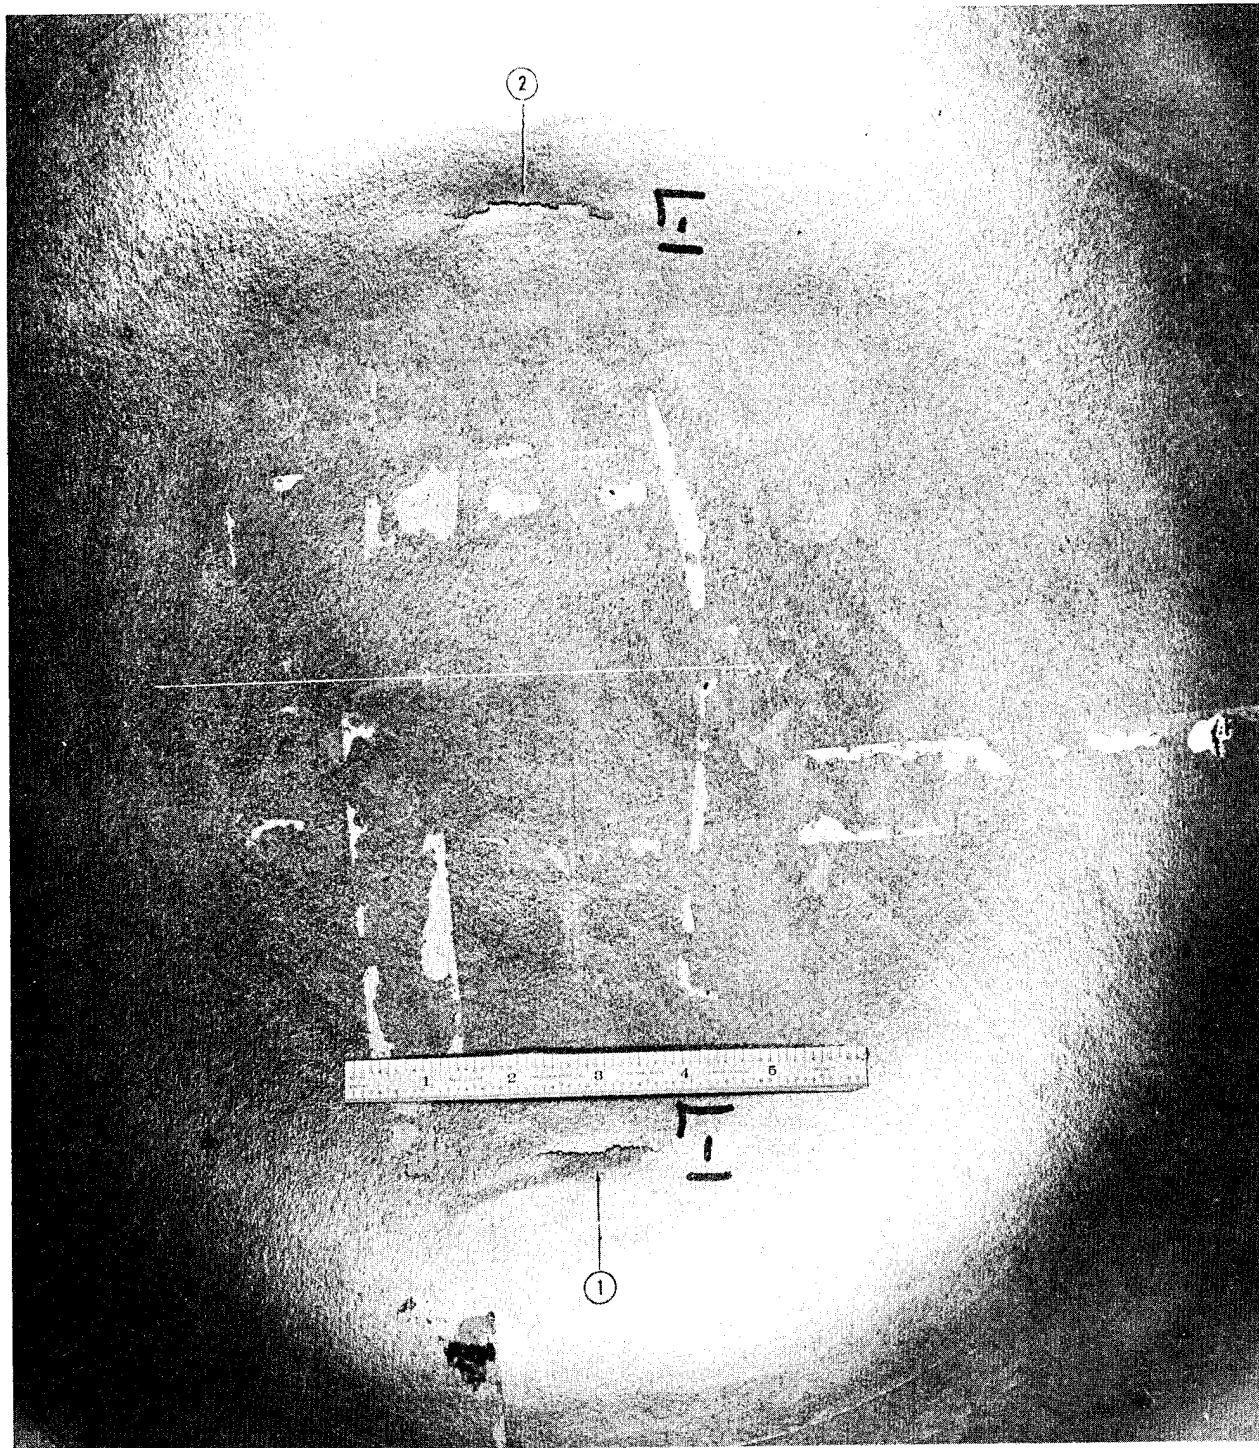
Figure 5 Cracks on the Inside Surface Near the Apex of Dome L1

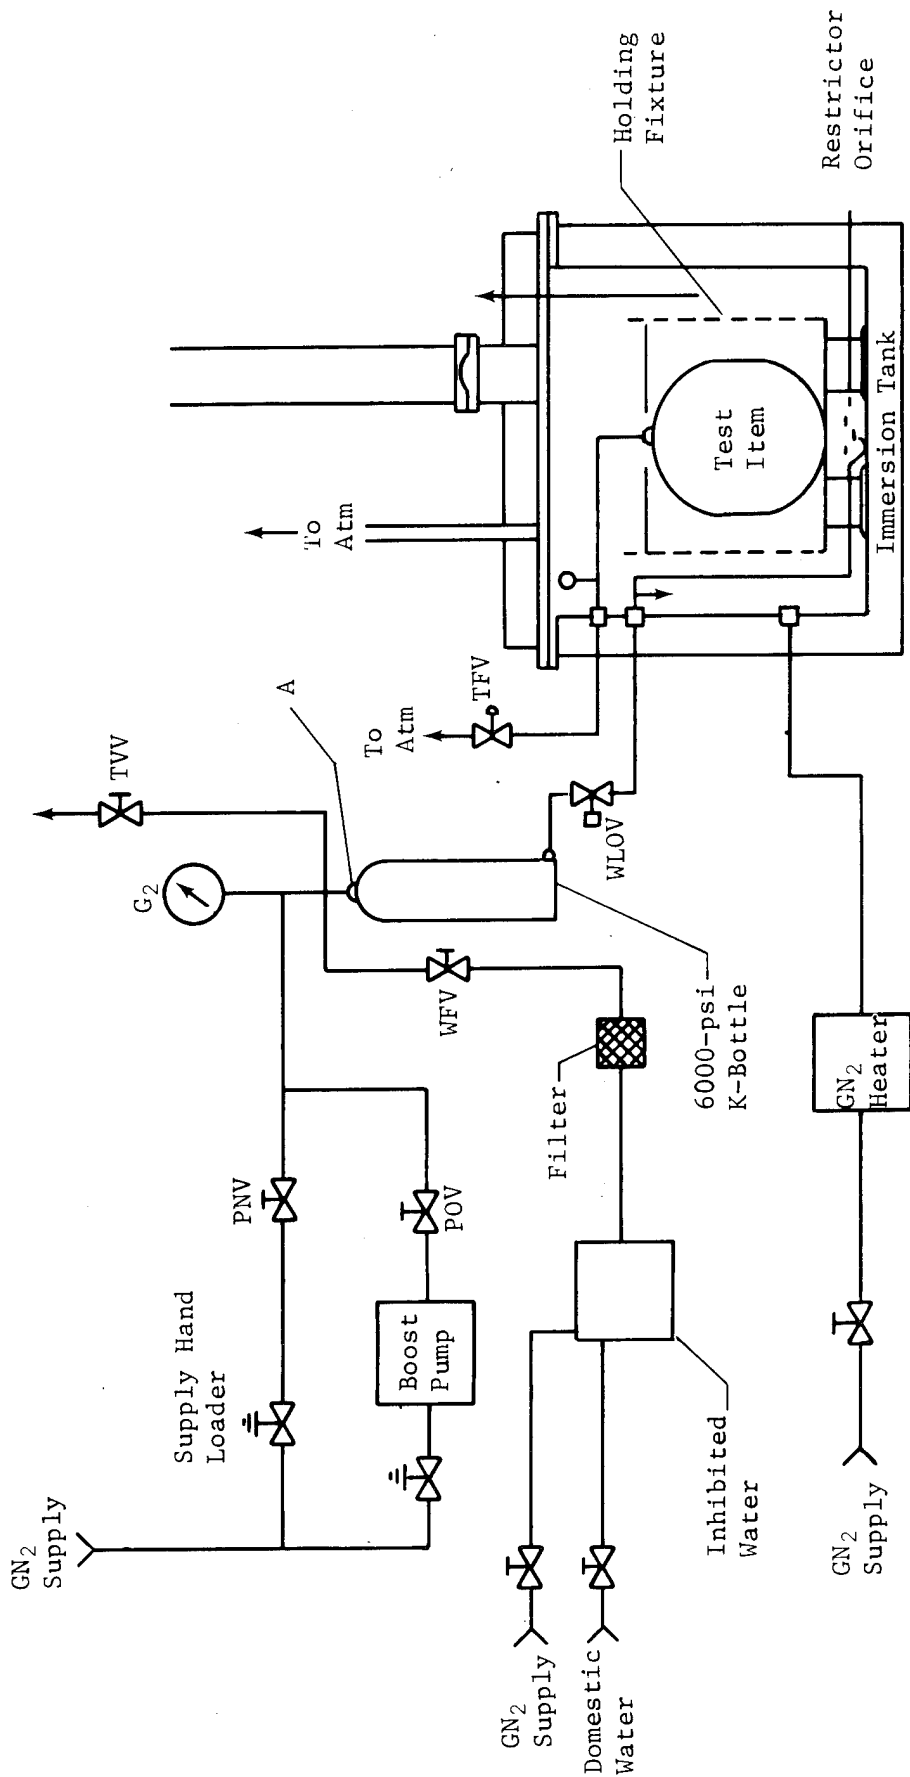
IMPORTANT: Do not balance the pressure data channel during or after postcalibration. A deadweight of P_1 is required in the "as-is" condition.
- _____ 33. Discontinue the immersion tank purge.
- _____ 34. Remove the immersion tank top and verify test item failure.
- _____ 35. Remove P_1 and deadweight through the indicated failure pressure.
- _____ 36. Photograph the failed test item in the holding fixture. All photographs will contain specimen identification, test, date, and time of failure.
- _____ 37. Carefully remove the test item from the holding fixture and photograph as necessary to show all of the failure.

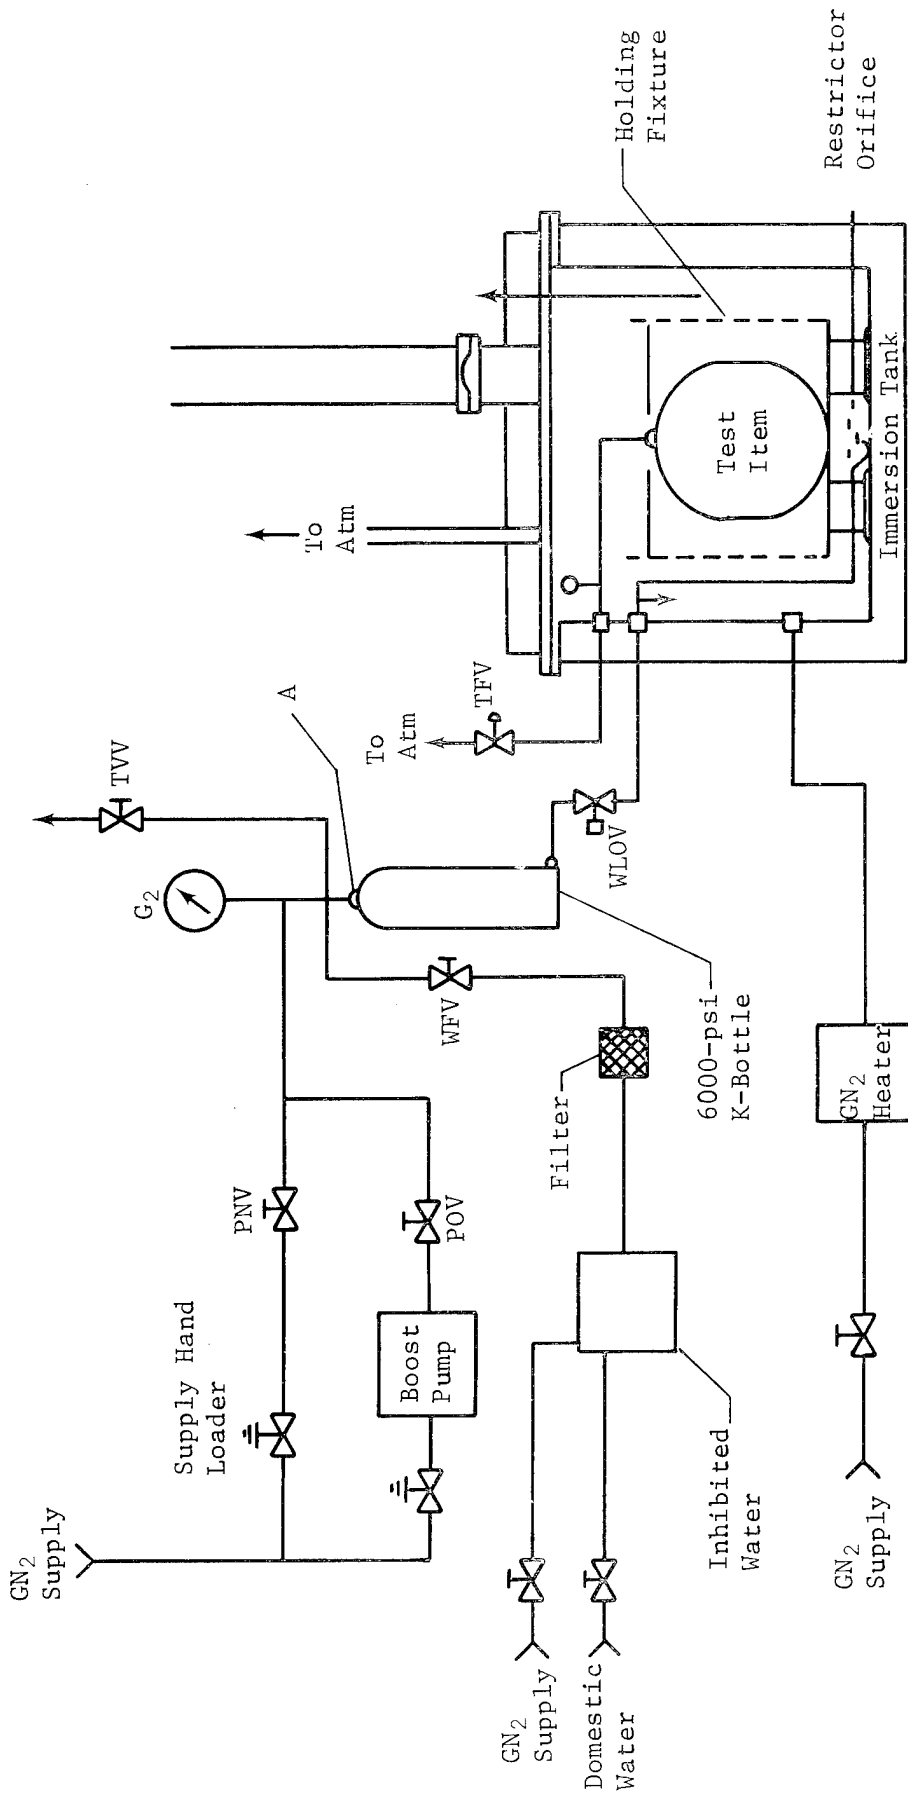
20. On successful completion of the 1000 pressure cycles, the test will be discontinued or the test item will be subjected to an ambient burst test at the test requestor's discretion.
