THE REMR 19960621 001 BULLETIN

NEWS FROM THE REPAIR, EVALUATION, MAINTENANCE, AND REHABILITATION RESEARCH PROGRAM

Environmentally Friendly Lubricants

Seismic Strengthening of Hotel Oakland Revisited: A Case Study

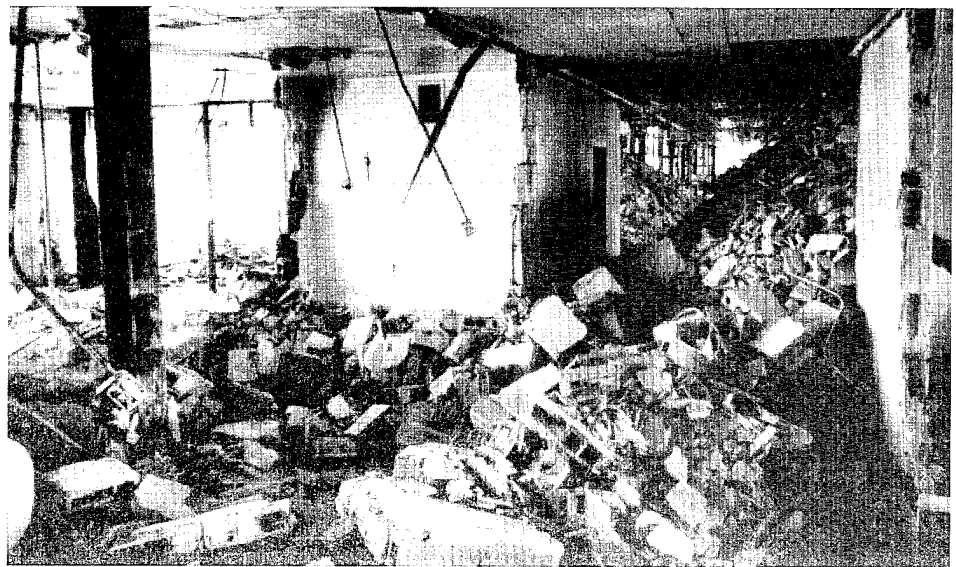
Figure 2. Clay tile partition rubble from 1979 renovations

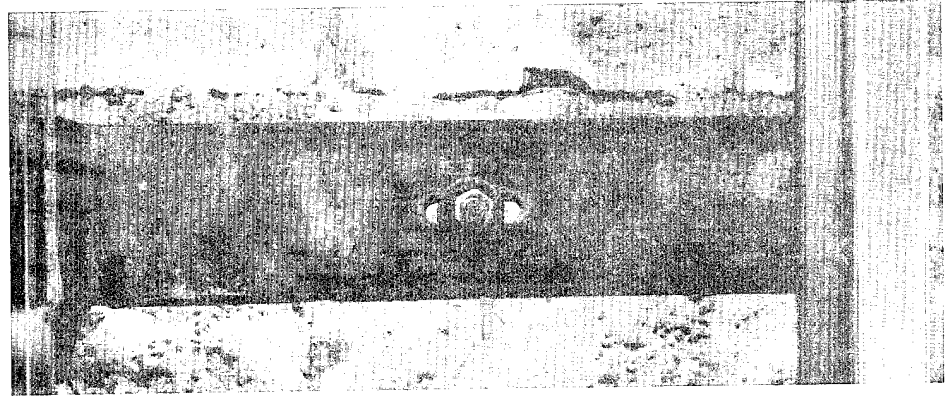
Figure 4. Detail of basketing anchor

The system devised was incorporated into the new wall furring that was applied within the steel frames of the exterior walls (Figures 3 and 4). Heavier structural studs were mixed in with the basic stud-furring system and were spaced so that wall anchors could be secured on approximately 3-ft centers in both vertical and horizontal directions. The wall anchors were 1/2-in.-diam bolts that were long enough to extend from the structural studs through the two interior wythes of the exterior wall and into the face brick. The bolts were inserted into the wall through holes drilled into the brick to a depth including partial penetration in the face brick. They were then anchored to the brick with polyester-resin epoxy cartridges.

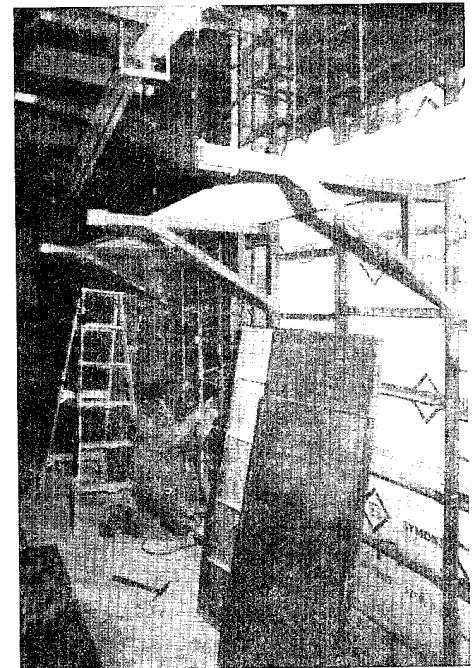
Figure 5. Forming for interior shear walls

Reinforcement of the exterior brick walls was important to the performance of the building in an earthquake, but it was only part of the story. To provide additional strength and ductility to resist major earthquakes, a new system of reinforced-concrete shear walls was designed to be added around the stair and elevator shafts (Figure 5). This system was well distributed around the building in the upper stories and was supplemented by additional shear walls from the second floor down to the foundations.

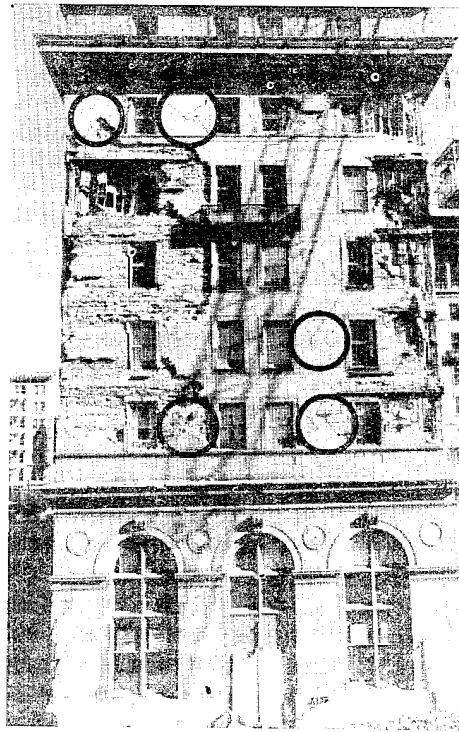
The most significant damage sustained by the hotel was cracking of some of the exterior brick walls. Although not load-bearing, these brick walls were the stiffest elements in the building, and they resisted the main thrust of the earthquake force. The damage was manifested as diagonal (X) cracks in the wall piers with virtually no cracking in the horizontal spandrels (Figure 6).

In the most severely damaged wing, the cracks were over 1/2 in. wide, with complex fracturing through the entire thickness of this wall. There were also areas where the face brick had fallen and other areas where it was loose. The damage in this area was enough to create a potential life-safety hazard that could not be ignored. An aftershock could dislodge portions of the wall that could fall on people below. It appeared that the brick in this area would have to be removed and replaced.

Figure 6. Damage to southwest facade after removal of loose brick

The exterior brick walls required significant work to repair the cracks caused by the earthquake. The cracks were injected with epoxy to restore original strength, and the finish was then patched to match the adjacent surfaces as closely as possible. The restoration process was complicated by the effects of cleaning on the existing material and on the new face brick and mortar.

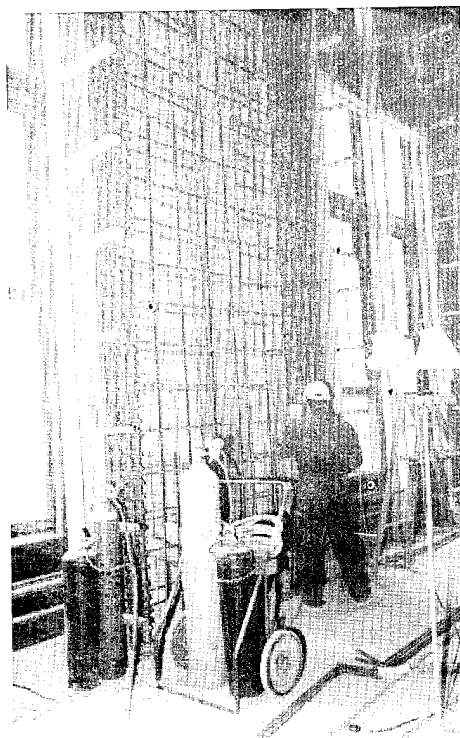
Figure 7. Strengthening of walls behind historical facades

Where the brick wall was removed, a reinforced concrete wall was constructed and finished with brick veneer to match the existing brick work. Major new foundation work was required to carry the additional weight of the new concrete walls and, more importantly, to resist the overturning effects of earthquake forces.

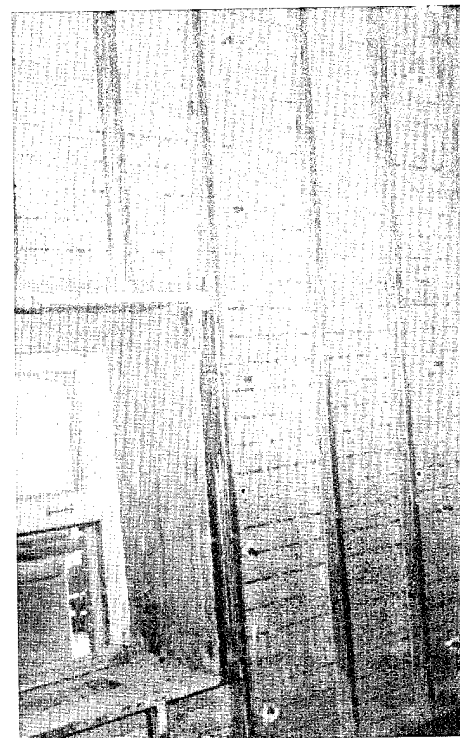
Figure 8. Strengthening of typical upper floor walls
