Fungal Degradation of Military Assets

Brenda Little, Patricia Wagner, Dennis Lavoie and Richard Ray

Naval Research Laboratory
Stennis Space Center, MS 39529

Keywords: wire rope, corrosion, fungi

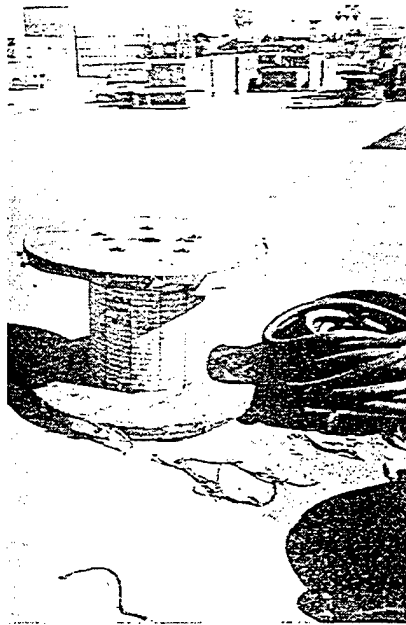
individual strands around an independent wire core coated with a thick maintenance grease and wrapped onto wooden spools (Fig. 1).¹ U. S. Navy standards further require that spools be wrapped in plastic prior to storage. Wire rope may be stored for weeks to months before being transported to U. S. Navy vessels. Any visible sign of corrosion disqualifies the rope for its intended purpose. Between May 1992 and February 1993, corrosion inspection statistics were compiled for 117 spools and compared with storage conditions. Five of fifty-eight highlines stored indoors showed some sign of corrosion whereas forty-two of the fifty-nine spools stored outdoors were unsuitable for use because of localized corrosion. Time in storage was not a factor. Further statistics were collected for highlines that had been removed from plastic packaging and were currently in use. Four of thirty-four highlines installed on winches were rusty when inspected. Fungal growth was observed on interiors of some wooden spools stored outdoors. Corrosion was most severe on wraps of wire in direct contact with the wooden spool flanges. There were numerous reports of a musty odor associated with spools when plastic packaging was removed.

Figure 1 - Wooden spool on which wire rope was stored; pieces of paper are attached to rim edges.

Laboratory data and field statistics strongly implicate the practice of storing carbon steel highlines in humid conditions wrapped in plastic with MIC. The replacement of plastic wrapping with paper packaging and redesign of wooden spool flanges to include slats one-half inch apart to promote ventilation are currently being evaluated as corrosion control measures.

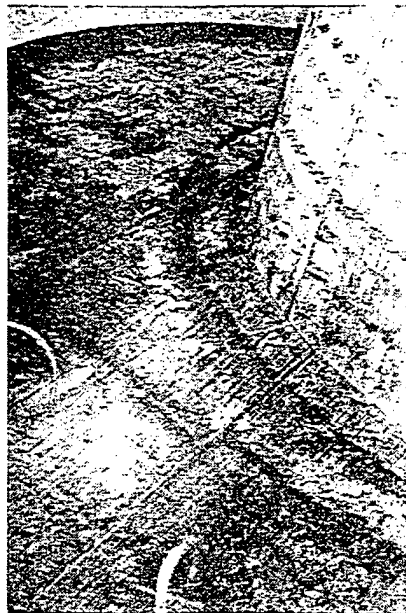
Sections of wood from spool interiors and pieces of brown shipping paper from spool rim edges (Fig. 2) were removed. Wood and paper samples with fungal fruiting bodies, spores, or mycelia were placed in Petri dishes with potato dextrose agar (PDA) and incubated in a dark room at 37°C. After a 1-week incubation, fungal species were identified as *Aspergillus niger* and *Penicillium* sp. The pH of the condensate within Petri dishes and in areas adjacent to growing fungi were monitored using a microelectrode with a tip diameter of 2.4 mm vs. saturated calomel reference electrode. Condensate in Petri dishes where either isolate was grown dropped from a pH of 7.0 to 4.9 in three weeks. Coated wire rope was exposed to pH 5.0 citric acid solution. Localized corrosion (Fig. 3a, b) was observed in each location the acid solution touched the rope.

Figure 2 - Inside surface of wooden spool; white deposits are the result of fungal growth.

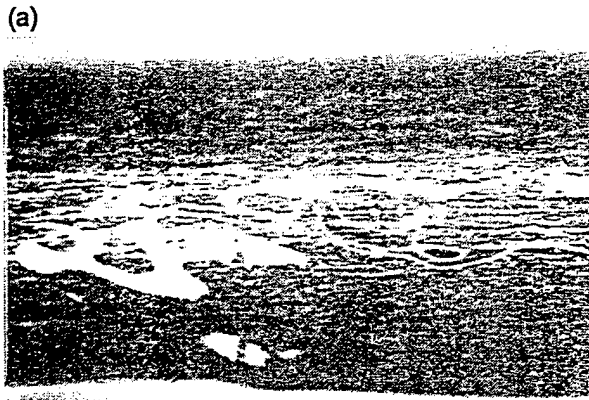
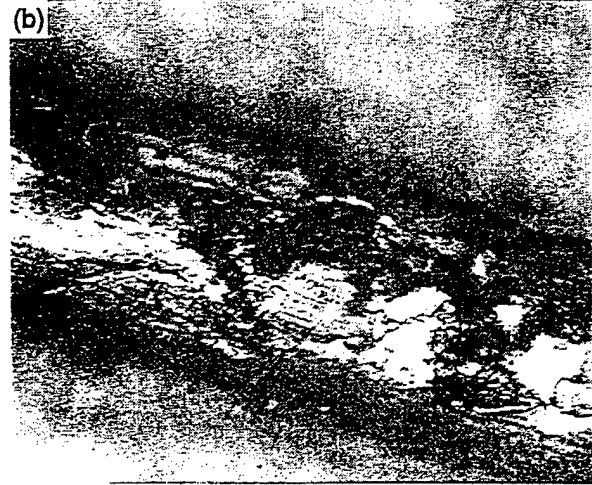
with fungal-contaminated wood may be due to either organic acid production or to initiation of corrosion nucleation sites. Citric acid solution at pH 5.0 did penetrate the protective grease and cause corrosion. Wire rope in direct contact with inoculated wood and agar was colonized by fungal mycelia and fungi were associated with corrosion products. In addition to organic acid production, fungi produce copious amounts of carbon dioxide. Carbon dioxide reacts with water to form carbonic acid. In our laboratory studies, condensates in covered, inoculated trays were in the range of pH 4.0–5.0. The acidic condensate penetrated the protective maintenance coating. Areas where the maintenance coating had been mechanically removed were particularly vulnerable to attack by acidic condensates.

Figure 3 – (a) Strand of wire with protective grease intact before exposure to acidic solution, 30x. (b) Localized corrosion after exposure to citric acid solution at pH 5.0, 40x.

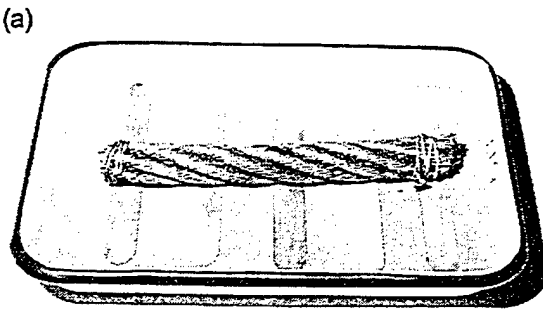
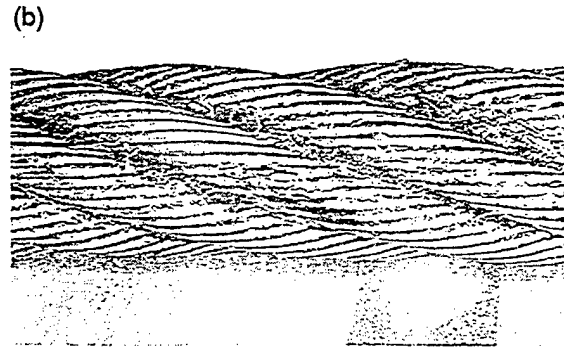
Wire rope received directly from the manufacturer was exposed on wooden tongue depressors in enamel trays containing PDA. Some trays were inoculated with fungi, covered with a clear plastic, and placed in a dark, 30°C environment. Other trays were inoculated but remained uncovered. Controls were uninoculated and covered. Wire rope in contact with wooden tongue depressors inoculated with either isolate developed localized corrosion in areas in direct contact with either the wood or the agar within four days (Fig. 4a, b). Fungi were attached directly to the wire and were associated with corrosion products in all inoculated trays (Fig. 5a, b, c). In the open, inoculated tray no additional corrosion was observed. No corrosion was observed in the abiotic, covered control. In the covered inoculated trays, corrosion developed in areas where condensate dripped onto the wire from the clear plastic in addition to areas in direct contact with wood and agar. Localized corrosion was observed on wire surfaces where the grease coating was thin or missing due to handling. In these cases, fungal cells were not associated with pitting and corrosion products. The maintenance coating is an amber-colored wax with organic corrosion inhibitors. The product, which has negligible solubility in water, was evaluated as a source of nutrients for the fungi by melting the grease in a Petri dish, allowing it to solidify, inoculating it directly with the isolates, and comparing to an abiotic control. Fungal isolates did not grow on the maintenance coating. Fungal growth could not be demonstrated on corroded rope sections not in direct contact with wood or agar.

Figure 4 – (a) Wire rope placed on wooden tongue depressors in a tray containing PDA inoculated with *Aspergillus niger*. (b) Wire rope that had been in contact with wood and PDA inoculated with *Aspergillus niger*. Rope rolled aside to show localized corrosion after contact with agar or wood.

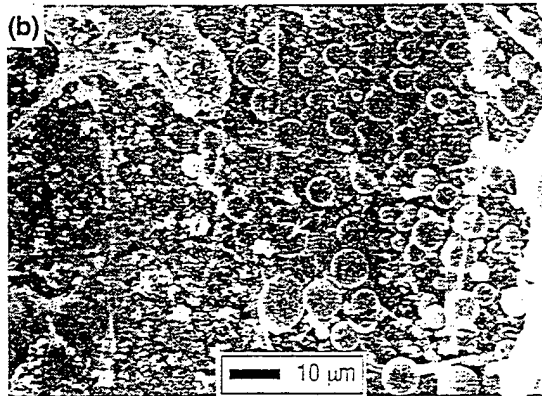
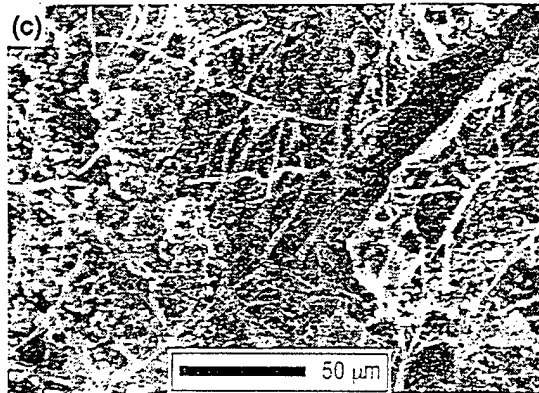
Both *Aspergillus niger* and *Penicillium* sp. produce copious amounts of citric acid as a result of hydrocarbon degradation.² Localized corrosion of the wire rope in direct contact

Figure 5 – (a) Light microscope photograph showing fungal mycelia attached directly to wire and associated with localized corrosion, 40 \times . (b) ESEM micrograph showing mycelia in association with corrosion products, 500 \times . (c) ESEM micrograph showing mycelia in association with corrosion products, 1000 \times .

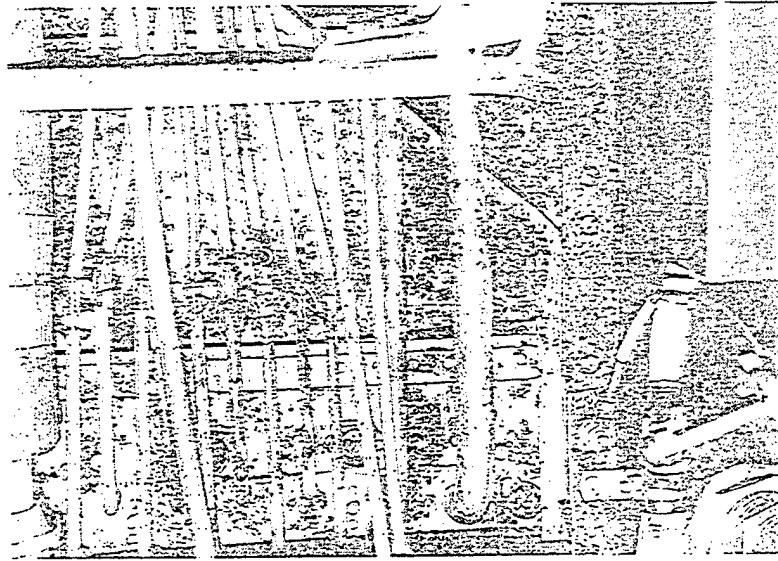
Military helicopters operating in humid environments mildew or mold on interior surfaces (Fig. 6).³ Cleaning accounts for a significant amount of the labor expended in field maintenance activities. In extreme cases, fungal growth has been known to form thick masses, especially in areas of the craft not regularly cleaned in the field, such as the bilge, behind sound insulation blankets, within tight spaces in the overhead, and behind fixed equipment such as electronics racks. Growth in such areas may not be discovered until aircraft are sent for depot-level maintenance after 5 to 7 years. Occasionally, aircraft placed in storage for a short time are so badly contaminated with noxious growth that they are unusable and must be returned for costly, depot-level recleaning.

Figure 6 — Fungal growth on interior of H-53 helicopter.

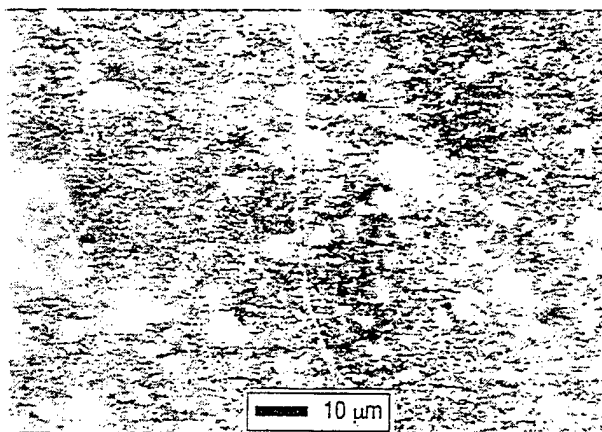
Fungi on polyurethane surfaces appeared well established, with mycelia and conidia (Fig. 8a), and germinating spores (Fig. 8b), but there was no obvious degradation at attachment points. Figure 9 illustrates incomplete removal of fungal structures by simulated field cleaning procedures. Hyphae were present in the experimental scratches on many coupons, and occurred in association with both occasional corrosion products in unbleached portions and thick corrosion products on the bleached portions.

Figure 9 — Polyurethane coated coupon surface after alcohol cleaning (1000 \times).

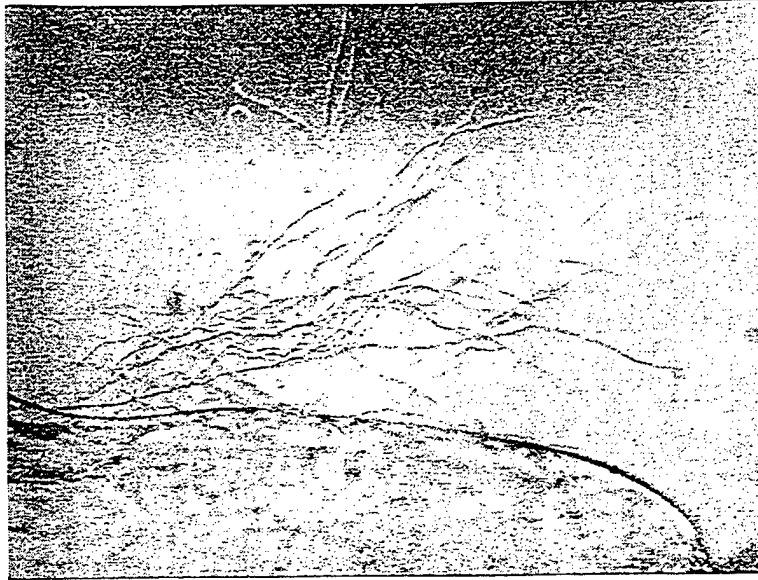
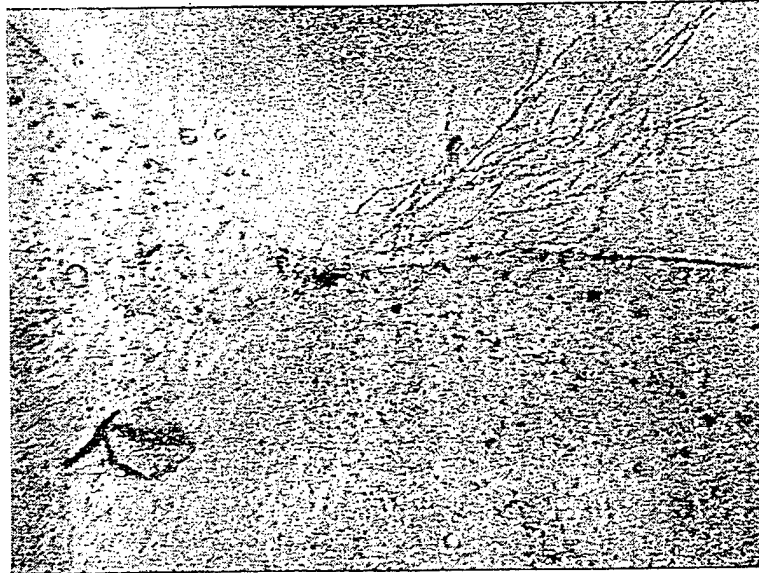
Extensive localized corrosion of the bottoms of carbon steel jet fuel storage tanks with subsequent leakage of fuel oil was recently investigated. *Hormoconis* (formerly *C. resiniae*), *Aspergillus*, *Penicillium* and *Fusarium* were identified in the fuel/water mixtures. Corrosion attack was located near the tank bottom at the fuel/water interface where an active micro-biological population was associated with free water. Fungi were observed growing over the entire surface of oil droplets and within suspended water droplets (Fig. 10). In the absence of water, no fungi were detected. Water soluble biocides are routinely added to fuel to prevent microbial growth. Problems occur when the biocides are exhausted or the amount of water has been underestimated. Attempts to form emulsions of fuel/water combinations accelerate fungal growth by increasing the surface fuel/water interfacial area and, therefore, the availability of oil, oxygen, and nutrients.

Figure 10 — Fungal mycelia in association with water droplets in jet fuel.
