ARMY RESEARCH LABORATORY

Investigation of the UH-60
Main Rotor Spindle Assembly
Retaining Rods P/N 70102-08102/-103

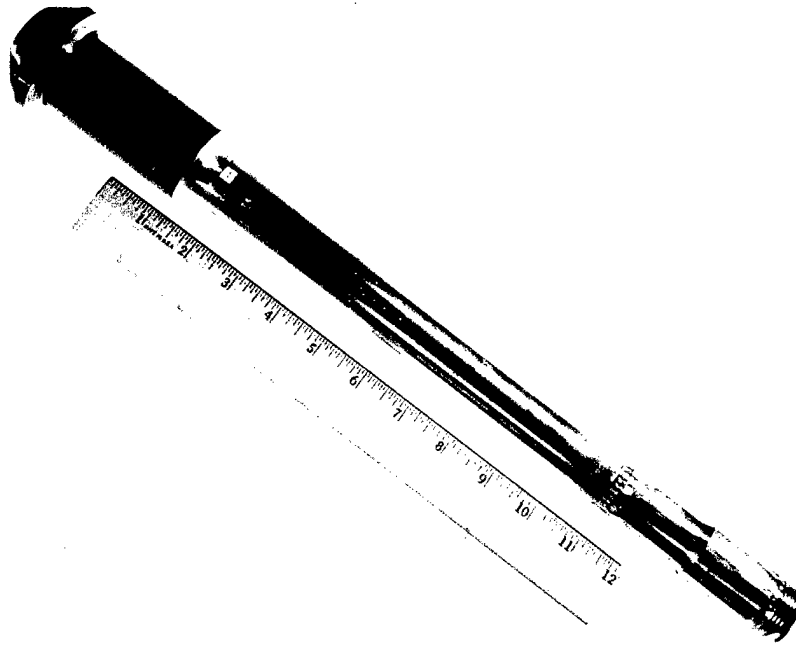
Figure 1. Failed SIK Rod -00938 in the As-Received Condition (Reduced 75%).

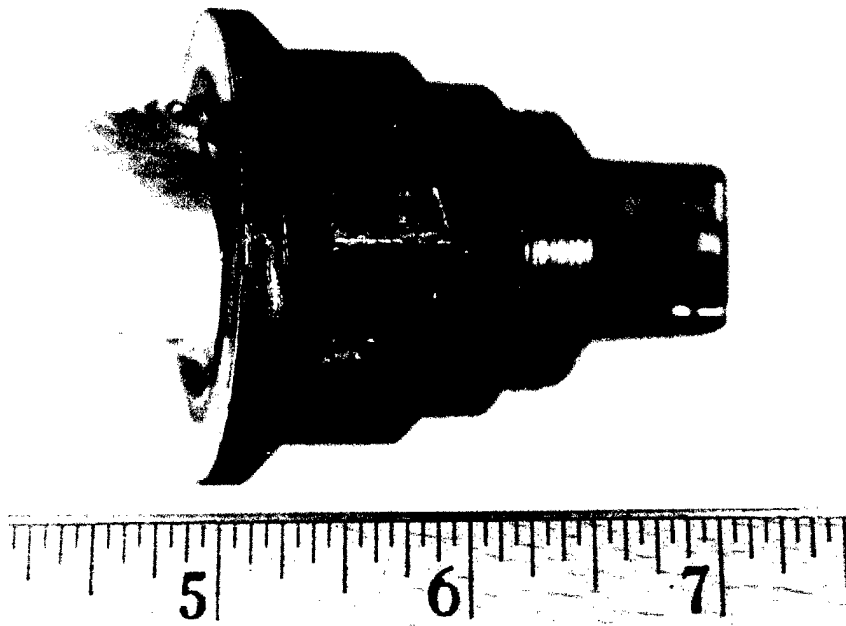
Figure 2. Failed Threaded End of SIK Rod -00938 in the As-Received Condition (Mag. 1.25x).

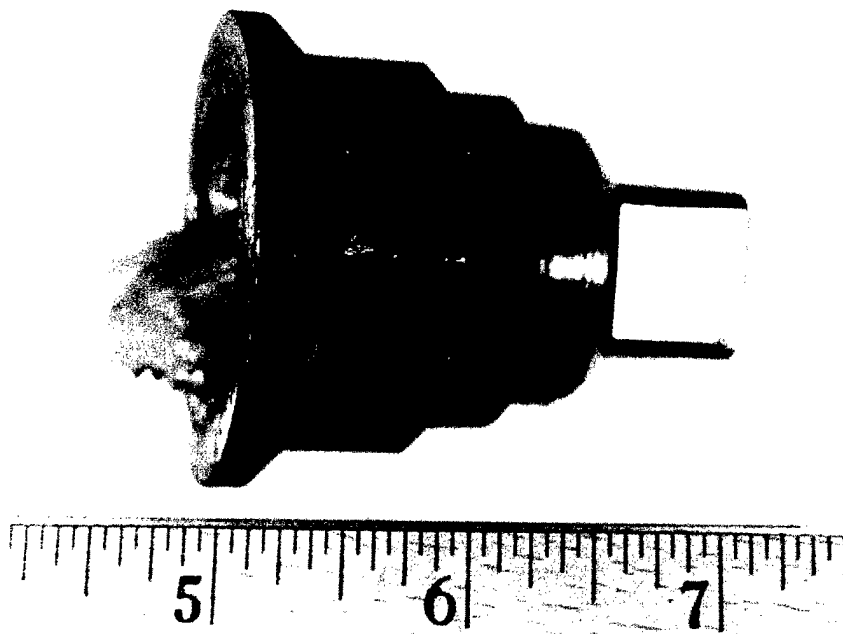
Figure 4. Failed Threaded End of SIK Rod -00973 in the As-Received Condition (Mag. 1.25x).

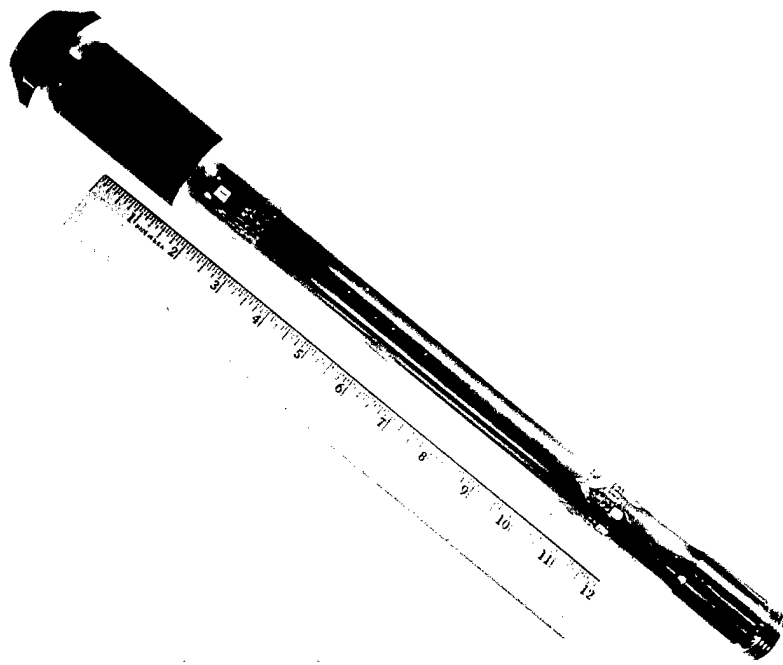
Figure 5. Failed PUR Rod -174 in the As-Received Condition (Reduced 75%).

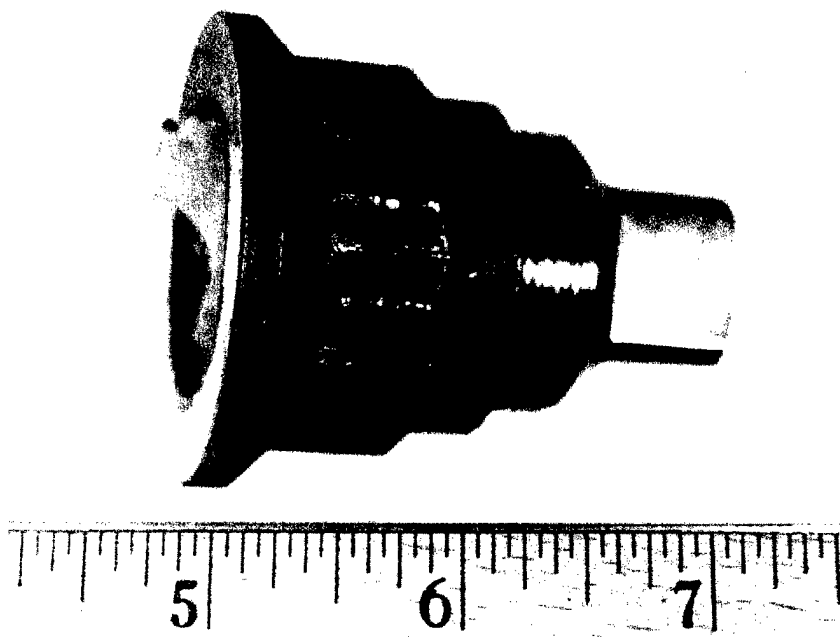
Figure 6. Failed Threaded End of PUR Rod -174 in the As-Received Condition (Mag. 1.25x).

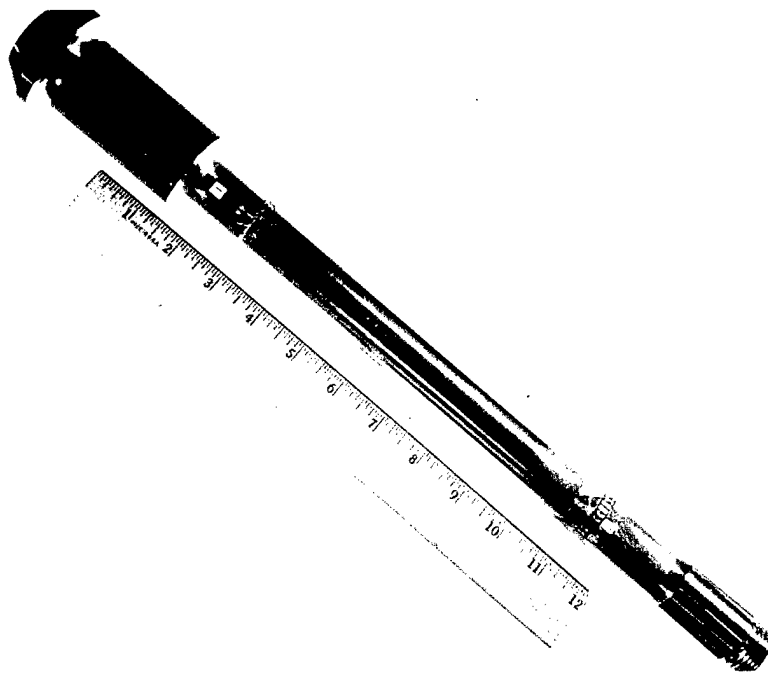
Figure 7. Failed PUR Rod -177 in the As-Received Condition (Reduced 75%).

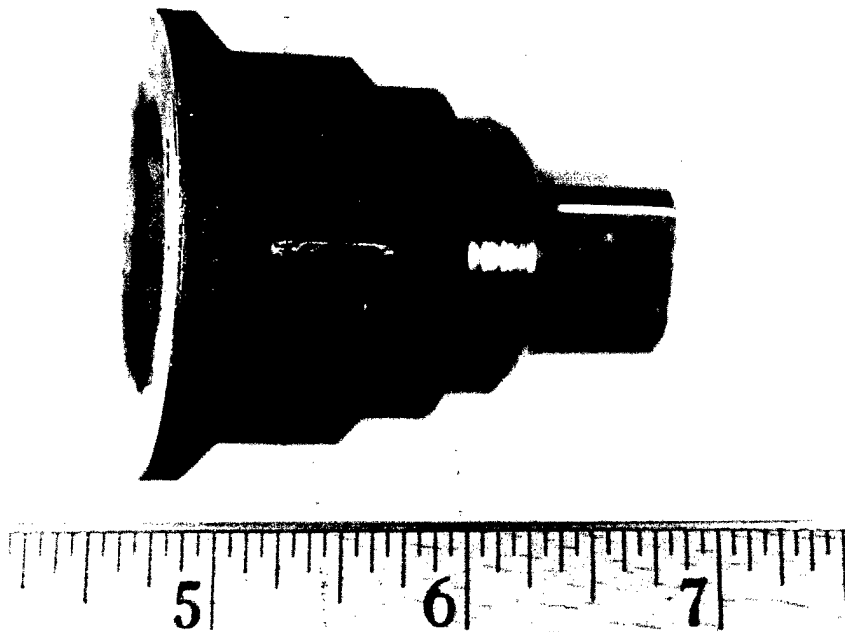
Figure 8. Failed Threaded End of PUR Rod -177 in the As-Received Condition (Mag. 1.25x).

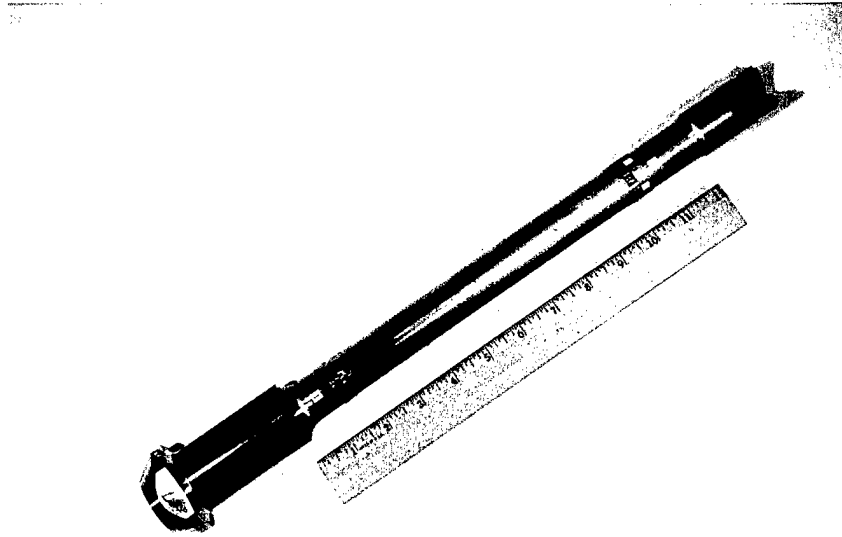
Figure 9. Failed S&S Rod -2 in the As-Received Condition (Reduced 80%).

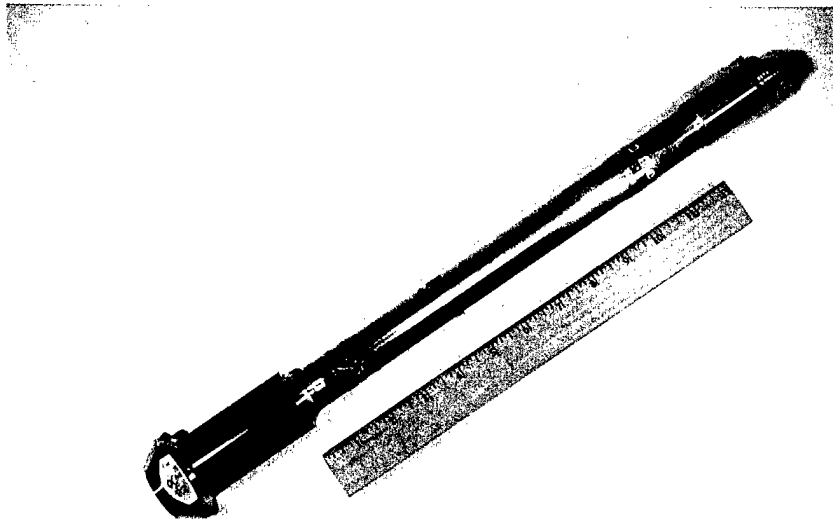
Figure 10. Failed S&S Rod -3 in the As-Received Condition (Reduced 80%).

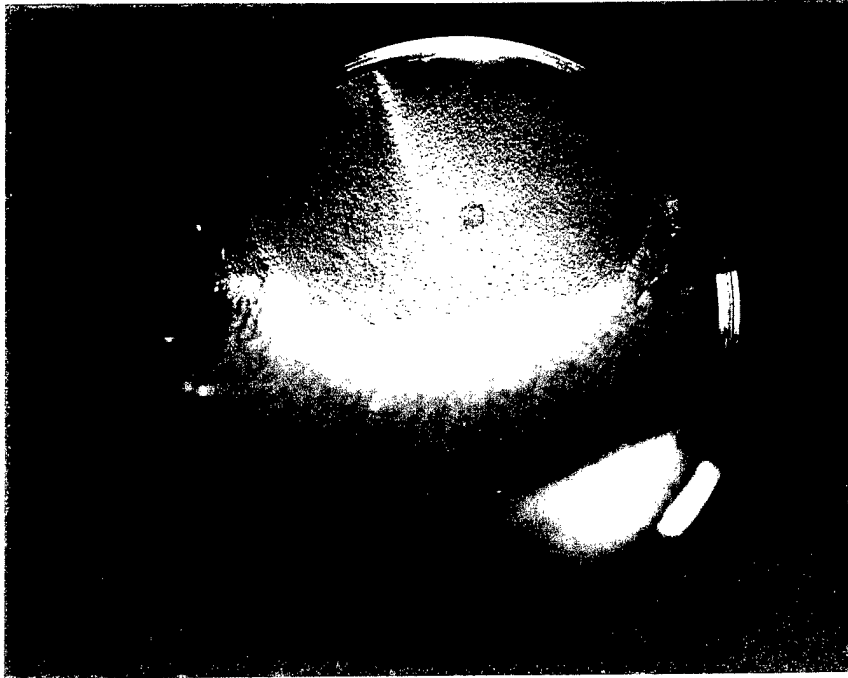
Figure 11. Fracture Surface of SIK Rod -00938 in the As-Received Condition. The Fatigue Region Is Within Focus (The Depth of Field Was Distorted by the Angled Shear Lips) (Mag. 2x).

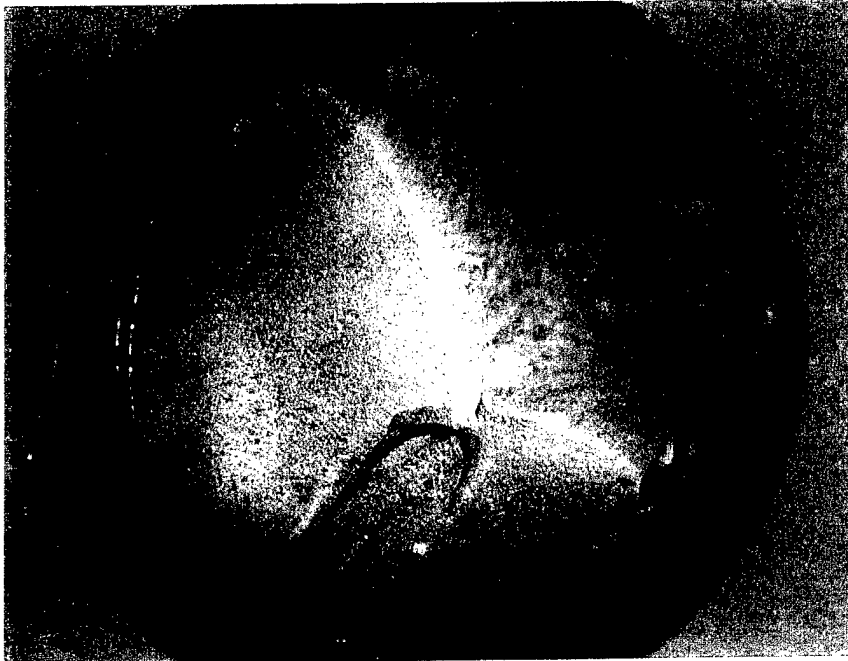
Figure 12. Fracture Surface of SIK Rod -00973 in the As-Received Condition. Again, the Fatigue Region Is Within Focus. Note the Two Planes of Fatigue Crack Propagation (Mag. 2x).

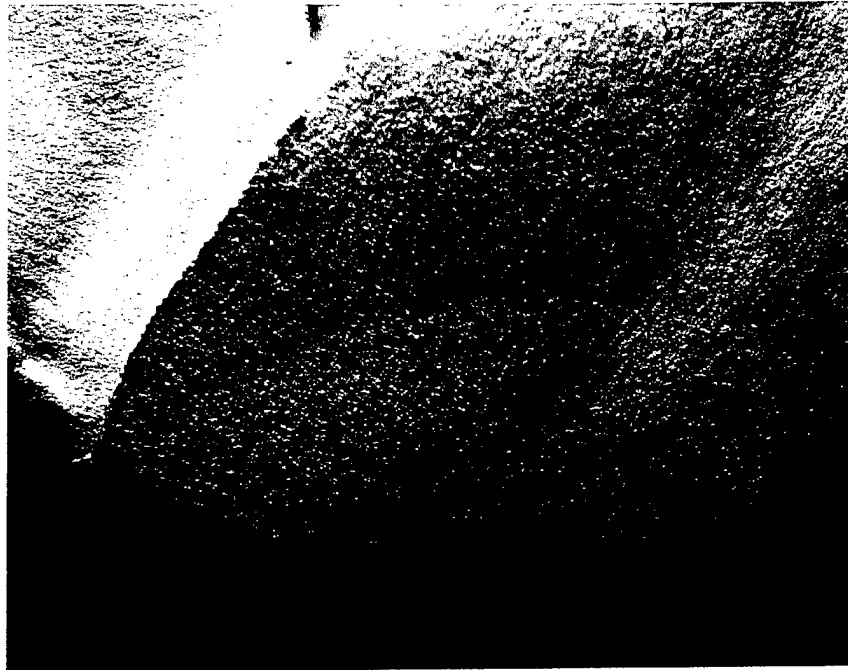
Figure 13. A Thumbnail Crack Noted on the Fracture Surface of SIK Rod -00973 (Mag. 7.5x).

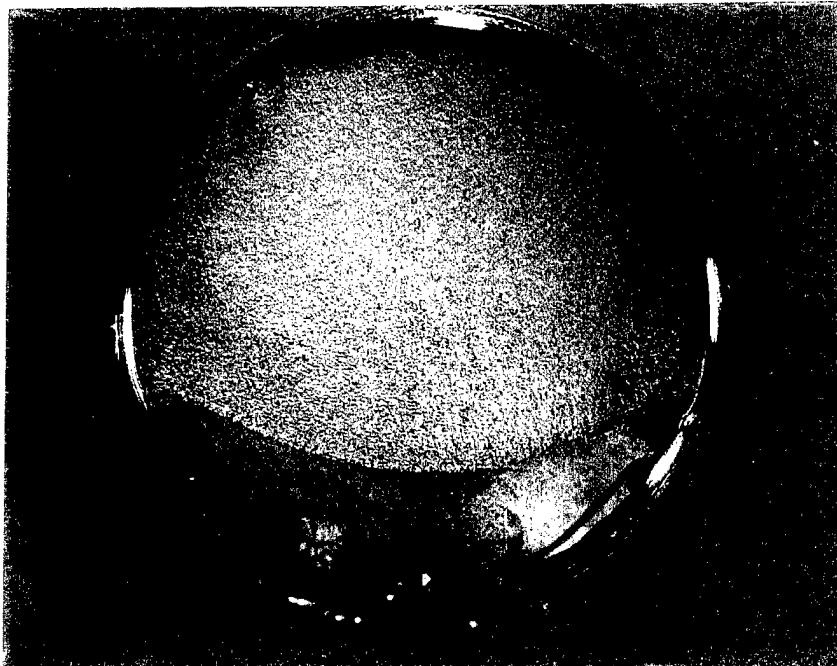
Figure 14. Fracture Surface of PUR Rod -174 in the As-Received Condition. Note the Increased Fatigue Zone as Opposed to the Fracture Surfaces of the SIK Rods (Mag. 2x).

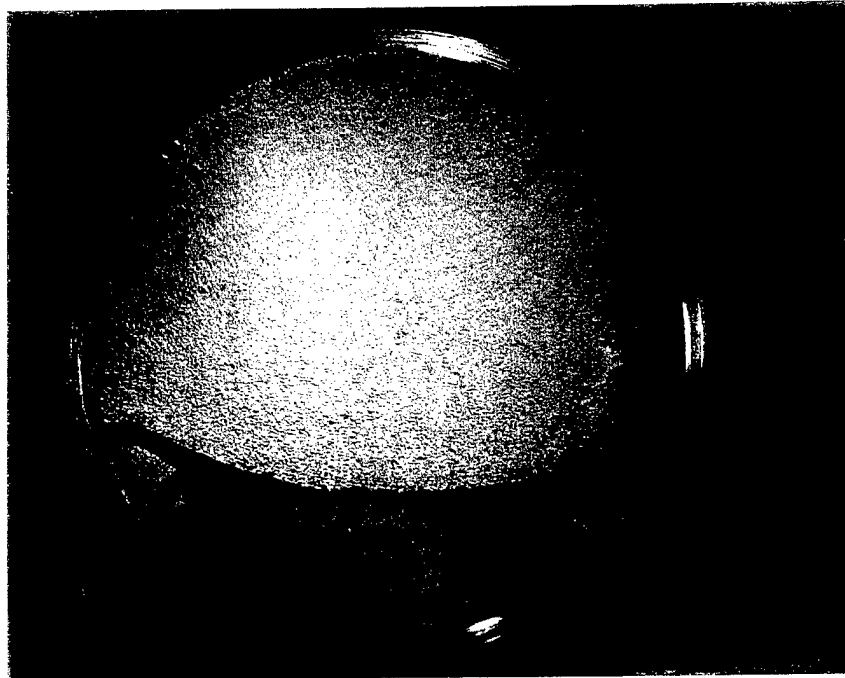
Figure 15. Fracture Surface of PUR Rod -177 in the As-Received Condition. Note the Increased Fatigue Zone as Opposed to the Fracture Surfaces of the SIK Rods (Mag. 2x).

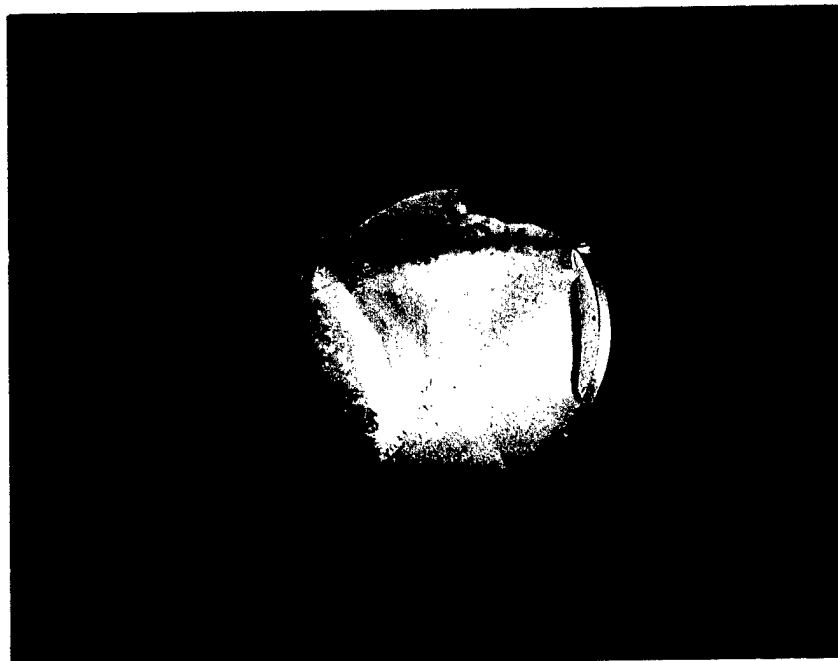
Figure 16. Fracture Surface of S&S Rod -2 in the As-Received Condition. The Fatigue Region Is Within Focus (Mag. 1.2x).

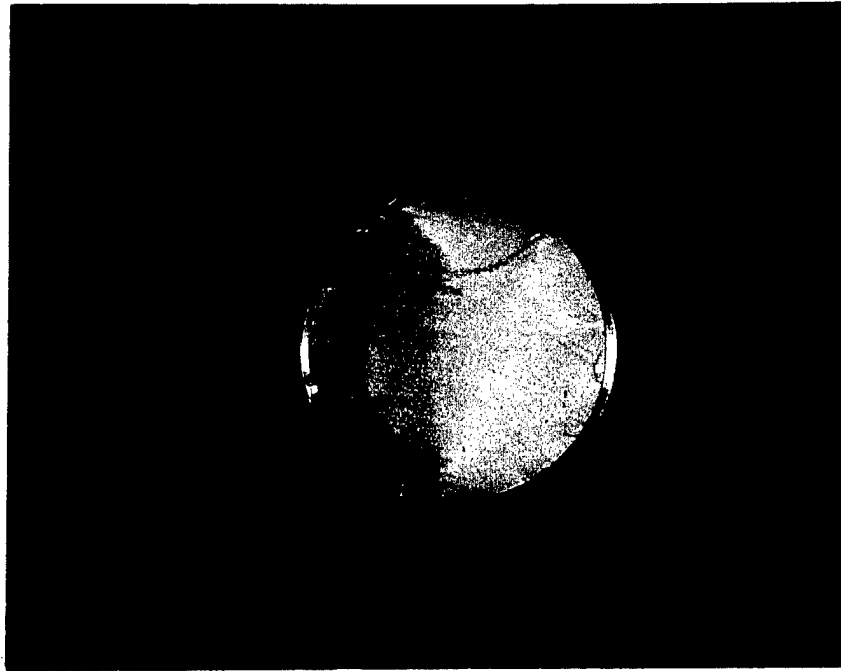
Figure 17. Fracture Surface of S&S Rod -3 in the As-Received Condition. Again, the Fatigue Region Is Within Focus. Note the Large Flat Fatigue Plane Similar to the PUR Samples (Mag. 1.2x).

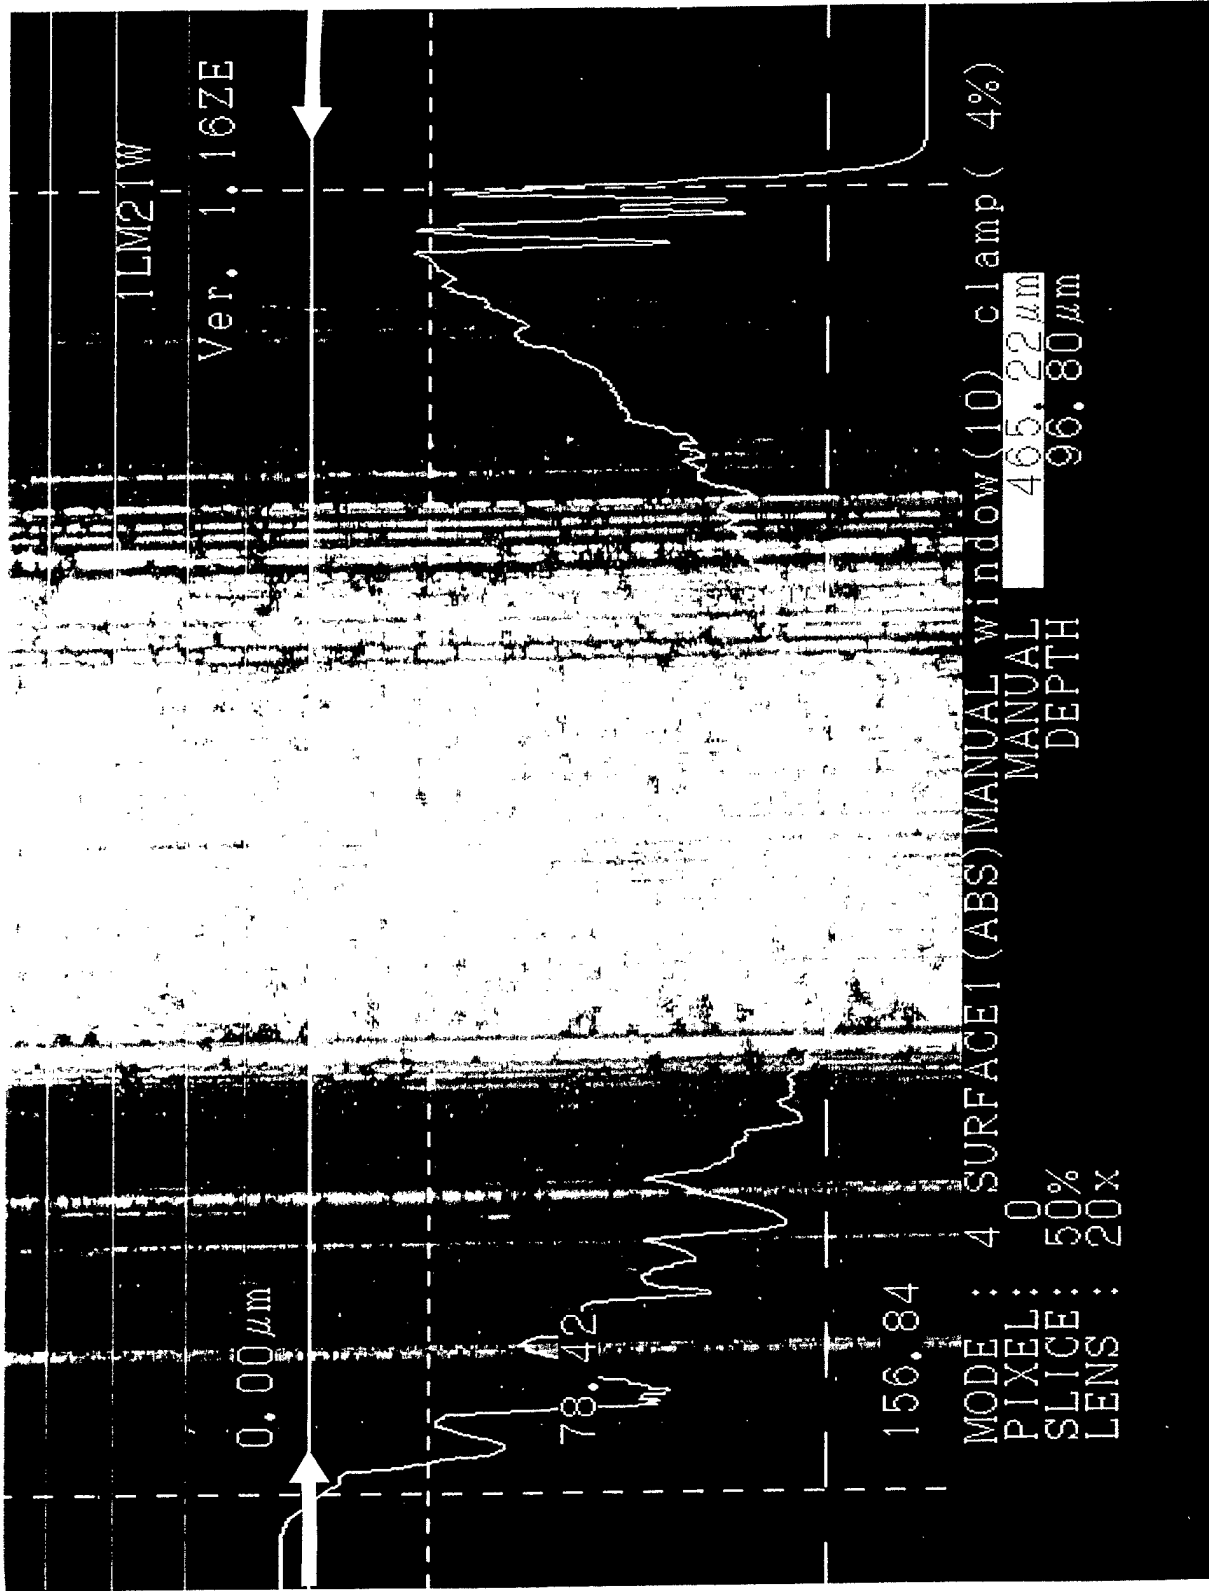
Figure 19. Lasertec Linear Scan Profile of SIK -00938 Rod Typical Thread Root (Mag. 500x).

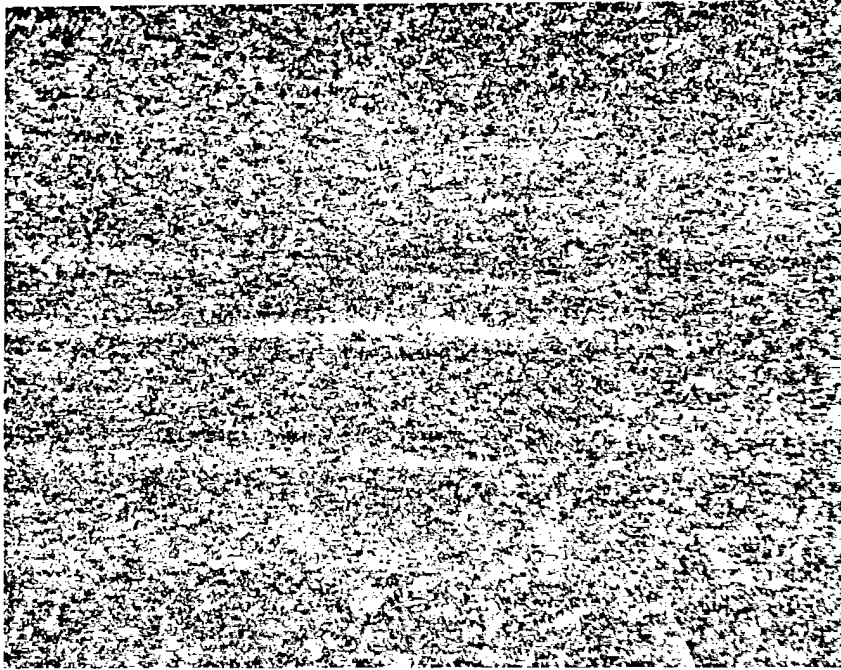
Figure 37. Structure of SIK -00973 in the Longitudinal Direction Showing Minimal Delta Ferrite Within the Banding. This Was the Only Delta Ferrite Noted Within the Structure of the SIK Samples. Vilella's Reagent (Mag. 100×).

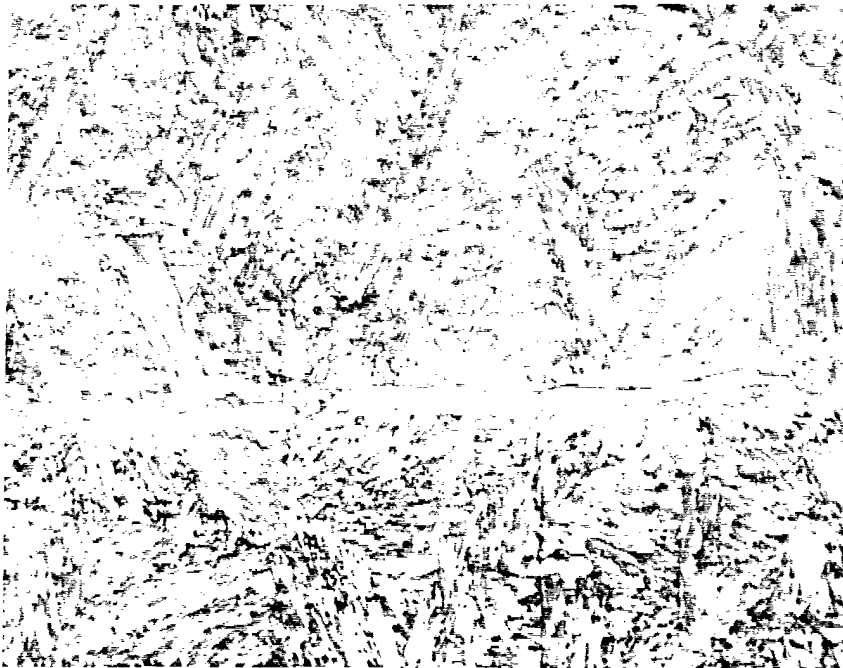
Figure 38. Enlarged View of a Ferrite Stringer Noted Within PUR Sample -174. Vilella's Reagent (Mag. 1kx).

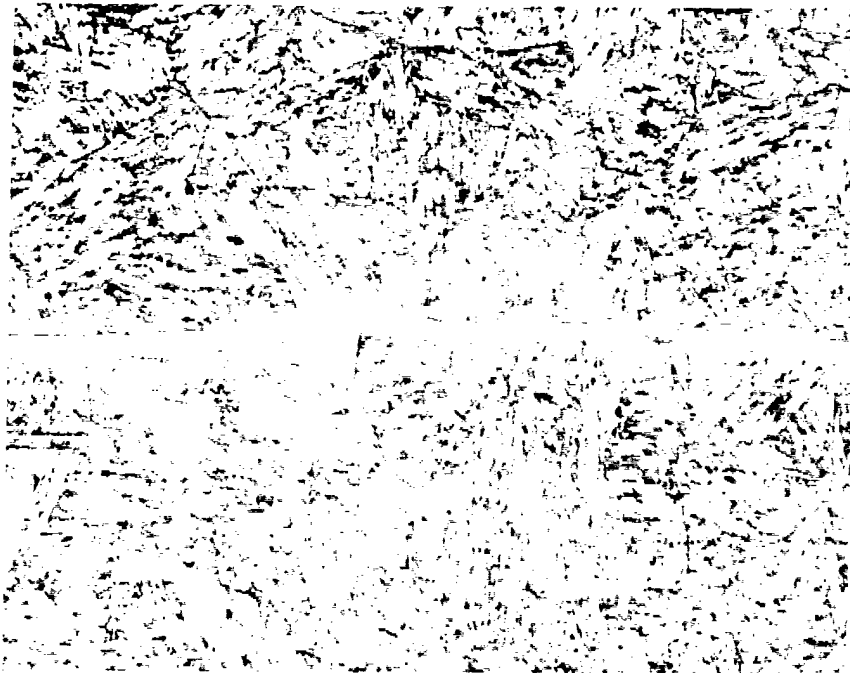
Figure 39. Enlarged View of the Ferrite Stringer Noted Within S&S Sample -2. Vilella's Reagent (Mag. 1kx).

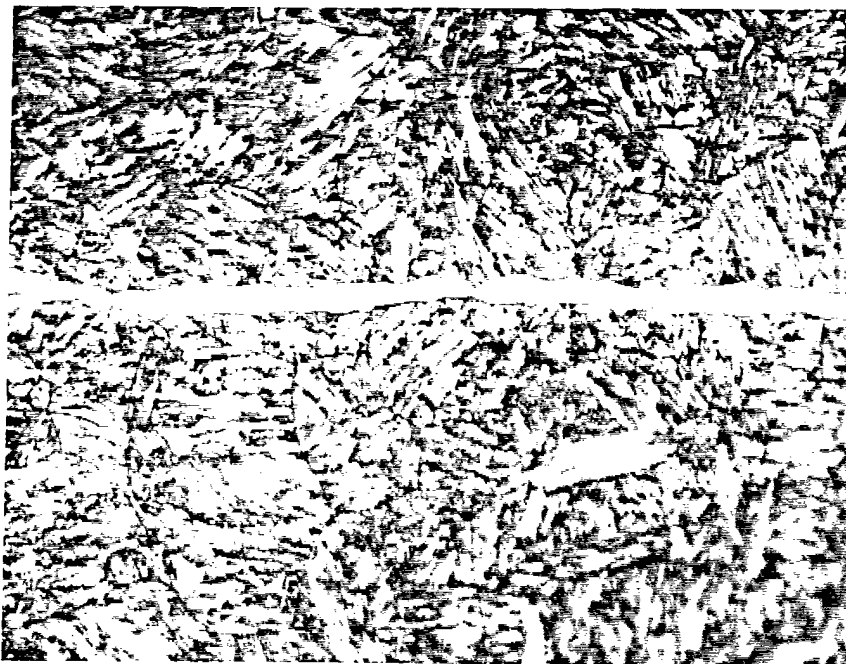
Figure 40. Enlarged View of the Ferrite Stringer Noted Within SIK Sample -00973. Vilella's Reagent (Mag. 1kx).

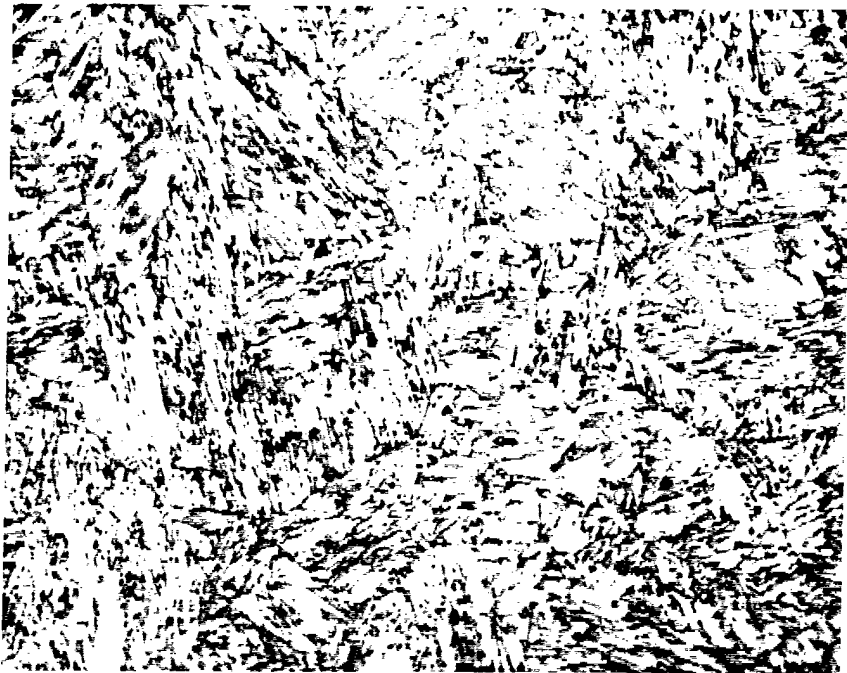
Figure 41. Structure of PUR Sample -174 in the Longitudinal Direction. Vilella's Reagent (Mag. 1kx).

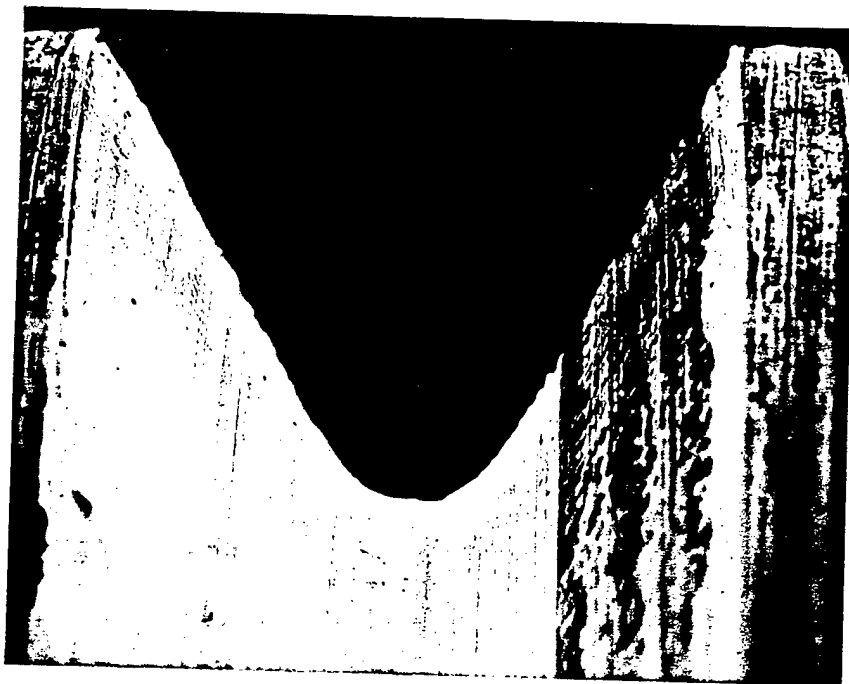
Figure 55. SEM Micrograph Depicting the Rough PUR Thread Root (Mag. 50x).

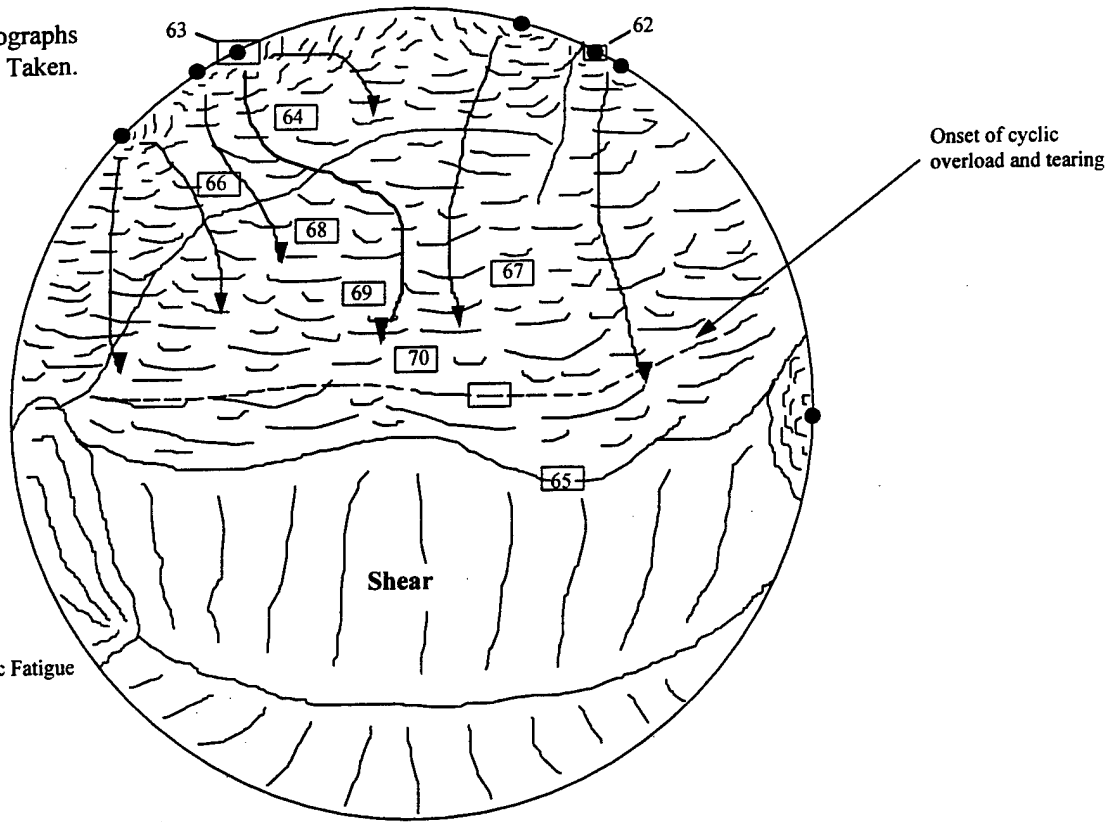
Figure 56. Schematic of the Fracture Surface of SIK Tie Rod -00938.

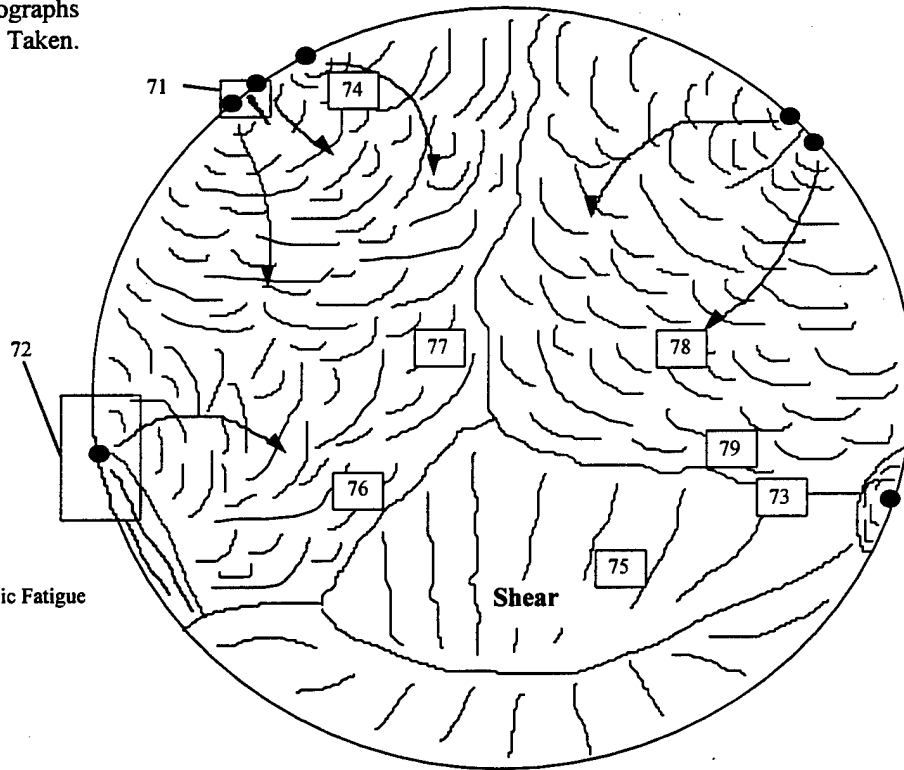
Figure 57. Schematic of the Fracture Surface of SIK Tie Rod -00973.

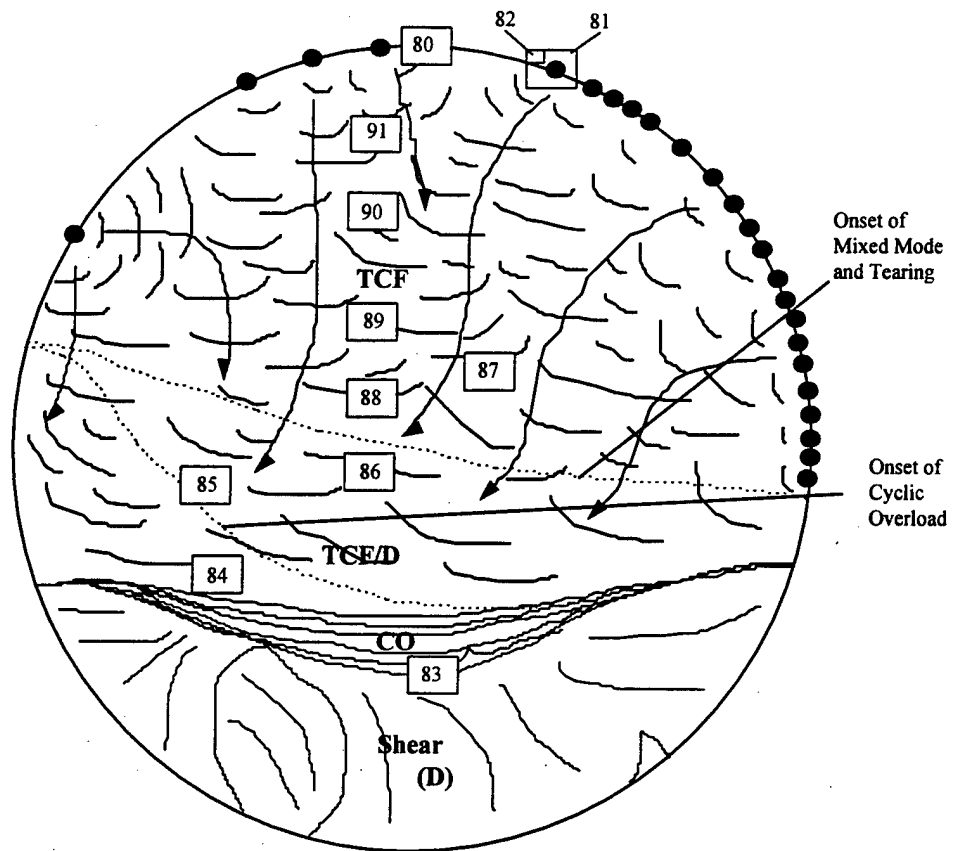
Figure 58. Schematic of the Fracture Surface of PUR Tie Rod -174.

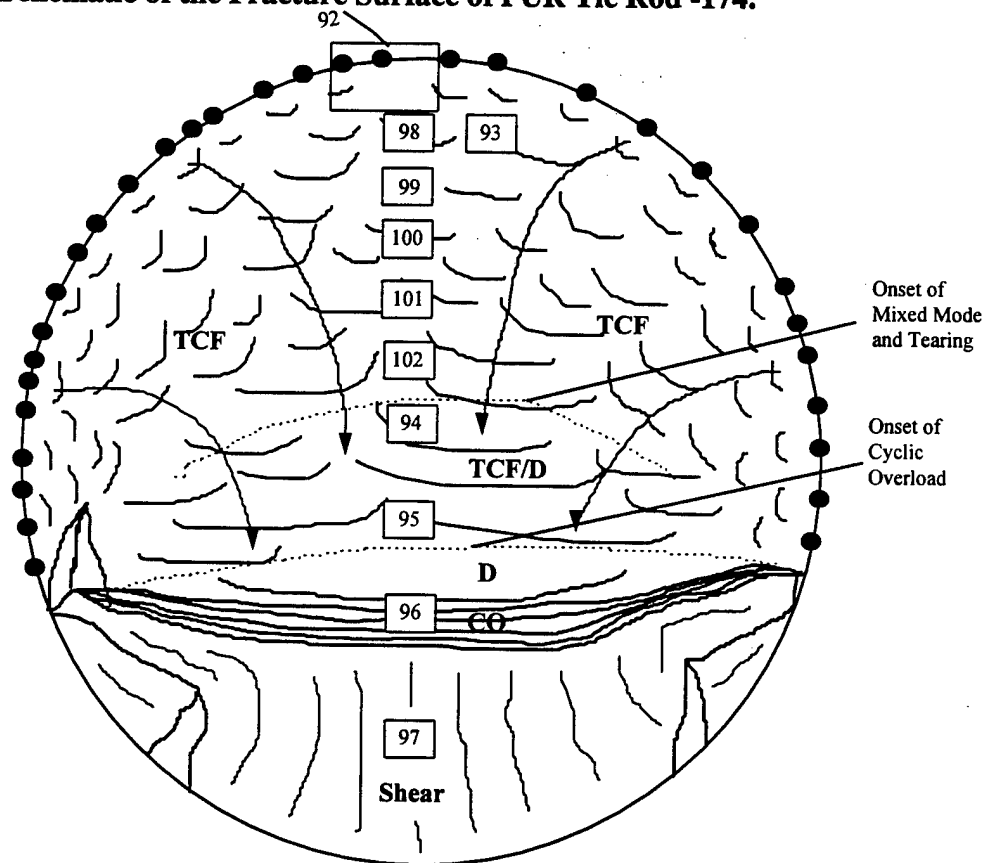
Figure 59. Schematic of the Fracture Surface of PUR Tie Rod -177.

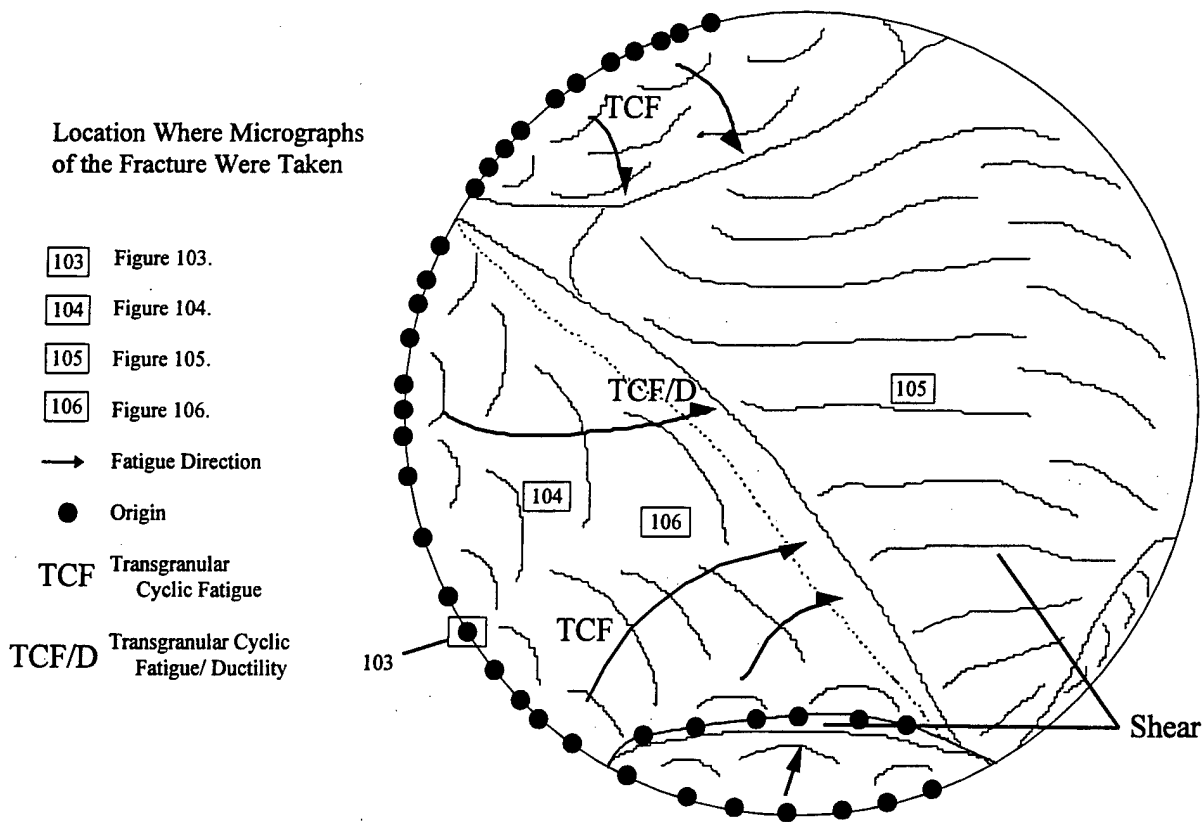
Figure 60. Schematic of the Fracture Surface of S&S Tie Rod -2.

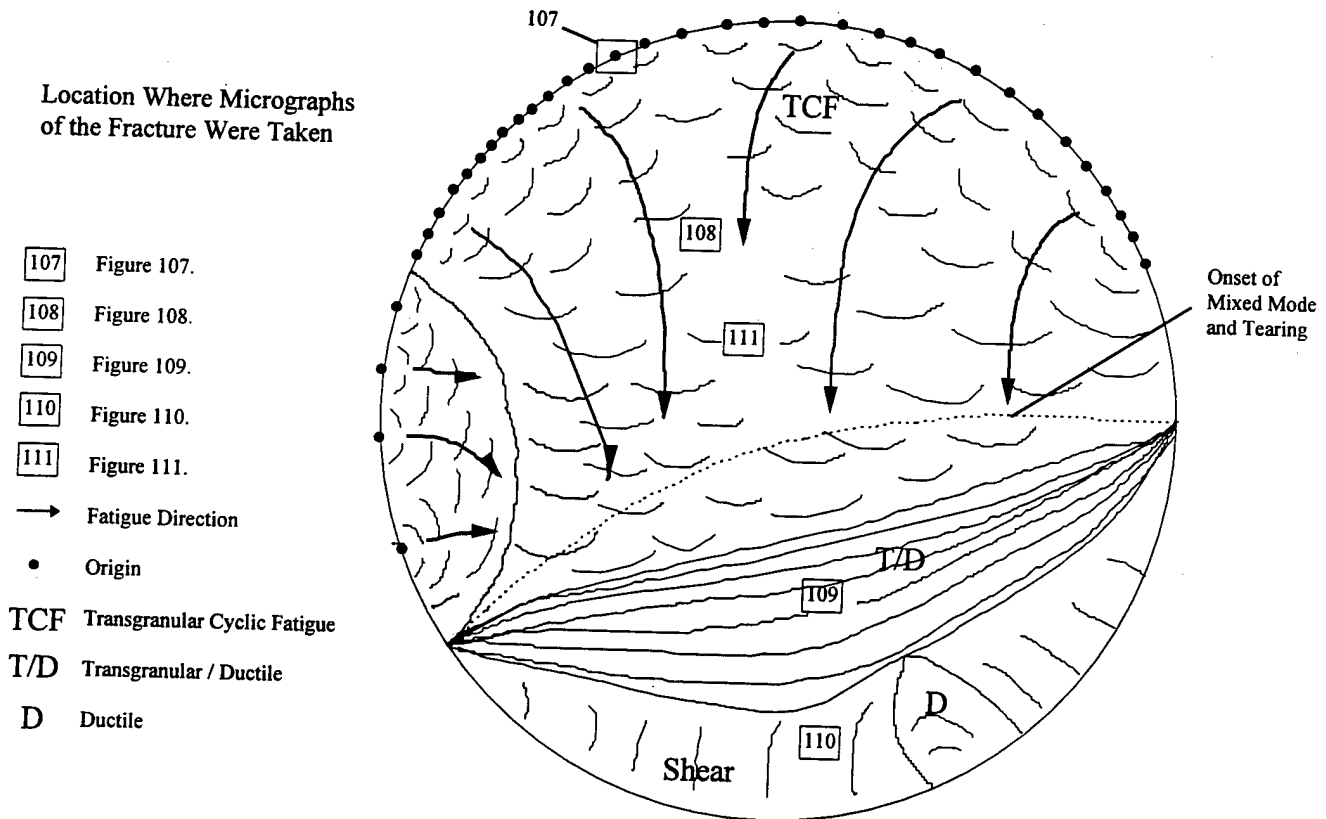
Figure 61. Schematic of the Fracture Surface of S&S Tie Rod -3.

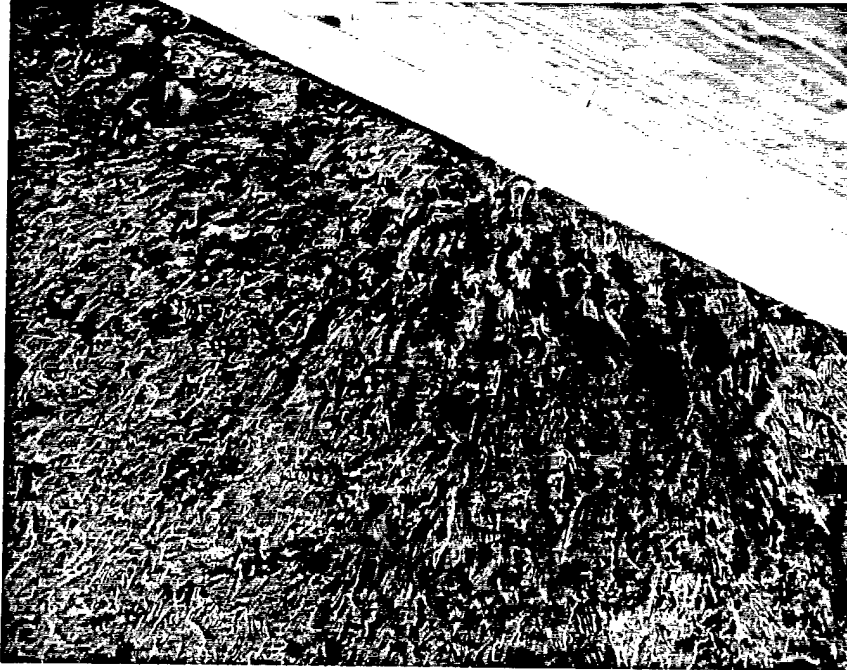
Figure 62. A Typical Origin on the Fracture Surface of SIK Rod -00938 (Mag. 500x).

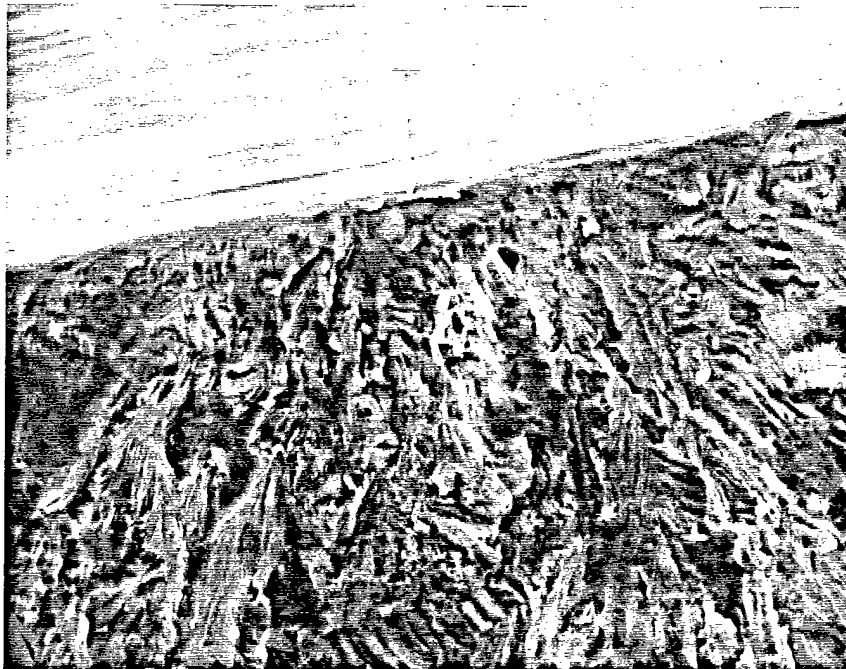
Figure 63. Another Origin on the Fracture Surface of SIK Rod -00938 (Mag. 1kx).

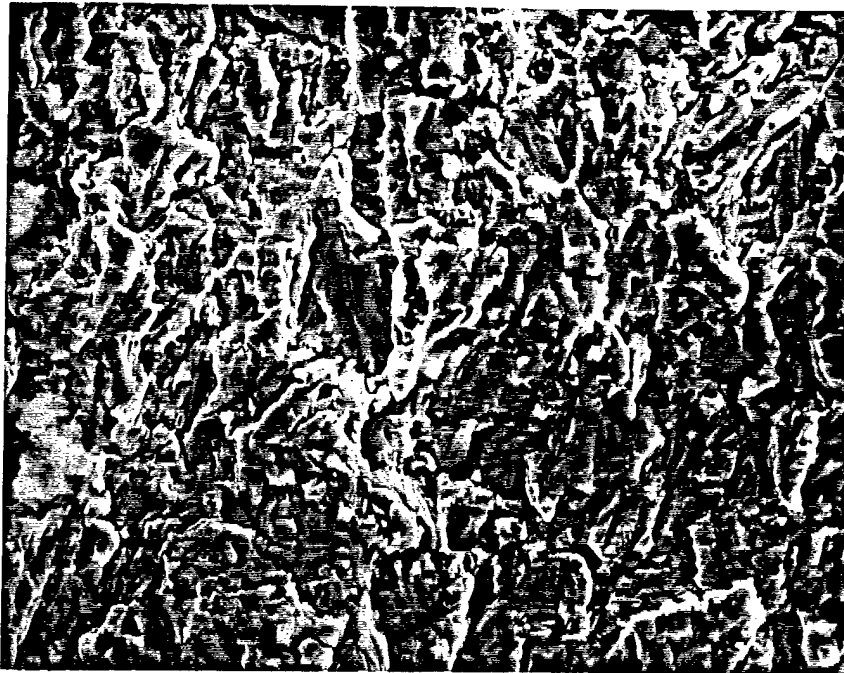
Figure 64. Typical Transgranular Morphology of SIK Rod -00938. This Morphology Was Characteristic of the Fatigue Region (Mag. 1kx).

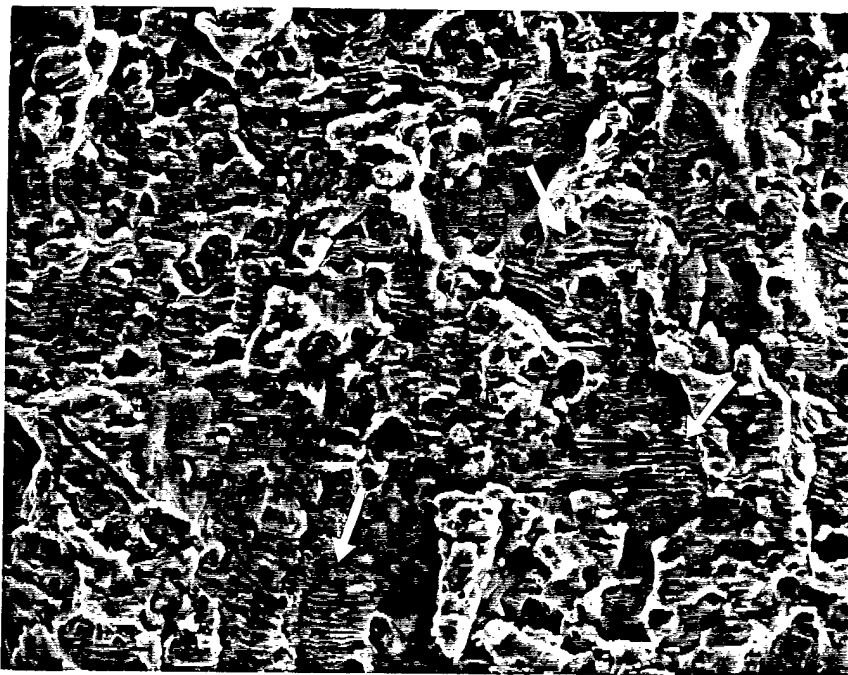
Figure 66. Typical Striations on the Fracture Surface of SIK Rod -00938 (Mag. 1kx).

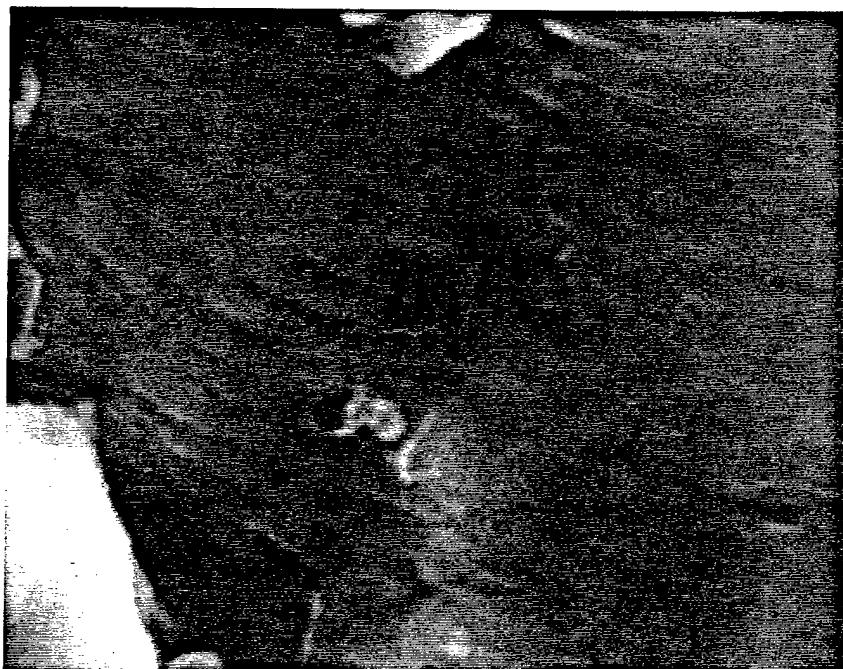
Figure 67. Striations Noted on the Surface of SIK Rod -00938 (Mag. 25kx).
