ARMY RESEARCH LABORATORY

Investigation of the UH-60
Main Rotor Spindle Assembly
Retaining Rods P/N 70102-08102/-103

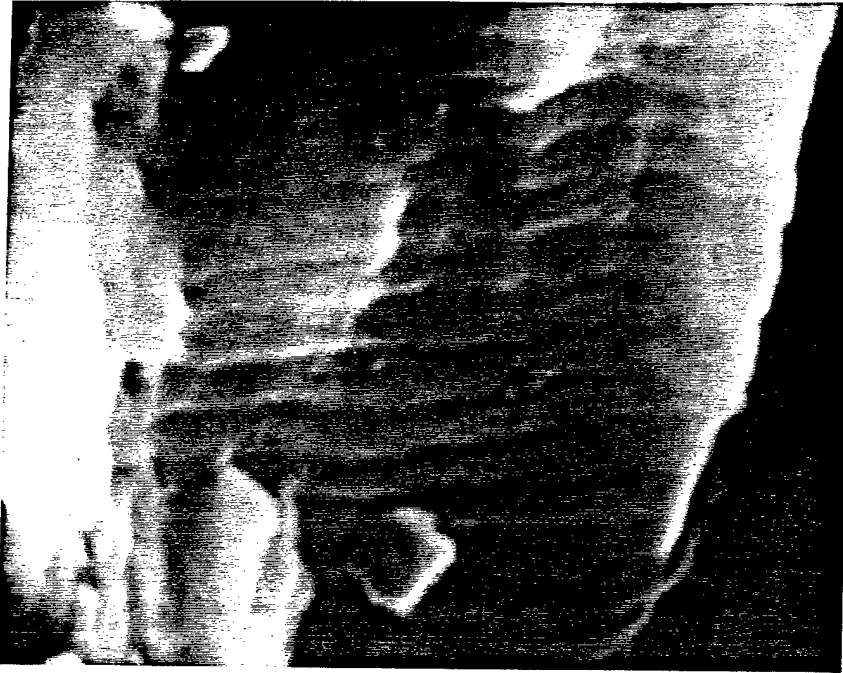
Figure 68. Additional Striations Noted on the Surface of SIK Rod -00938 (Mag. 25kx).

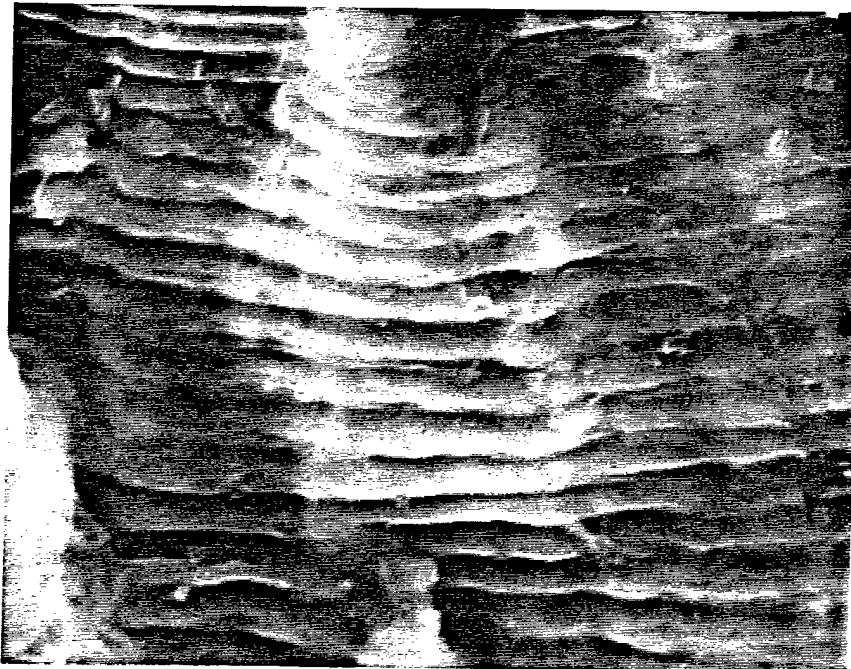
Figure 69. Striations Noted on the Surface of SIK Rod -00938 (Mag. 10kx).

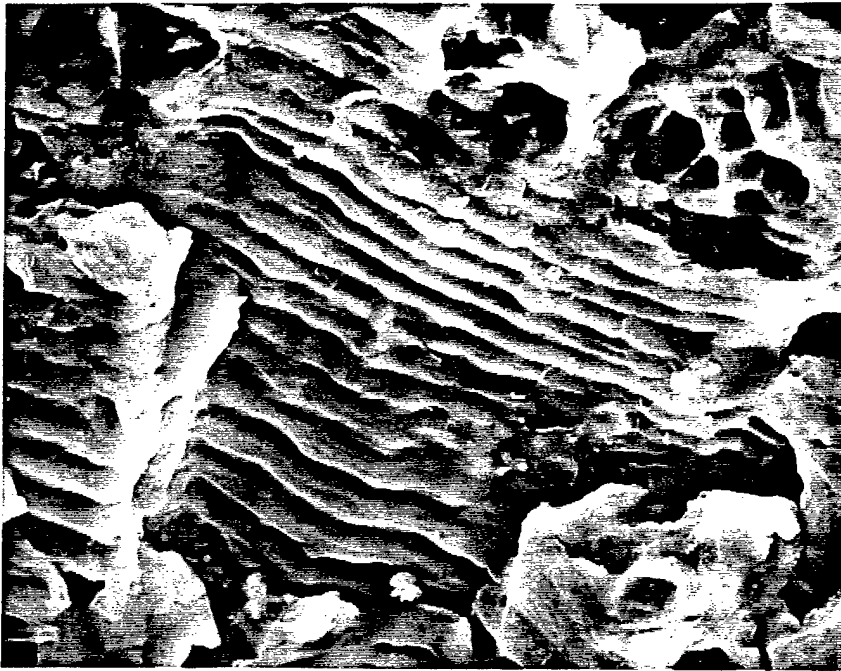
Figure 70. Striations Noted on the Surface of SIK Rod -00938 (Mag. 5kx).

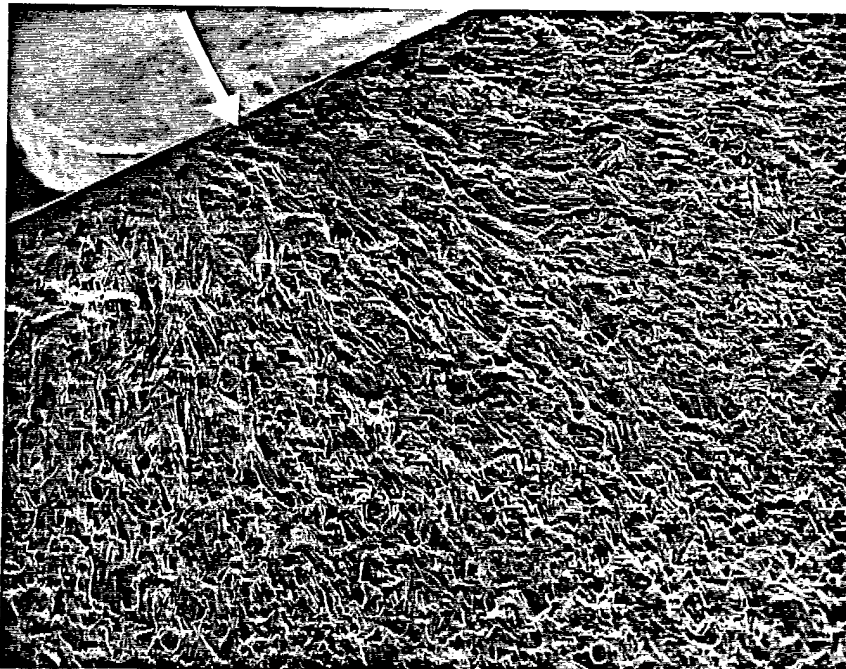
Figure 71. Typical Origin Noted on the Fracture Surface of SIK Rod -00973 (Mag. 200x).

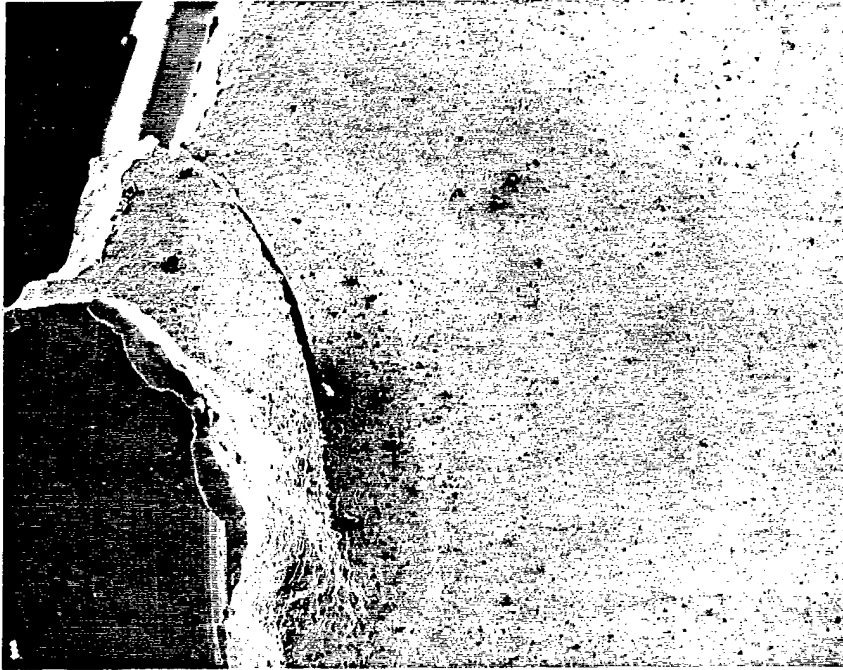
Figure 72. Typical Origin Noted on the Fracture Surface of SIK Rod -00973 (Mag. 20x).

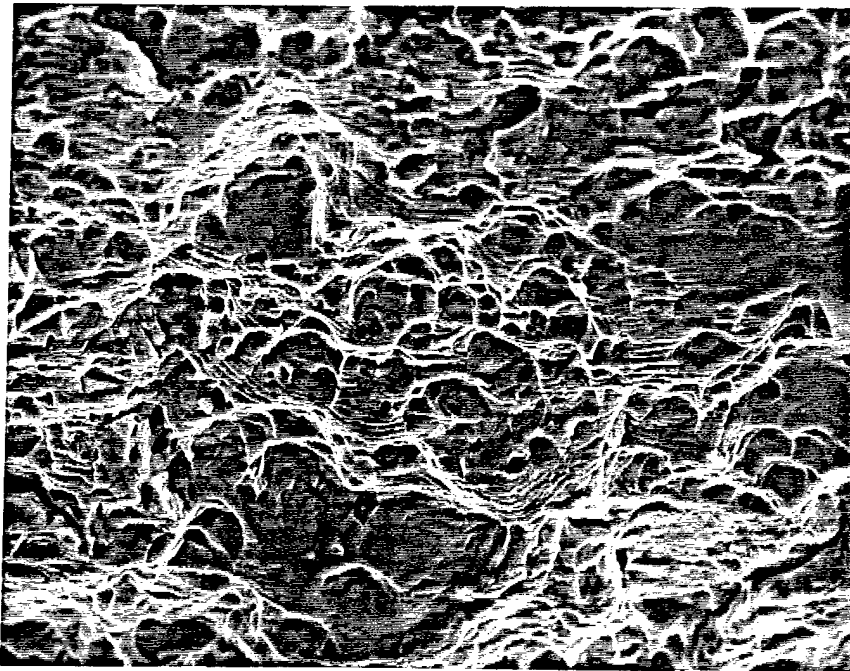
Figure 73. The Transgranular/Ductile Morphology of SIK Rod -00973 Away From the Origins (Mag. 1kx).

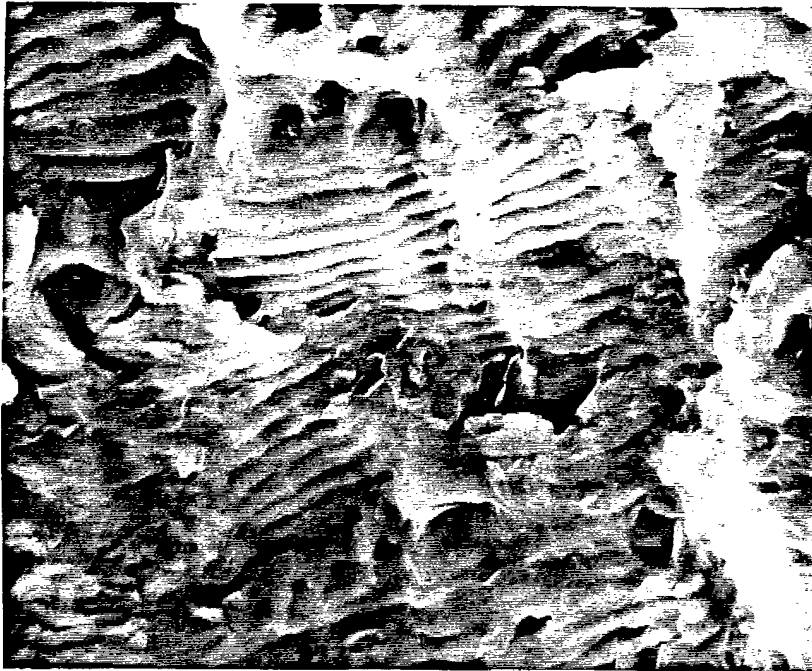
Figure 76. Typical Striations Noted on the Surface of SIK Rod -00973 (Mag. 5kx).

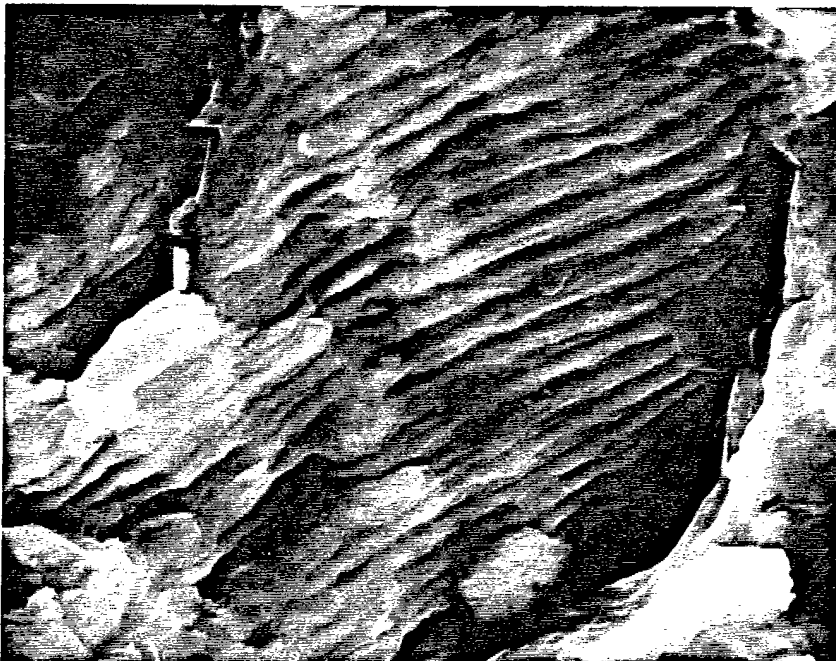
Figure 77. Typical Striations Noted on the Surface of SIK Rod -00973 (Mag. 10x).

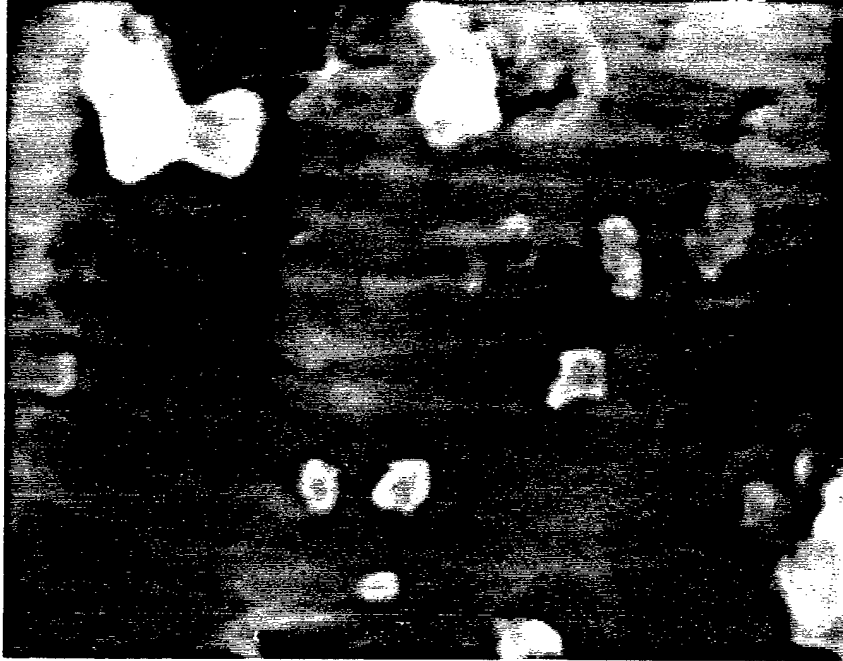
Figure 78. Typical Striations Noted on the Surface of SIK Rod -00973 (Mag. 20kx).

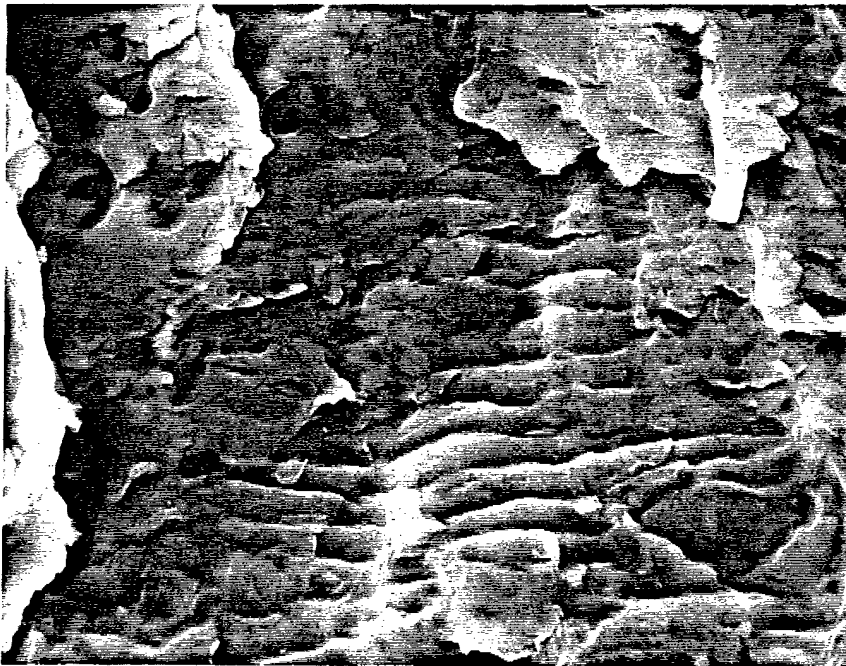
Figure 79. Typical Striations Noted on the Surface of SIK Rod -00973 Near the Shear Region (Mag. 5kx).

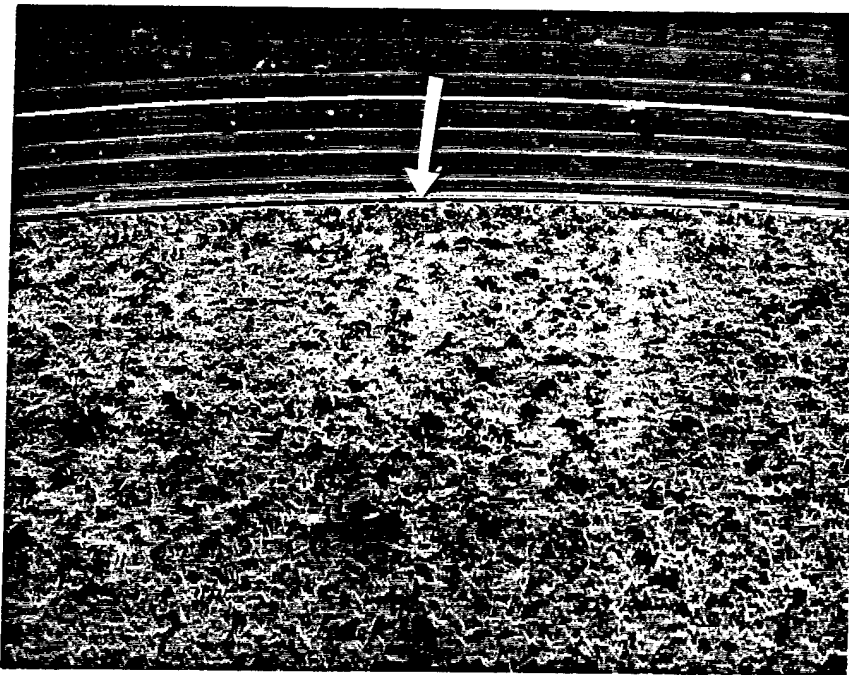
Figure 80. Typical Origin Located on the Fracture Surface of PUR Rod -174 (Mag. 50x).

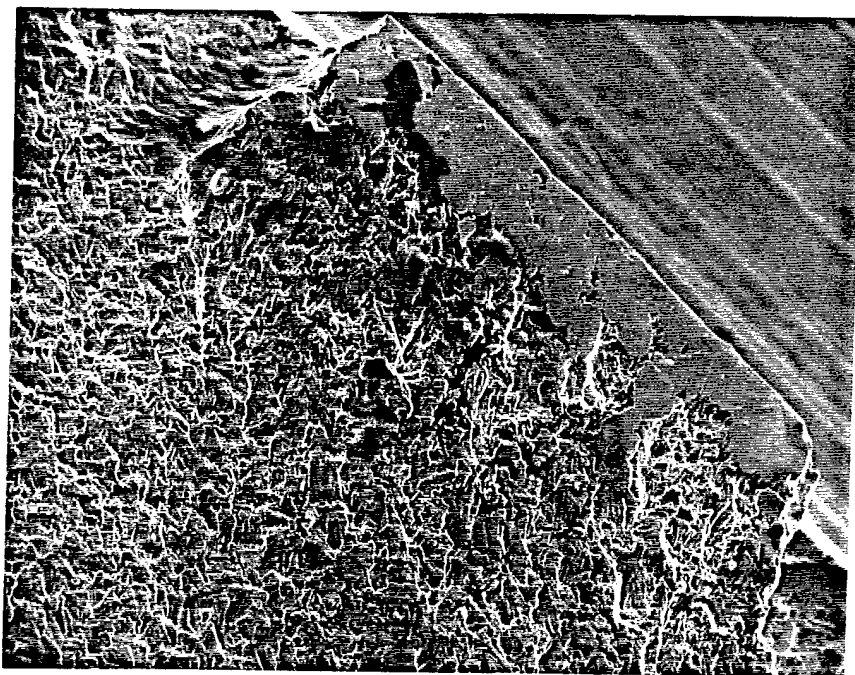
Figure 81. Typical Origin Located on the Fracture Surface of PUR Rod -174 (Mag. 150x).

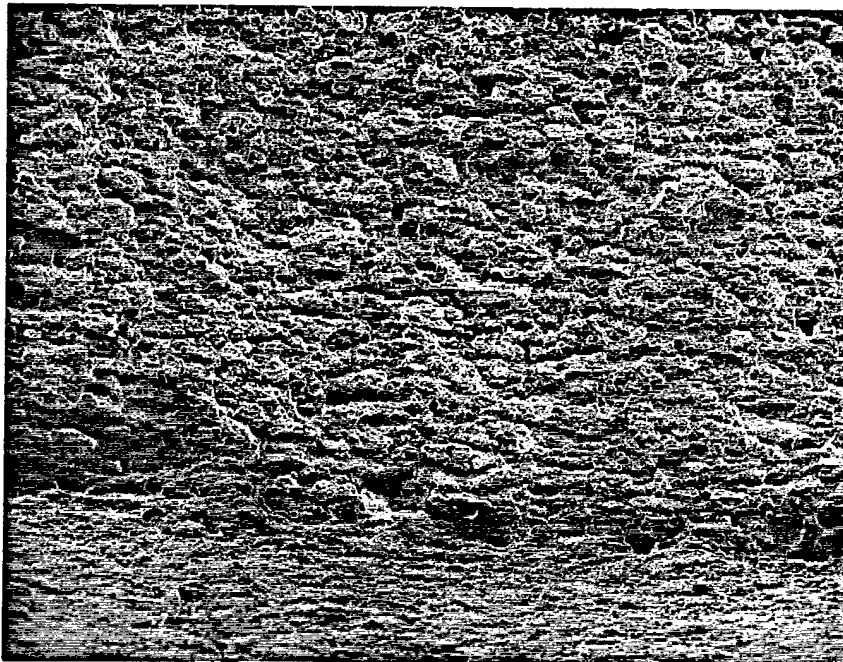
Figure 83. The Morphology of PUR Rod -174 Consisting of a Transition Zone Between Cyclic Overload and Shear (Mag. 50x).

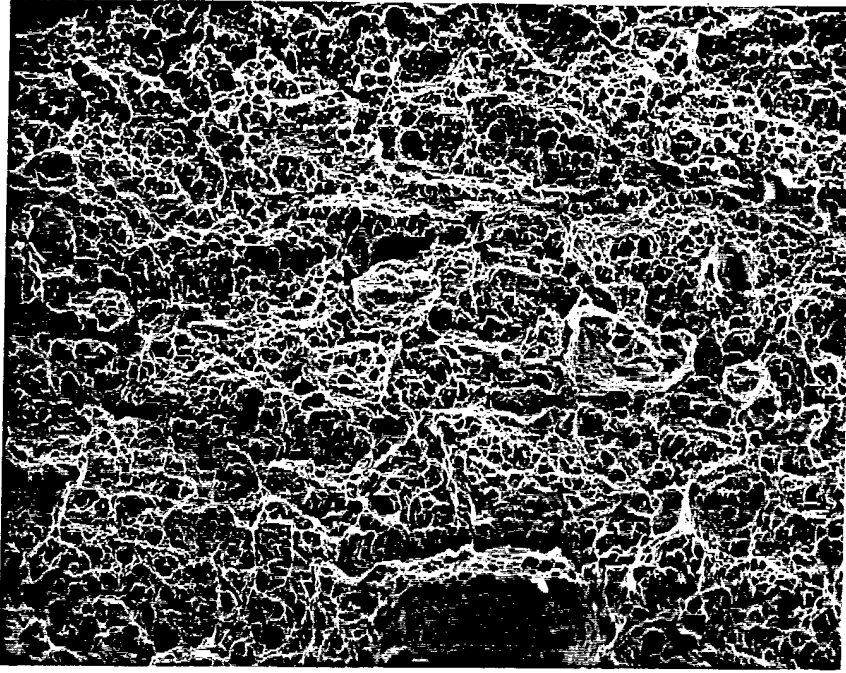
Figure 84. Cyclic Overload Morphology on the Fracture Surface of PUR Rod -174 (Mag. 200x).

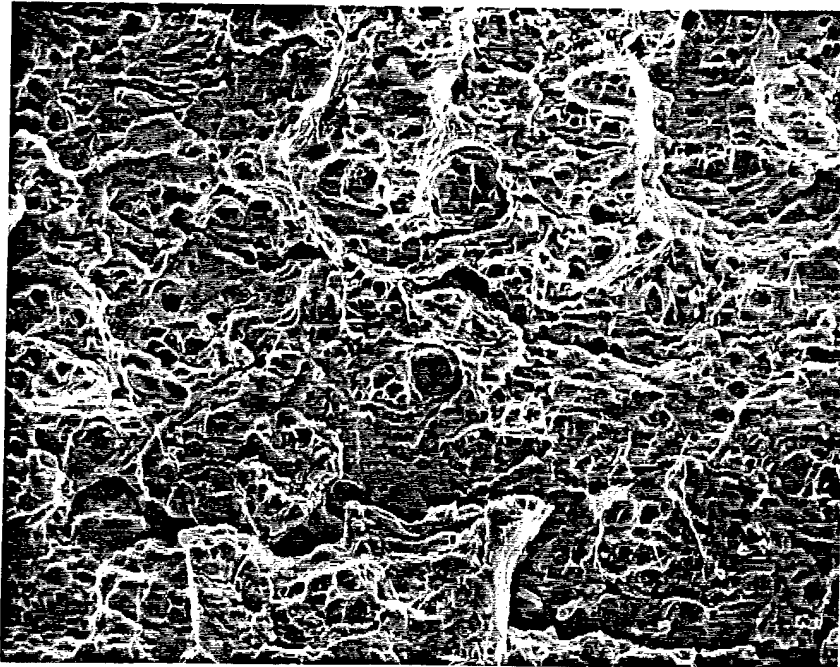
Figure 85. A Morphology Consisting of Tearing as Well as Cyclic Overload Noted on the Fracture Surface of PUR Rod -174 (Mag. 500x).

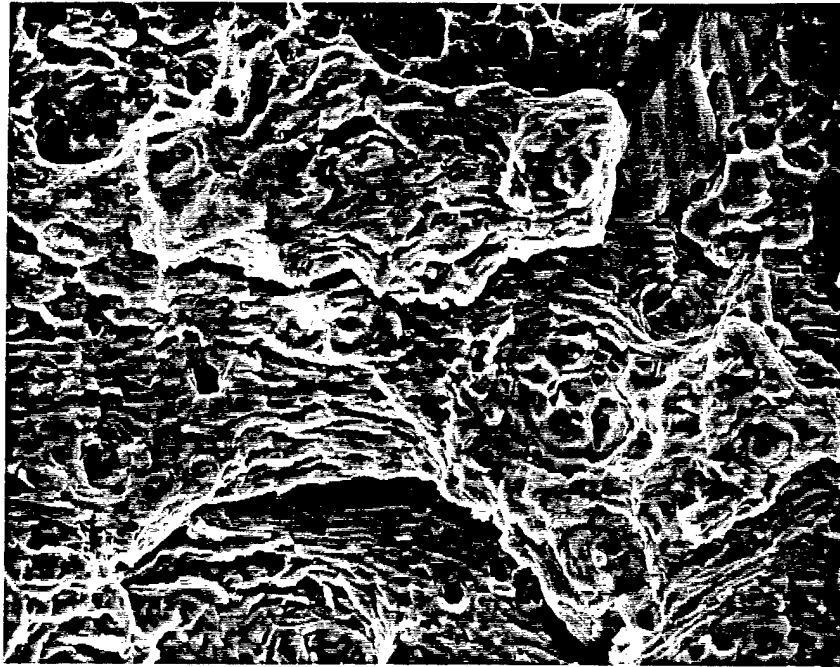
Figure 86. A Morphology Consisting of Striations, Tearing, and Ductility Observed on the Fracture Surface of PUR Rod -174 (Mag. 1kx).

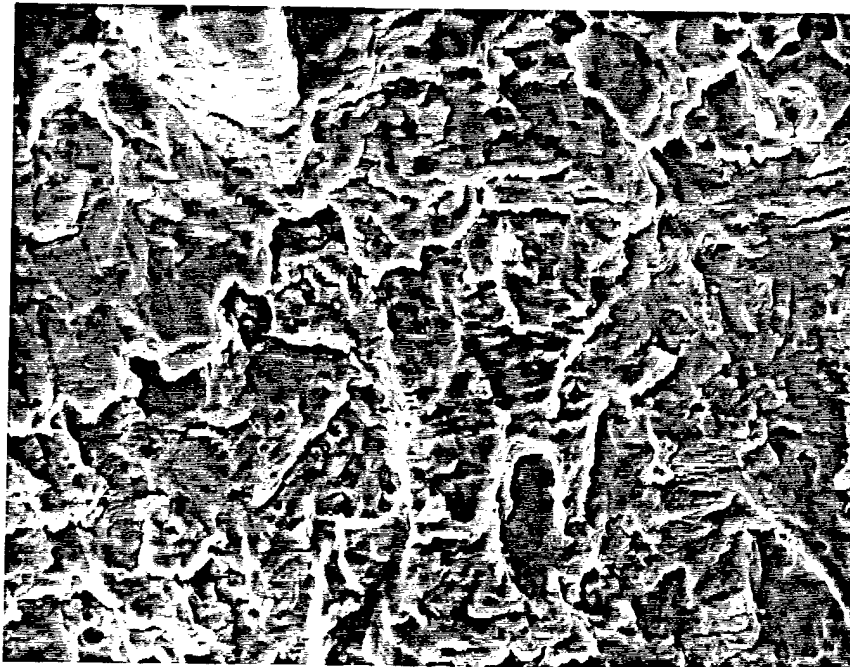
Figure 87. The Transgranular Morphology Representative of the Fatigue Zones of PUR Tie Rod -174 (Mag. 1kx).

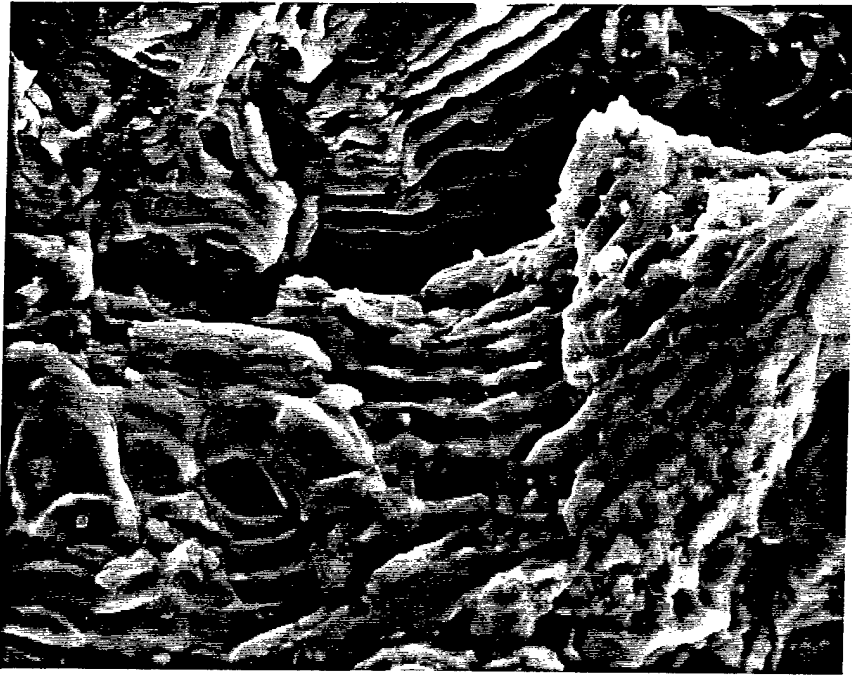
Figure 88. Striations Noted Within the Fracture Surface of PUR Rod -174 (Mag. 3kx).

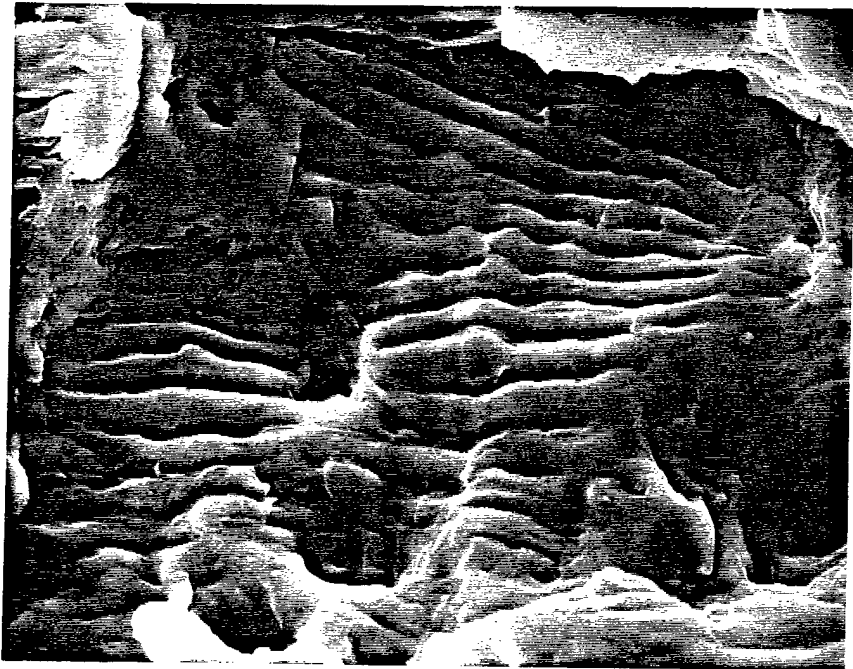
Figure 89. Striations Noted Within the Fracture Surface of PUR Tie Rod -174 (Mag. 5kx).

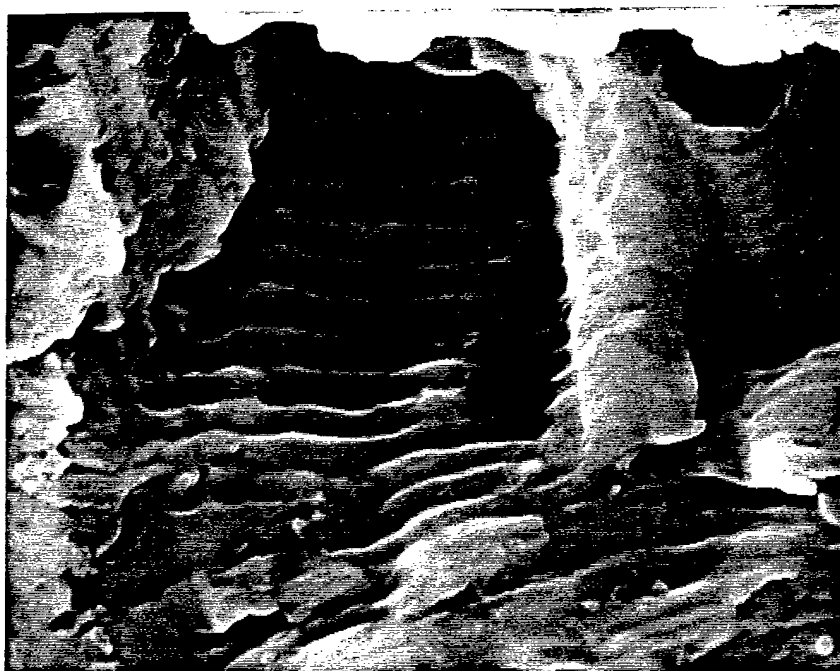
Figure 90. Striations Noted Within the Fracture Surface of PUR Rod -174 (Mag. 10kx).

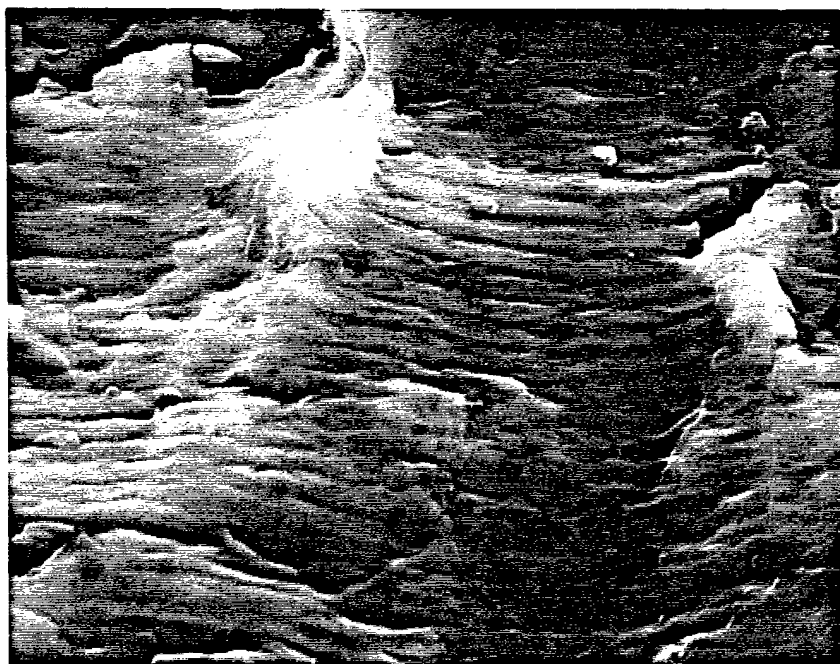
Figure 91. Striations Noted Within the Fracture Surface of PUR Rod -174 (Mag. 10kx).

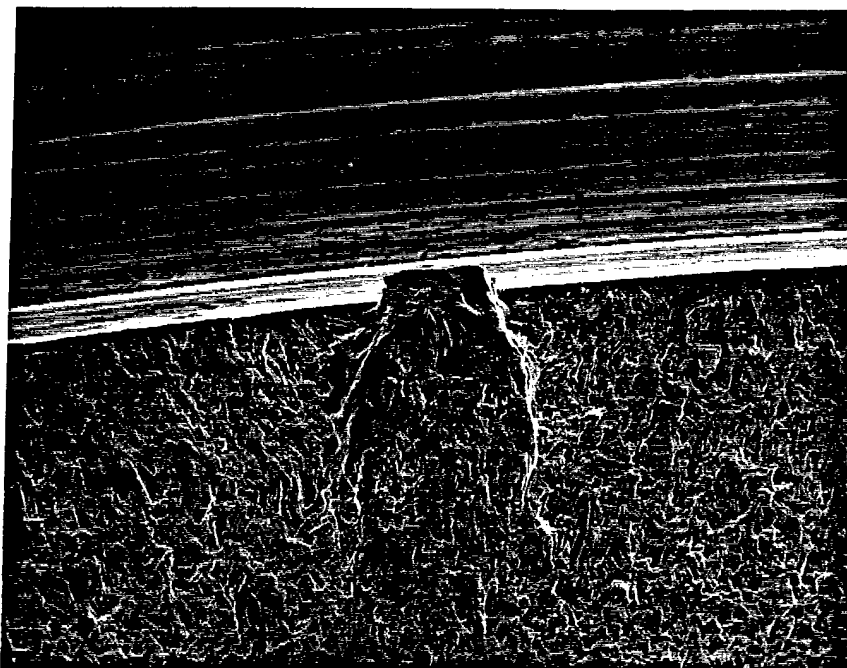
Figure 92. A Typical Origin of PUR Rod -177 (Mag. 100×).

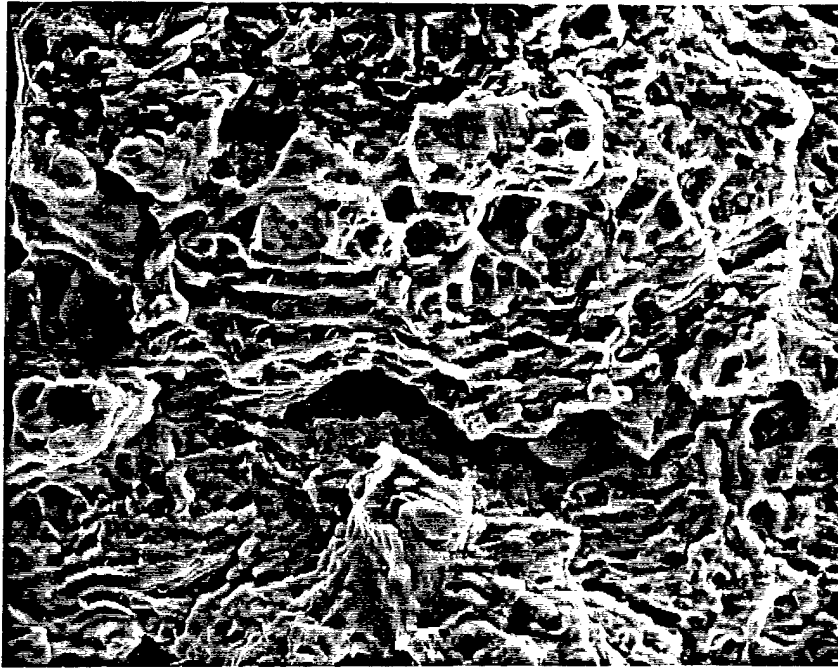
Figure 94. A Transgranular Morphology Mixed With Tearing on the Fracture Surface of PUR Rod -177 (Mag. 1kx).

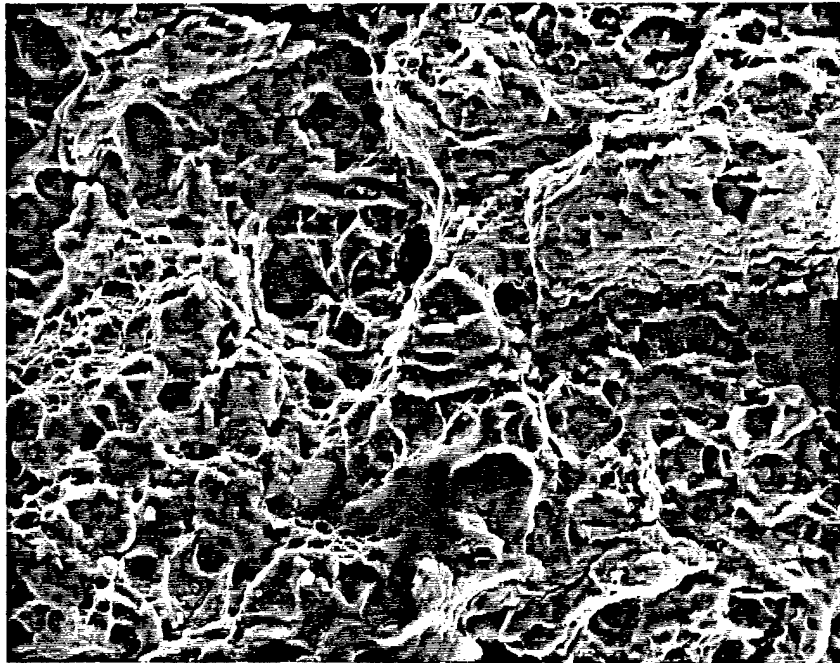
Figure 95. The Morphology of PUR Rod -177 Consisting of Striations Mixed With Ductility (Mag. 1kx).

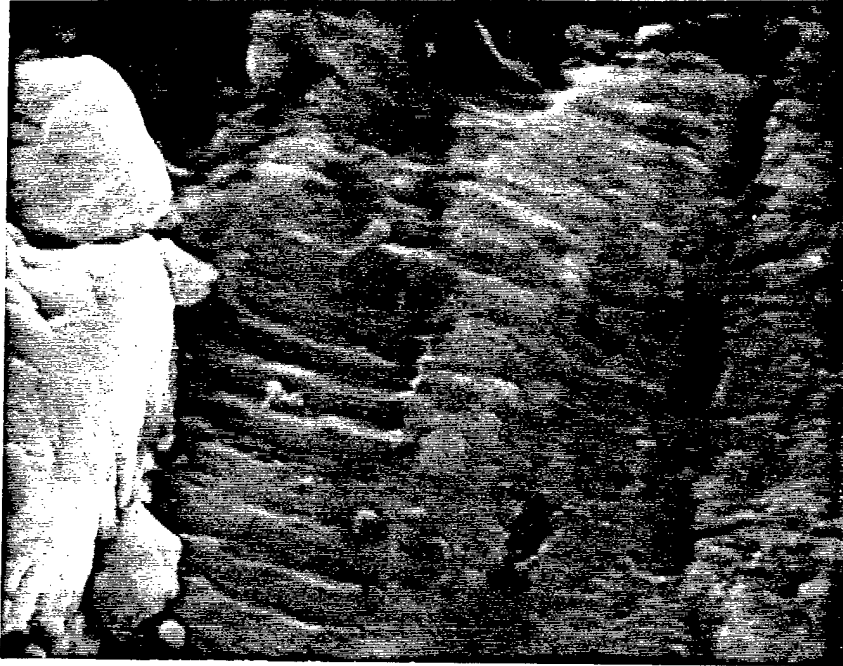
Figure 98. Striations Noted on the Fracture Surface of PUR Rod -177 (Mag. 10kx).

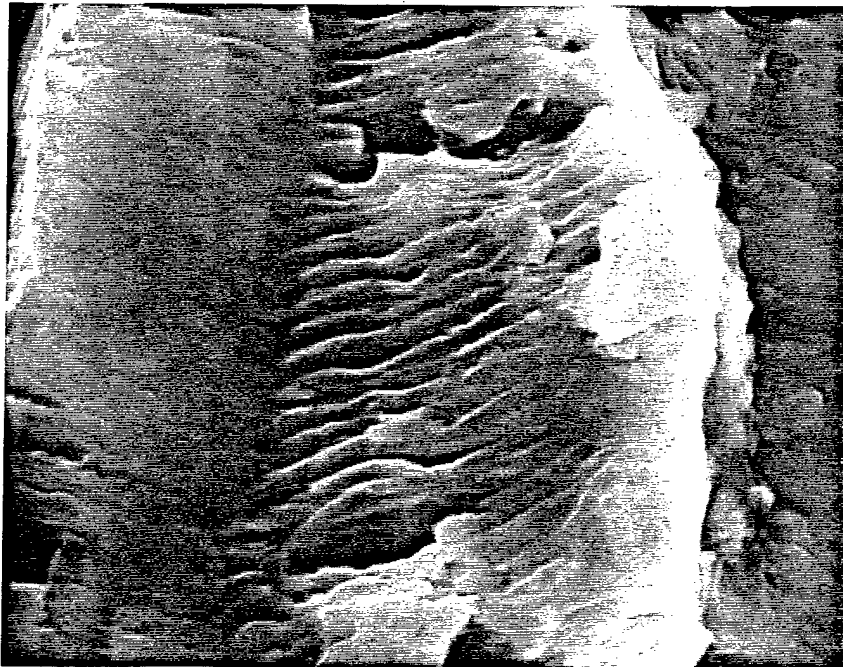
Figure 99. Additional Striations Noted on the Fracture Surface of PUR Rod -177 (Mag. 10kx).

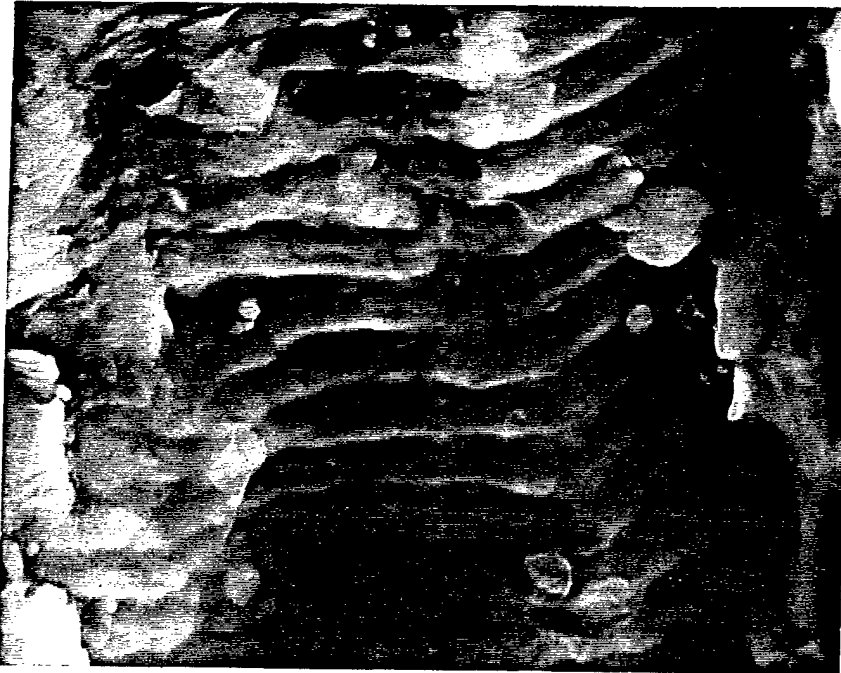
Figure 100. Striations Noted on PUR Rod -177, Note How Spacing Is Increasing From Figure 98 and 99 (Mag. 10kx).

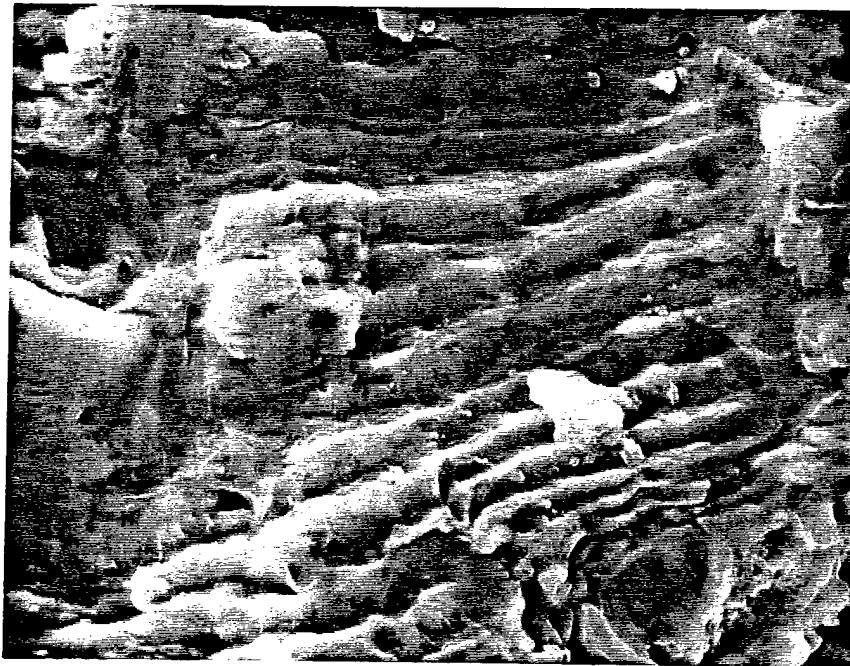
Figure 101. Striations Noted on the Fracture Surface of PUR Rod -177 (Mag. 5kx).

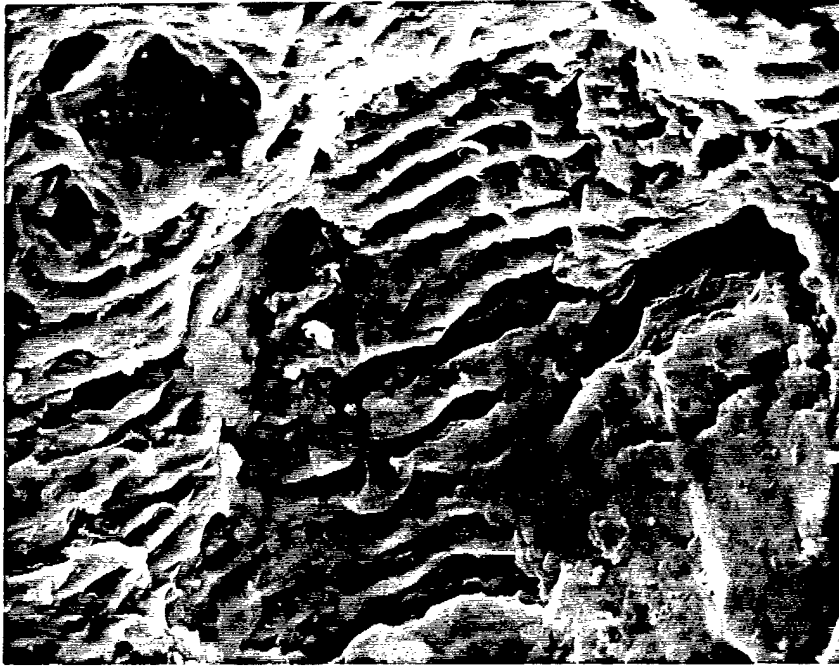
Figure 102. Striations Noted on the Fracture Surface of PUR Rod -177 (Mag. 3kx).

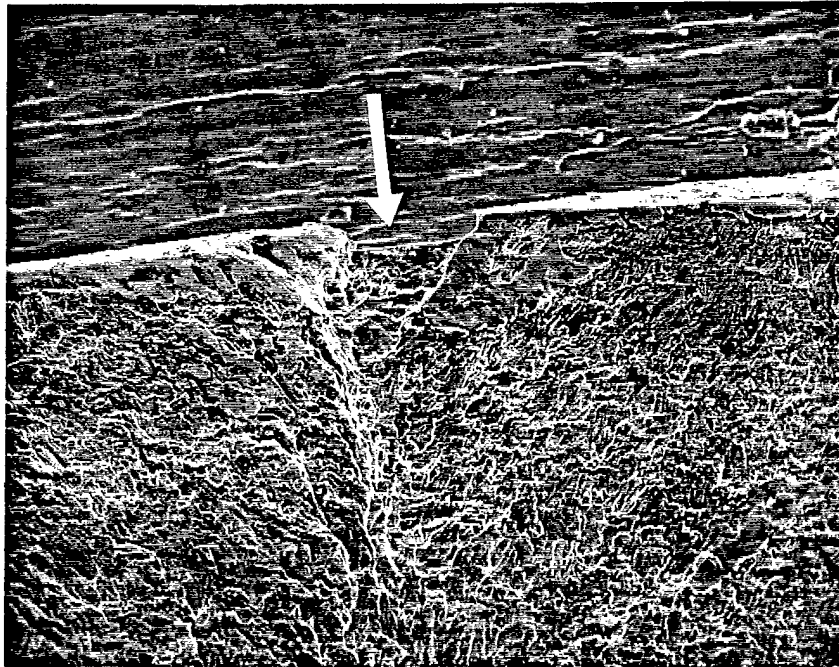
Figure 103. A Typical Origin on the Fracture Surface of S&S Tie Rod -2 (Mag. 150x).

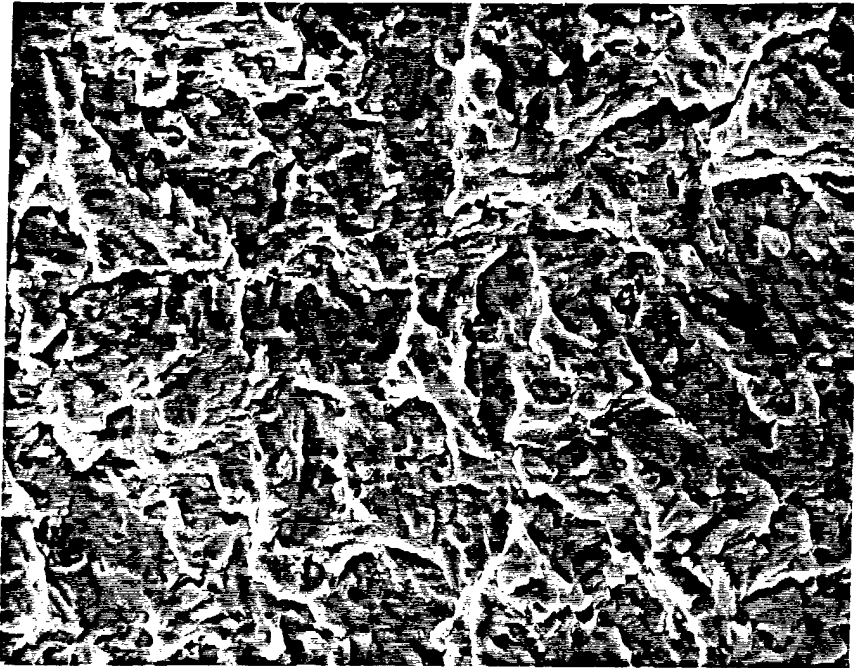
Figure 104. Typical Transgranular Morphology of S&S Rod -2. This Morphology Was Characteristic of Fatigue (Mag. 1kx).

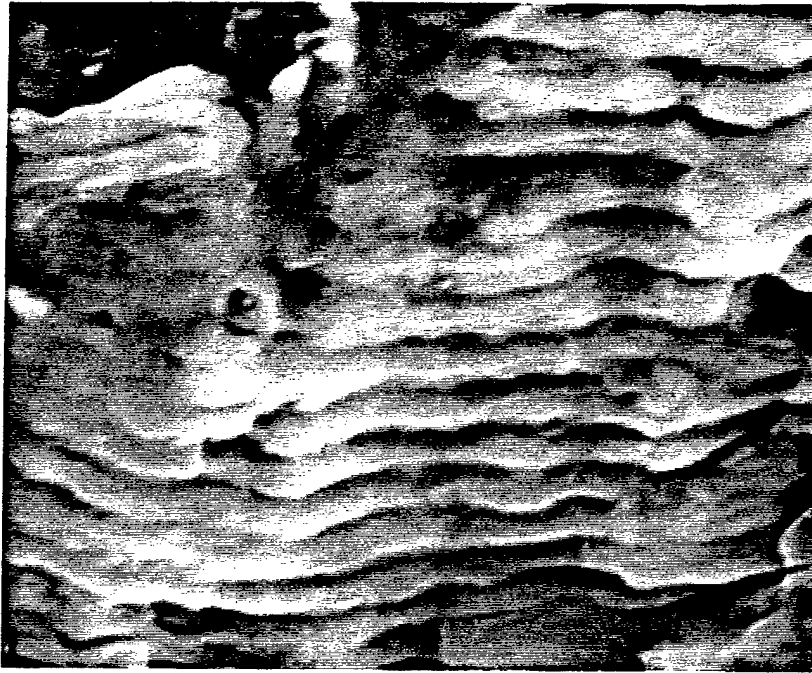
Figure 106. Typical Striations Noted on the Surface of the S&S Rod -2 (Mag. 10kx).

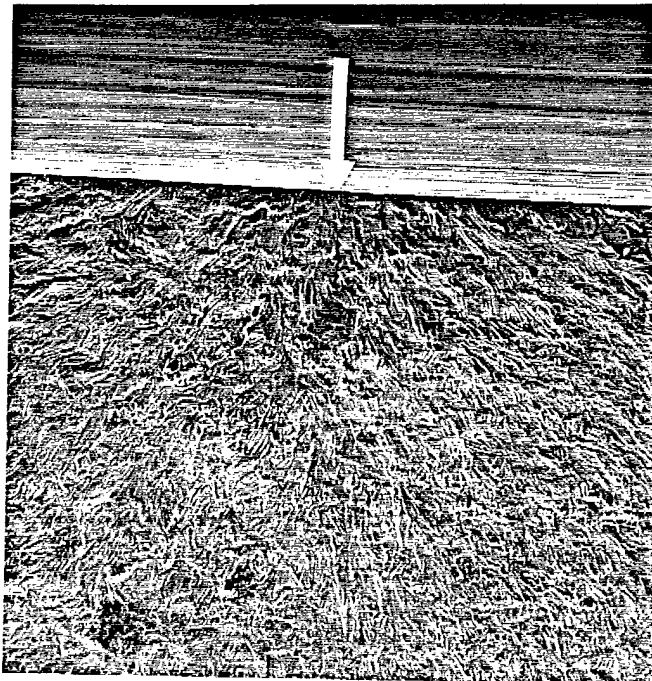
Figure 107. Typical Origin Noted on the Fracture Surface of the S&S Rod -3 (Mag. 200x).

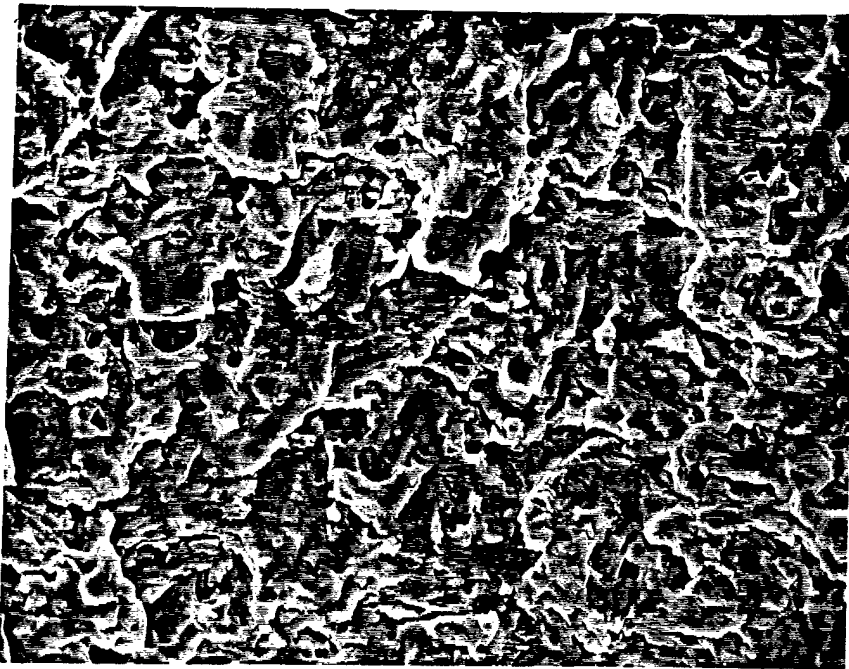
Figure 108. The Transgranular Morphology Contained Within the Fatigue Zone of the S&S Tie Rod -3 (Mag. 1kx).

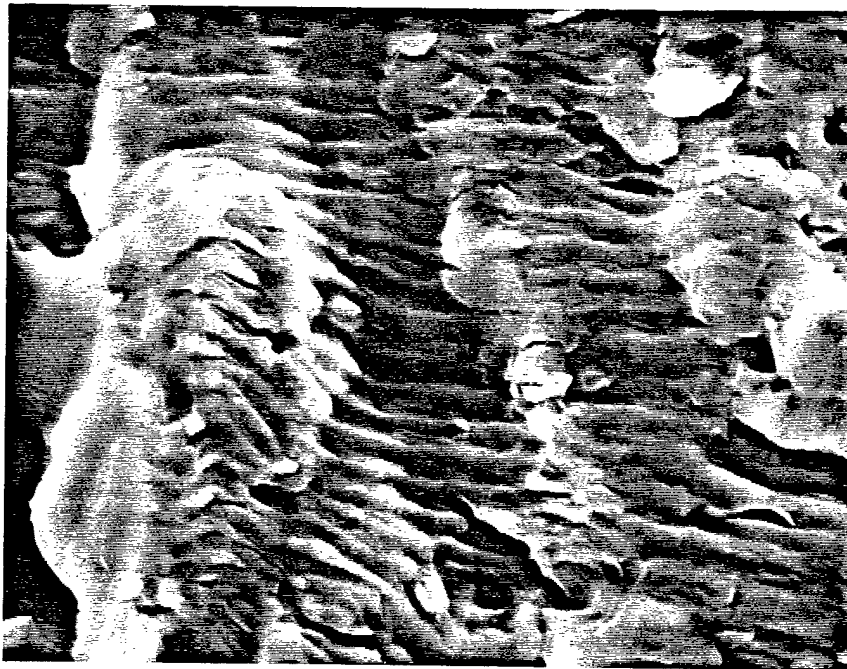
Figure 111. Typical Striations Noted on the S&S Tie Rod -3 (Mag. 5kx).
