# Nondestructive Evaluation (NDE) Techniques Assessment for Graphite/Epoxy (Gr/Ep) Composite Overwrapped Pressure Vessels

30 October 1998

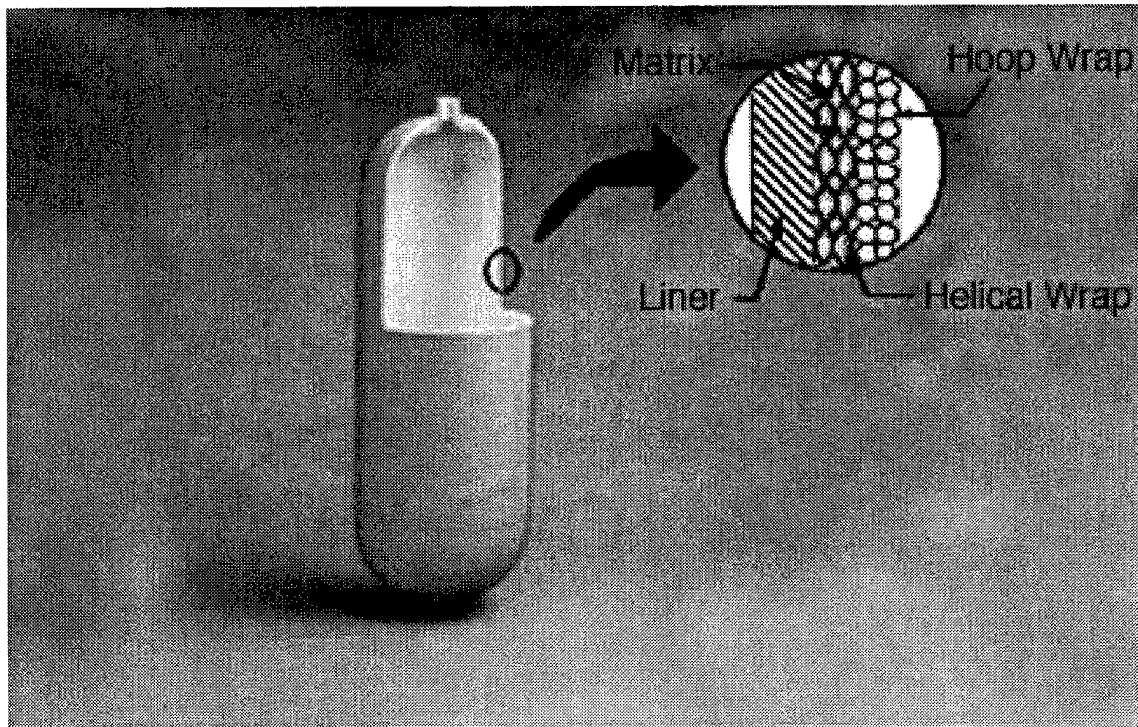
Figure 1. Sectional view of a typical COPV.

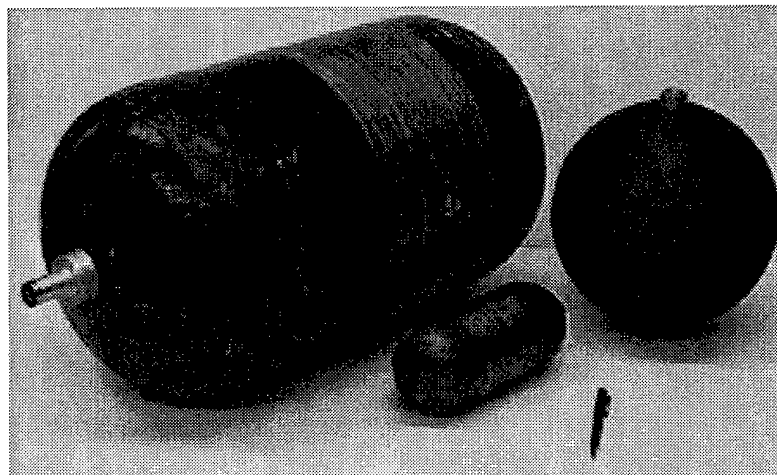
Figure 2. COPVs used in impact damage detection study. The characteristics of these vessels are tabulated in Table 1.

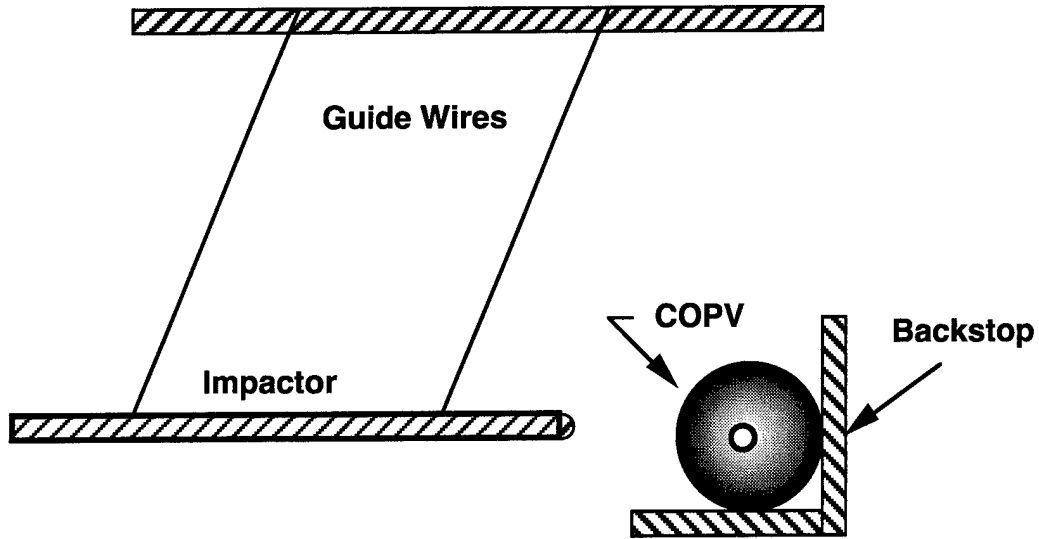
Figure 3. Schematic representation of impactor apparatus.

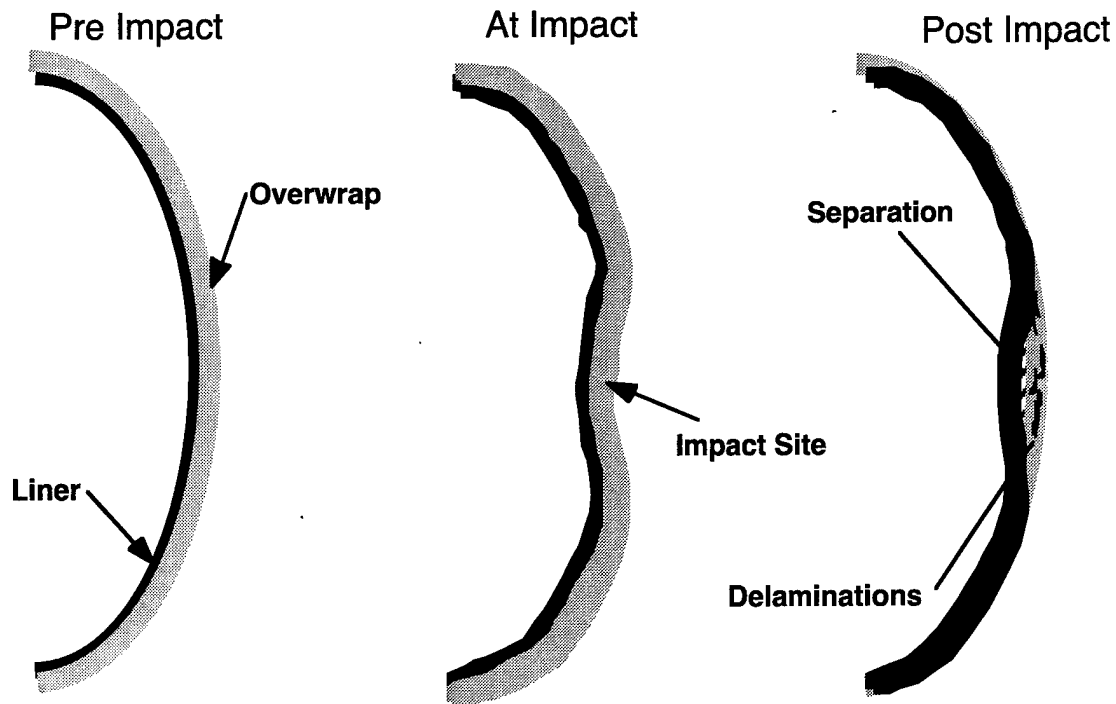
Figure 5. Cross-sectional view of the impact damage event.

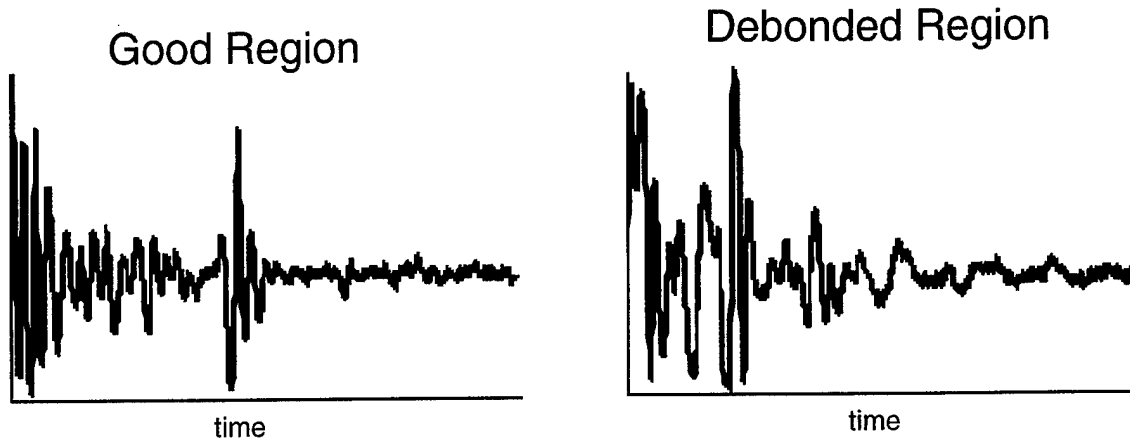
Figure 6. Pulse echo A-scans from a good and debonded region of an impacted COPV. The measurements were made using a 10-MHz transducer and Ultragel II™ couplant. Note the strong (early) response from the backside of the overwrap in the debonded region.

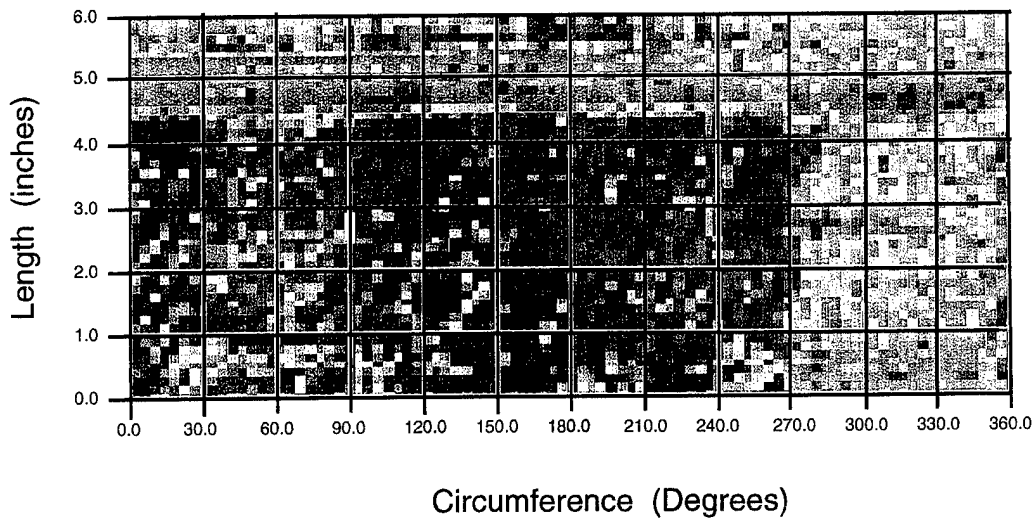
Figure 7. C-scan image of a 10 cm X 23 cm COPV after a 10-J impact. The impact site gives rise to an obvious, somewhat circular indication centered at about (125°, 1.5 in). The rectangular indication on the right was due to a label affixed to the bottle. The stripe along the top of the scan was due to the curved edge of the bottle.

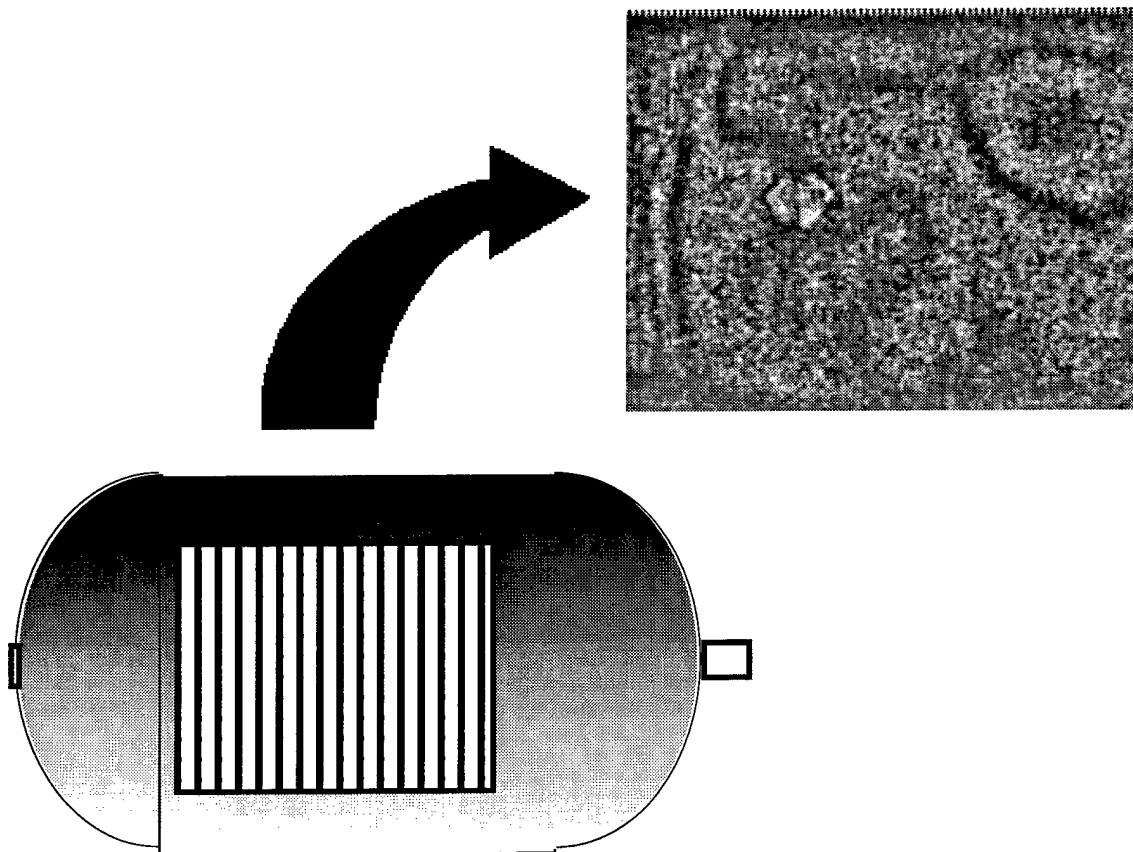
Figure 8. Shearographic image of 35-J, 25-mm tup impacted cylindrical COPV.

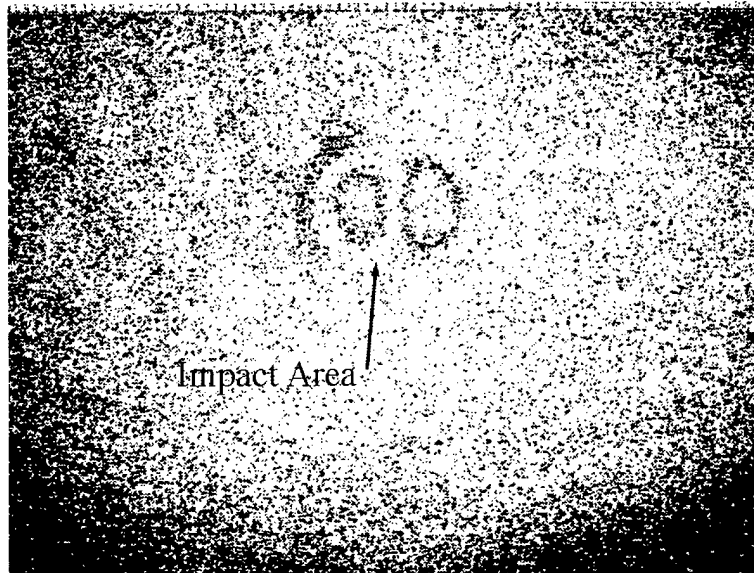
Figure 9b. Post-impact shearographic image of the spherical COPV following a 20-J impact with a 25-mm diameter tup. A 40-psi pressure differential was employed to create the image.

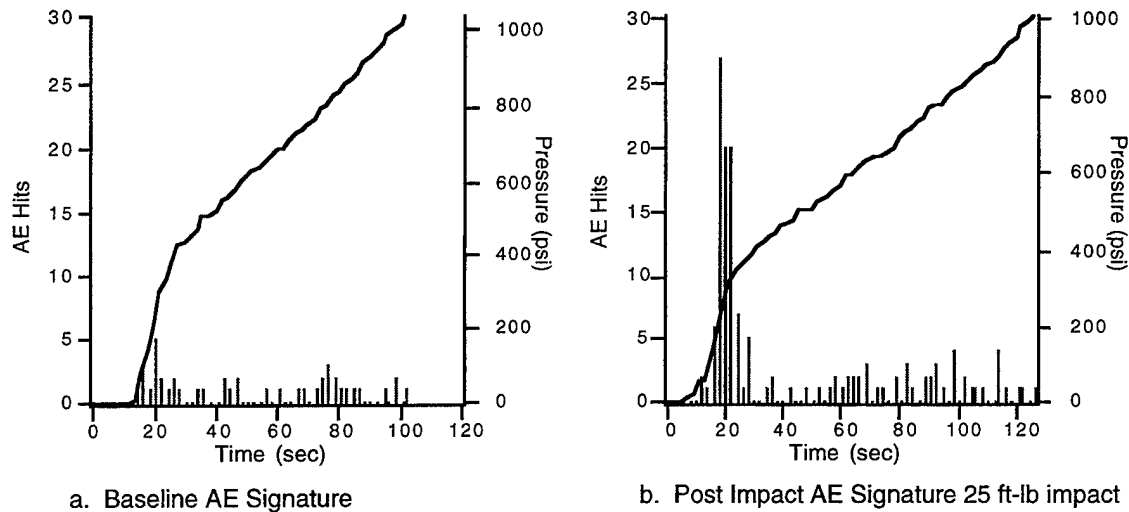
Figure 13. Acoustic emission data for for the 10 X 23 cm cylindrical COPV (a) before and (b) after a 35-J impact.

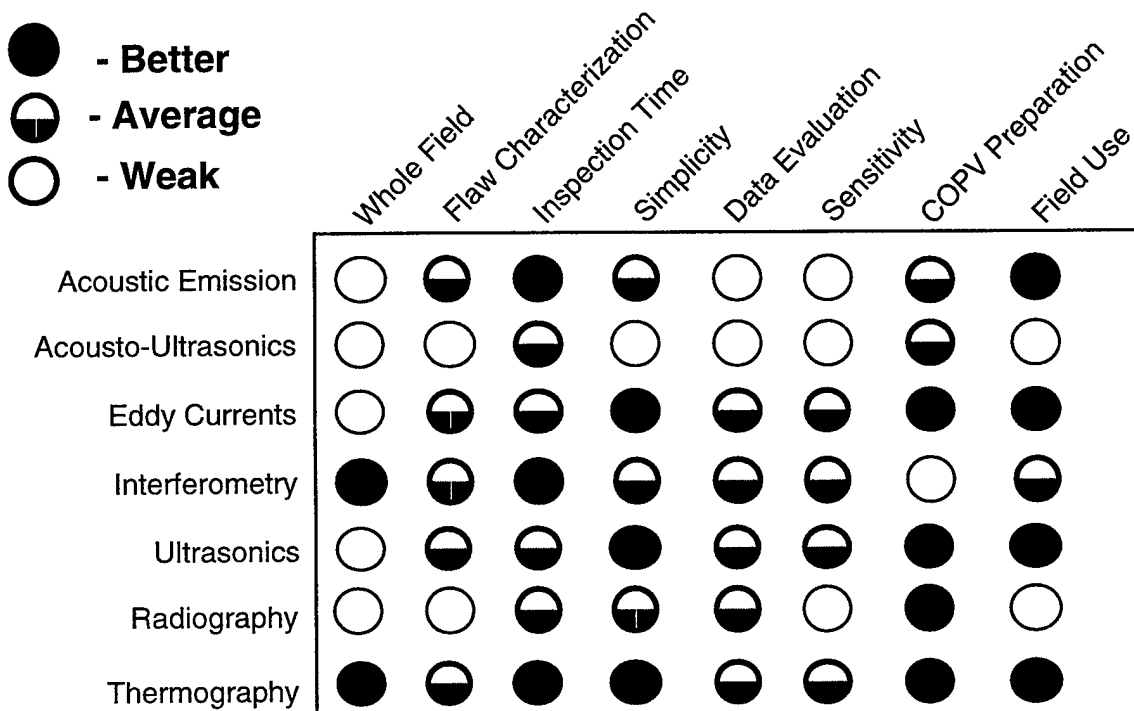
Figure 14. A summary of the features of various NDE techniques for the inspection of graphite epoxy overwrapped pressure vessels.
