# **DEMONSTRATION AND VALIDATION OF THERMAL SPRAY VITRIFICATION OF LEAD-CONTAINING PAINT ON STEEL STRUCTURES**

**CERL TR 99/61**

**July 1999**

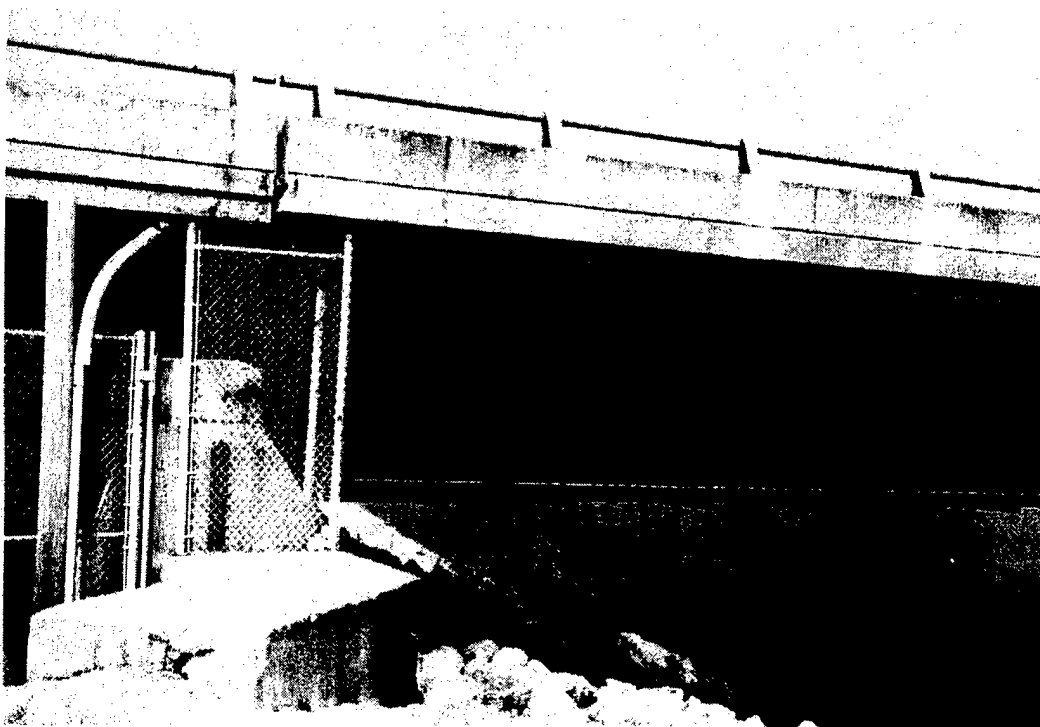
**Figure B- 7. The Viaduct Bridge at the Rock Island Arsenal after the TSV demonstration.**

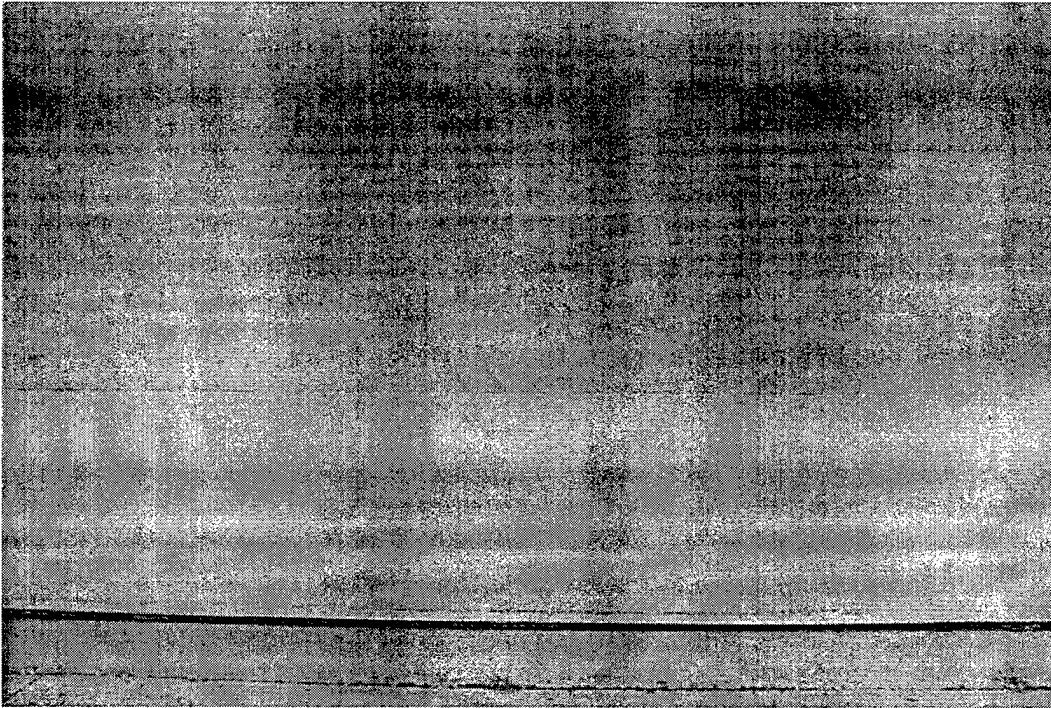
Several of the bolts on the bottom of the door that were heavily corroded failed and fell off the door during the heating and cooling during the TSV. This failure was anticipated during the initial inspection of the door. After TSV processing, new bolts were installed.

**Figure B- 11. Photograph of the hangar door exterior before TSV application.**

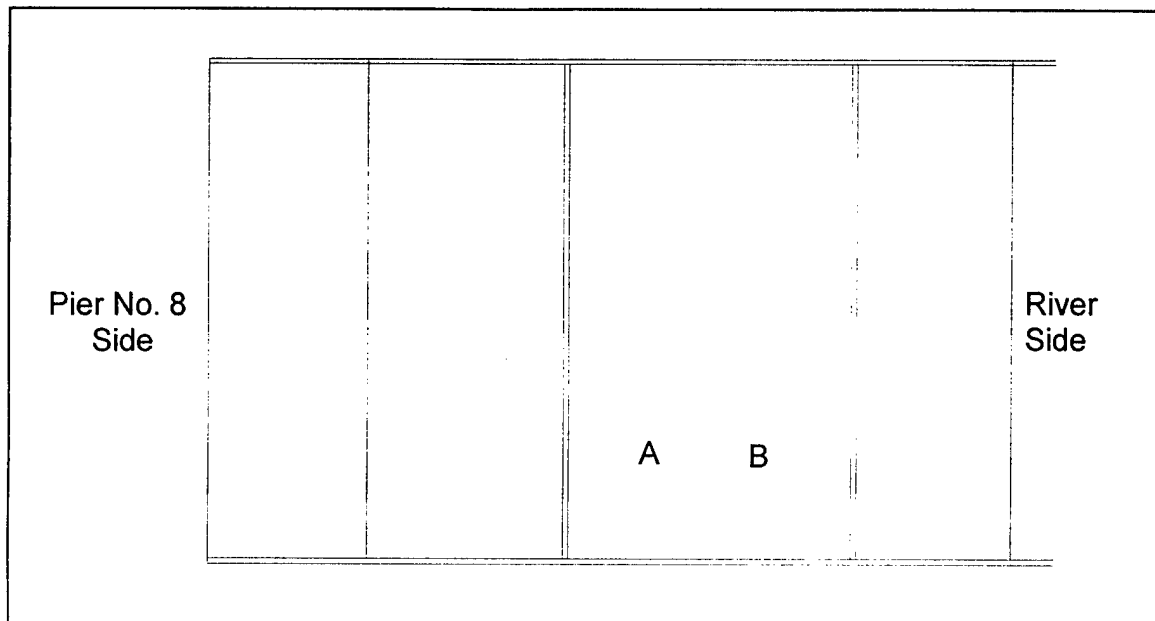
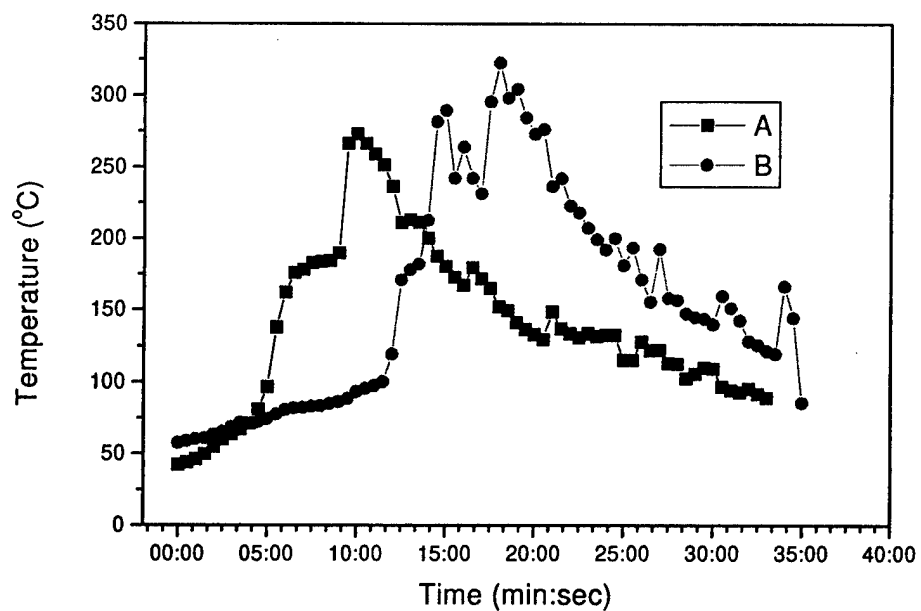
During the initial application of TSV, it was noted by the operator that the vertical web of the beam was warping. The application of TSV was immediately stopped and the degree of warping was measured and found to range up to 3/8 inch. A structural engineer from the Corps of Engineers Rock Island District inspected the beam and concluded that the warping did not adversely impact the structural integrity of the beam or of the bridge. The warping was due to excess heat applied to the vertical web of the beam during preheating of the substrate. The steel temperature on the back of a vertical web of the bridge was measured with a thermal couple during application of the TSV to the front side of the vertical web and is shown in Figure C-3 and C-4. The maximum temperature recorded for the two locations was 273 °C (523 °F) and 322 °C (611 °F).

Figure C- 4. Steel temperature measurements during TSV application.
