## **Assessment of Paint Layers by FE-SEM and EDS Examination**

**ARL-TR-3232**

**June 2004**

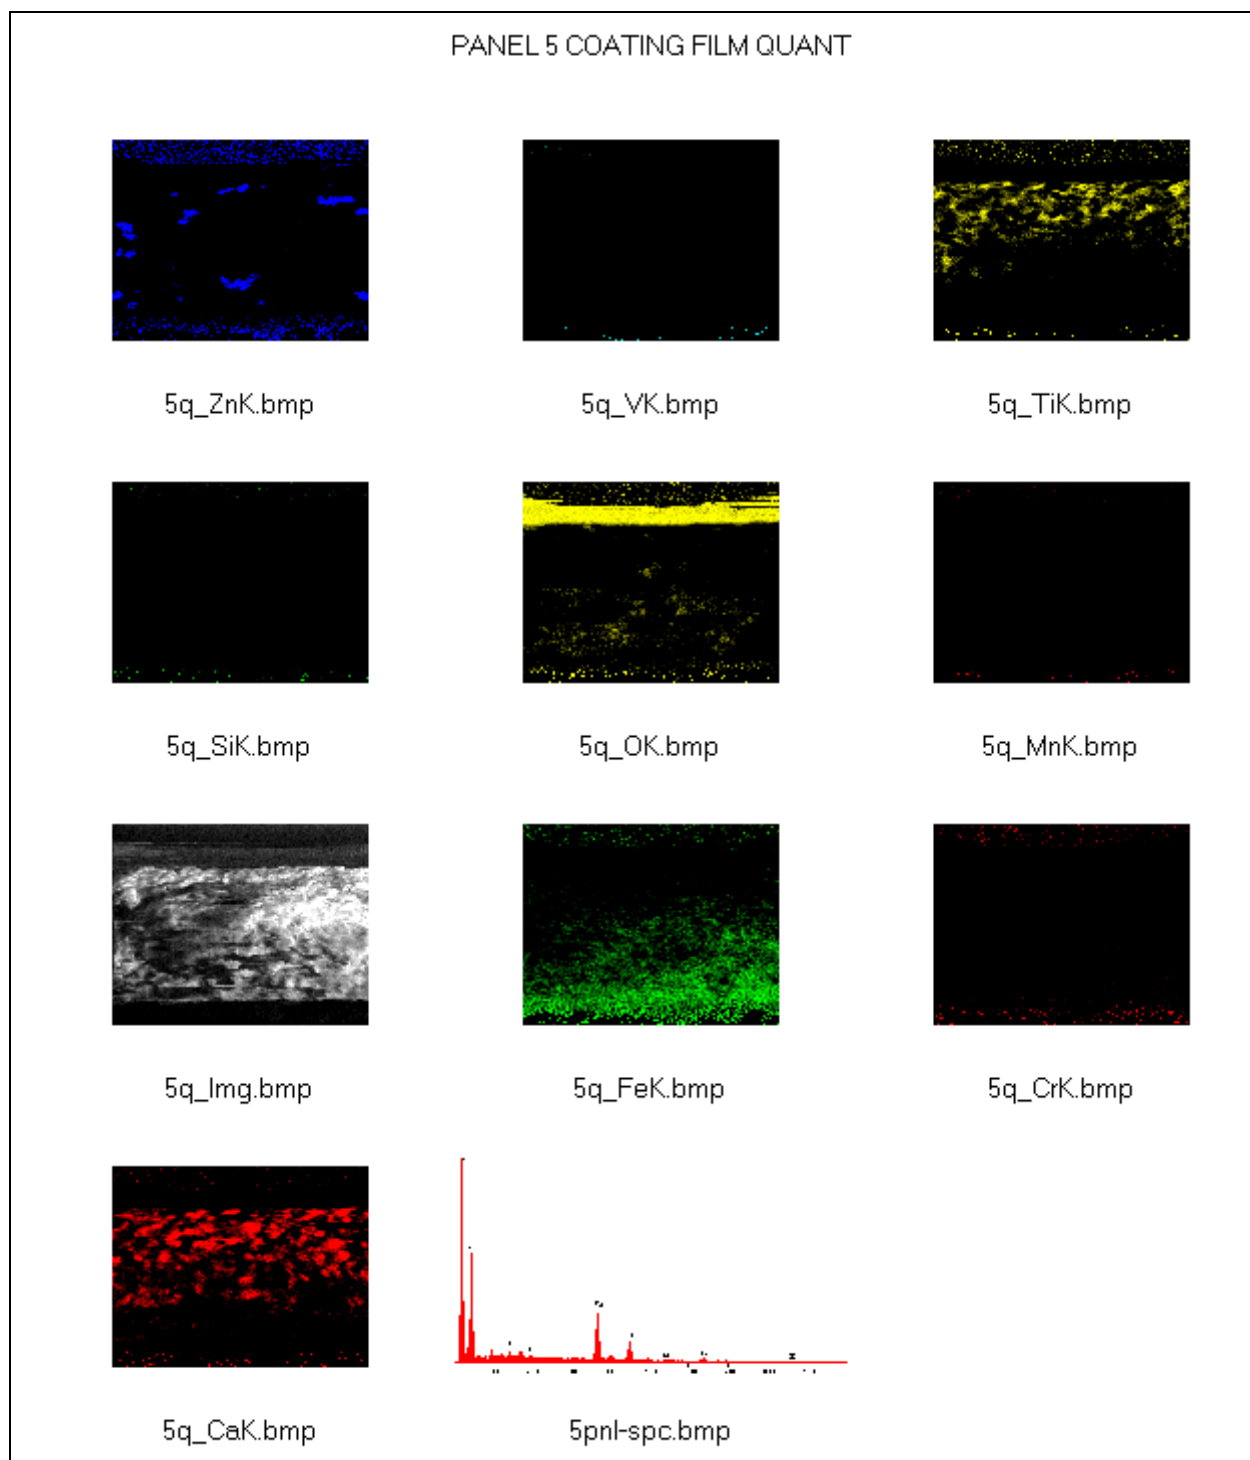
EDS detector. Figure 21 shows the results of a Quant elemental mapping of the free film oriented along the x-axis. The beam was 20 KeV with a 10- $\mu$ A emission current. The mapping was done with a 400-ms dwell time and a  $128 \times 100$  pixel frame. The Zn K map reveals the presence of a number of large clusters. The apparent V K response is really a Ti K $\beta$  response installed by the auto ID function. The bright solid band in the O K response is not readily explained, especially in the absence of any visible charging on the image map. The Fe K

Figure 21. Free film from panel 5. Contrast enhanced for visibility.

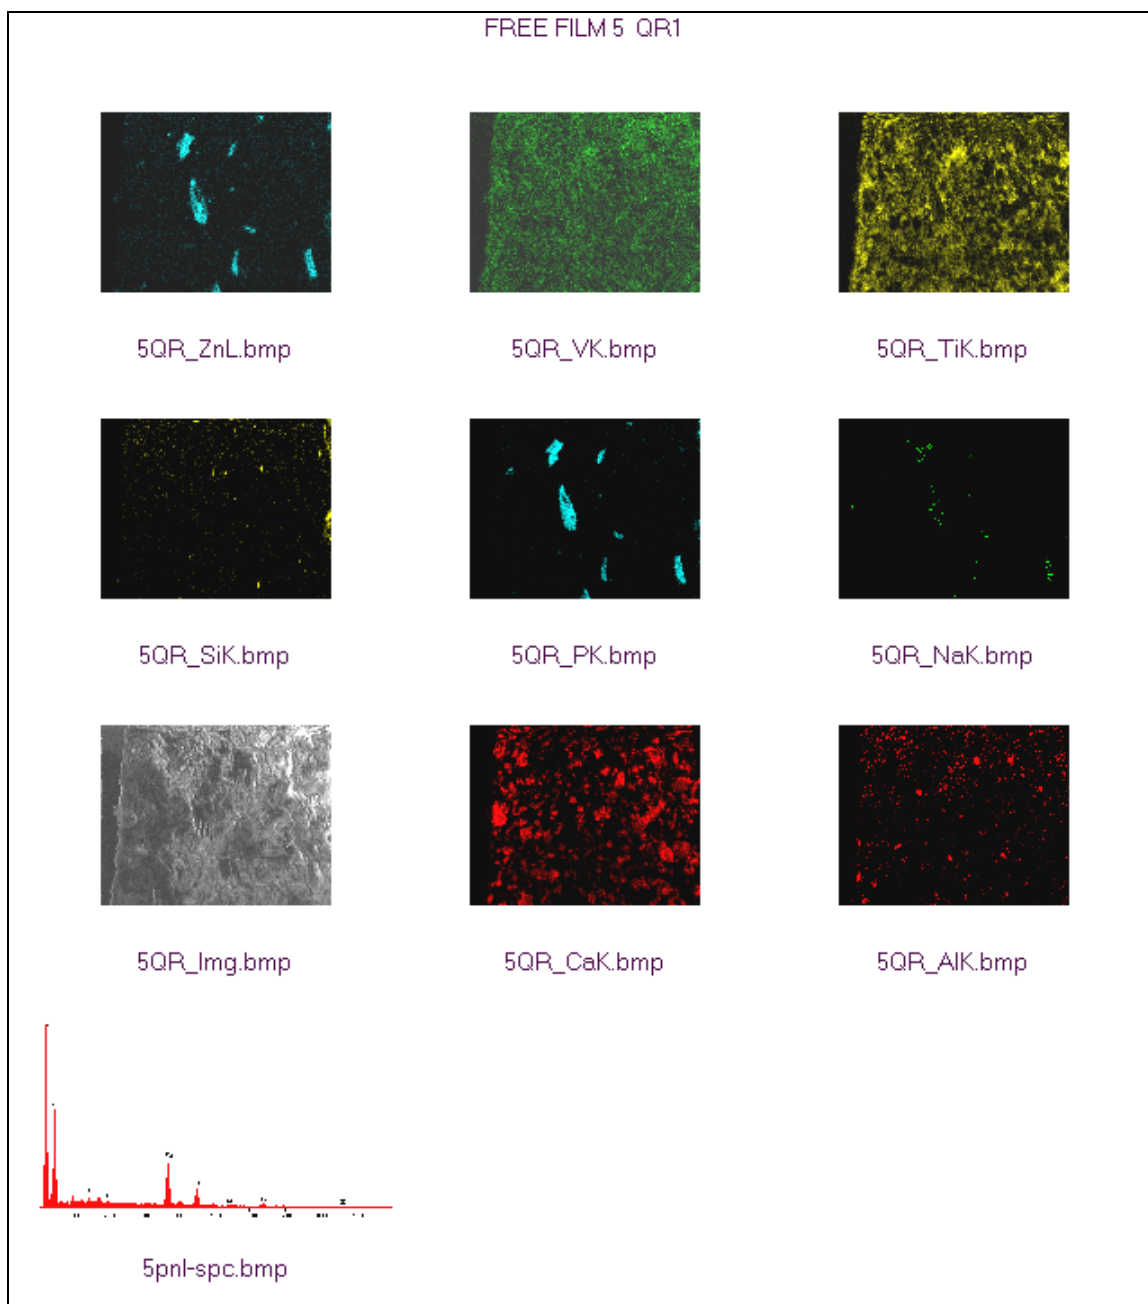
The maps and spectrum shown in figure 24 were collected on a region of the free film away from the clip, so that only the coating was in the beam path (y-axis sample alignment). The emission current could be lowered from 10 to 7  $\mu\text{A}$  and still generate sufficient counts to collect a map with a 360-ms dwell time. In addition, the numerical aperture value was raised from 5.0 to 5.5.

Both the Ca K and the Ti K maps are consistent with those in figure 21. The distributions seen in the Zn L, P K, and Na K maps are noteworthy, as they appear to be confined to the right-hand two-thirds of the film thickness. The size of these clusters and the Ca K clusters are significantly different from the Ti K distribution.

Figure 24. Panel 5 coating free film oriented along the y-axis.

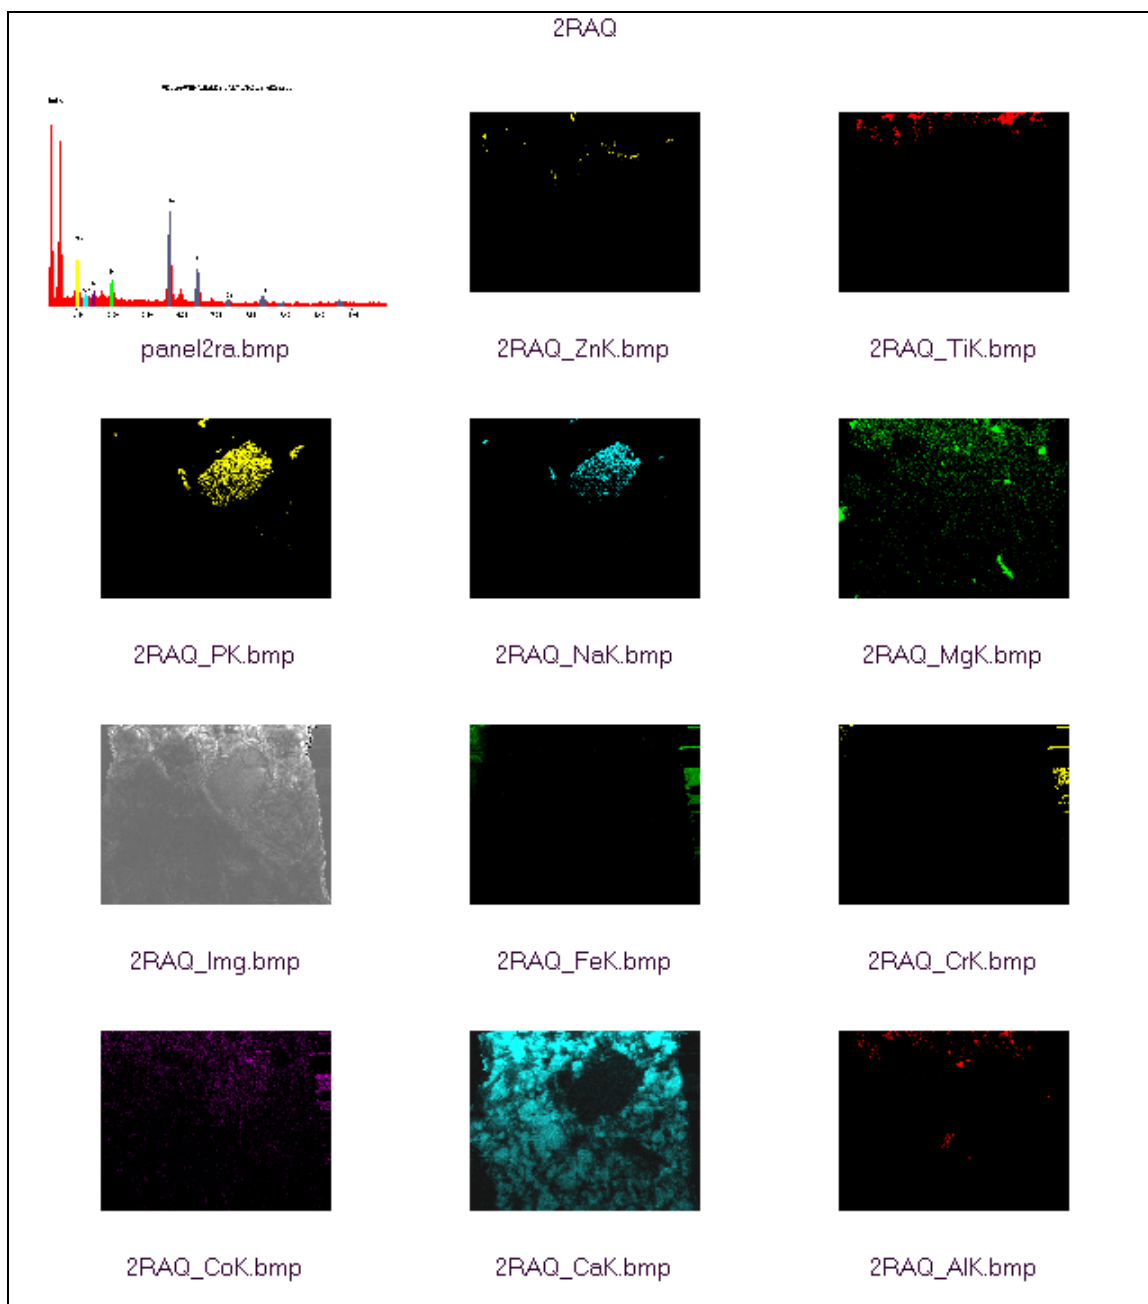
figures 26 and 27. As in the panel 5 free film, the Na, P and Zn maps exhibit large particles in the film.

The differences between figures 26 and 27 arise from the differences in the film geometry at the two sites. The surface plane labeled RAQ faces the EDS detector directly, while the surface plane labeled RBQ slopes off to the right. Note the difference of the Cr K maps between the two sites. The sample was apparently rotated to the apparent 90° position and tilted to expose the left hand image face of the coating. The mappings are mislabeled and reversed. The S-4700 does

Figure 26. Quant mapping results from panel 2 free film, y-axis alignment.

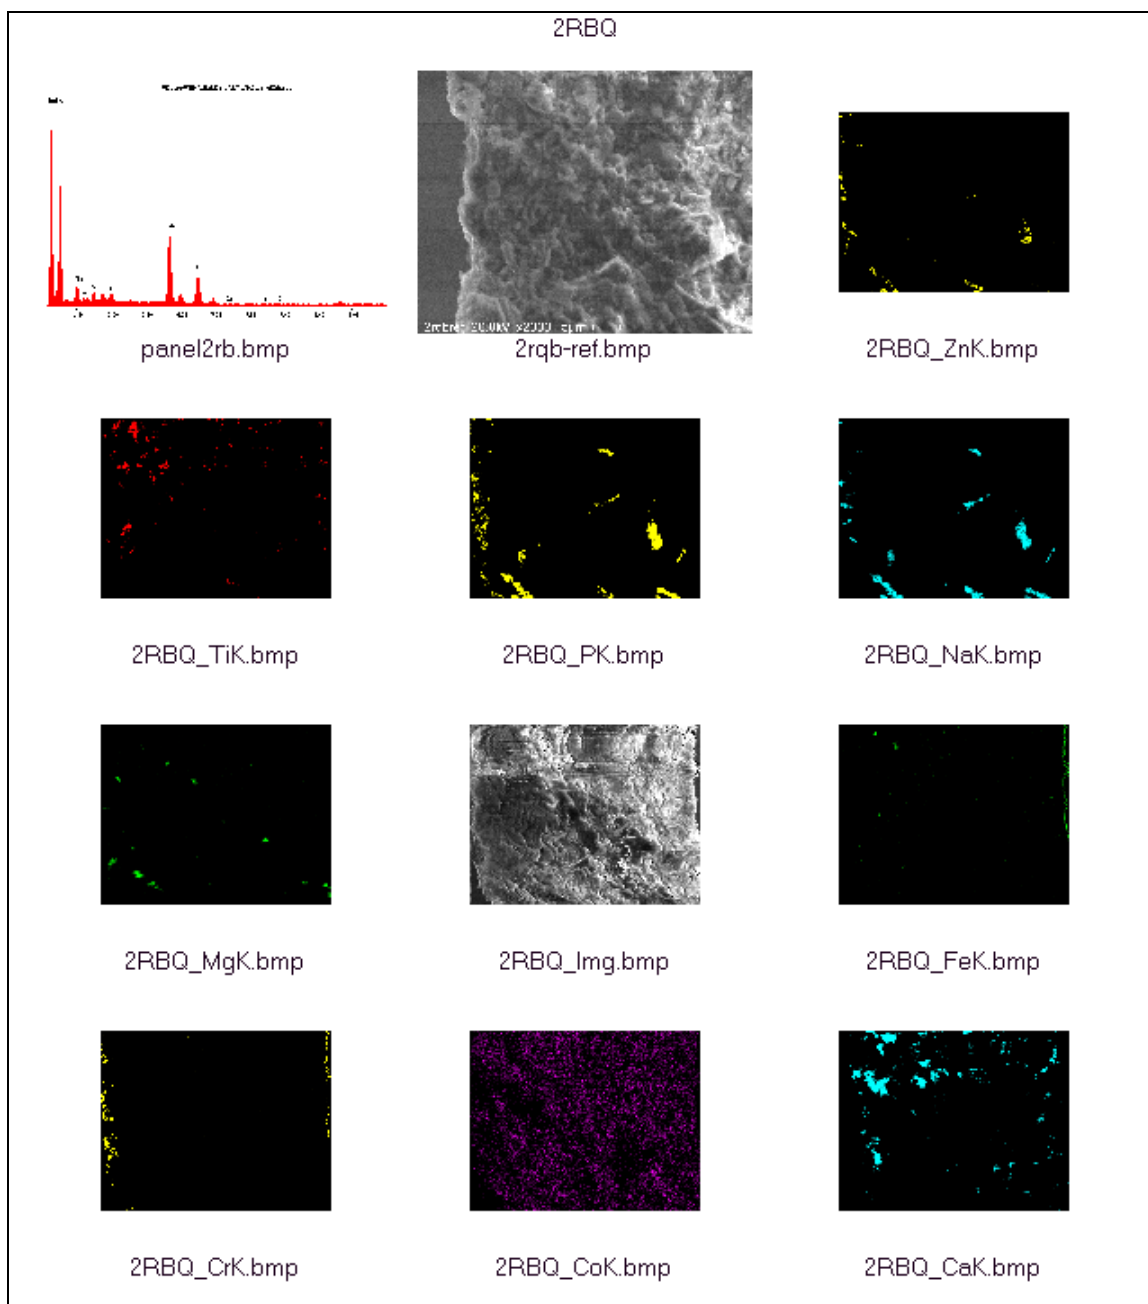
Figure 27. Second Quant mapping of panel 2 free film, y-axis alignment.

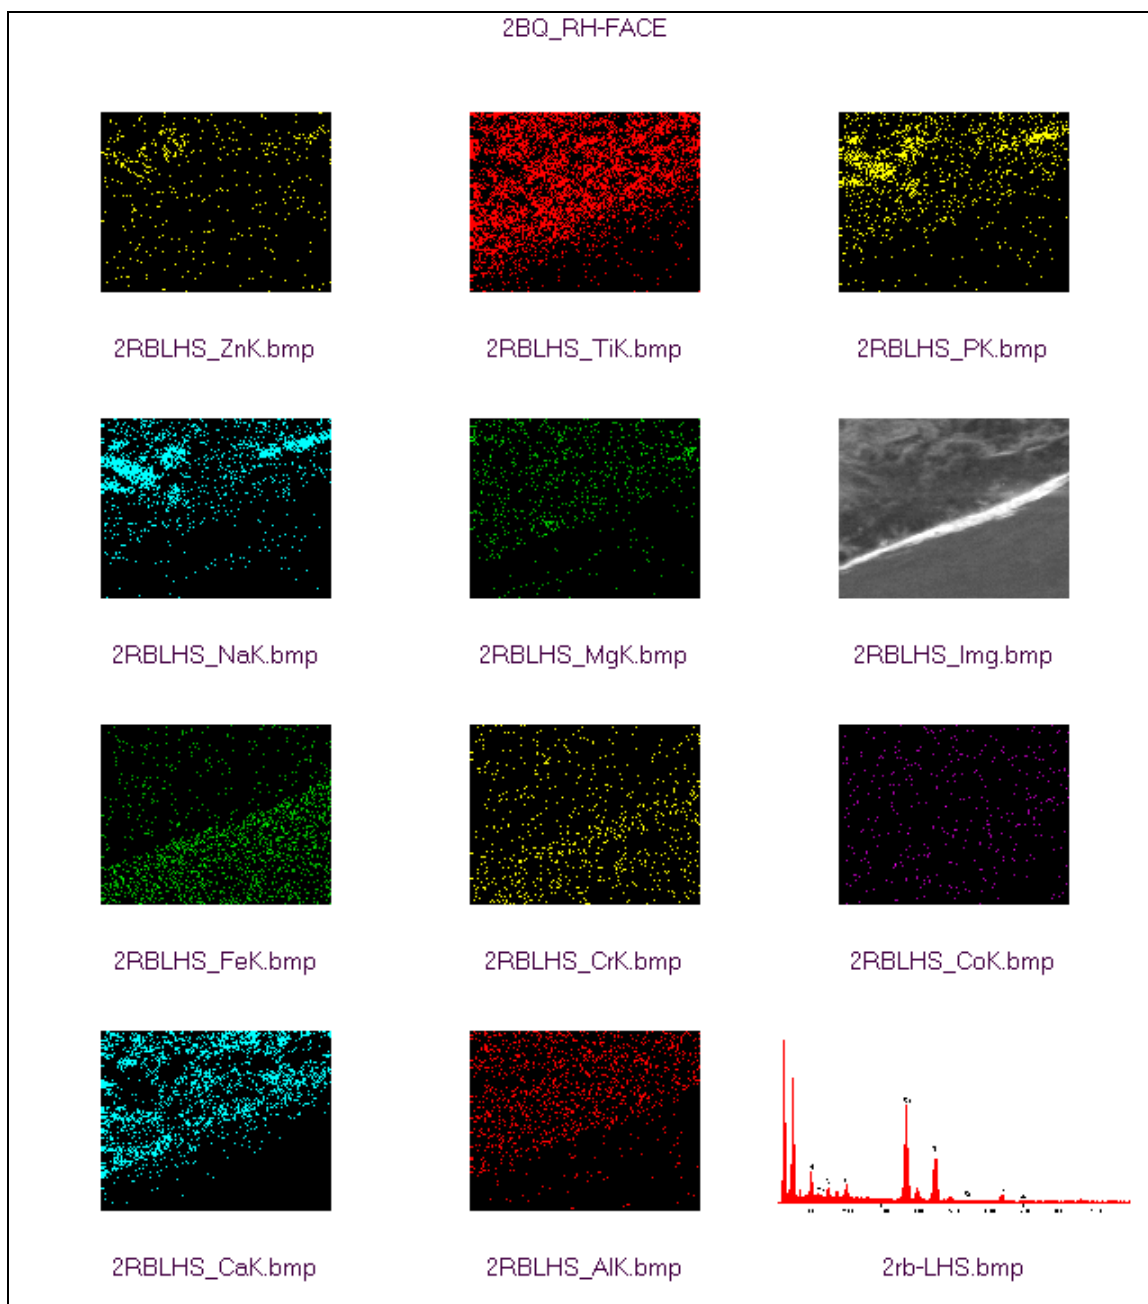
The Cr K maps in figures 29 and 30 appear to be similar for each edge. This may be a result of stacking the panels coated face to chromated face. These Live maps don't have sufficient information to identify a panel interface surface (figure 31).

Figure 29. Live elemental map of right-hand face of panel 2 free film, mapped at 20-KeV, 2-KX, and 100-ms dwell time.

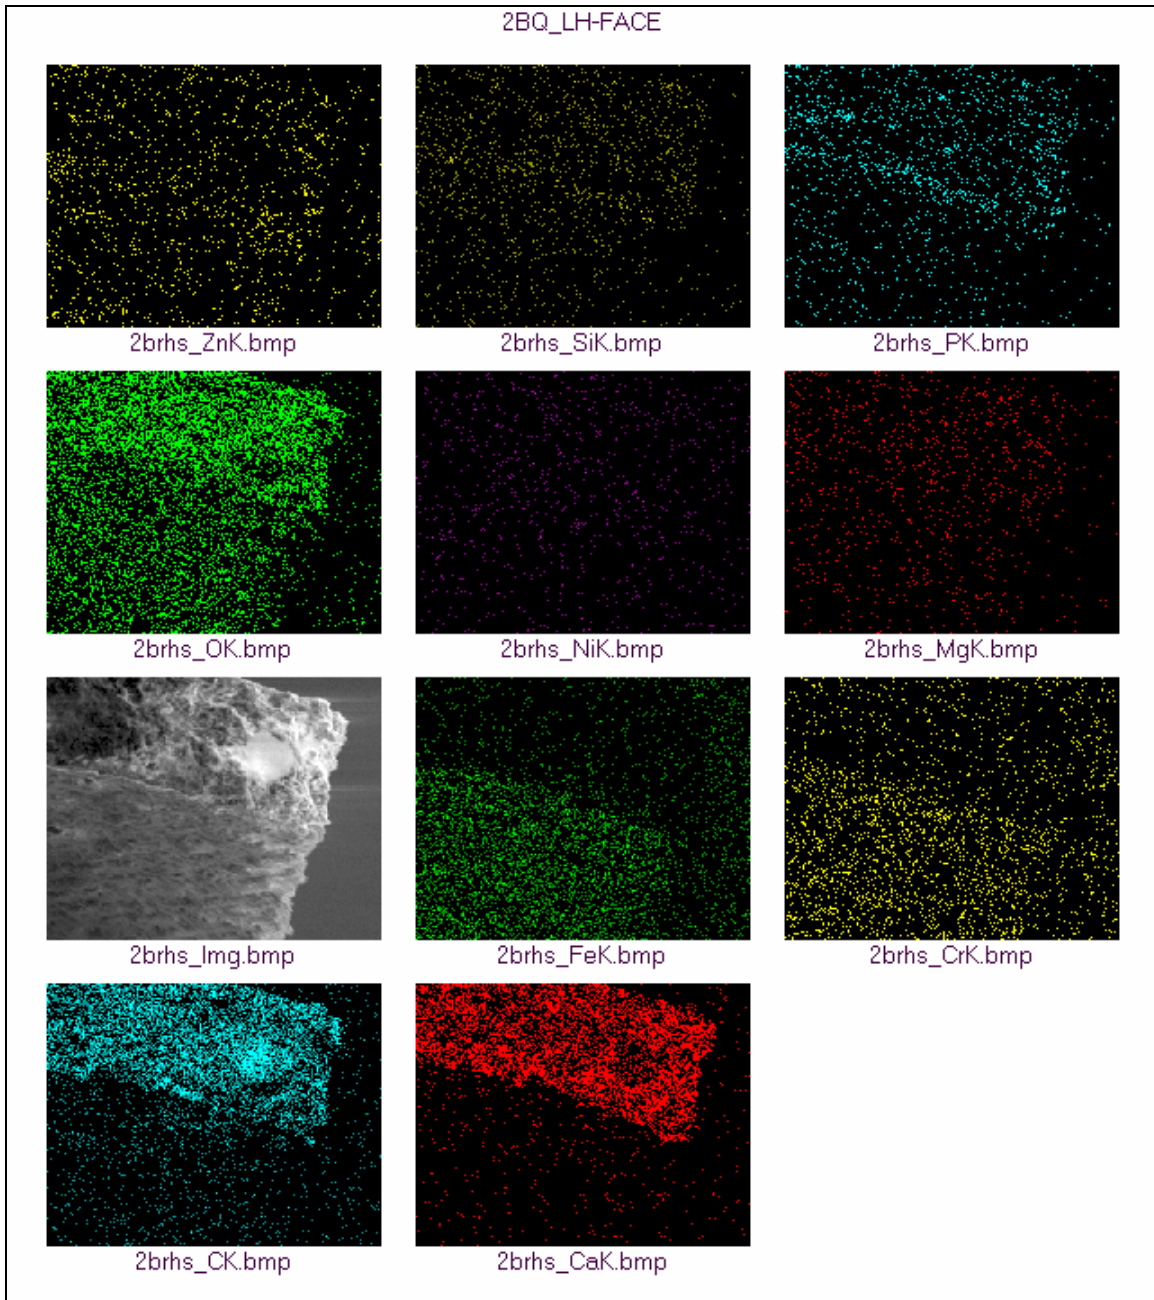
Figure 30. Live elemental map of panel 2 free film, left-hand face at 20-KeV, 900x, and 125-ms dwell time.

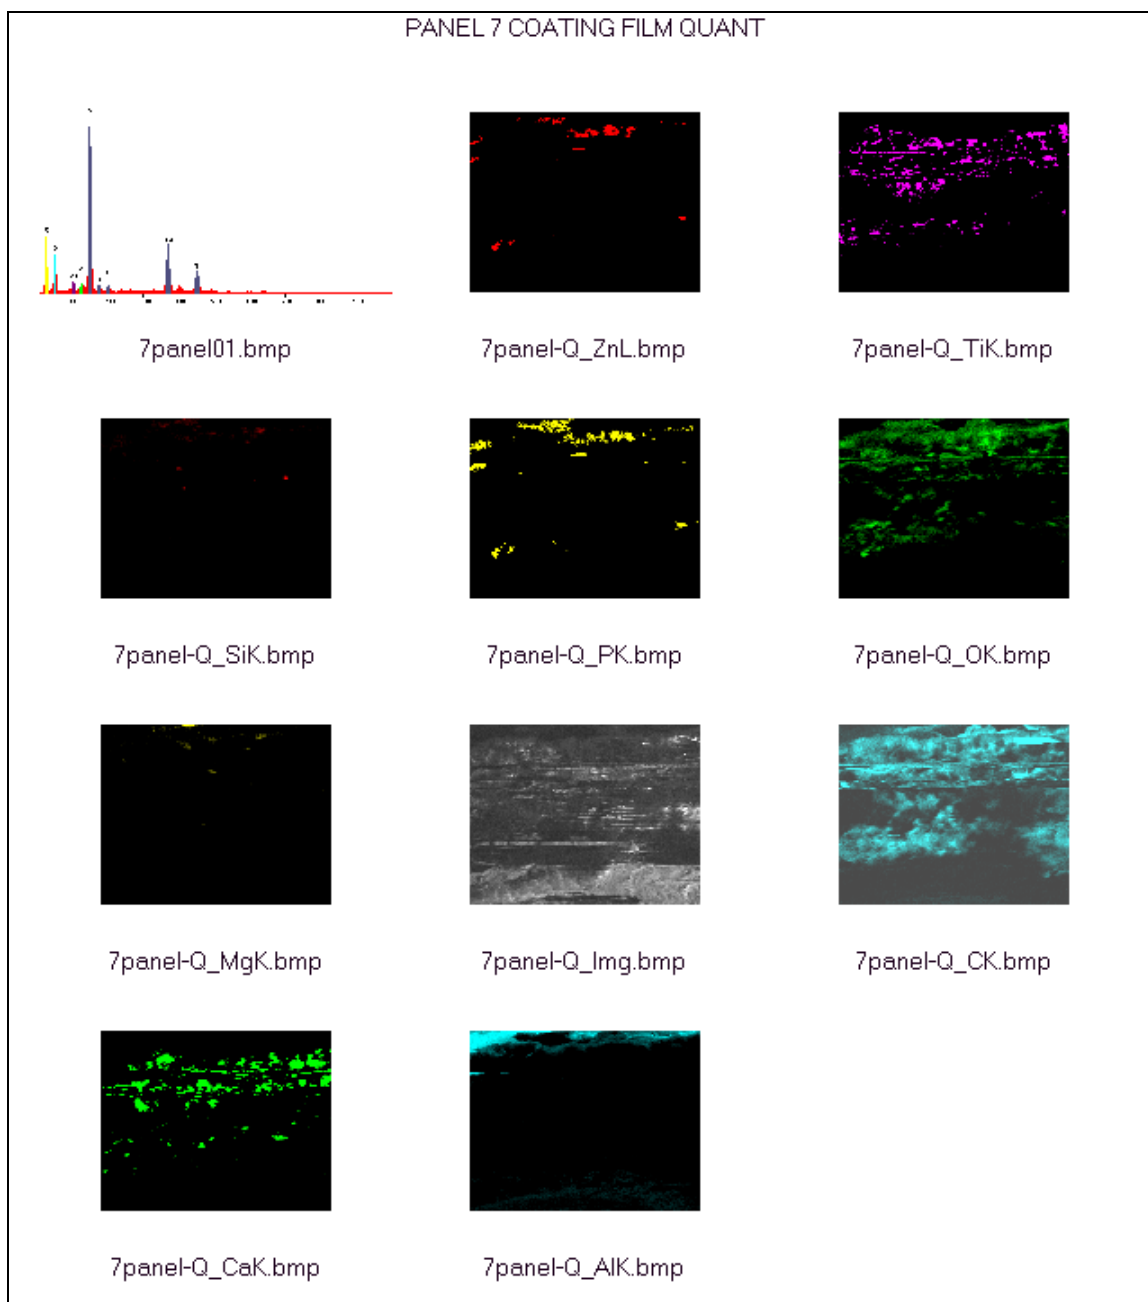
In figure 33, note the Al K map and then the distributions seen in the Zn L and P K maps. For panel 7, the Zn P inclusions are closely associated with the panel coating interface area, indicating the primer chemical and physical distributions. This primer was applied to all the panels at the same time. No distinct chromium layer or peak visible.

Figure 33. Elemental map of panel 7 coating cross section.
