**ROYAL AIRCRAFT ESTABLISHMENT**  
F A R N B O R O U G H , H A N T S

**REVIEWED ON:** TECHNICAL NOTE: No. ARM.534

**DEVELOPMENT OF THE  
INDICATOR, ANTI-SUBMARINE,  
TRAINING No.1, Mk.1**

January, 1954

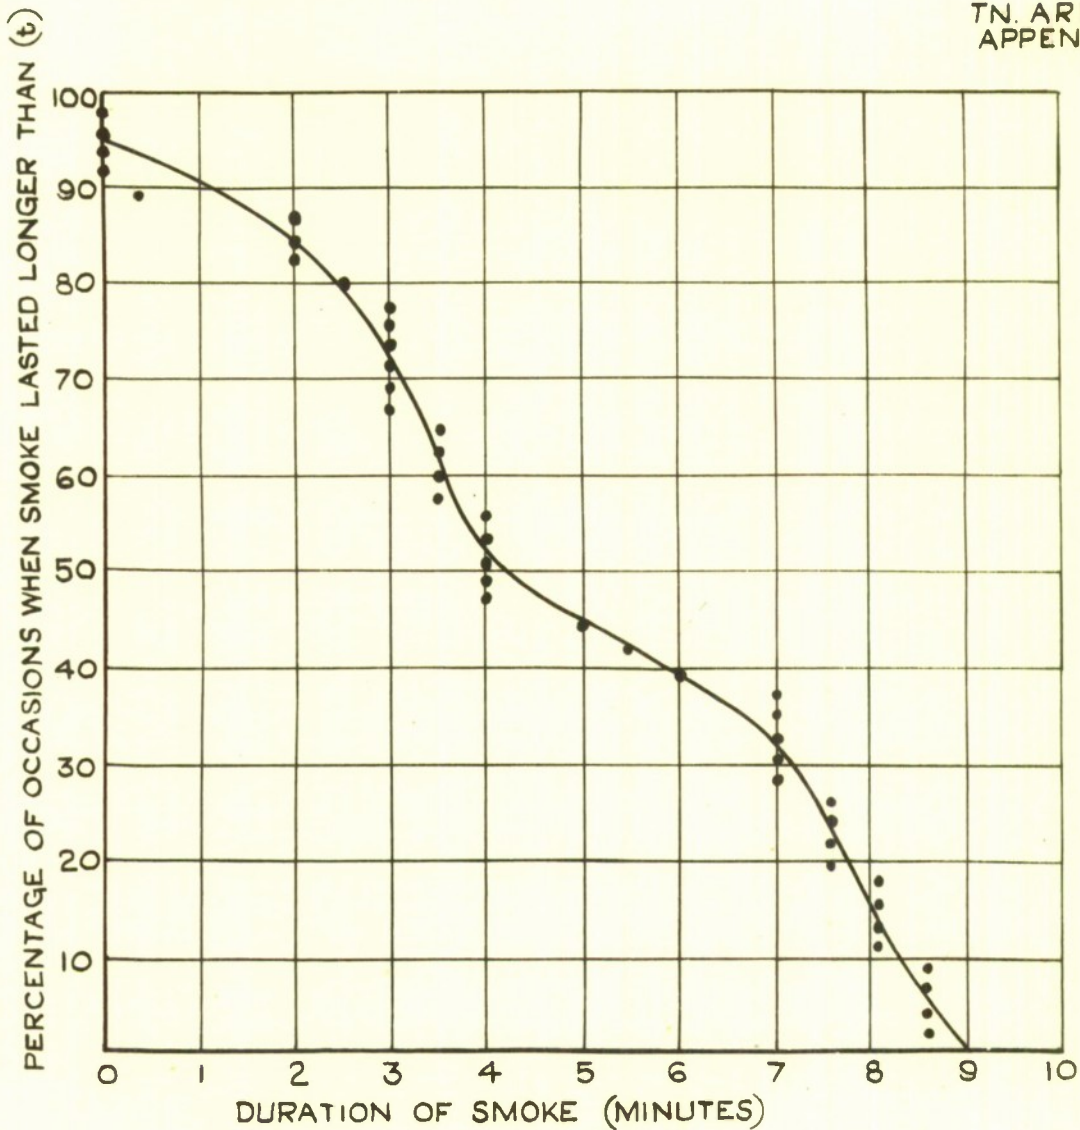
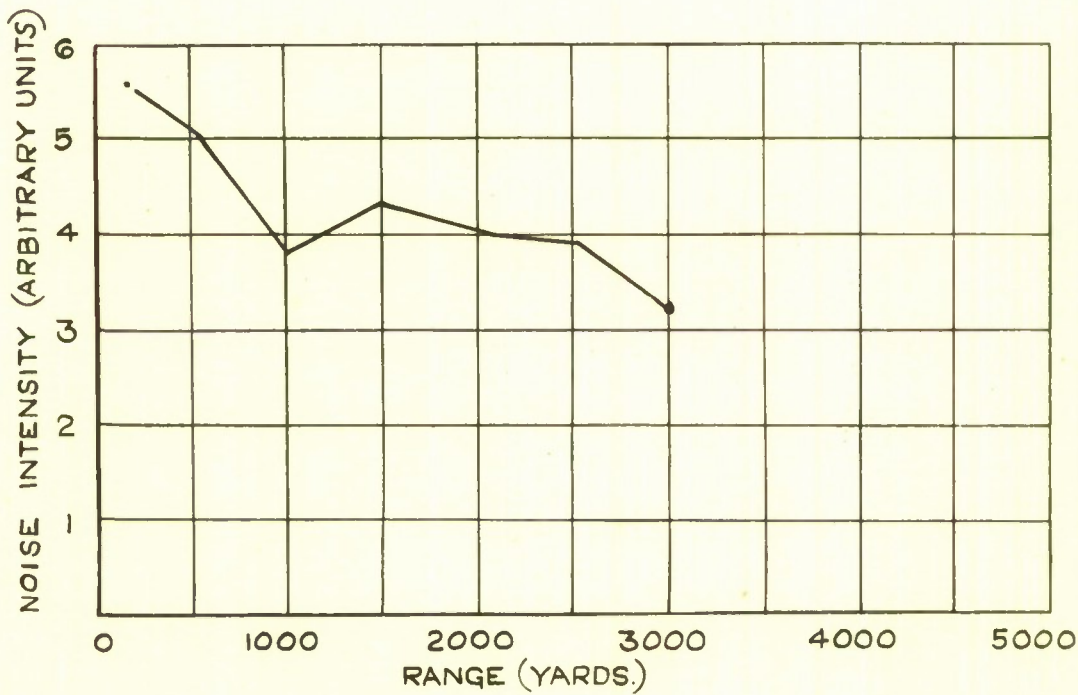
- (a) Serviceability
    - Sound Unit - 95.5% - (2 explosions not heard)
    - Smoke Unit - 88% - (5 gave smoke for less than 1 minute)
    - Overall Unit - 84% - (7 unserviceable sound or smoke).
  - (b) Sound Unit - Audibility Range
  - (c) Smoke Unit - Burning times
  - (d) Smoke Visibility Ranges - observations were not reported.
- } See graphs reproduced at Appendix IV.

LENGTH OF TIME SMOKE  
COMPONENT FUNCTIONED.

AUDIBILITY OF CHARGE.

INDICATOR A/S TRAINING No. 1 MK I - A.S.W.D.U. TRIAL No. 337.  
PERFORMANCE OF STORES WITH 203 SOUND CHARGE.  
EX REPORT R.A.F. ST. MAWGAN - A.S.W.D.U./C20/464 TRIALS-8/53.

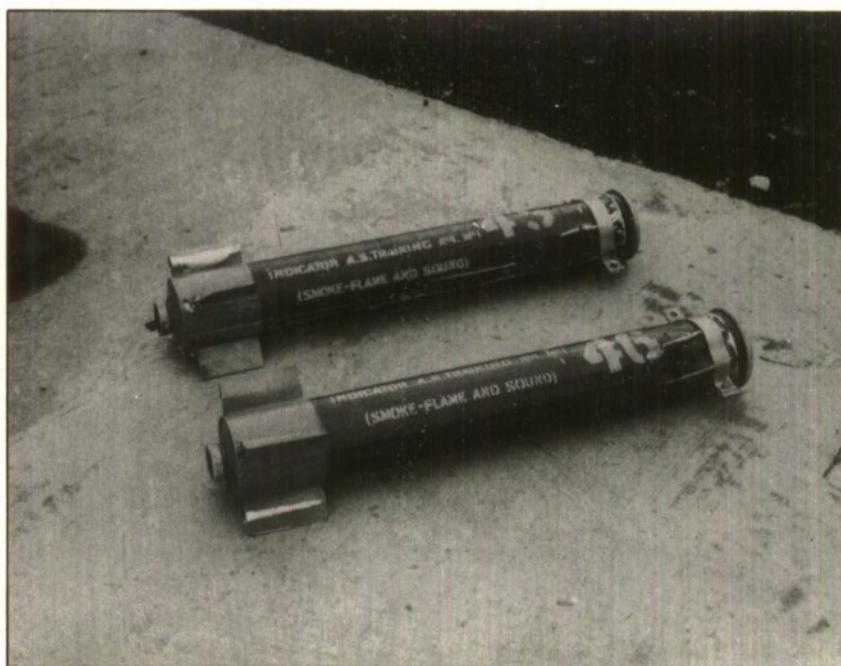
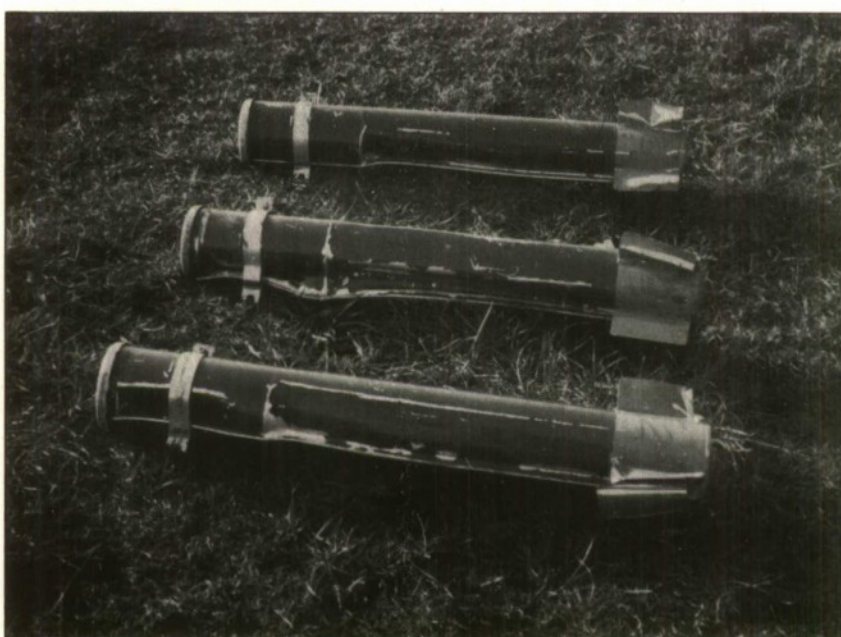
FIG.2. INDICATOR, A/S TRAINING No.1, Mk.1  
DAMAGE CAUSED TO PROTOTYPE FLOATS BY SOUND UNIT FUNCTIONING

In equipping the float to withstand the high crushing forces imparted by the functioning of the sound unit Fig.2 it was considered that the spruce liner support should be replaced by materials possessing:

Outward bulging and or splitting of the casing rear end, non bursting of the rupture disc (0.0015 thick copper foil) or complete removal of the emission housing confirmed the presence of excessive pressure within the floats at ignition.

1. 24 S.W.G. (.022) M.S. OUTER CASING WITH SPRUCE SUPPORT LINER

2. 24 S.W.G. (.022) M.S. OUTER CASING LINED WITH SPRUCE AFT AND MAGNESIUM ALLOY SLEEVE CASTING FORWARD

- (I) Higher radial compressive strength.
- (II) Low and consistent density (for floatation).
- (III) Low Moisture content (to improve the shelf life of the pyrotechnic compositions).

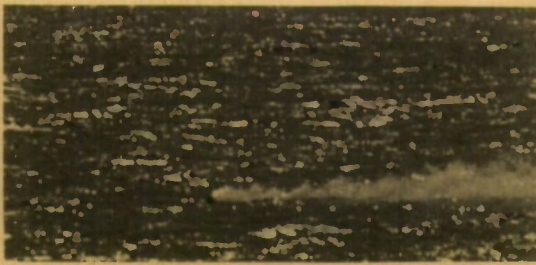
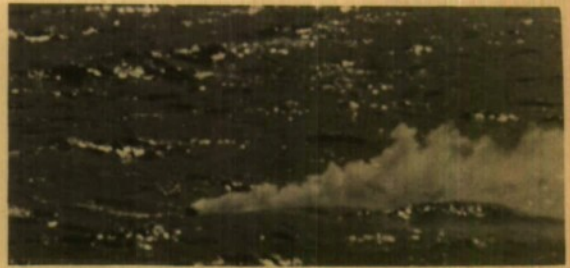
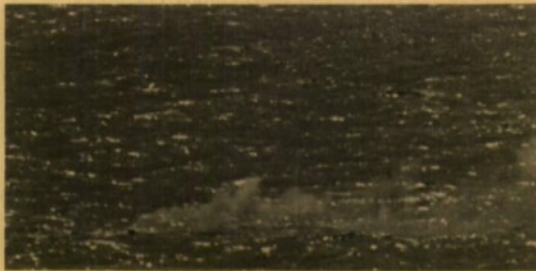
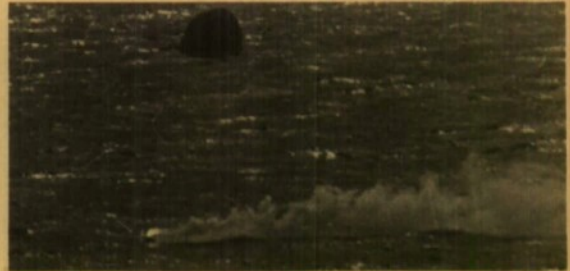
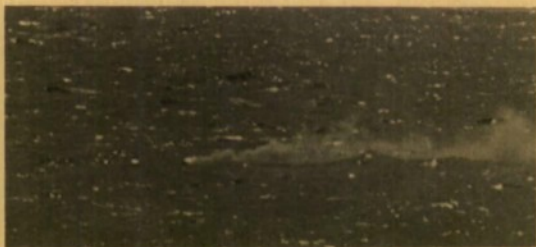
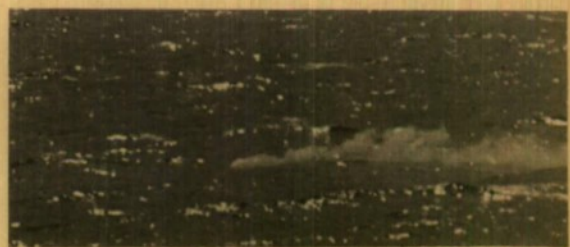
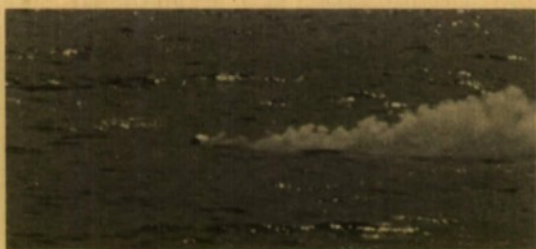
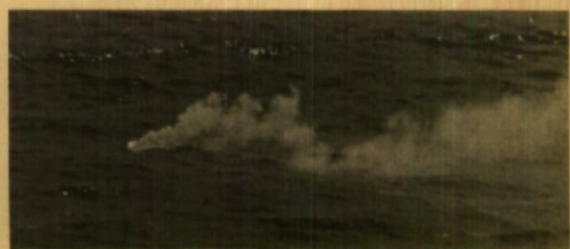
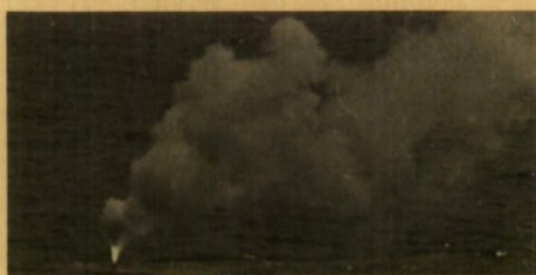
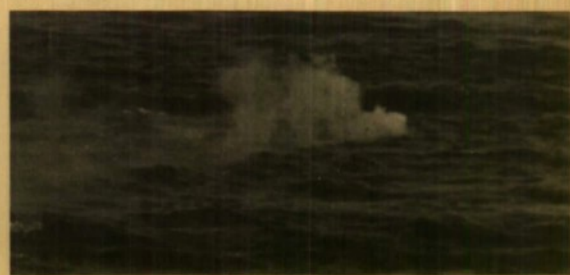
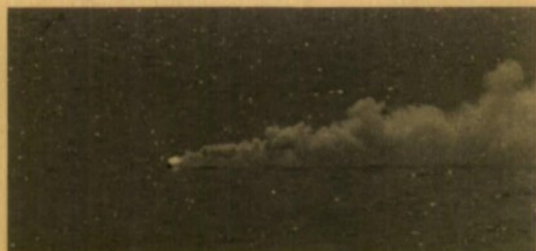
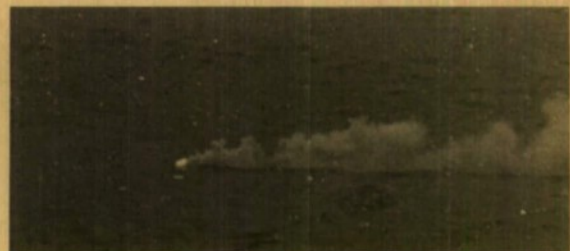
FIG.3. INDICATOR, A/S TRAINING No.1, Mk.1

The functioning of these stores was satisfactory throughout. In light sea and wind conditions all gave good smoke and flame, Fig.3 for times ranging from  $5\frac{1}{2}$  to 7 minutes. These results having shown that the ideals of store arrangement and performance had almost been attained, clearance was accordingly given for the completion of manufacture of the outstanding Indicators (with 20 S.W.G. Aluminium emission cone as preferred by manufacturers).

DEVELOPMENT TRIAL (5) - AIR PROOF - WESTON-SUPER-MARE, 21-6-51

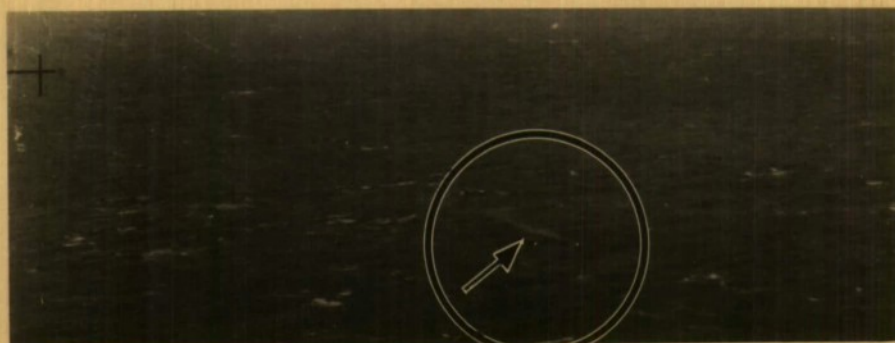
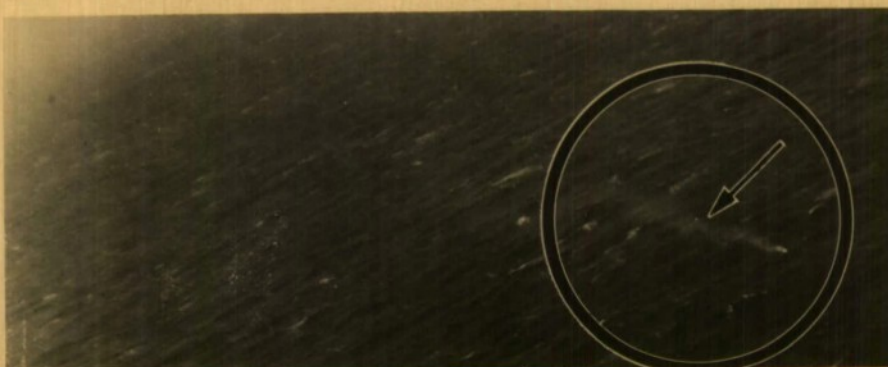
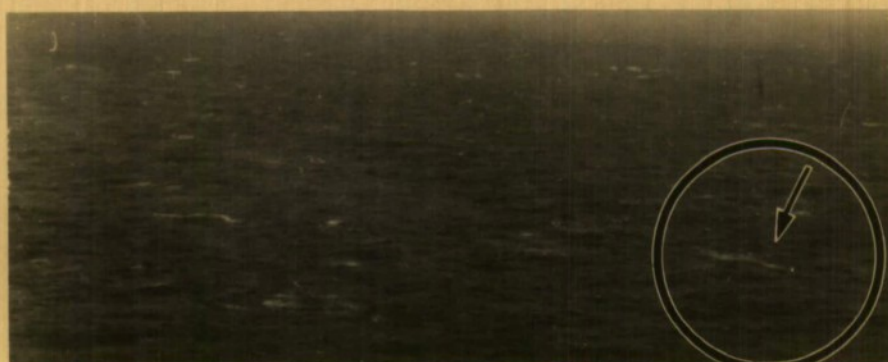
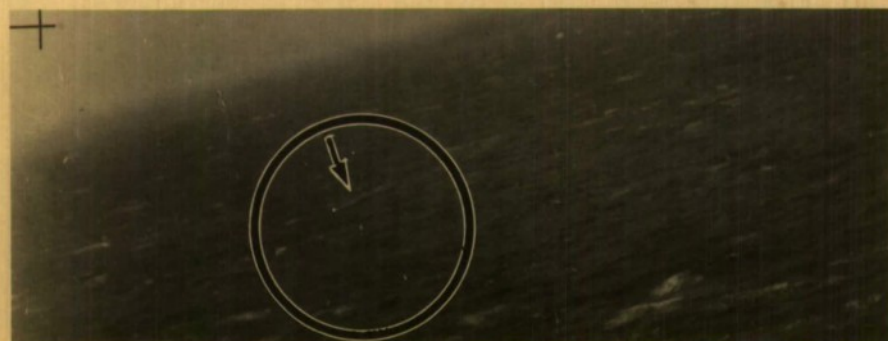
the eight Indicators which were seen to produce smoke. Air photographs of four of these are given in Fig.4. A photograph taken of a Marker Marine emission with that from an Indicator alongside Fig.4/4 failed to register the former. Visually, the emission from the Indicator was adjudged to be as effective as that produced by the marker.

EMISSIONS 2  
A.S.T.I. (DROP 6)  
& 1 MARKER MARINE  
NO.2 SOMEWHERE.  
HEIGHT  
1000 FT } ESTD.  
RANGE  
1500 YDS }

A.S.T.I. EMISSION  
(DROP 8) FROM  
HEIGHT  
5000 FT } ESTD.  
RANGE  
1000 YDS }

A.S.T.I. EMISSION  
(DROP 9) FROM  
HEIGHT  
250 FT } ESTD.  
RANGE  
600 YDS }

A.S.T.I. EMISSION  
(DROP 11) FROM  
HEIGHT  
250 FT } ESTD.  
RANGE  
800 YDS }  
NOTE. NO REPRO-  
DUCTION OF MARKER  
MARINE SEEN BURNING  
ALONGSIDE.

A.S.T.I. EMISSION  
(DROP 14) FROM  
HEIGHT  
250 FT } ESTD.  
RANGE  
1000 YDS }  
NOTE. 2 A.S.T.I.  
DROPPED - EMISSION  
FROM BOTH SEEN  
VISUALLY.

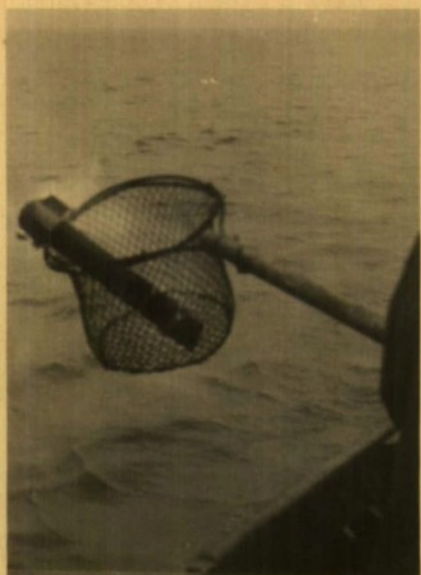
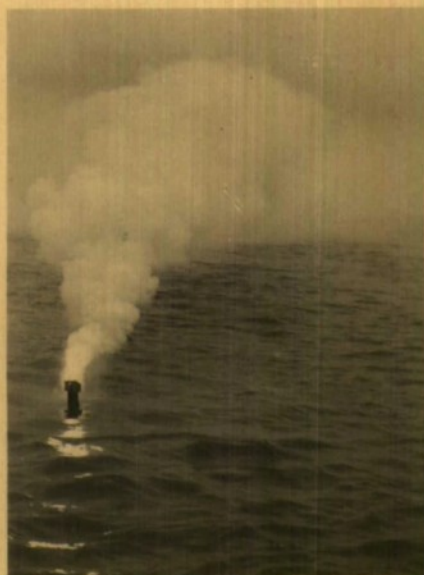
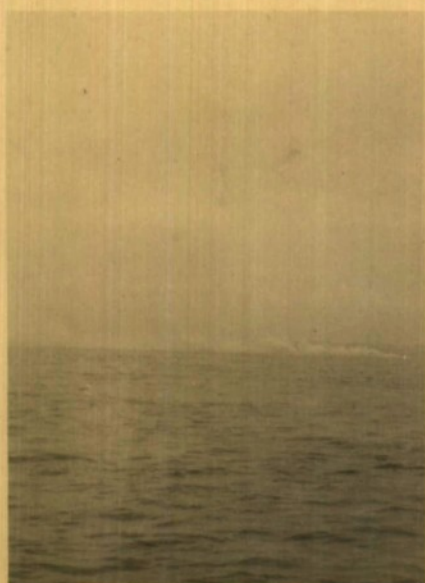
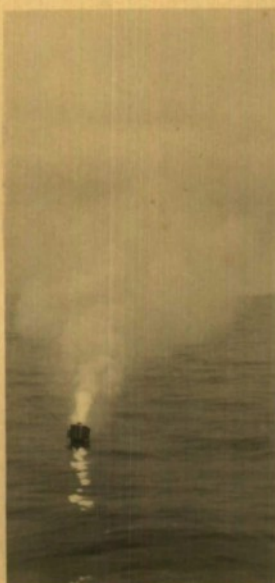
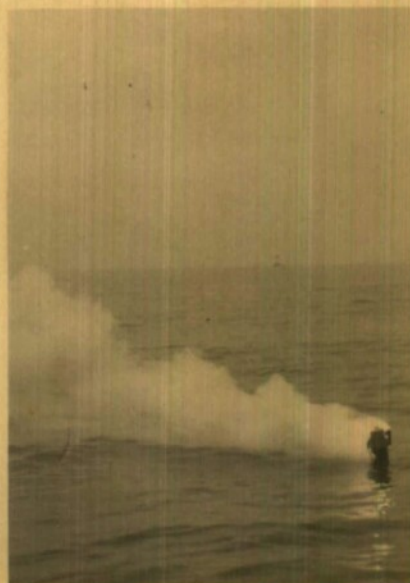
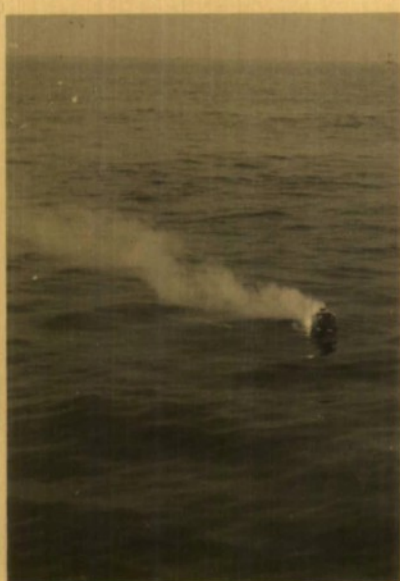
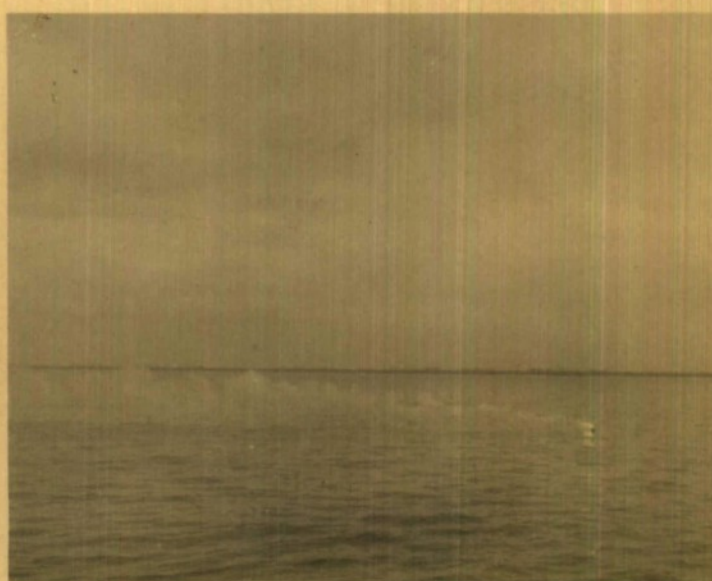
FIG.5. INDICATOR, A/S TRAINING No.1, Mk.1

DEVELOPMENT TRIAL (8) - AIR PROOF - ENGLISH CHANNEL, 7-1-53

1. No.1 - RECOVERY, BURNING COMPLETED  
NOTE ABSENCE OF DAMAGE TO FLOAT
